# Walmersley Old Road, Bury BL9 6RZ

## Site Information

| Description | The land at Walmersley Old Road, Bury BL9 6RZ is some 0.64 hectares in extent and is greenbelt land. | Existing Use | Vacant Land |

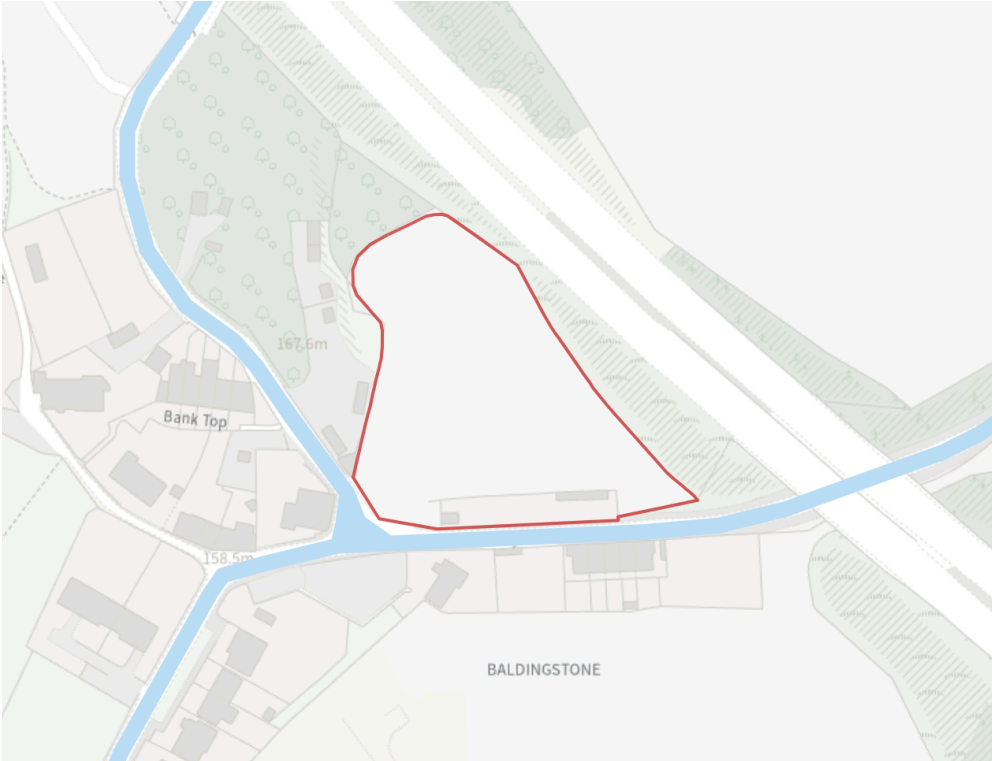
| ACCESS | STATUS | CONCLUSION |
|---|---|---|
| Access to Adopted Road<br>Potential Access Roads | ✔ Yes | <i>The site has direct access to an adopted public road via Bentley Lane, meaning no third-party permissions are required to establish a suitable access point.</i> |

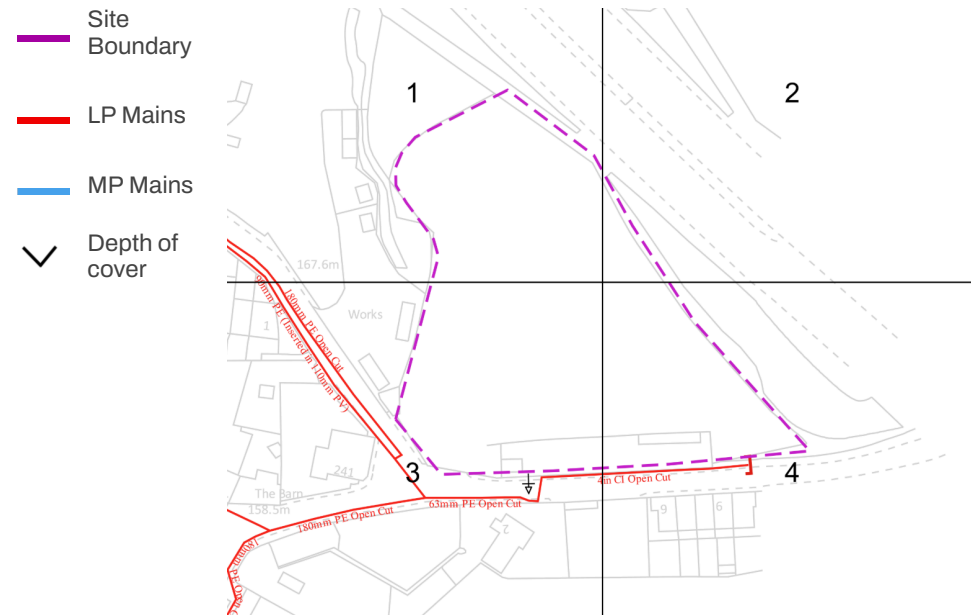
| Gas Utilities | Electric Utilities |

| INFRASTRUCTURE | STATUS | CONCLUSION |
|---|---|---|
| Utility Connectivity | ✓ Good | <i>The site has been reviewed for utility connectivity. The assessment confirms the site is well connected with infrastructure located on Walmersley Old Road and Bentley Lane. LP mains are located south of its boundaries along Bentley Lane. LV cables are located south and southwest of its boundaries along Walmersley Old Road and Bentley Lane. Combined Public Sewers are located southwest of its boundaries along Walmersley Old Road and Live Distribution Mains are located adjacent to its boundaries, south along Bentley Lane.</i> |

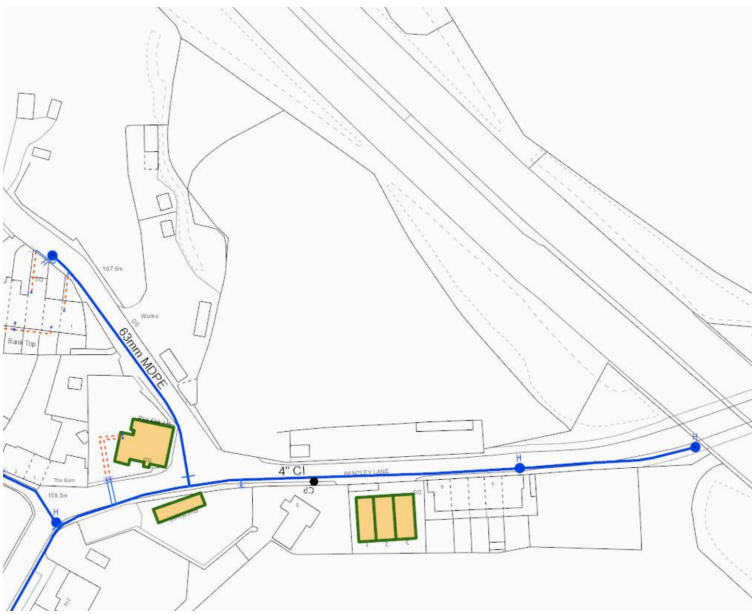
# Clean Water Utilities

- Live Distribution Main

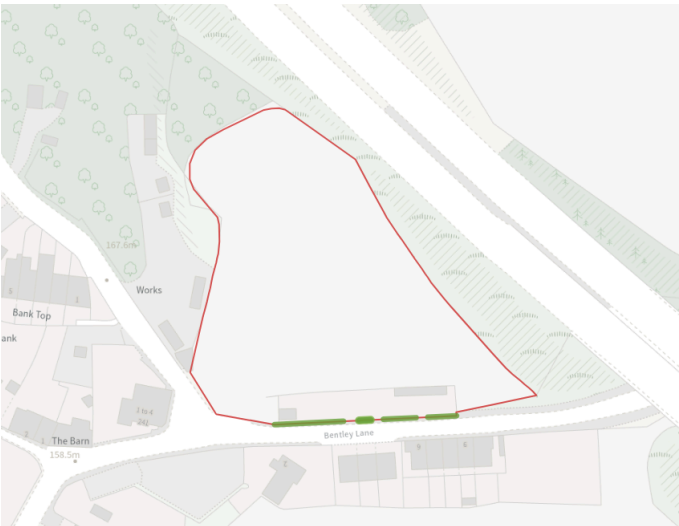
### Hedgerow

The site has been reviewed for Hedgerow. The assessment confirms there is hedgerow present within and adjacent to its boundaries.

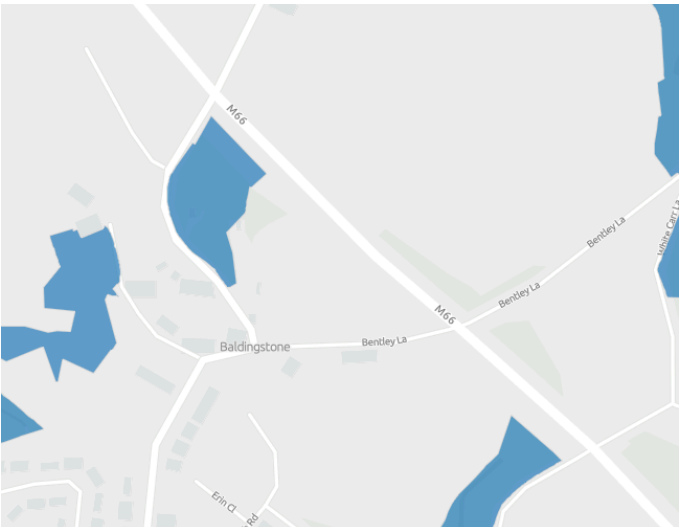
## Forest & Woodland

The site has been reviewed for forest and woodland using the national forest inventory. The assessment confirms that forest and woodland are present adjacent to its boundaries.

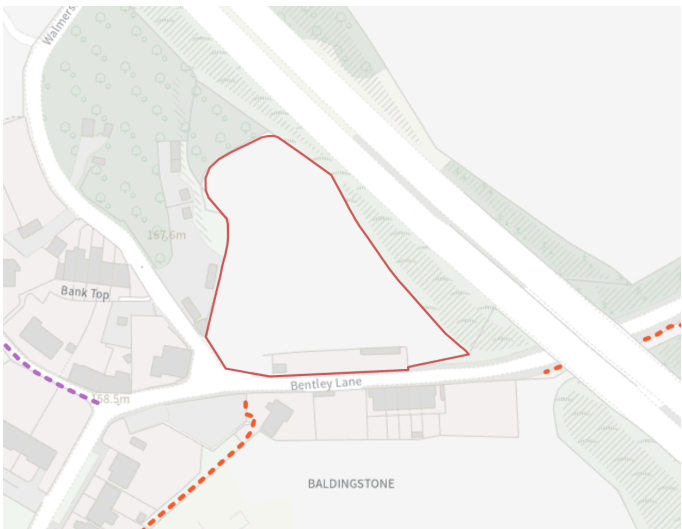
Public Right of Way (PRoW)

The site has been reviewed against local authority mapping records to assess the presence of any Public Rights of Way (PRoW) that may impact development potential. The assessment confirms that a PRoW is present adjacent to the site.

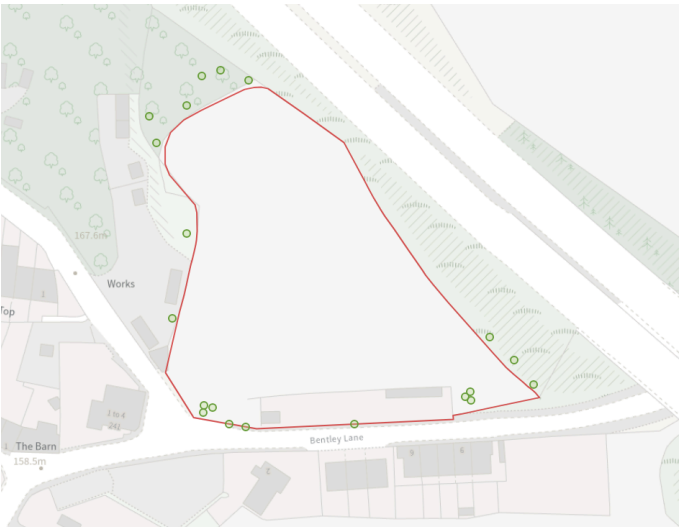
### Mature Trees

The site has been reviewed for mature trees. The assessment confirms there are mature trees within and adjacent to its boundaries

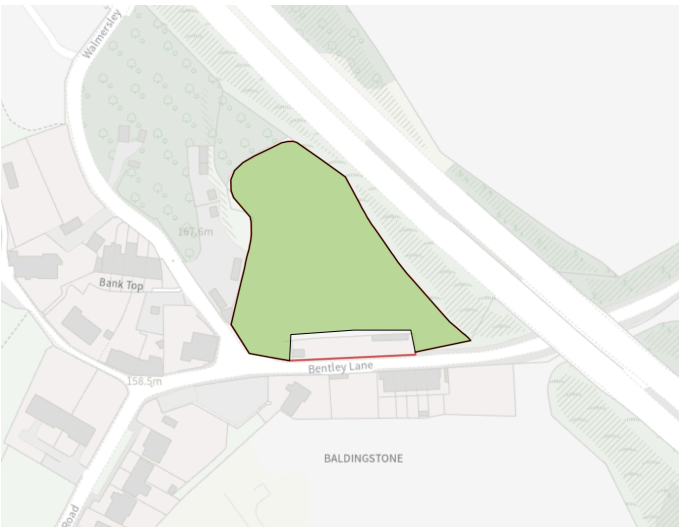
### Overgrown Vegetation

The site has been assessed for overgrown vegetation. The assessment confirms that the site does have overgrown vegetation located within its boundaries.

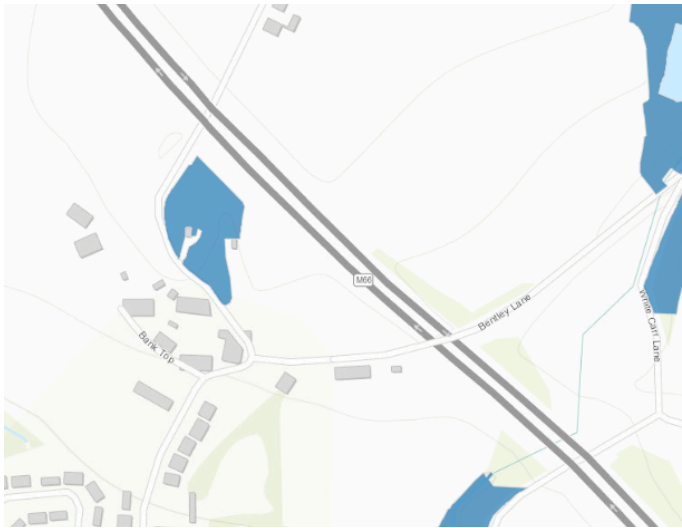
Priority Habitats Inventory

The site has been reviewed for Priority Habitat Areas. The assessment confirms the site is located adjacent to a deciduous woodland priority area.

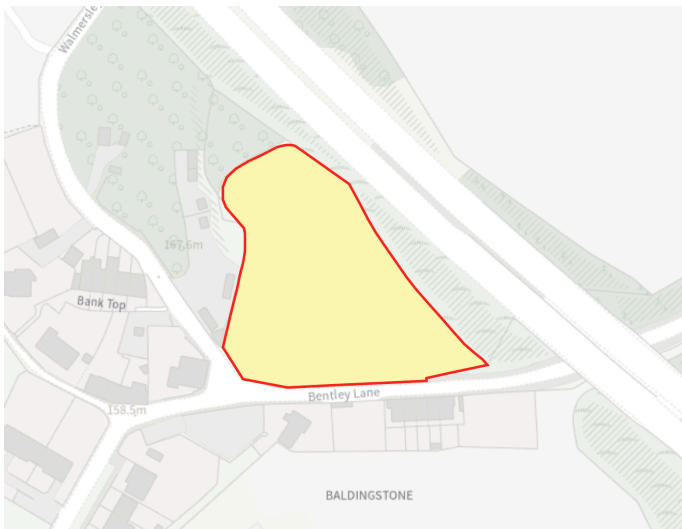
The site has been assessed against the Provisional Agricultural Land Classification (PALC) to determine the quality of the land for agricultural use. The assessment confirms that the site is classified as Grade 4 (Poor)Low agricultural value; unlikely to raise significant planning concerns.

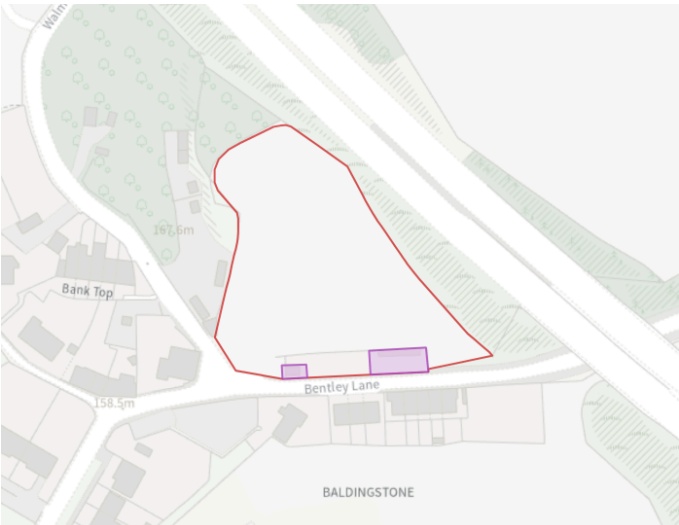
Built Structures

The site has been reviewed for built structures. The assessment confirms there are built structures present within its boundaries.

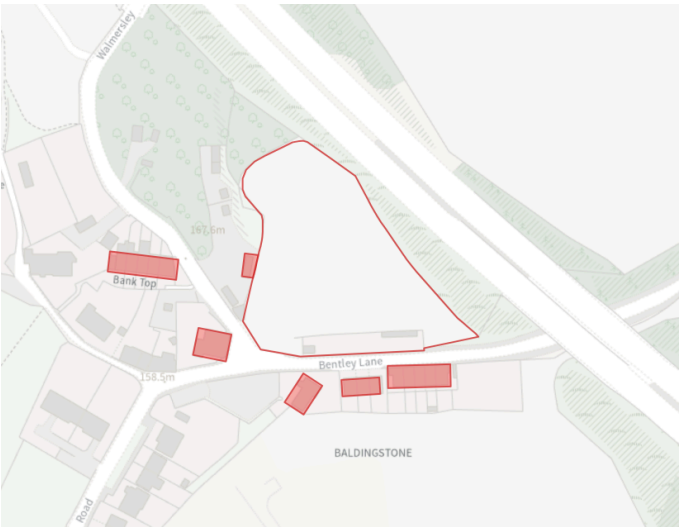
## Surrounding Property

The site has been reviewed for Surrounding Properties. The assessment confirms there are surrounding properties adjacent to its boundaries.

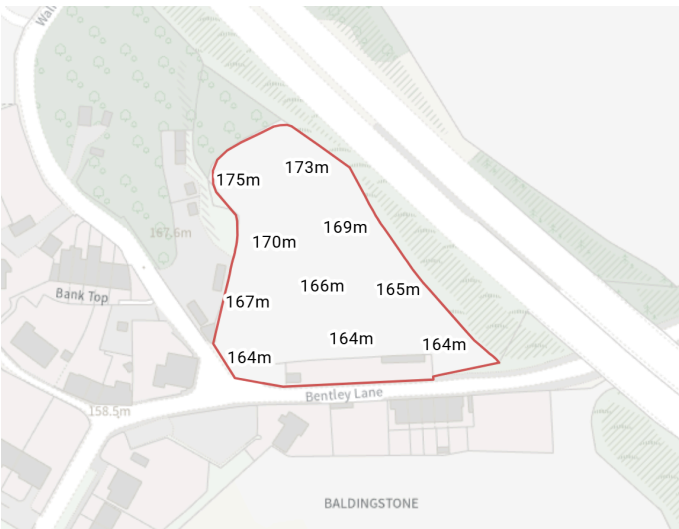
## Topographical Features

The site's topography has been reviewed to assess any natural or man-made features that may impact its development potential. The assessment confirms that the site has varied elevation levels which may pose challenges for site layout, drainage, and access design.

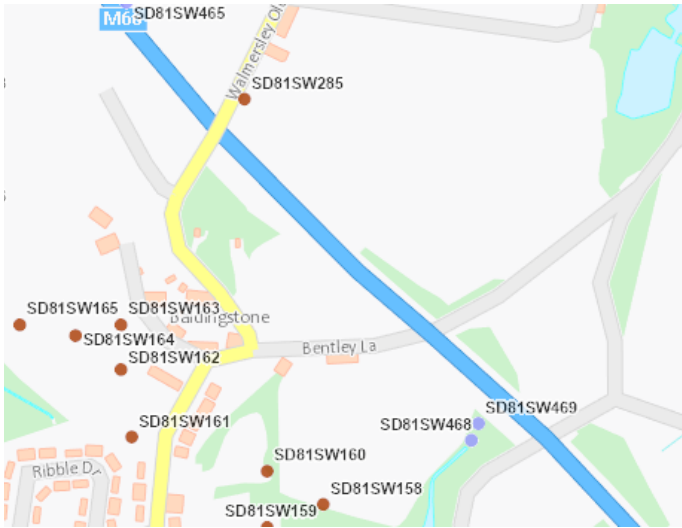
Existing Ground Conditions (Borehole Surveys)

The site has been reviewed for Existing Ground Conditions. The assessment confirms Borehole Surveys are present within 50m of its boundaries.

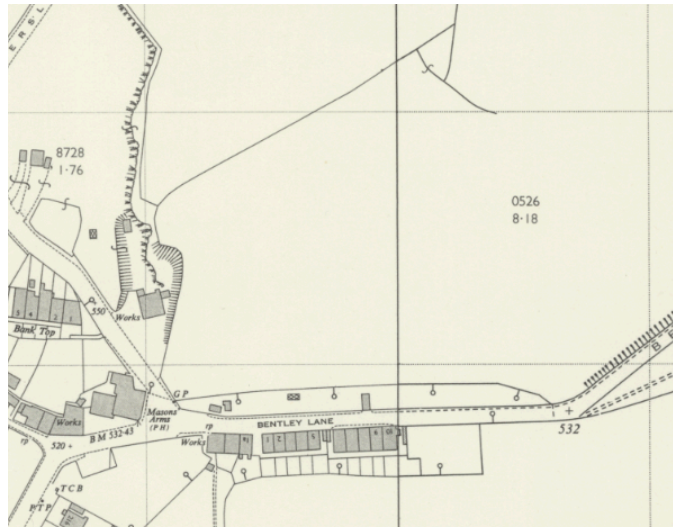
*The site has been reviewed for Previous Site Uses. The assessment confirms there has been no previous site uses however, within 50m of its boundaries there has been Works, Quarry, School and Public House.*

### Works (1949 - 1974)

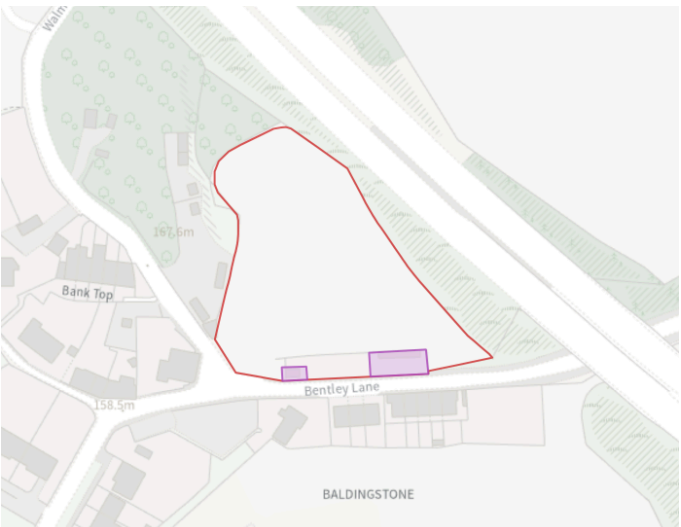
## Existing Foundations

*The site has been reviewed for Existing Foundations. The assessment confirms there are existing foundations present within its boundaries.*
