# **Radcliffe and Redvales FRMS - Hardy's Gate Bridge Flood Gates**

Bat Survey Report

June 2023

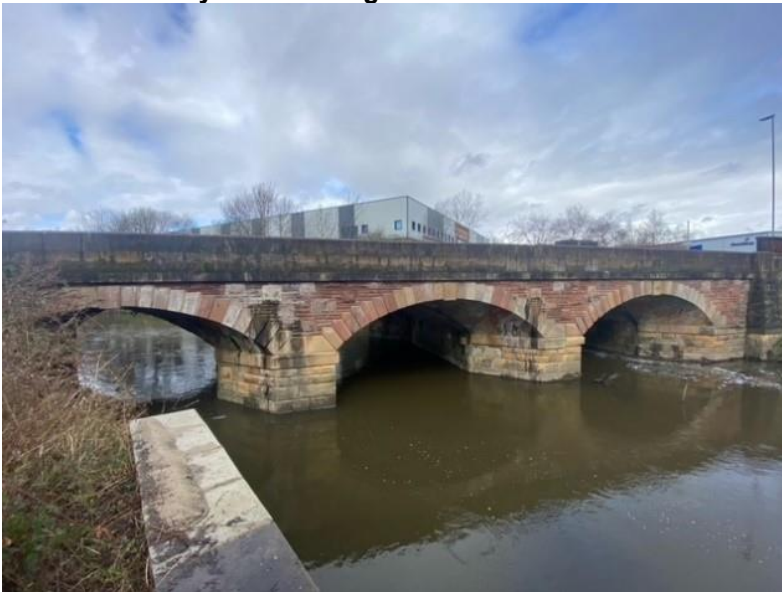
**Photo 1.2: Hardy's Gate Bridge – Eastern Elevation**

Radcliffe and Redvales is an area located on the outskirts of Greater Manchester, encompassing the southern extent of Bury and the western extent of Radcliffe. HGB (central grid reference SD 380253 408426) crosses the River Irwell carrying Dumers Lane, as shown on Figure 1.1 below. HGB is made up of stone blocks and mortar, comprising three arches. The habitat immediately surrounding the structure is riparian habitat comprising broadleaved woodland, scattered scrub and scattered trees. In this location, the River Irwell is prone to flooding with flood waters reaching the underside of HGB during flood events. Surrounding land use comprises industrial buildings and residential estates to the north and south.

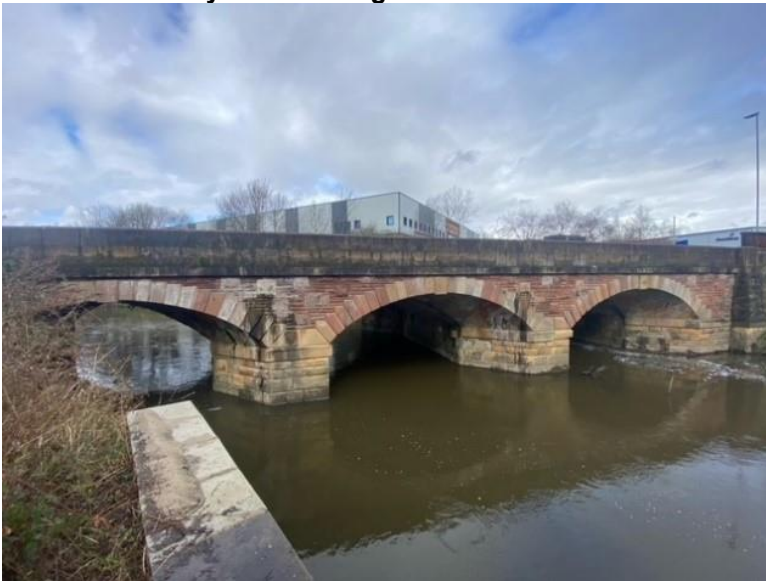
**Photo 3.1: Hardy's Gate Bridge – Eastern Elevation**

A PRA of the structure was undertaken on 23 March 2023. HGB is made up of stone blocks and mortar, comprising three arches. No expansion joints are present as part of the bridge design.

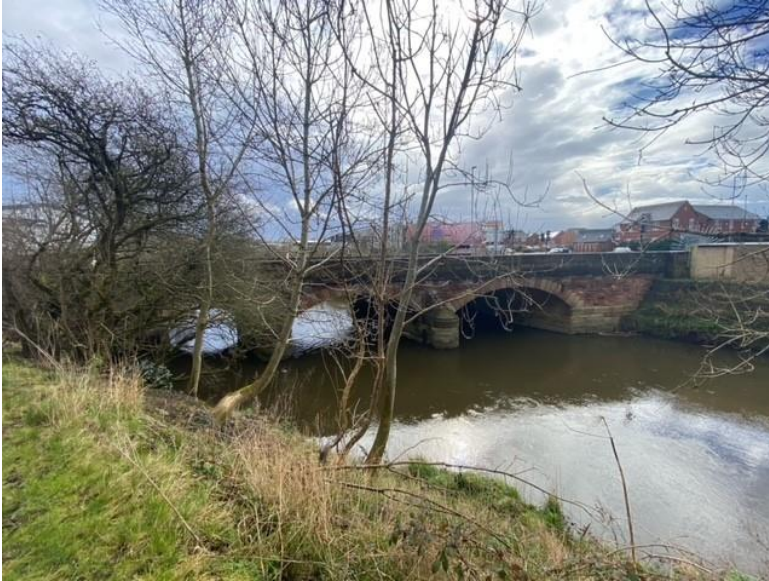
**Photo 3.2: Hardy's Gate Bridge – Western Elevation**

No PRFs were identified within the stone or mortar from an inspection of the eastern or western elevations and the bridge appeared to be well sealed. However, due to the lack of access to the underside of the bridge and limited view to the underside, opportunities for PRFs within the bridge materials, underneath the arches of the bridge, cannot be ruled out. However, images from a 2015 inspection report (Sanderson Watts Associates, 2015) of HGB show the underside of the arches to be well sealed and in good condition. Additionally, repointing work was recommended within the report, which appears to have been undertaken, further reducing the suitability for PRFs.

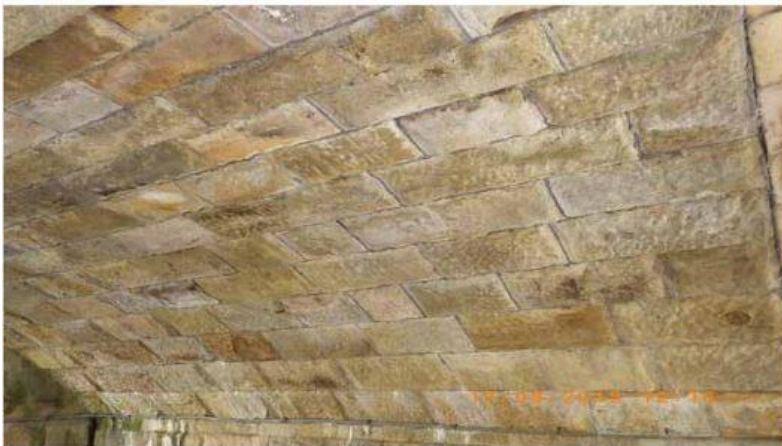
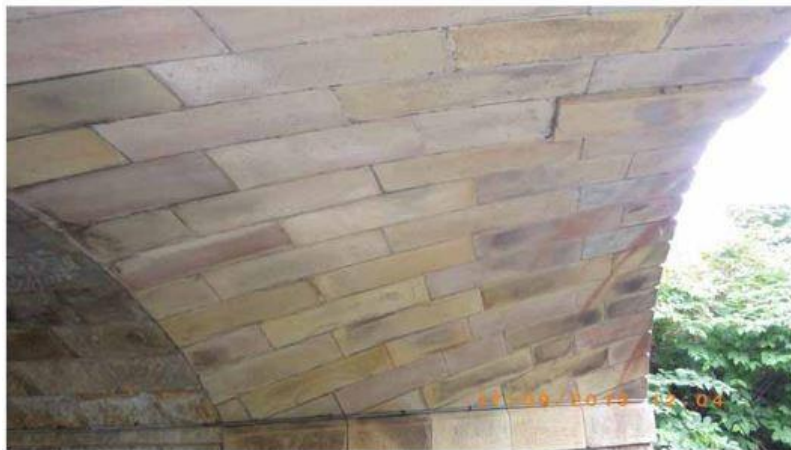
**Photo 3.3: Underside of Hardy's Gate Bridge**

Although it is deemed that the condition of the bridge is unlikely to have deteriorated significantly since the inspection and the repointing work was carried out, due to the age of this inspection report it cannot solely be relied upon for this assessment.

If it is not possible for the works to be undertaken within the bat hibernation period, then a pre-construction detailed inspection of the underside of the bridge should be undertaken, by a Level 2 bat licensed ecologist. This inspection should be undertaken during the active bat season to assess whether there are any PRFs within the underside of the bridge arches. If PRFs are found to be present these should be inspected with an endoscope (where possible) and further recommendations may be advised.

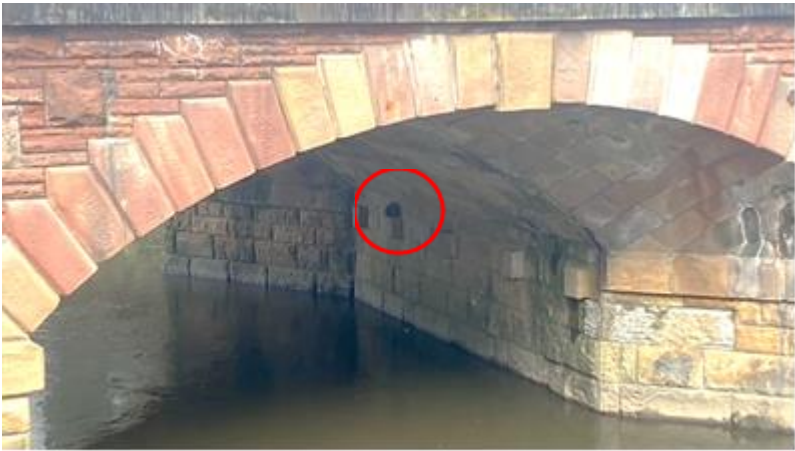
Photo 3.6: Bird Nest – Underneath Arch, Viewed From Eastern Elevation

During the PRA, a bird nest was identified on a narrow ledge underneath an arch of the bridge.

A bird nest was identified underneath the bridge. If the works cannot be undertaken outside of the bird nesting season (taken to be March to August inclusive), a pre-construction check (not more than 24 hours before construction starts) must be undertaken by a suitably experienced ecologist to identify if any birds are nesting within or close to HGB. If a bird nest is found, it must be left in-situ and protected from works; no works can be undertaken in that area until the young birds have fledged from the nest site. This may take up to six weeks depending on the species.

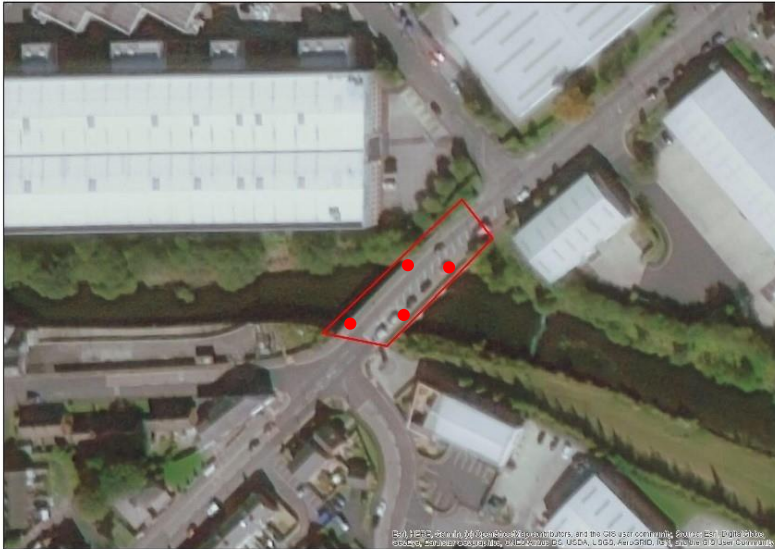
**Figure 3.1: Emergence Survey Surveyor Locations (red dots)**

Positions of surveyors (red dots) during the survey can be found on Figure 3.1 below.

No emergences were recorded during the survey; however, a precautionary principle has been applied to the recommendations due to limited visibility from reflections off the watercourse surface during the survey and constant bat activity for the duration of the survey.

Bats were observed persistently foraging and commuting along the riparian corridor, through and around the arches of HGB and foraging on the surface of the watercourse for the duration of the survey. Therefore, it was not possible to conclusively rule out bats emerging from the underside of HGB.
