## Phase 1 GeoEnvironmental Desk Study

4 Butt Hill Road

**4 BUTT HILL ROAD, PRESTWICH**

**Report No. A6372/24/BDS**

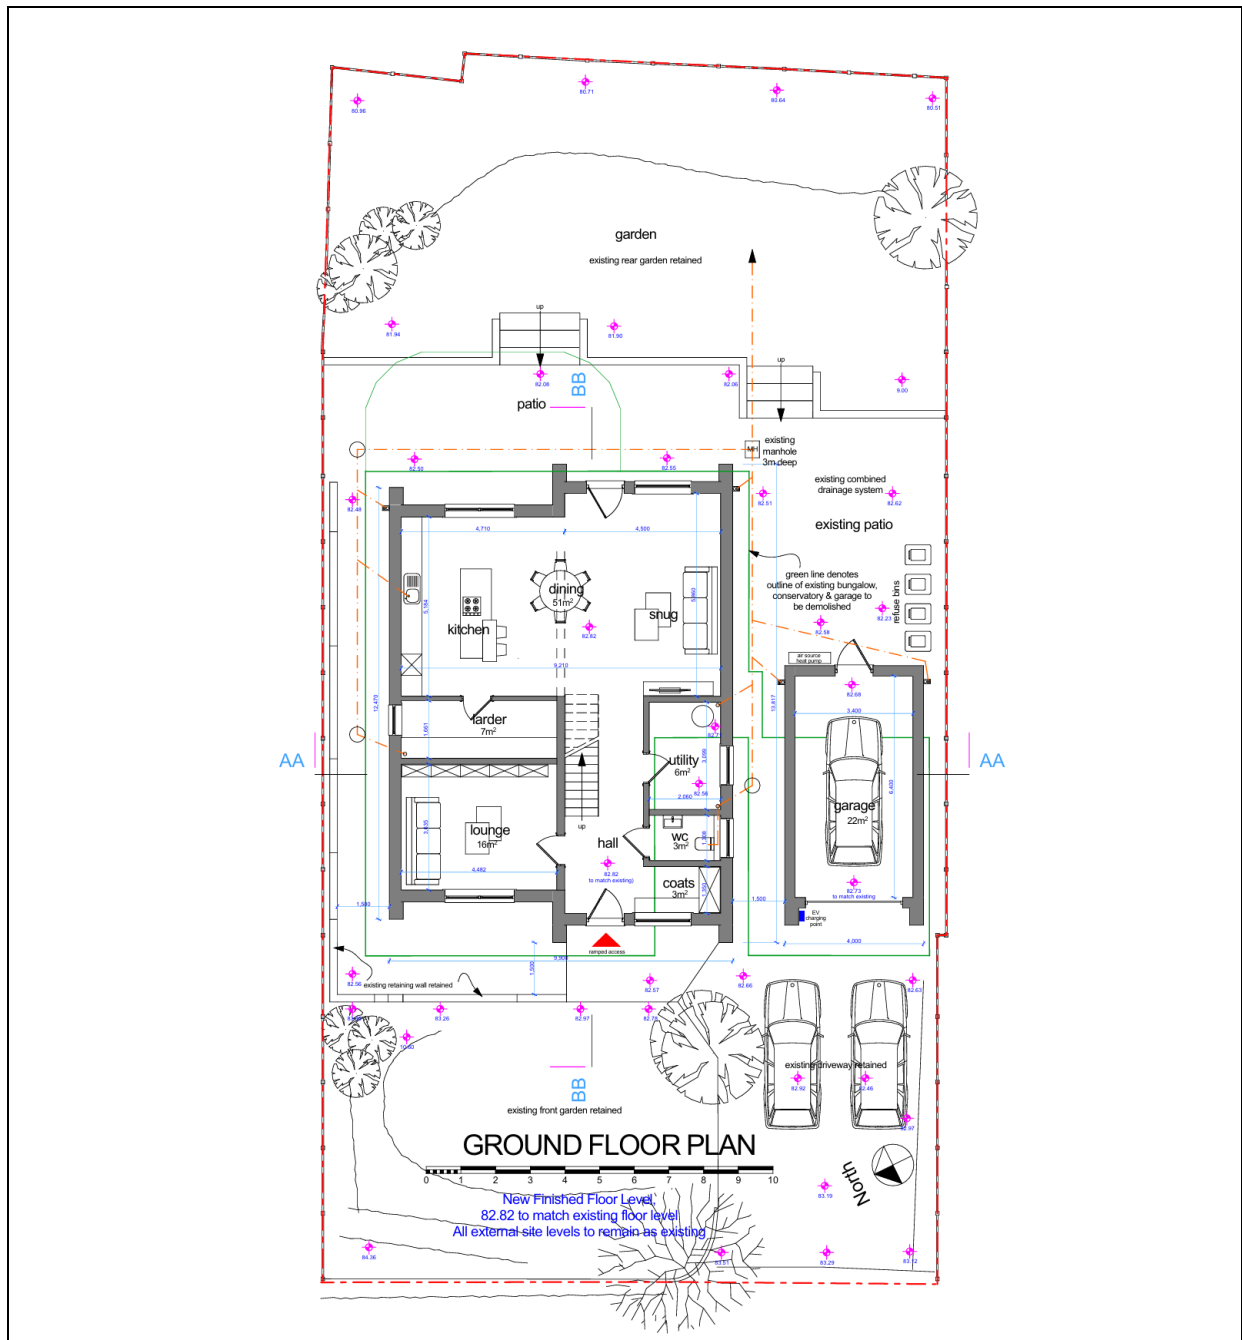
**Figure 1: Proposed Development Plan**

- 1.1 Earth Environmental & Geotechnical Ltd has been commissioned by PHD Designs on behalf of Lesley & Tony Jacobs (the Client) to undertake a Phase I GeoEnvironmental Desk Study for 4 Butt Hill Road, Prestwich, Manchester.
- 1.2 It is understood that the Client intends to replace the existing bungalow at 4 Butt Hill Road with a two-storey house which will occupy the existing bungalows footprint.
- 1.3 A proposed development plan is presented in Figure 1, overleaf.

- 7.1 It is understood that the Client intends to replace the existing bungalow at 4 Butt Hill Road with a two-storey house which will occupy the existing bungalows footprint.

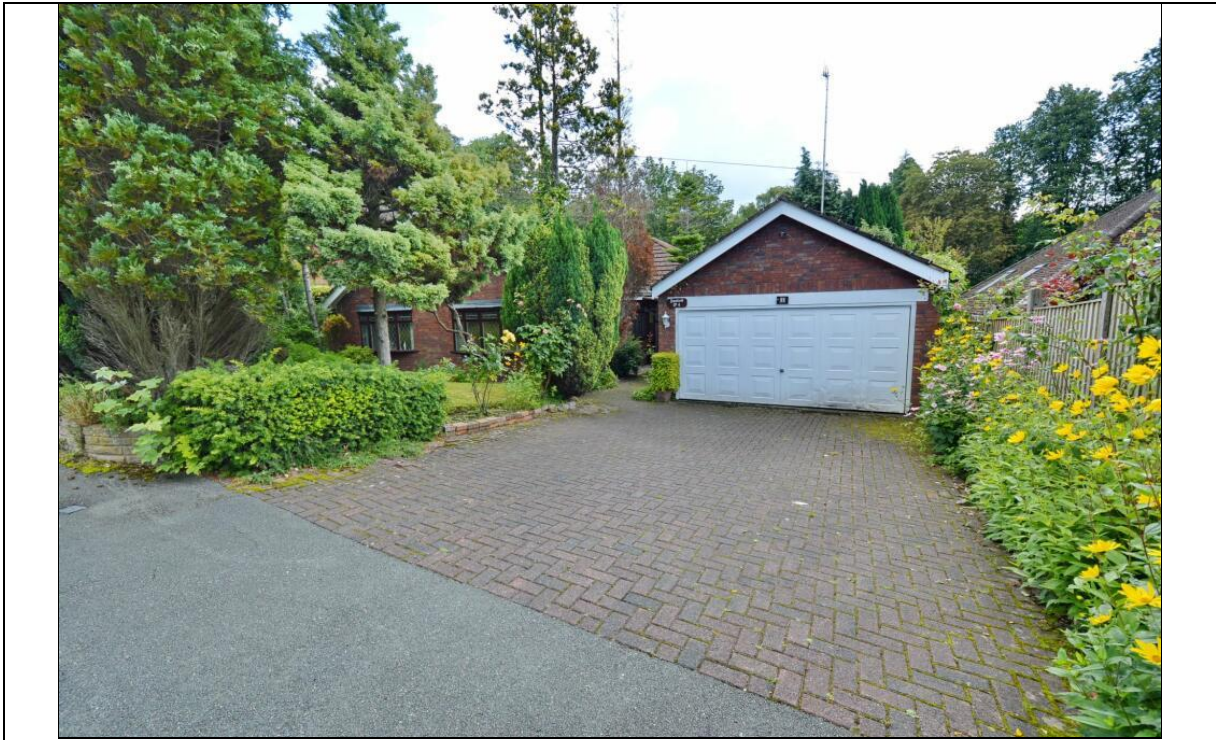
**Figure 3: Site Photograph**

- 2.5 The site is currently occupied by a single storey domestic dwelling in the central area of the site with a garage located directly south of the dwelling. A hardstanding red brick driveway is located on the western side of the property whilst soft landscaped areas are located at the northwestern and eastern ends of the property. A hard surfaced concrete and brick path surrounds the house and the garage.

- 2.7 The general surrounding area comprises of residential dwellings.
- 2.8 A location plan is shown below as Figure 2, together with a recent site photograph as Figure 3 (overleaf).

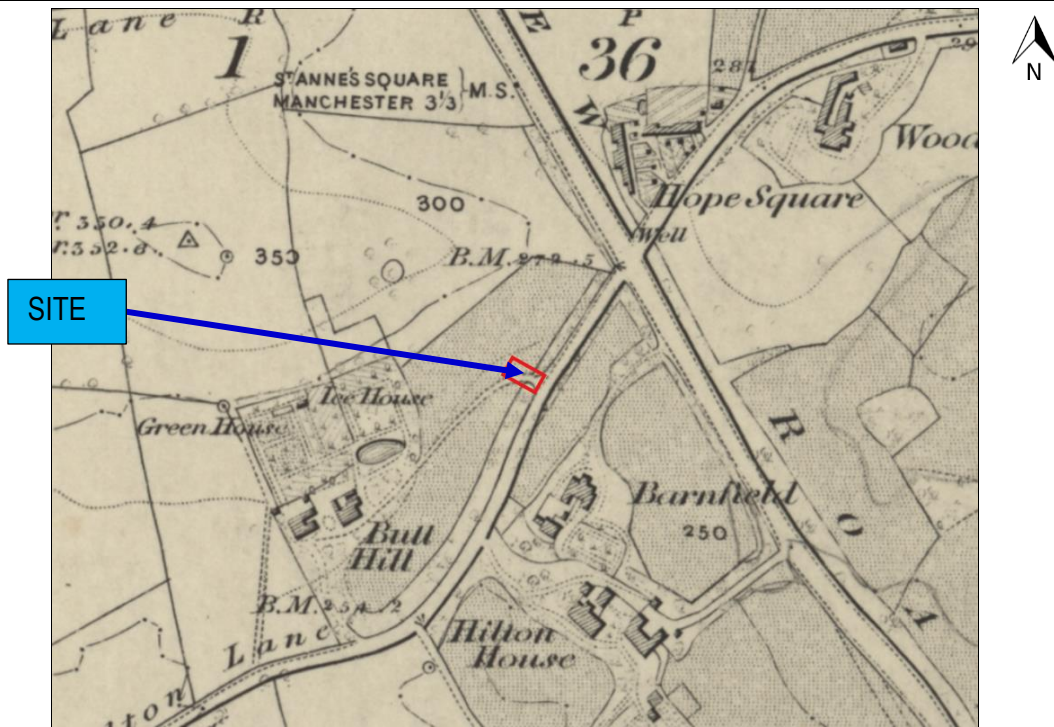
Figure 4 OS Map Extract 1844-1845

| Date | Scale | On-Site History | Surrounding Land Use History |
|---|---|---|---|
| 1844-1845 | 1:10,560 | The site is located within Butt Hill.<br>A footpath runs through the central area of the site. | A public road is located directly southeast of the site.<br><br>A pond is located approximately 50m southwest of the site.<br><br>Residential / farm related developments are located approximately 40m south, 65m southwest, 70m west and 95m northeast of the site.<br><br>A well is located approximately 90m northeast of the site. |

- 4.1 The historical development of the site has been determined by reference historical plans and Google Earth imagery. The reviewed historical plans comprise only readily available records and may be limited; however, the information available to date indicates that additional searches are unlikely to add to our understanding of the site. The earliest available historical mapping covering the site dates back to 1844-1845.
- 4.2 The site history is summarised in Table 2 and Table 3, below, followed by selected extracts from maps and aerial photographs in Figure 4 to 7.
