**Job title:** New Office Block, Bury

**Report type:** Geo-Environmental Appraisal

**Prepared for:** JD Sports

**Date:** 31 March 2022

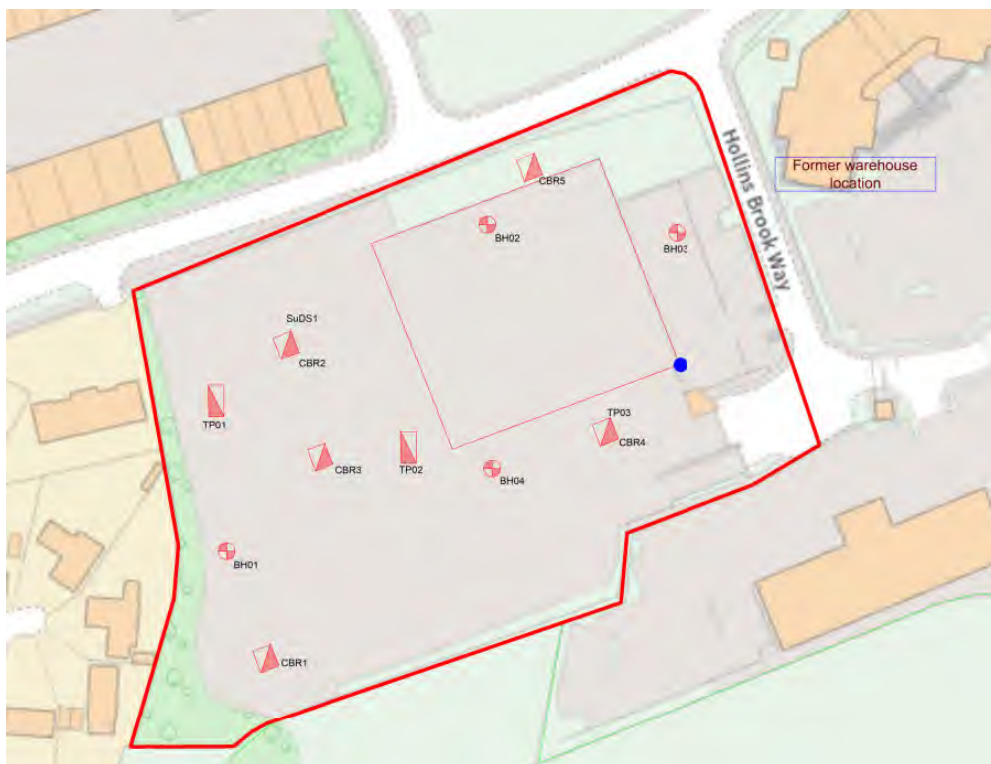
Exploratory Hole Locations

- Dark brown to black sandy gravel in SuDS1, TP01, TP03, BH03, and BH04 underlying the hardstanding from a minimum depth of 0.3m bgl to a maximum depth of 1.3m bgl.
- Dark brown clayey gravelly sand in TP02, BH01, and BH02 from a minimum depth at ground level to a maximum depth of 0.9m bgl.
- Orange brown sandy gravel in BH03 between depths of 0.4m and 1.8m bgl.

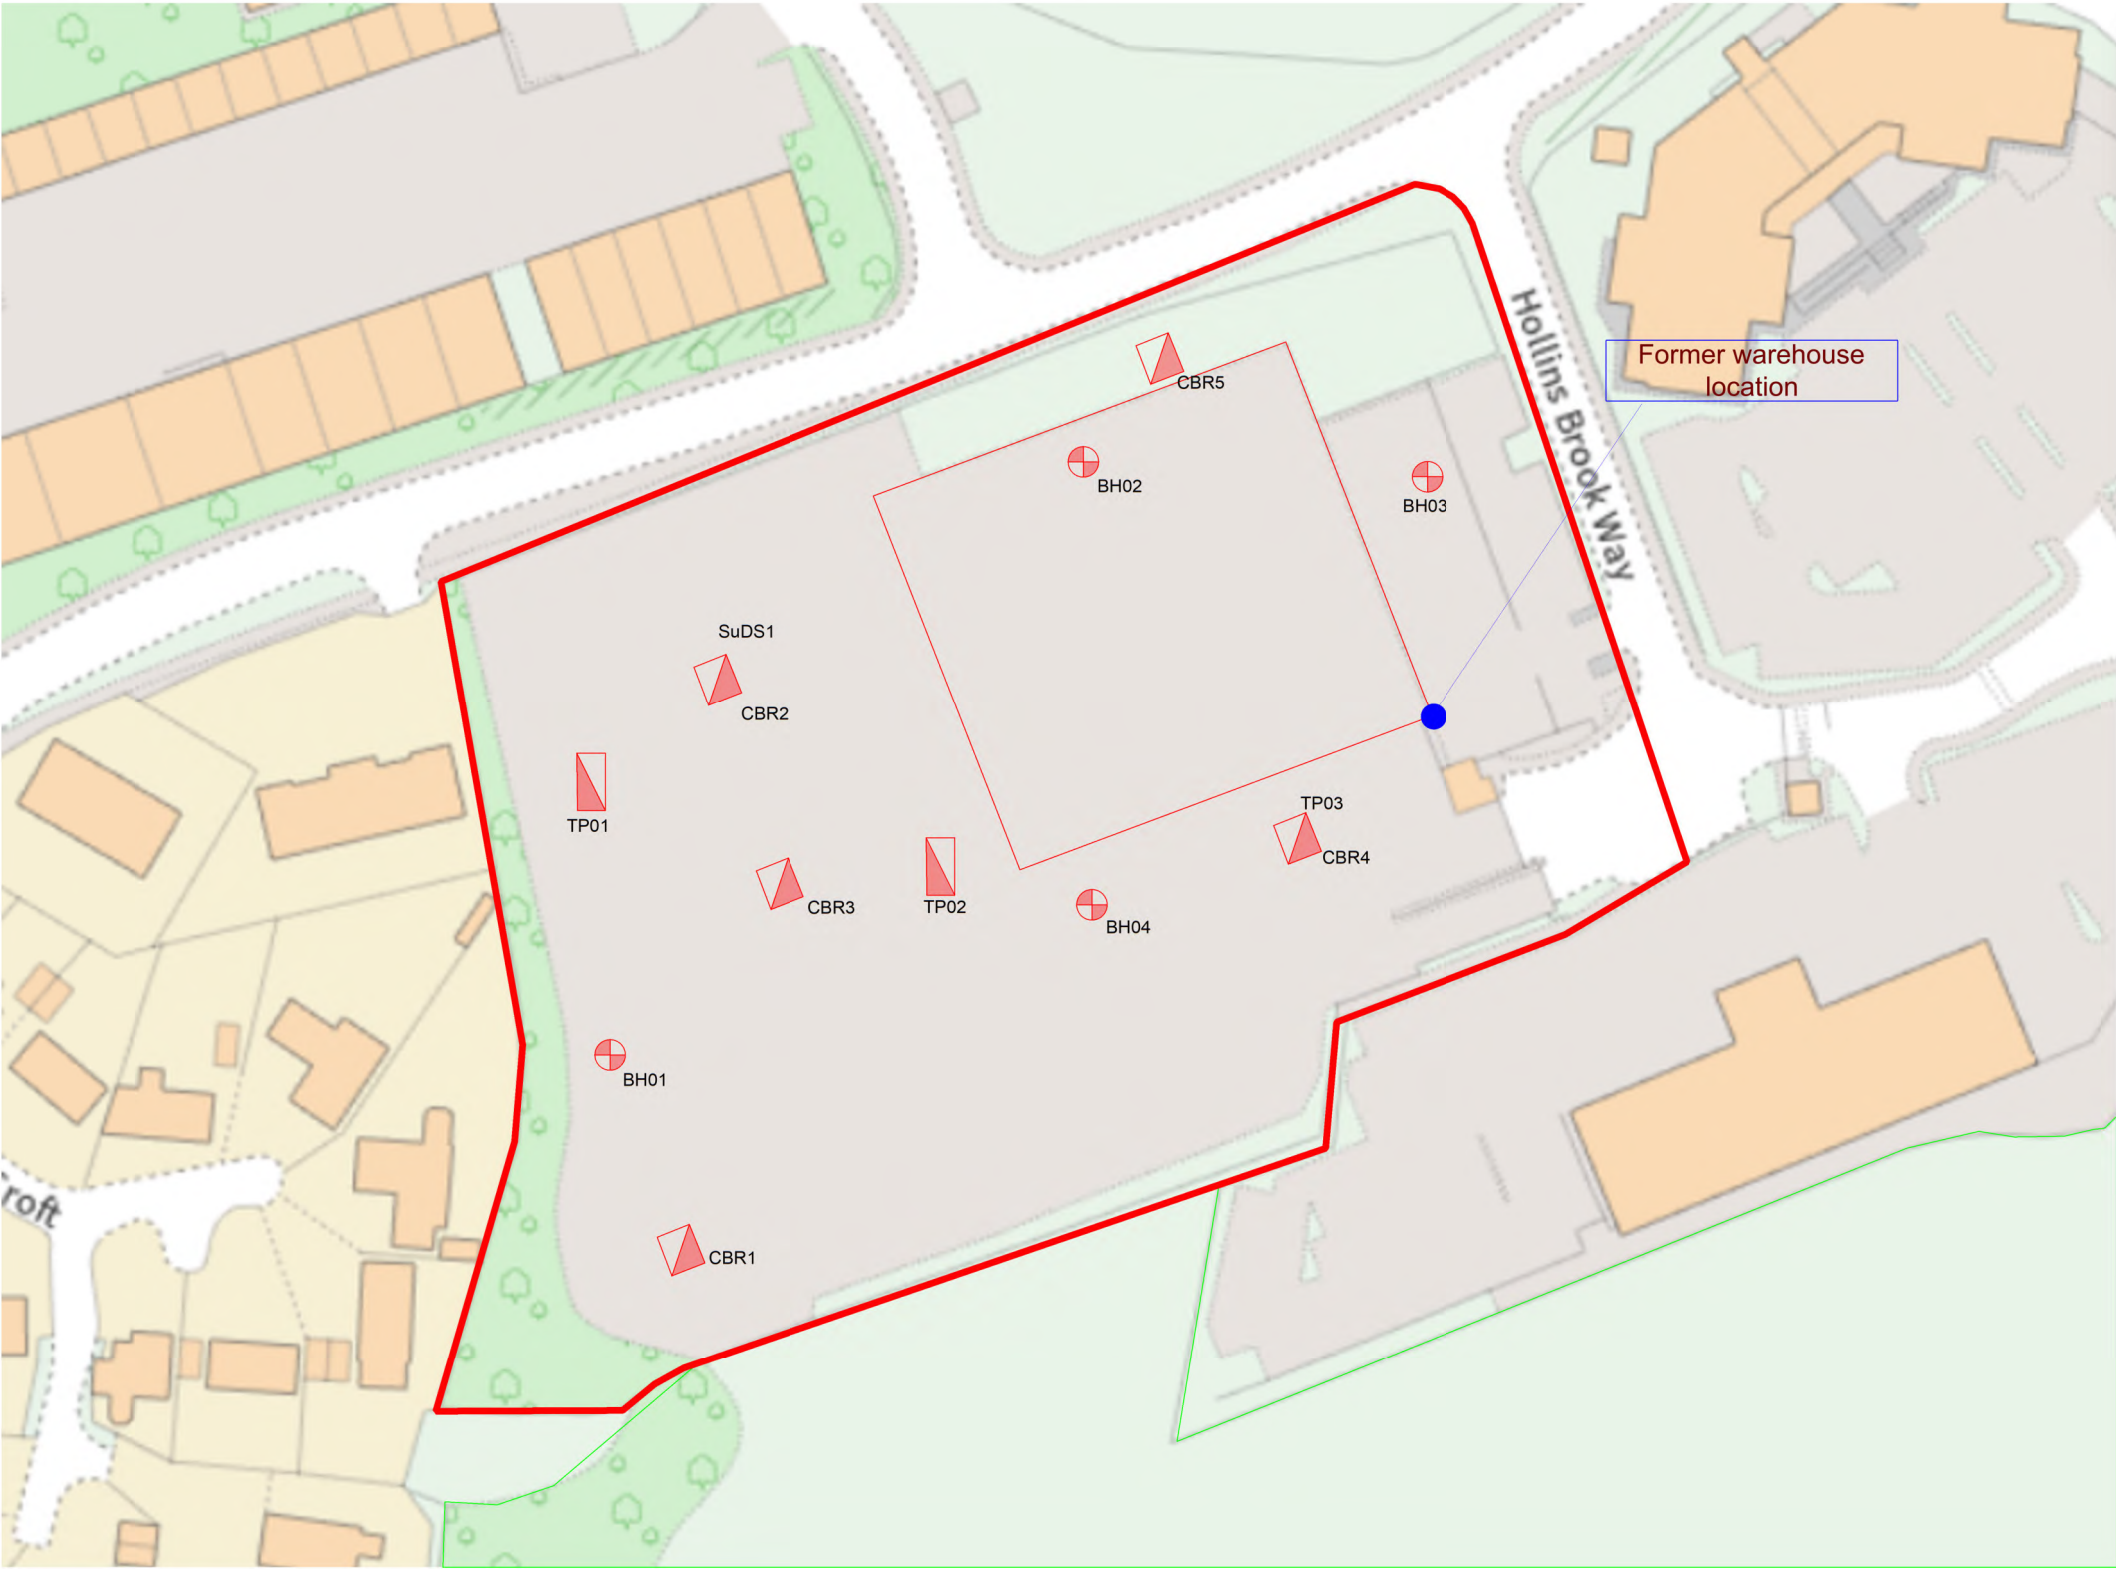
Groundwater strikes were observed at locations TP01 to TP03, BH02 and BH03 at depths between 1.6m and 4.0m bgl and were observed within the natural Sand deposits.
