# DAYTIME BAT SURVEY & BAT EMERGENCE SURVEY

## BARN AT MEADOWCROFT FARM, WALSHAW, BURY

**RACHEL  
HACKING  
ECOLOGY**

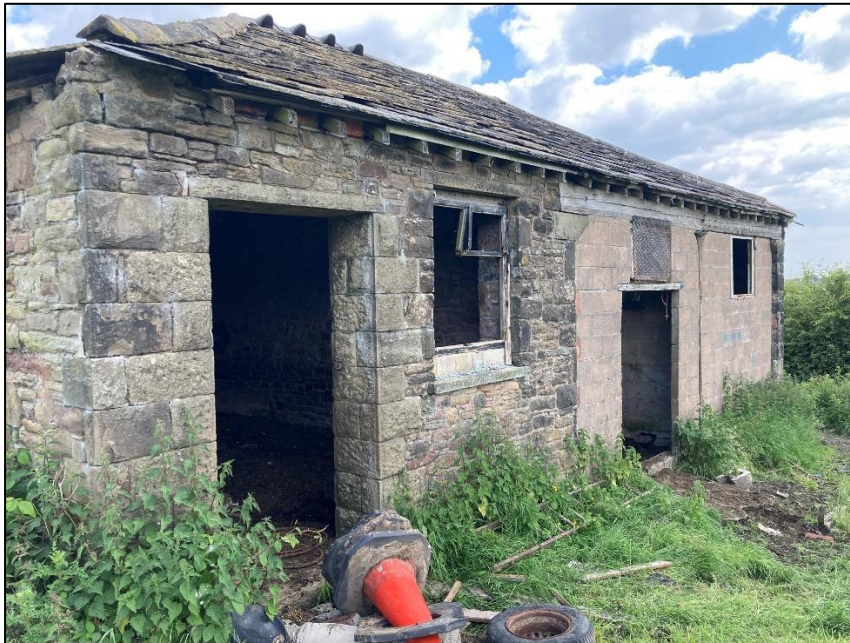
- 3.1 The barn is a single-storey single-skin stone-built structure, which has been partially rebuilt with breezeblock at the front (see Photographs 1 and 2). The stonework is complete and all mortar is in place, but is weathered in places. The windows and doors are missing, with only remnant dilapidated wooden window frames in-situ within the front elevation.

*Photograph 1 showing the front elevation of the building*

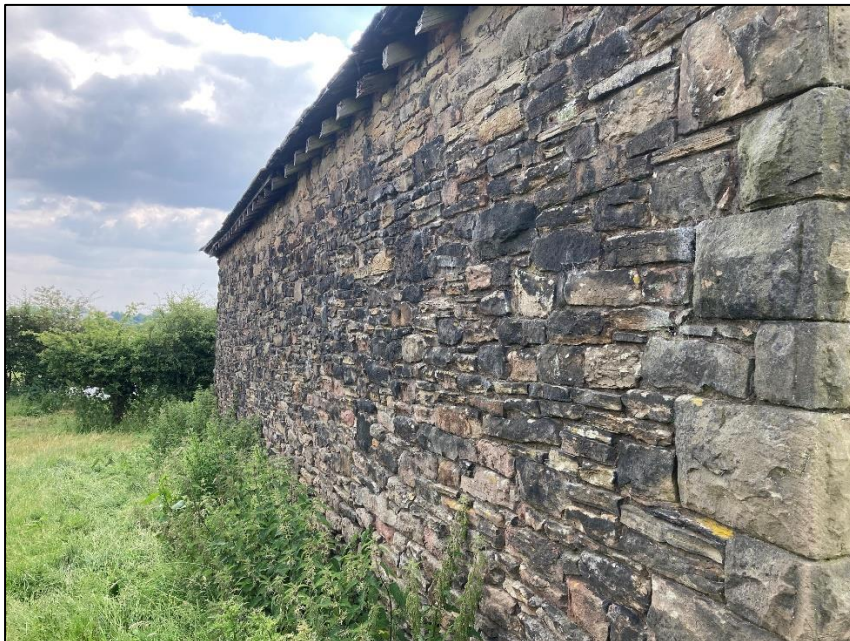
*Photograph 2 showing the rear elevation of the building*

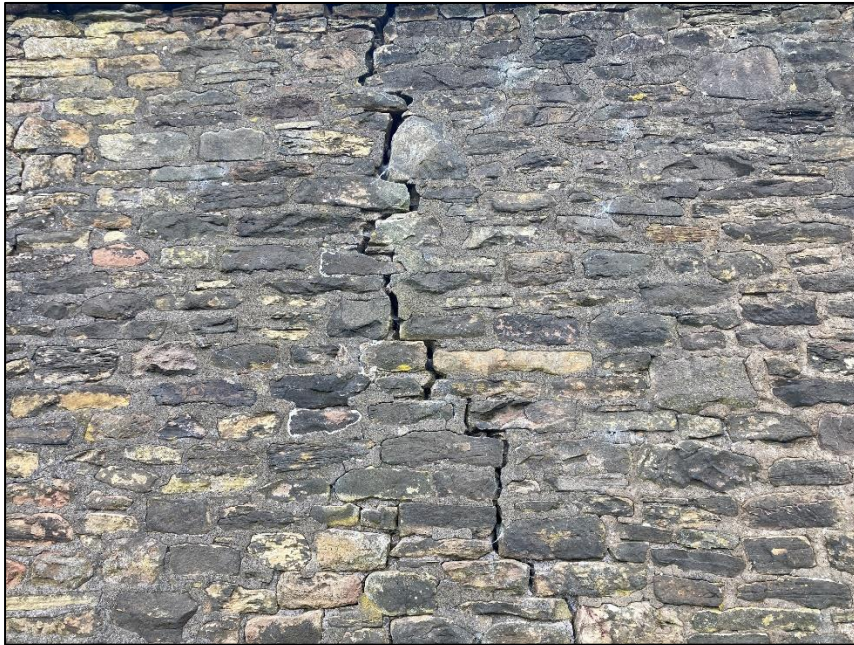
- 3.2 A large crack exists on one of the side elevations (see Photograph 3). This is covered in cobwebs. It was surveyed with the use of an endoscopic camera and no evidence of bat usage was found. The crack does not lead to the interior.

*Photograph 3 showing the crack within the stone wall*

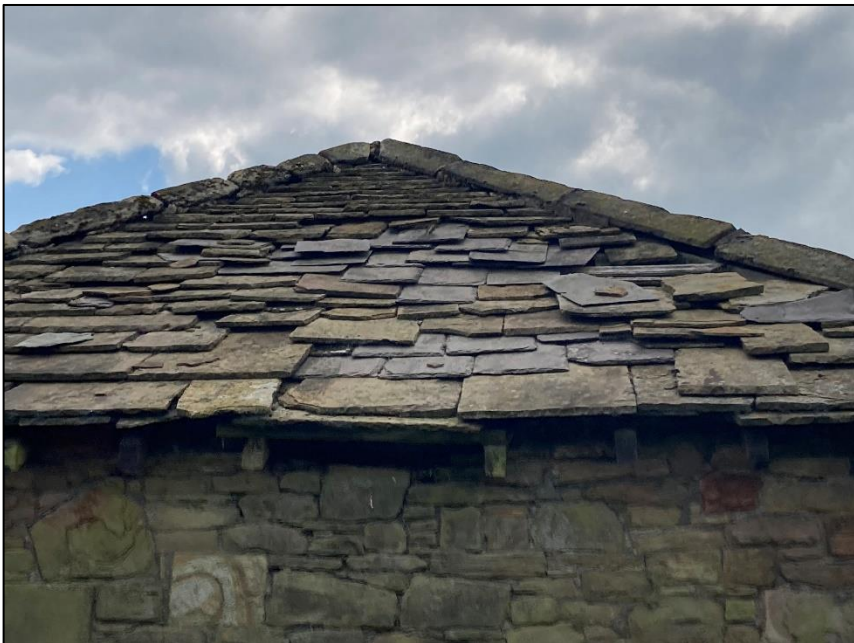
- 3.3 The roof is pitched, with a mixture of stone and slate tiles (see Photograph 4). Many tiles have slipped, leaving small gaps. The ridge stone tiles are intact but the mortar is missing. Large gaps exist where the roof meets the walls. The ends of the roof timbers are exposed.

*Photograph 4 showing the roof tiles on one elevation*

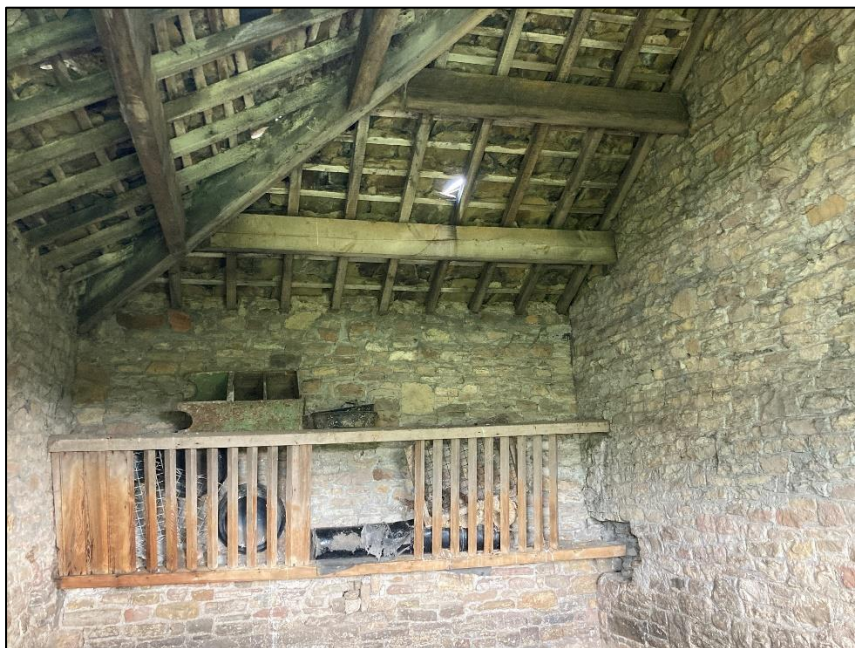
- 3.4 Internally, the barn is divided into two. Cattle take shelter inside the barn. The interior stone walls are in good condition, with minimal missing mortar (see Photograph 5). Where gaps do exist in the mortar, these were surveyed with an endoscopic camera and no evidence of bat usage was found. The walls are covered with cobwebs. In one half of the barn, a ceiling has been created (see Photograph 6). This is intact and the timbers offer no suitable bat roosting cavities.

*Photograph 5 showing the interior walls and roof structure of one half*

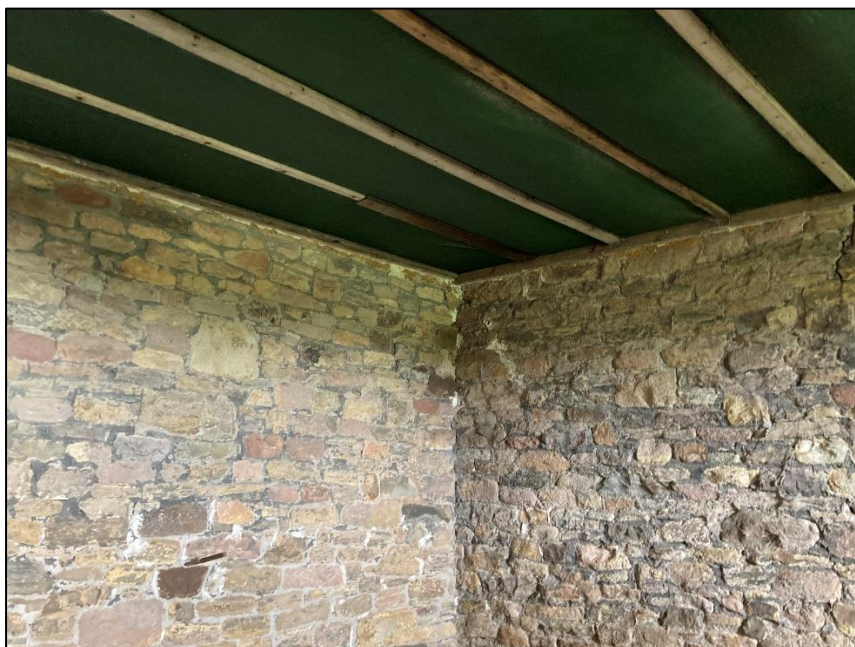
*Photograph 6 showing the interior walls and roof structure of the other half*

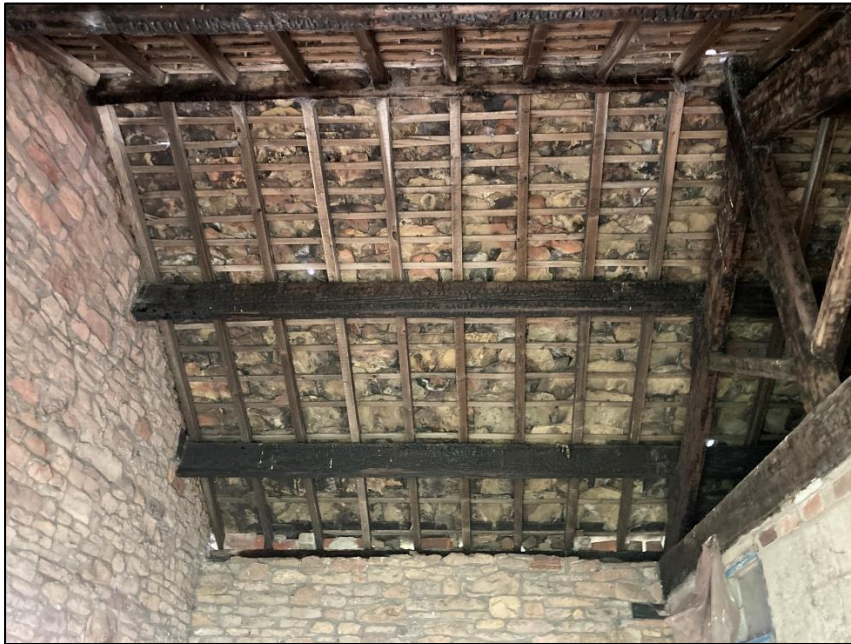
- 3.5 Across the barn, the roof is mostly open with no concealed roof voids (see Photograph 7). The roof timbers are intact and no cavities suitable for roosting bats were found within the timbers. The roof tiles are unlined, with small amounts of roof mortar still visible in places. Multiple gaps exist within the roof, making the interior damp. Cobwebs exist across the roof. A small void exists above where a room has been created (see Photograph 8). This could be inspected and was found to be extremely dusty and well-lit from multiple gaps at the roof edges. No evidence of bat activity was found within the barn. No evidence of Barn Owl was found. Disused bird nests were noted.

*Photograph 7 showing the roof structure*

- 5.4 It should be noted that bat absence is very difficult to prove definitively due to their mobility and size, and single or small numbers of bats are able to roost in extremely small spaces, such as in gaps between tiles. The development work should be undertaken with care, for example with roof tiles lifted rather than dragged.

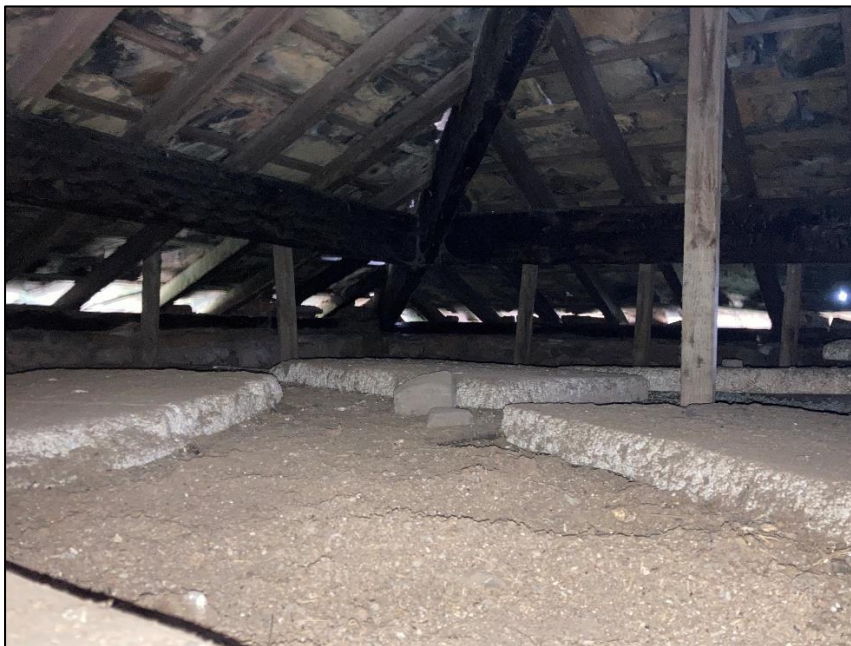
*Photograph 8 showing the small void*

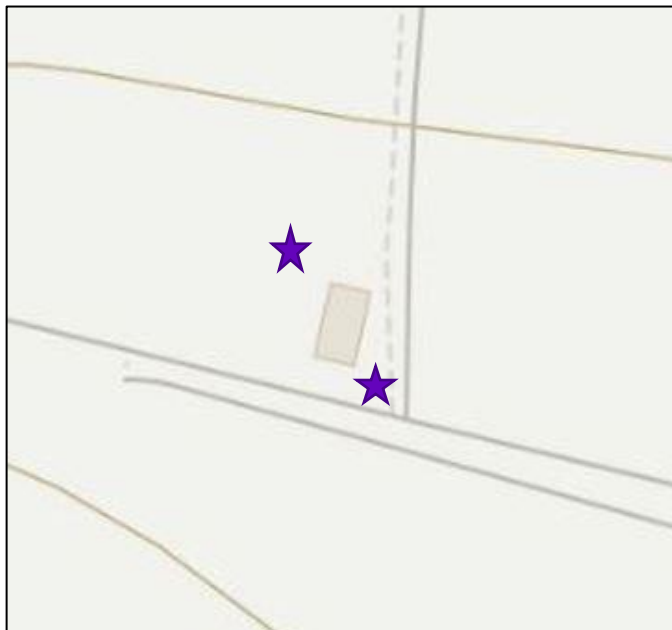
- 4.2 Figure 2 shows the locations of the bat surveyors during the survey (purple stars),

Figure 2 showing the locations of the surveyors (purple stars)
