**Eccleston Homes**

**Desk Study  
&  
Ground Investigation Report**

**Mondi Site, Ramsbottom**

**REPORT NO: 19ECH016/DSGI**

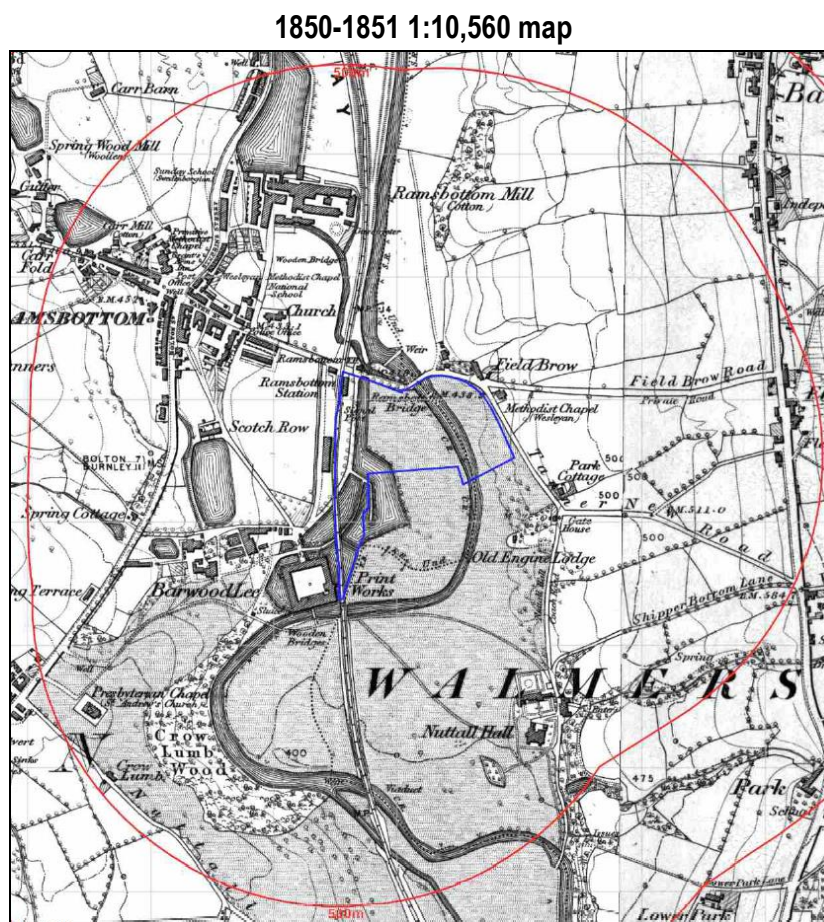
The earliest map, from 1850-1851, shows the site to be split between undeveloped land and the River Irwell in the east and reservoirs in the west. A small strip of land adjacent to the railway line is shown as a treelined road. An extract of the map is shown below;

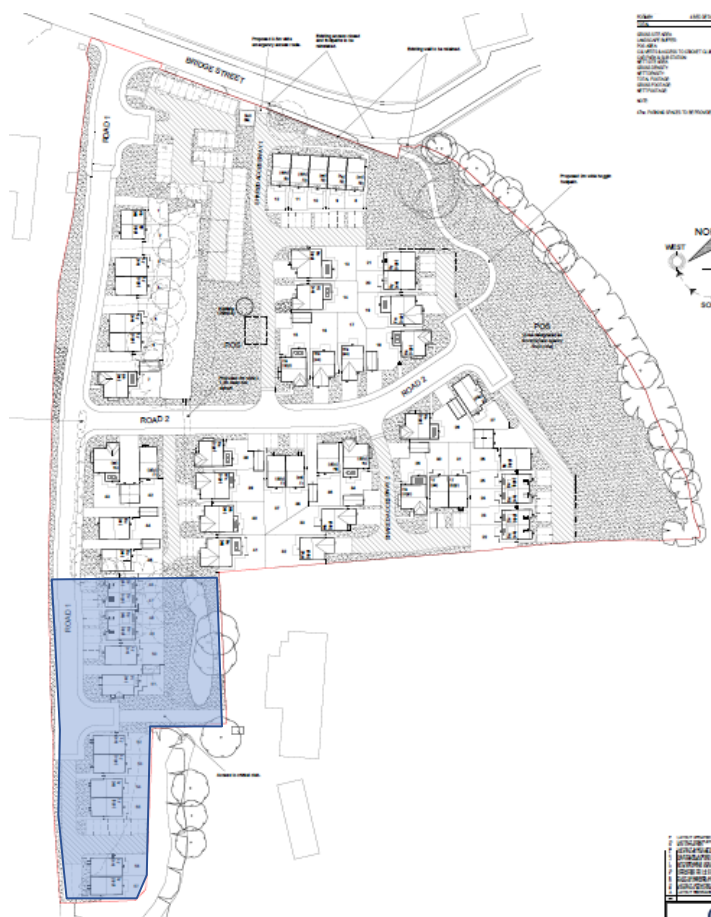
The area in the south west corner identified very different composition of Made Ground in the form of organics / textile / paper waste / plastics within a predominantly granular matrix with boulders of concrete. Processing of this material under a mobile plant licence is anticipated with control of groundwater and groundwater treatment potentially required. This area is shown below:

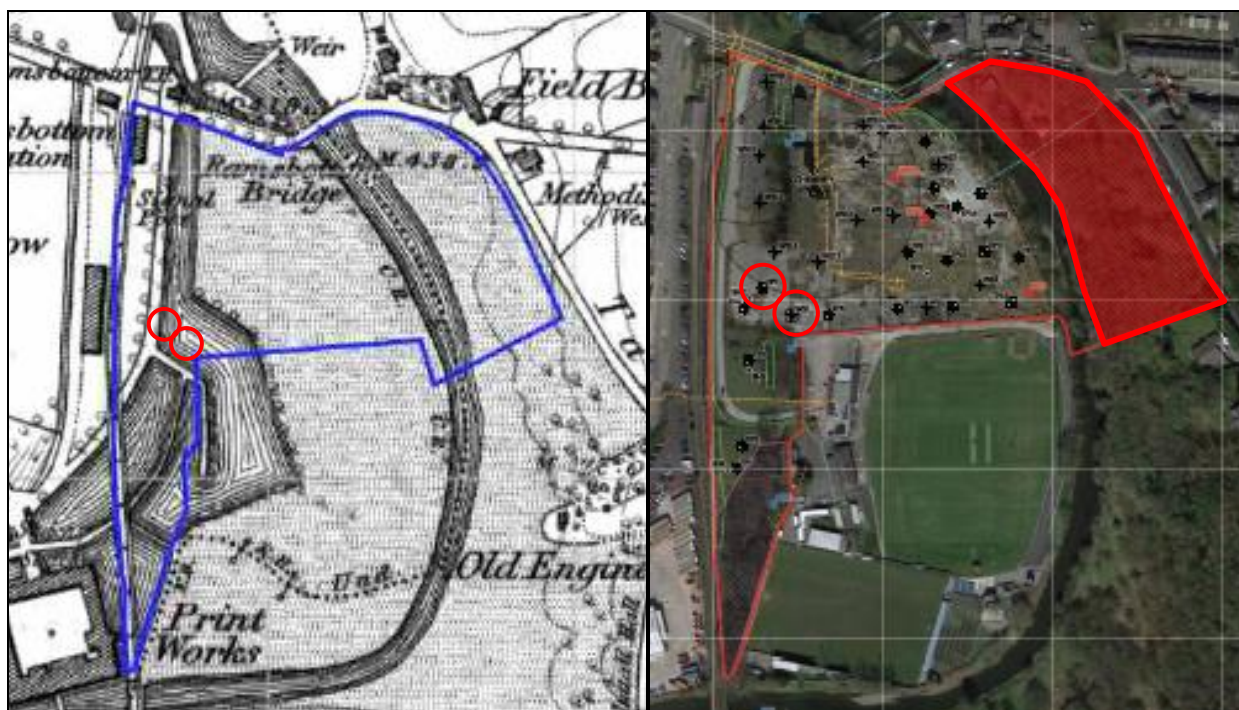
The Made Ground exceedances have been recorded at varying depths between 0.10mbgl and 2.00mbgl. With deeper exceedances at 2.25mbgl (TP5) and 2.75mbgl (WS1), within potential Made Ground strata.

Based on the locations of TP5 and WS1, in relation to the formerly existing reservoirs, it is now considered likely that these are Made Ground samples from backfill / basal reservoir materials. As shown in the sketch below;

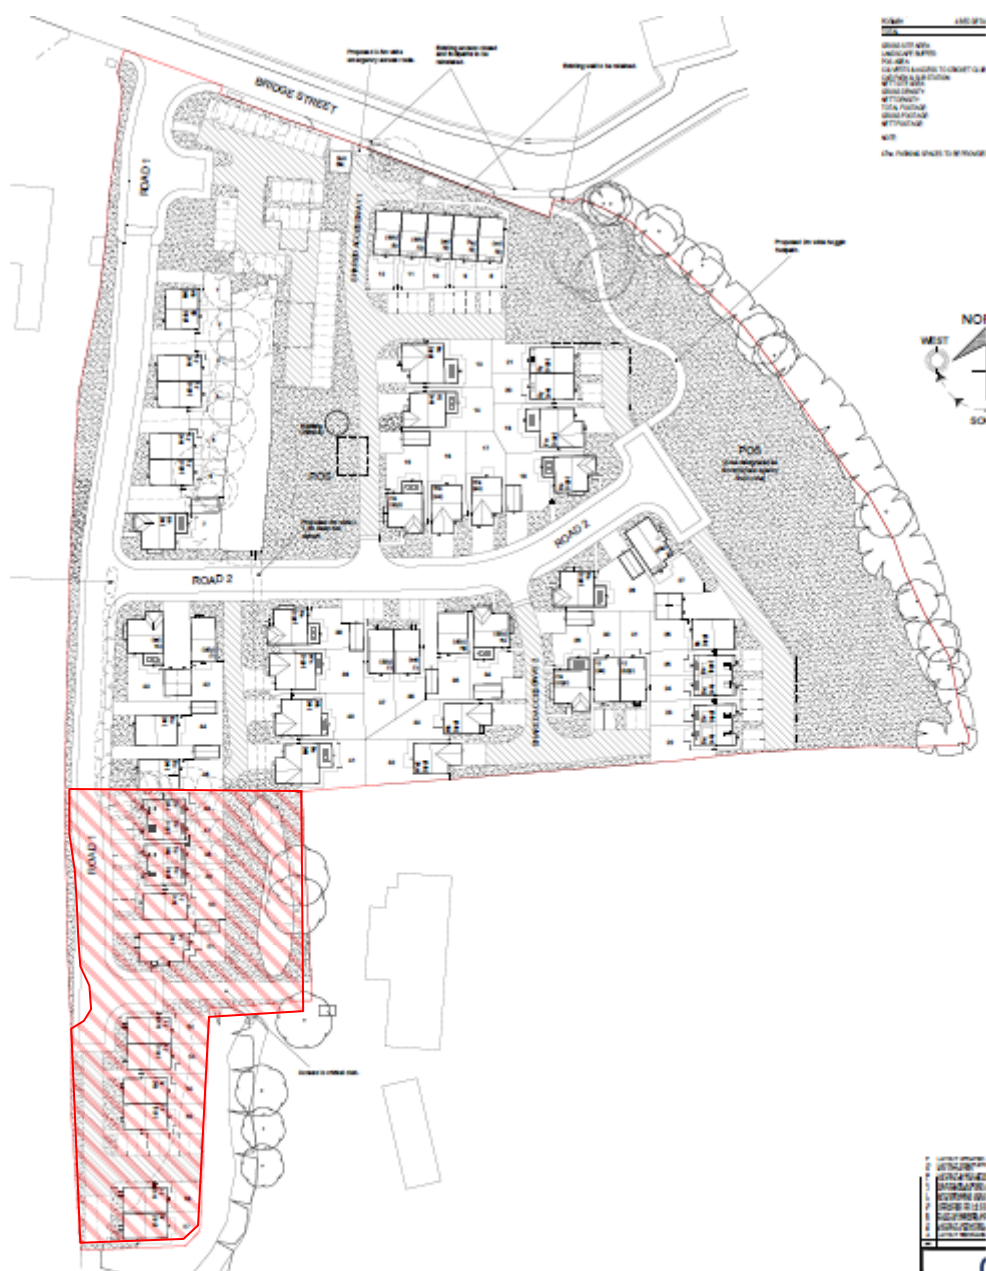
Due to proximity of railway and possibly interconnected bodies of fill / water care must be taken when considering remedial work / foundations in this locality.

The anticipated impacted area is shown below;
