## Invasive Species Method Statement

Former Mondi Site  
(Site 1)  
Holcombe Mill  
Bridge Street  
Ramsbottom  
BL0 0BS  
Ref: P.1202.19

October 2023

**Invasive Species Method Statement**

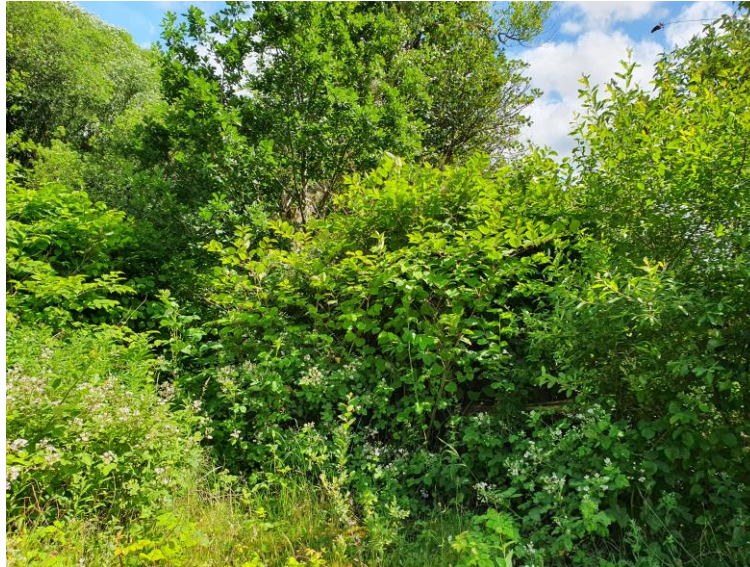
- 2.2 Stands of Himalayan balsam, and Japanese knotweed are located on the banks of the River Irwell, running along the entirety of the eastern site boundary. Japanese knotweed has begun to spread from the riverbank and has started to encroach upon the areas of scrub on the site (photograph 1). The Japanese knotweed 7m root zone extends further into the site and also needs to be taken into consideration as marked on drawing P.1202.19.04A.

**Photograph 1: Stand of Japanese Knotweed within scrub vegetation.**

- 4.1 The riverbank and areas within the site are infested with Japanese knotweed. All Japanese knotweed should be isolated prior to site clearance. The Japanese knotweed should be fully excavated, to a depth of 3m to ensure all material is removed, including 3m of earth surrounding the plant to ensure all the rhizome root material has been removed. This can be done at any time of year. Alternatively, if timescales allow the Japanese knotweed can be controlled through stem injection of herbicide to reduce the impact on native species within the vicinity. The areas will be fenced off and no building works will occur in this exclusion zone until it is confirmed that Japanese knotweed has been successfully eradicated from this zone by chemical treatment. An appropriate notice will be placed on the fence informing the workforce that a Japanese knotweed exclusion zone lies within the fenced area (see appendix 4 for notice example).

- 4.3 If the Japanese knotweed is to be controlled by herbicide injection, the plants will first be stem injected with glyphosate in July.
- 4.4 The site will be treated with stem injection glyphosate again in September to ensure all Japanese knotweed is treated including any regrowth or any stands missed during the initial treatment.

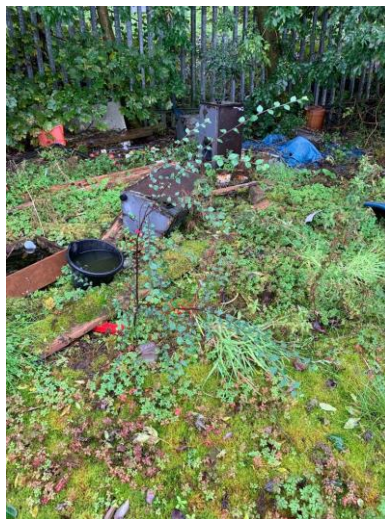
- 5.1 Multiple stands of cotoneaster were noted on the site on the western boundary and spreading further into the site (Photograph 3).

**Photograph 3: Cotoneaster spreading into the site from the western boundary.**

- 5.2 All cotoneaster should be isolated prior to site clearance. The plant should be fully excavated, including 500cm of earth surrounding the plant to ensure all roots have been removed. This can be done at any time of year; however, it is recommended that the plant should be removed in spring or early summer (April-July) when the plant is in flower and does not have berries. The earth should be shaken off the roots and the entire plant mulched or burned. If berries are present on the plant, the stems should be covered with a strong paper bag to prevent berries falling to the ground during transfer and the plant should be burned to prevent the seeds sowing and establishing further individuals.

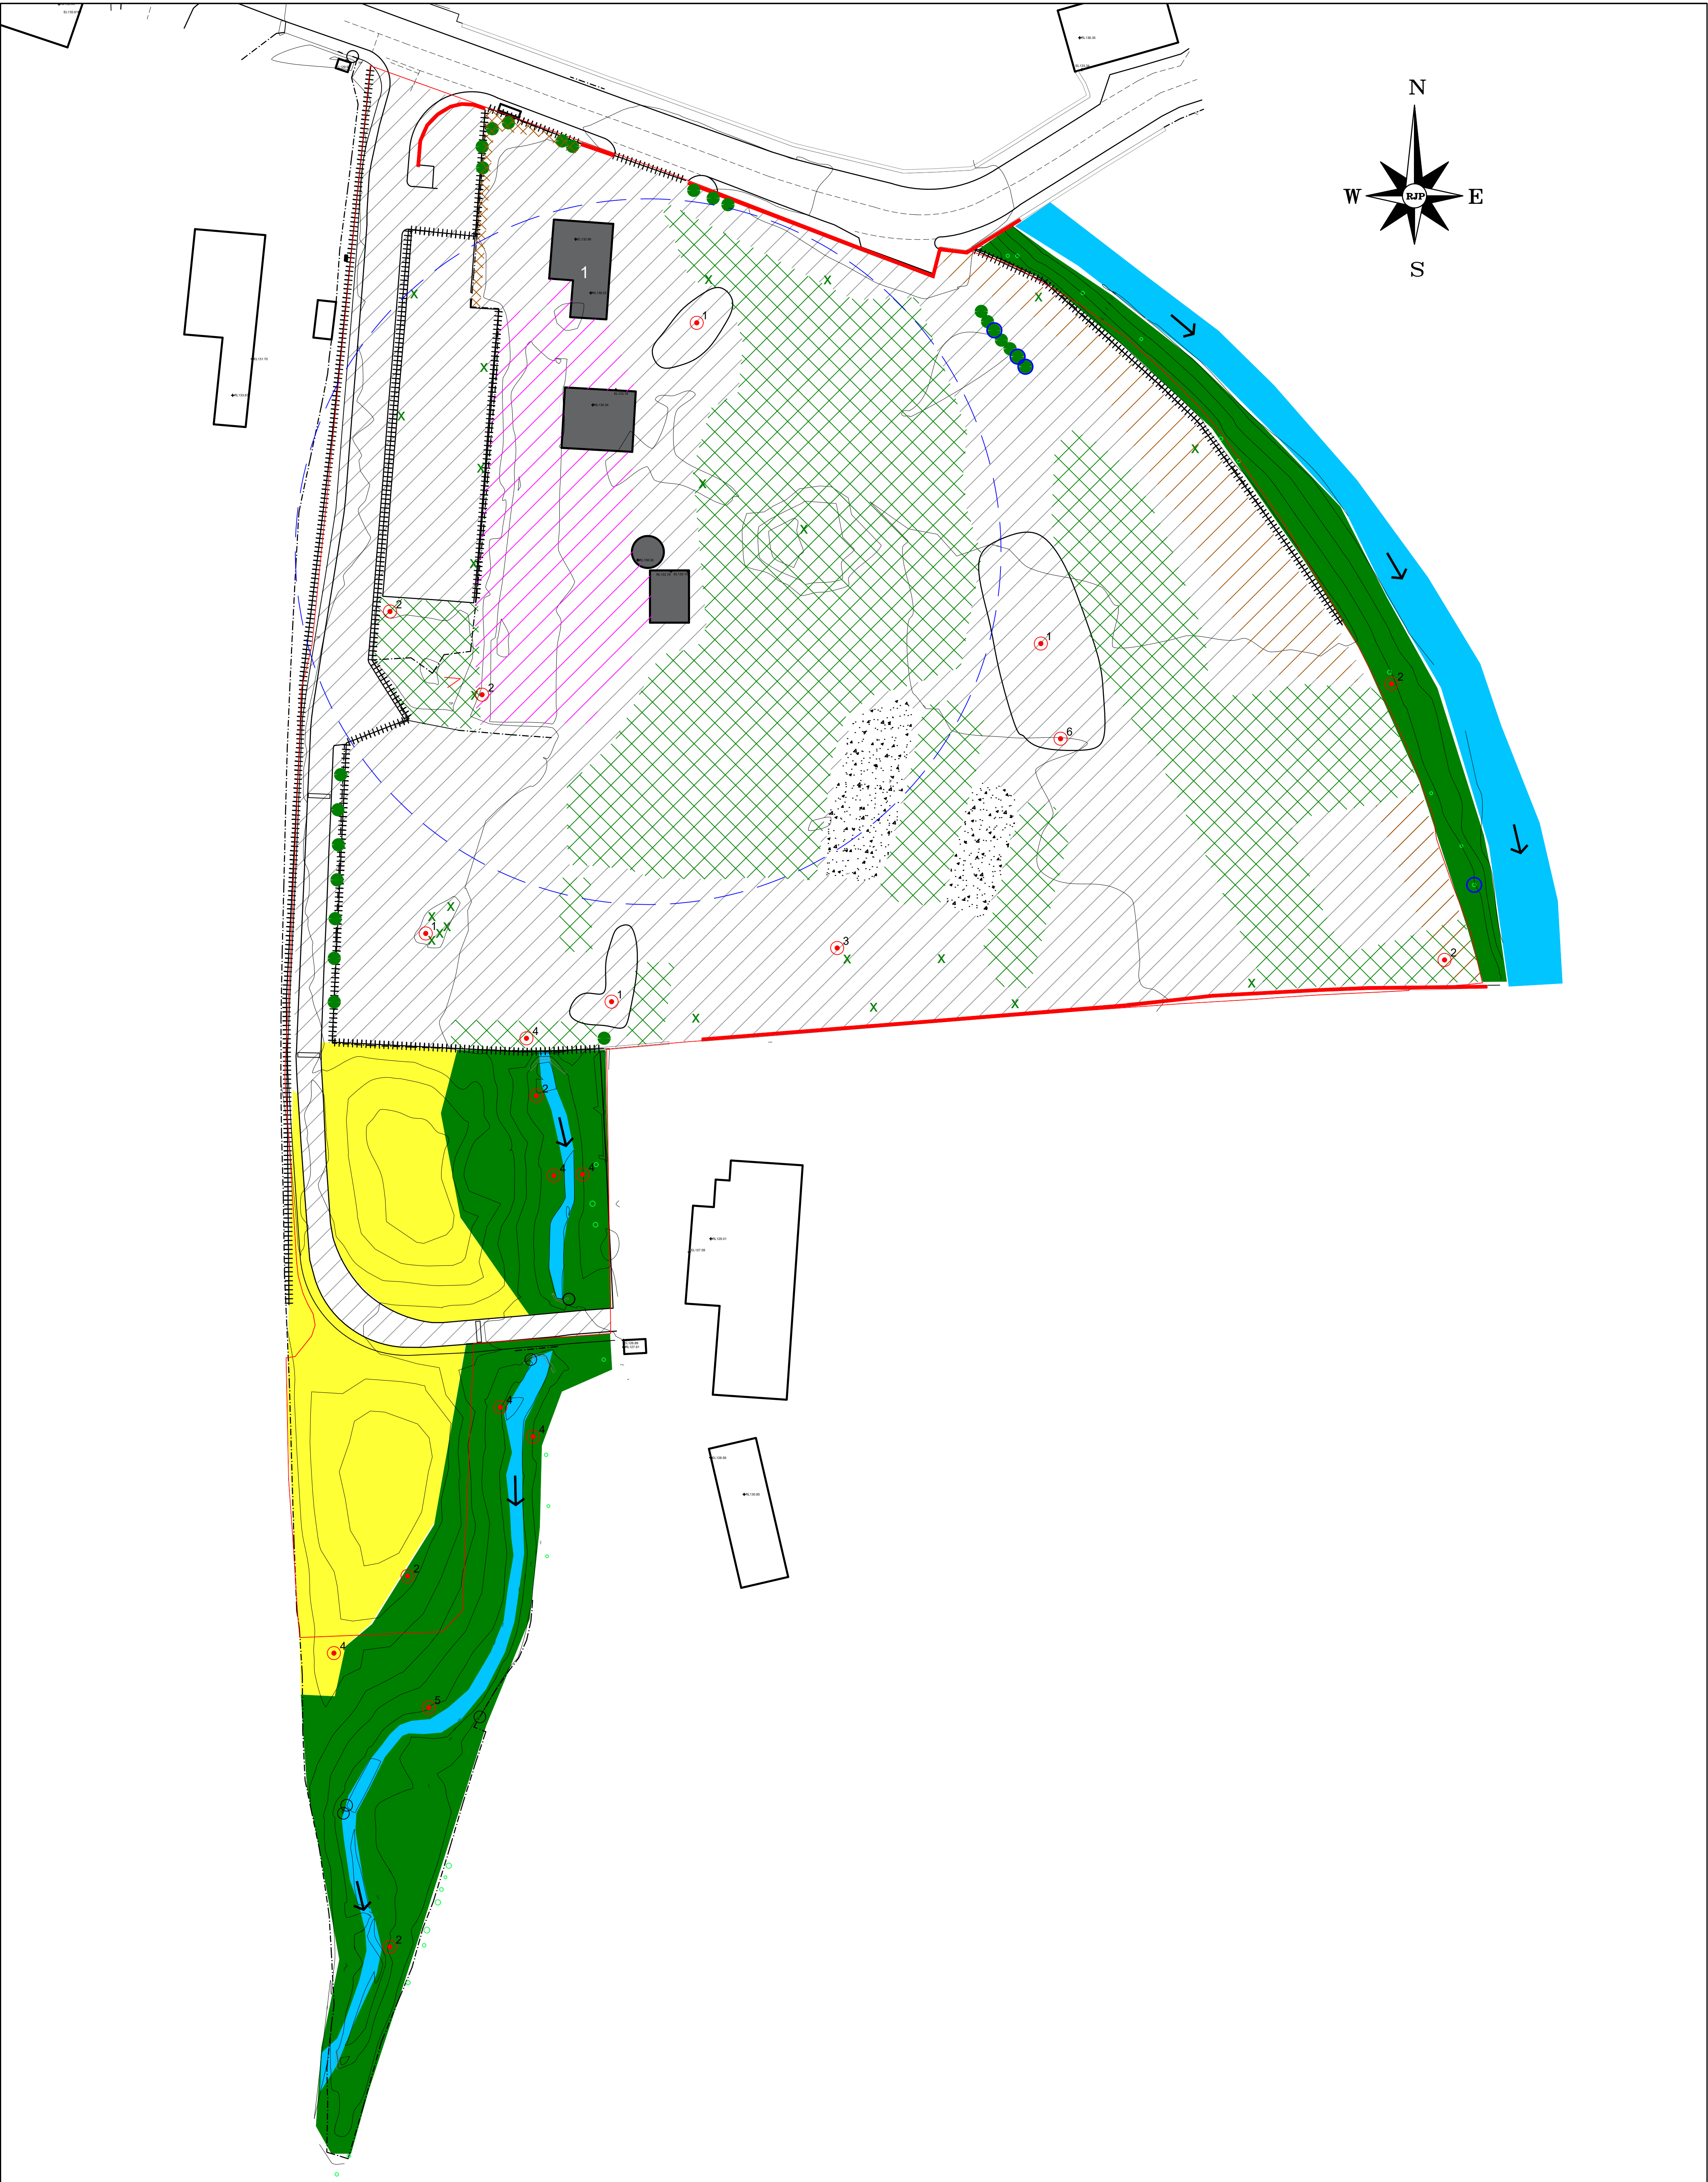
DRAWING No:  
P.1202.19.03

- 2.1 The site lies adjacent to the local high street with shops and industrial mills lying to the north and west. A railway line borders the site to the west. The river Irwell meanders around the site boundary to the east, with a cricket and football ground located south of the site. Habitats present within the site include dense scrub, broadleaved scattered trees, scattered scrub, tall ruderal, semi-natural broadleaved woodland, introduced scrub, and a water course. These habitats are presented on drawing P.1202.19.03A (*Appendix 1*). The areas of invasive species are presented on drawing P.1202.19.04A (*Appendix 2*).

DRAWING TITLE:  
Phase One Habitat Survey
