## **GROUND INVESTIGATION REPORT**

**FOR  
9 CHATSWORTH AVENUE,  
PRESTWICH,  
MANCHESTER,  
M25 1LZ**

**PREPARED FOR  
TURNKEY INDEPENDENT  
PROPERTY SERVICES LIMITED**

**REPORT NO. 7832B  
MARCH 2024**

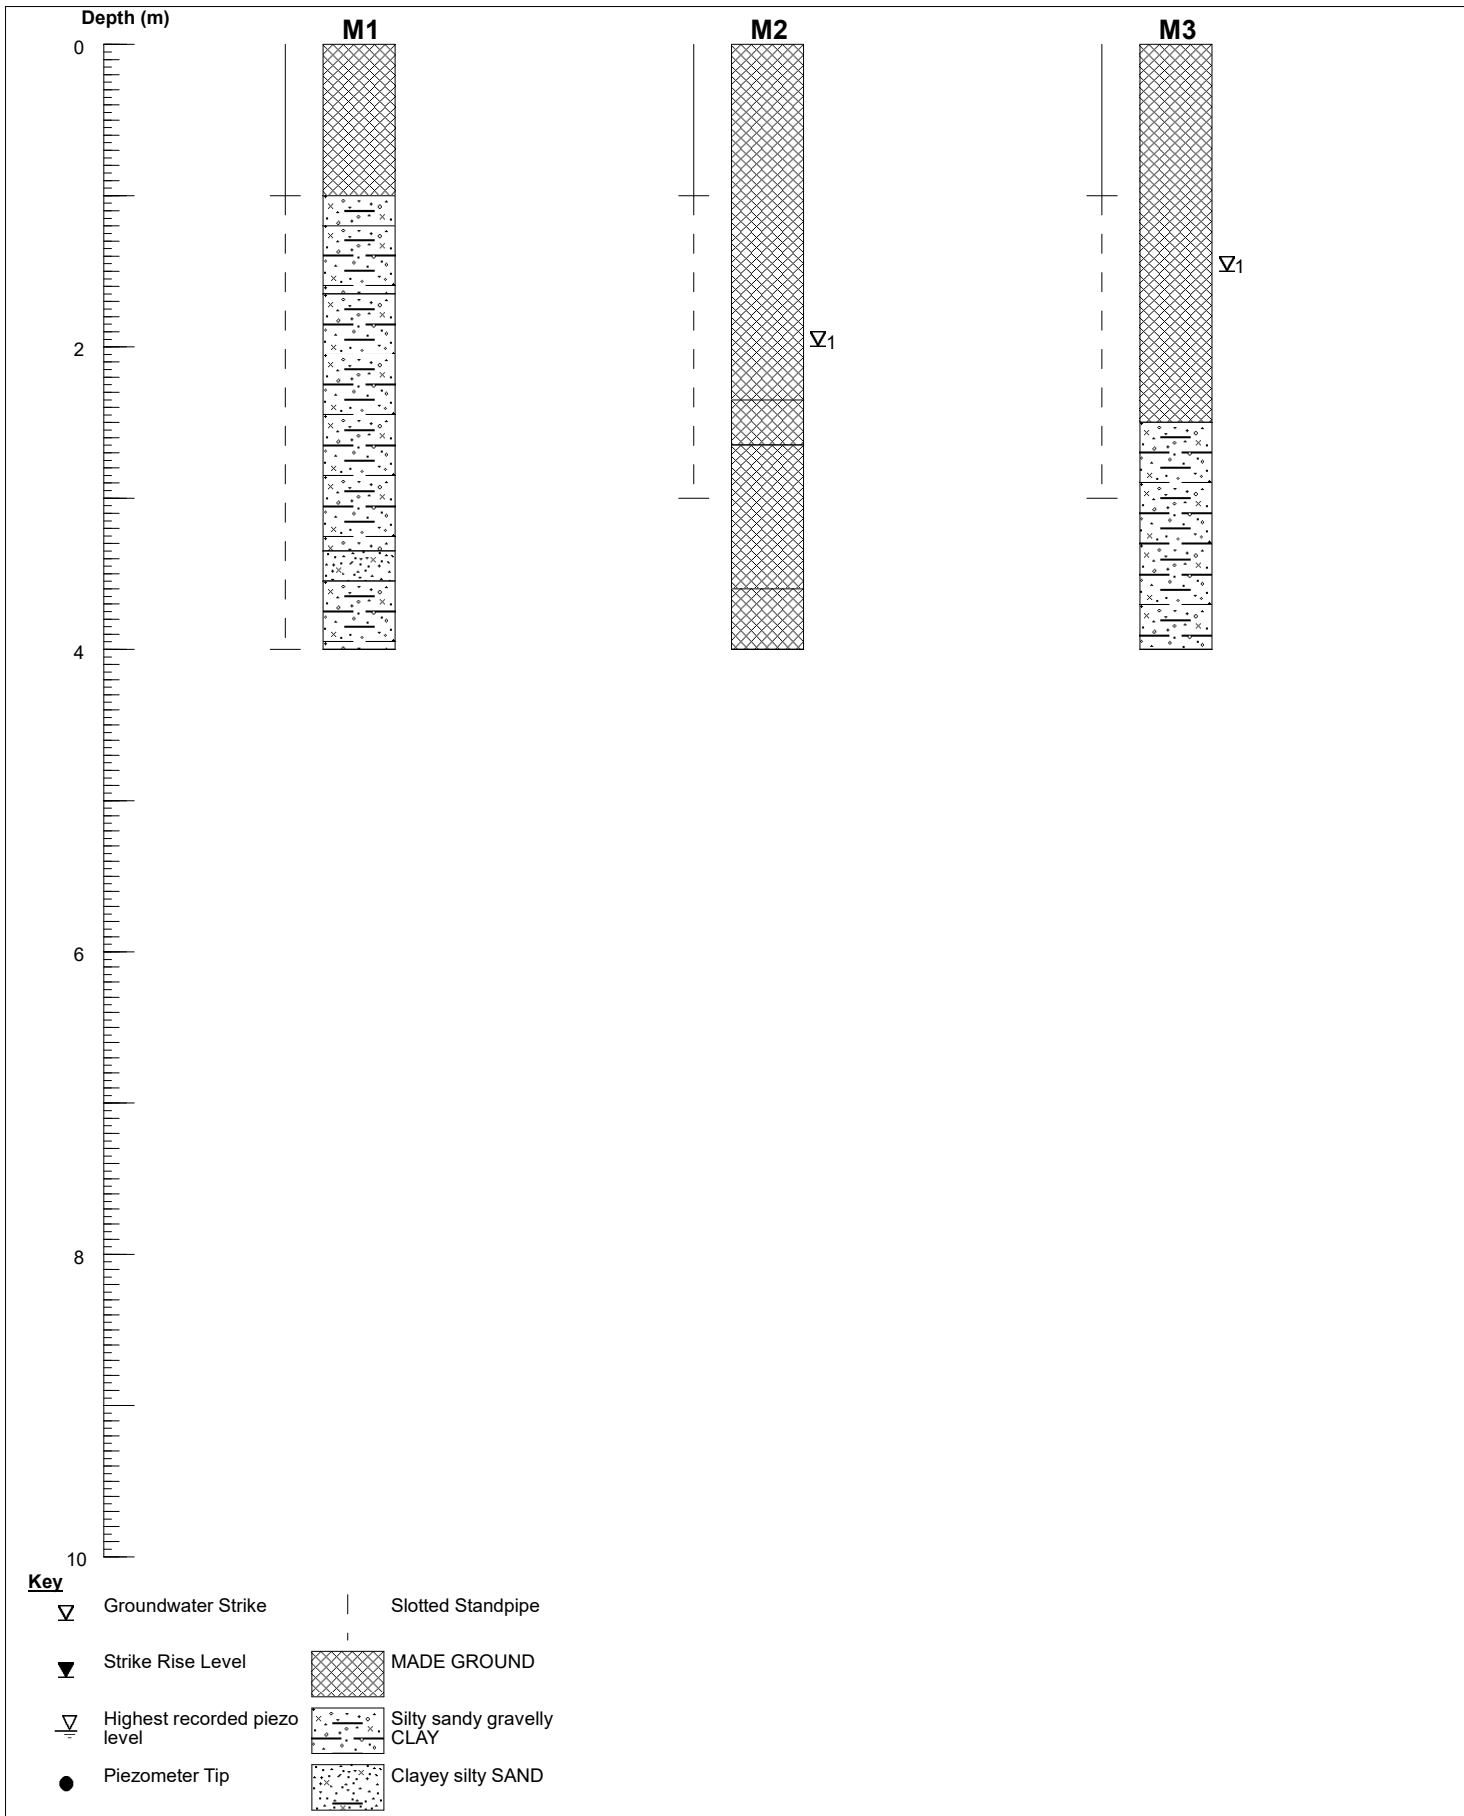
M1, M2 and M3 encountered made ground to depths of 1.00m, >4.00m and 2.50m respectively. M1 comprised dark brown gravelly silty sand with occasional rootlets to 1.00m. M2 comprised dark brown ashy gravelly silty sand to 2.35m, dark brown sandy silty gravel to 2.65m, soft dark brown ashy slightly gravelly sandy silty clay to 3.60m and dark grey slightly gravelly slightly sandy silty clay with occasional rootlets to 4.00m. M3 and HD2 comprised dark brown ashy gravelly silty sand with occasional rootlets to 2.50m and 1.20m respectively. HD1 comprised dark brown ashy gravelly sand to 0.50m, underlain by dark brown gravelly silty sand with occasional rootlets.

Cohesive deposits were found underlying the Made Ground in M1 and M3. In M1 these comprised soft orangish brown and brown mottled slightly gravelly sandy silty clay to a depth of 1.20m, overlying firm orangish brown slightly gravelly sandy silty clay with occasional pockets of sand to a depth of 1.65m, overlying firm medium strength brown slightly gravelly slightly sandy silty clay to a depth of 3.35m and between 3.55 and 4.00 metres. In M3 the cohesive deposits comprised soft to firm slightly gravelly slightly sandy silty clay with occasional pockets of sand.

Groundwater inflows were recorded in M2 and M3 at depths of 2.00m and 1.50m depths respectively within the old pond area. It should be noted that they were only left open for a short period of time and groundwater levels and rates of inflow may be subject to seasonal and/ or climatic variations.

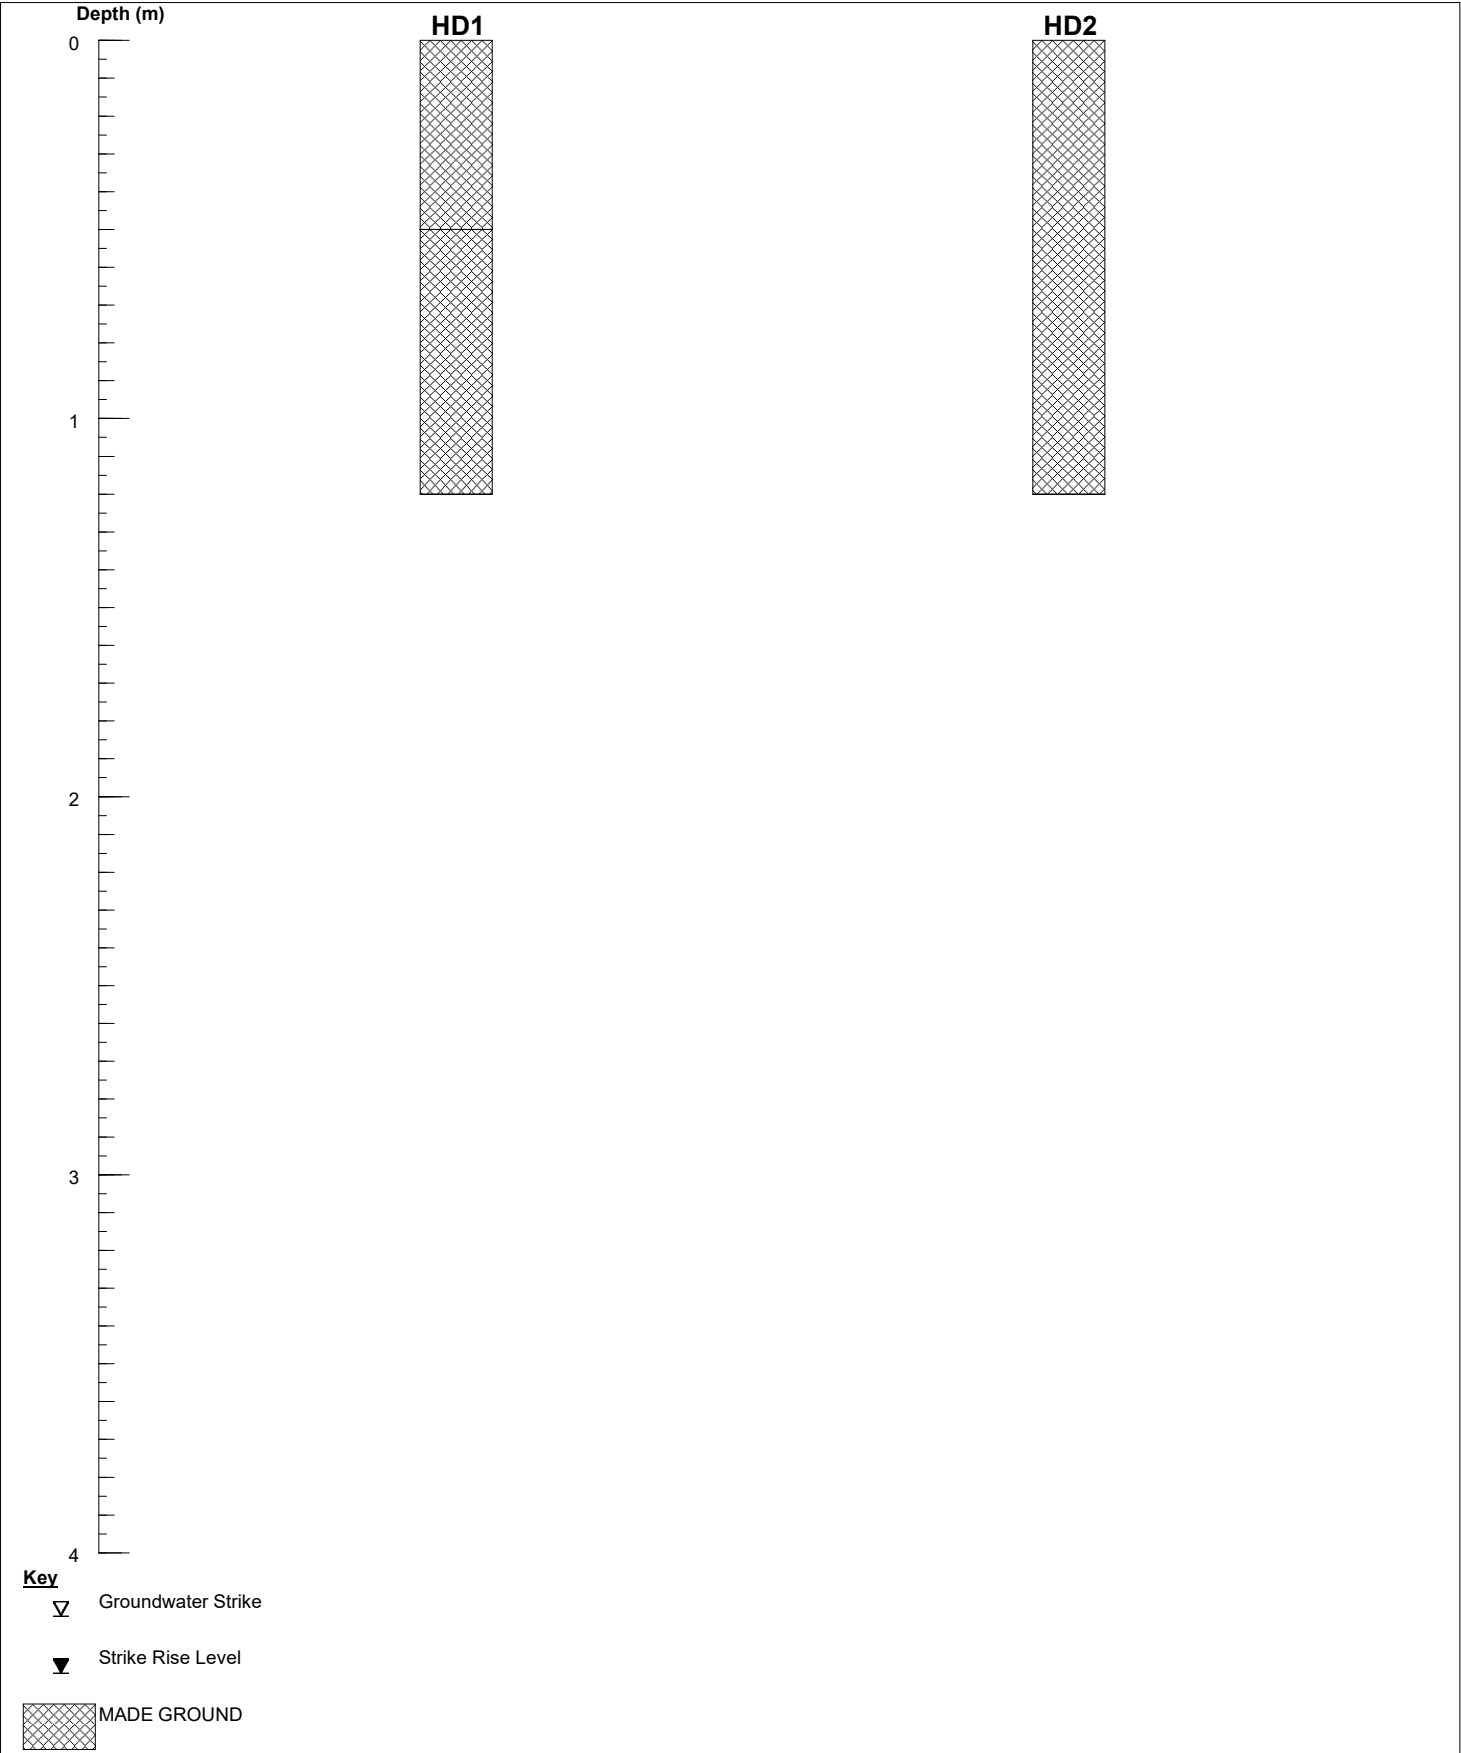
| <div>Remarks</div> <div>No groundwater encountered.<br/>Pit sides remained vertical and stable.<br/>On completion backfilled with arisings.</div> | | | | | | | | Scale (approx)<br>1:25 | Logged By<br>SS/HB | |

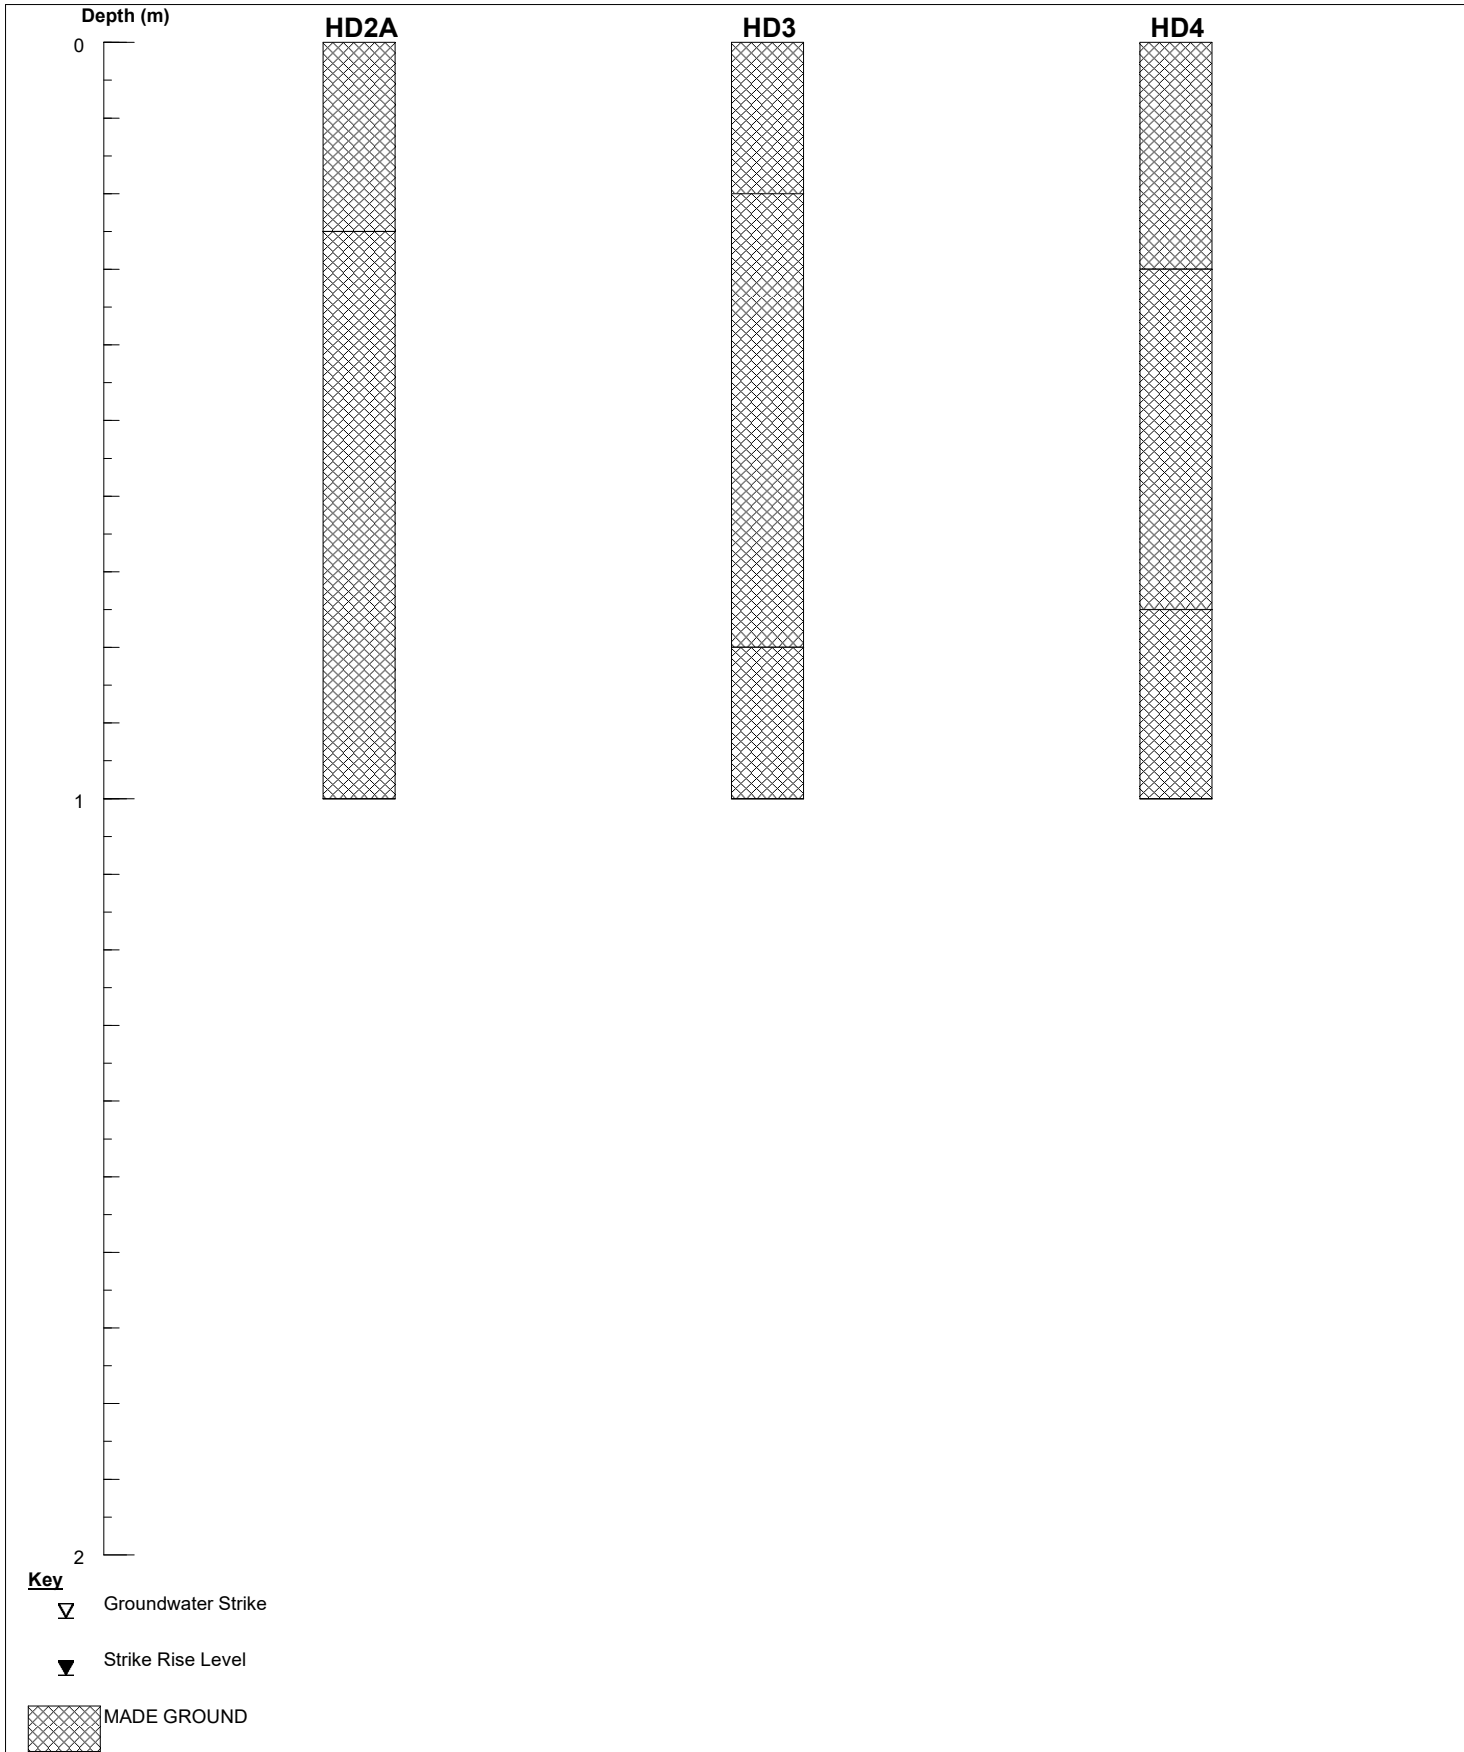
In HD2A, HD3 and HD4, the made ground comprised grey sandy silty clayey fine to coarse gravel sized fragments of stone, brick and concrete to depths of 0.25m, 0.20m and 0.30m respectively. This was underlain by brown ashy sandy silty very clayey fine to coarse gravel sized fragments of brick, glass, ceramic and clinker to 1.00m in HD2A, by brown gravelly silty very clayey fine to coarse sand to 0.80m and light brown slightly gravelly silty clayey fine to coarse sand to 1.00m in HD3, and by brown ashy sandy silty clayey fine to medium gravel sized fragments of clinker, brick, concrete and coal to 0.75m and brownish orange sandy silty clayey fine to medium gravel sized fragments of ash and clinker to 1.00m in HD4.

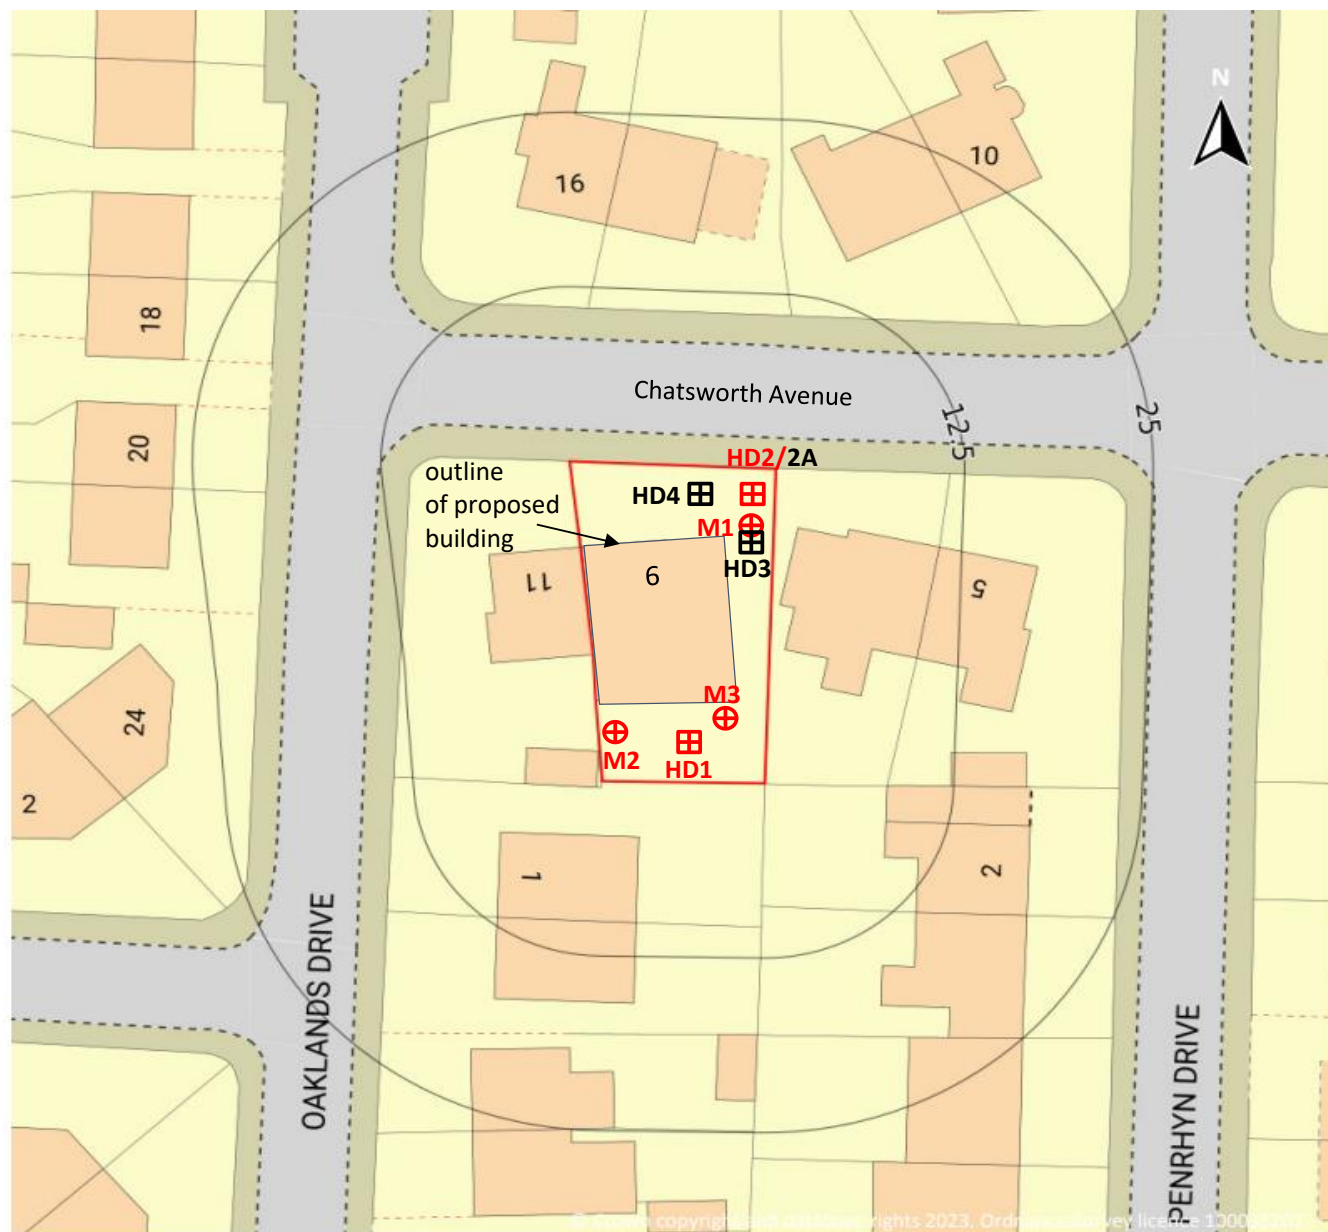
As shown on Figure 2, the about 0.03 hectare rectangular shaped site which comprises a party constructed residential property following the demolition of the previous building on site. It is bound by Chatsworth Avenue to the north, 7 Chatsworth Avenue to the east, the rear garden of 1 Oaklands Drive to the south, and 11 Chatsworth Avenue to the west.

Two hand dug trial pits were taken out at the positions determined and set out by Sub Surface North West Limited, as shown on Figure 2. The hand dug trial pits were excavated to depth of 1.20 metres. Samples were taken for logging, in accordance with BS.5930:2015+A1:2020, and testing. The resulting Hand Dug Trial Pit Records are appended. On completion the hand dug trial pits were backfilled with arisings.

Three hand dug trial pits were taken out at the positions determined and set out by Sub Surface North West Limited, as shown on Figure 2. The hand dug trial pits were excavated to a depth of 1.00 metre. Samples were taken for logging, in accordance with BS.5930:2015+A1:2020, and testing. On completion the hand dug trial pits were backfilled with arisings.
