# Phase II Geoenvironmental Site Assessment

Site: Willow Street, Bury

Reference: 17-285-R1-2

Date: January 25

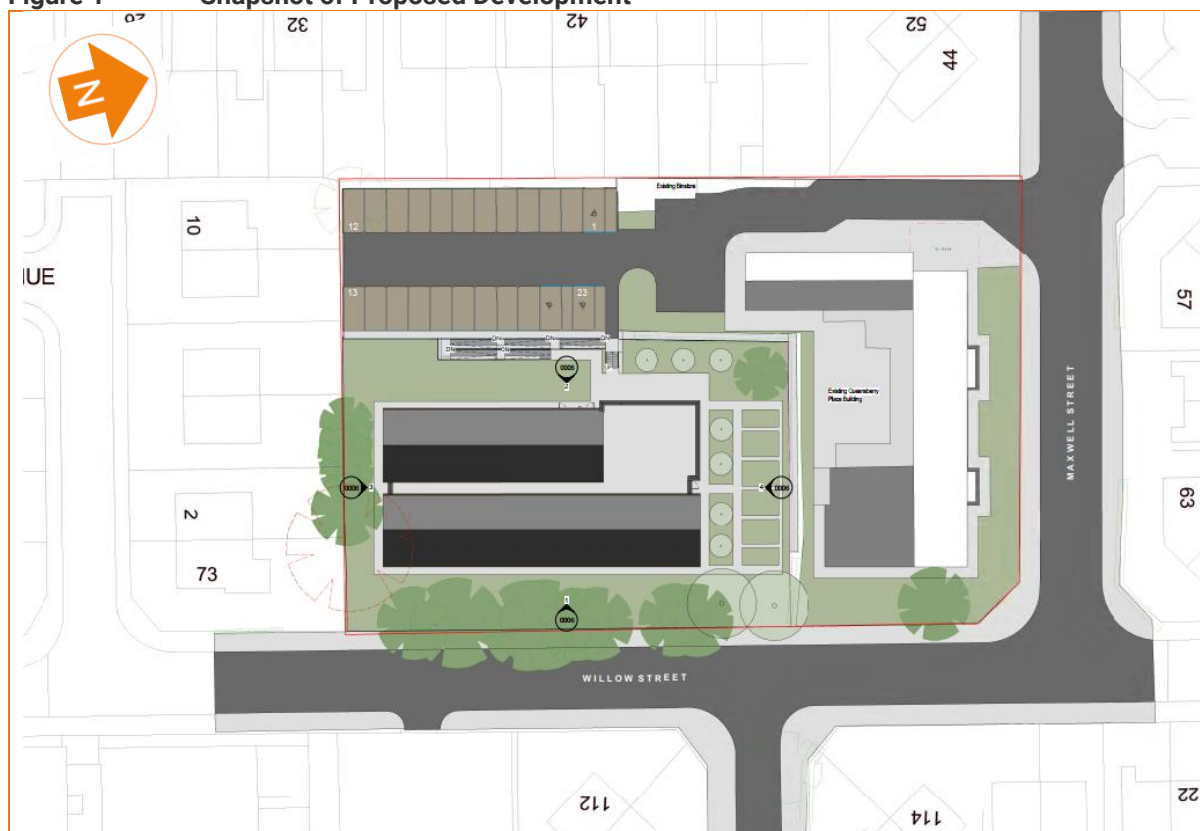
**Figure 1** Snapshot of Proposed Development

A snapshot of the Proposed Development Layout is indicated in Figure 1 below and Drawing 17-285-R2 (APPENDIX IV)

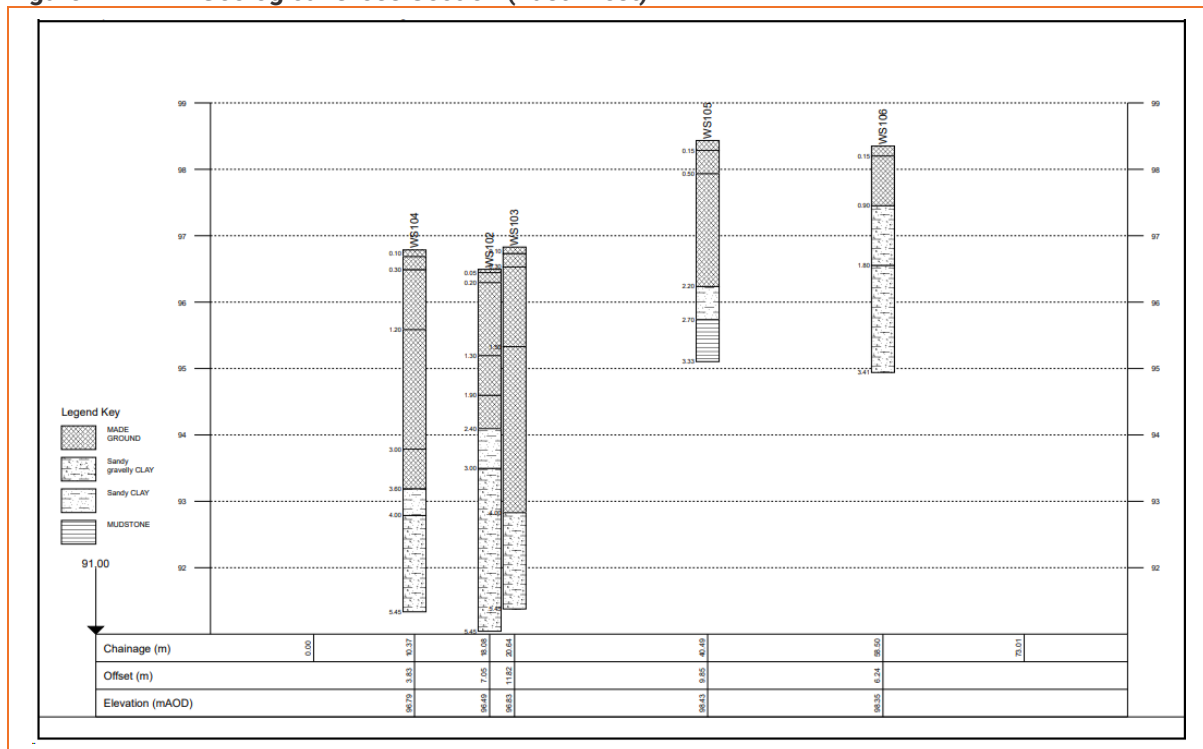
**Figure 2 Geological Cross Section (East-West)**

Made Ground deposits were encountered within all exploratory hole locations to depths of between 0.90 m and 4.00 m bgl. It should be noted that within WS103 where Made Ground was encountered to 4.00 m bgl, the recovery of material was poor, and this is therefore an estimated depth of Made Ground.

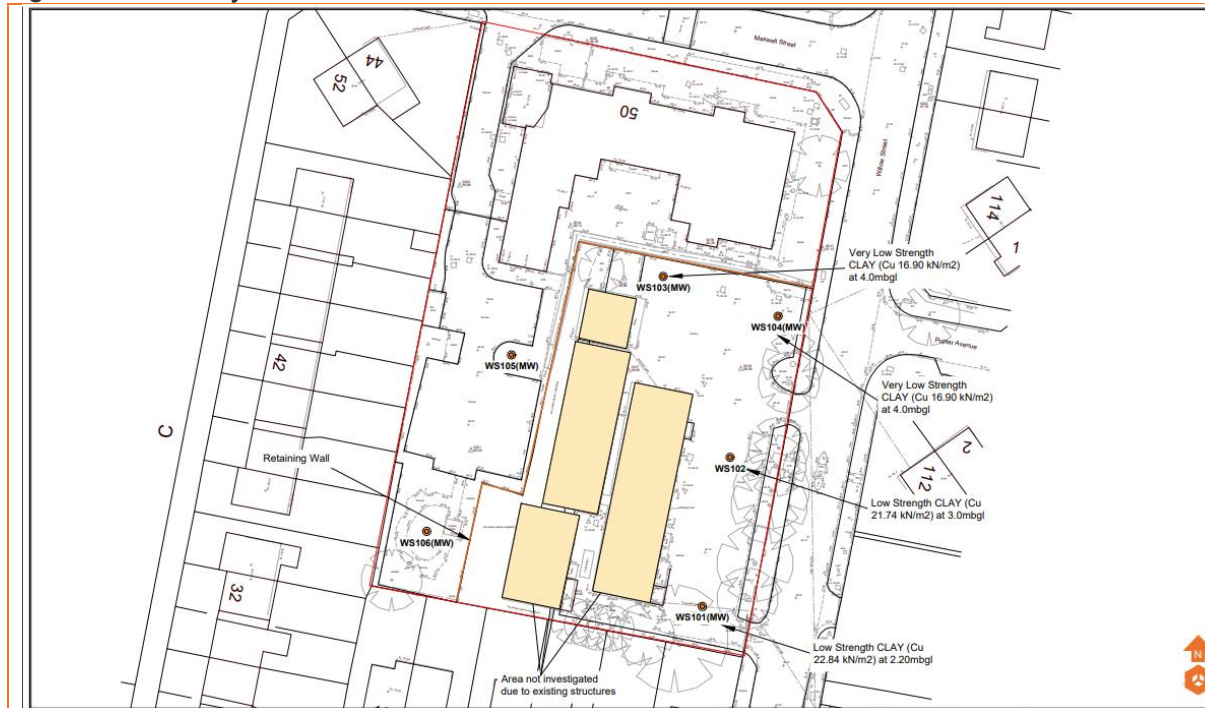
**Figure 6 Key Geotechnical Foundation Constraints**

Figure 6 below identifies key constraints and considerations with respect to the foundation recommendations.

Following this assessment, the following foundation recommendations have been determined:

- ✳ Within the footprint of the proposed building, the depth of Made Ground varies from 2.20 to 4.00 m bgl.
- ✳ Much of the underlying CLAY is soft to firm with an undrained shear strength less than 30kN/m<sup>2</sup>.
- ✳ Therefore, an engineered foundation solution is likely to be required comprising (VSCs) or a piled foundation onto the glacial clays or underlying bedrock.

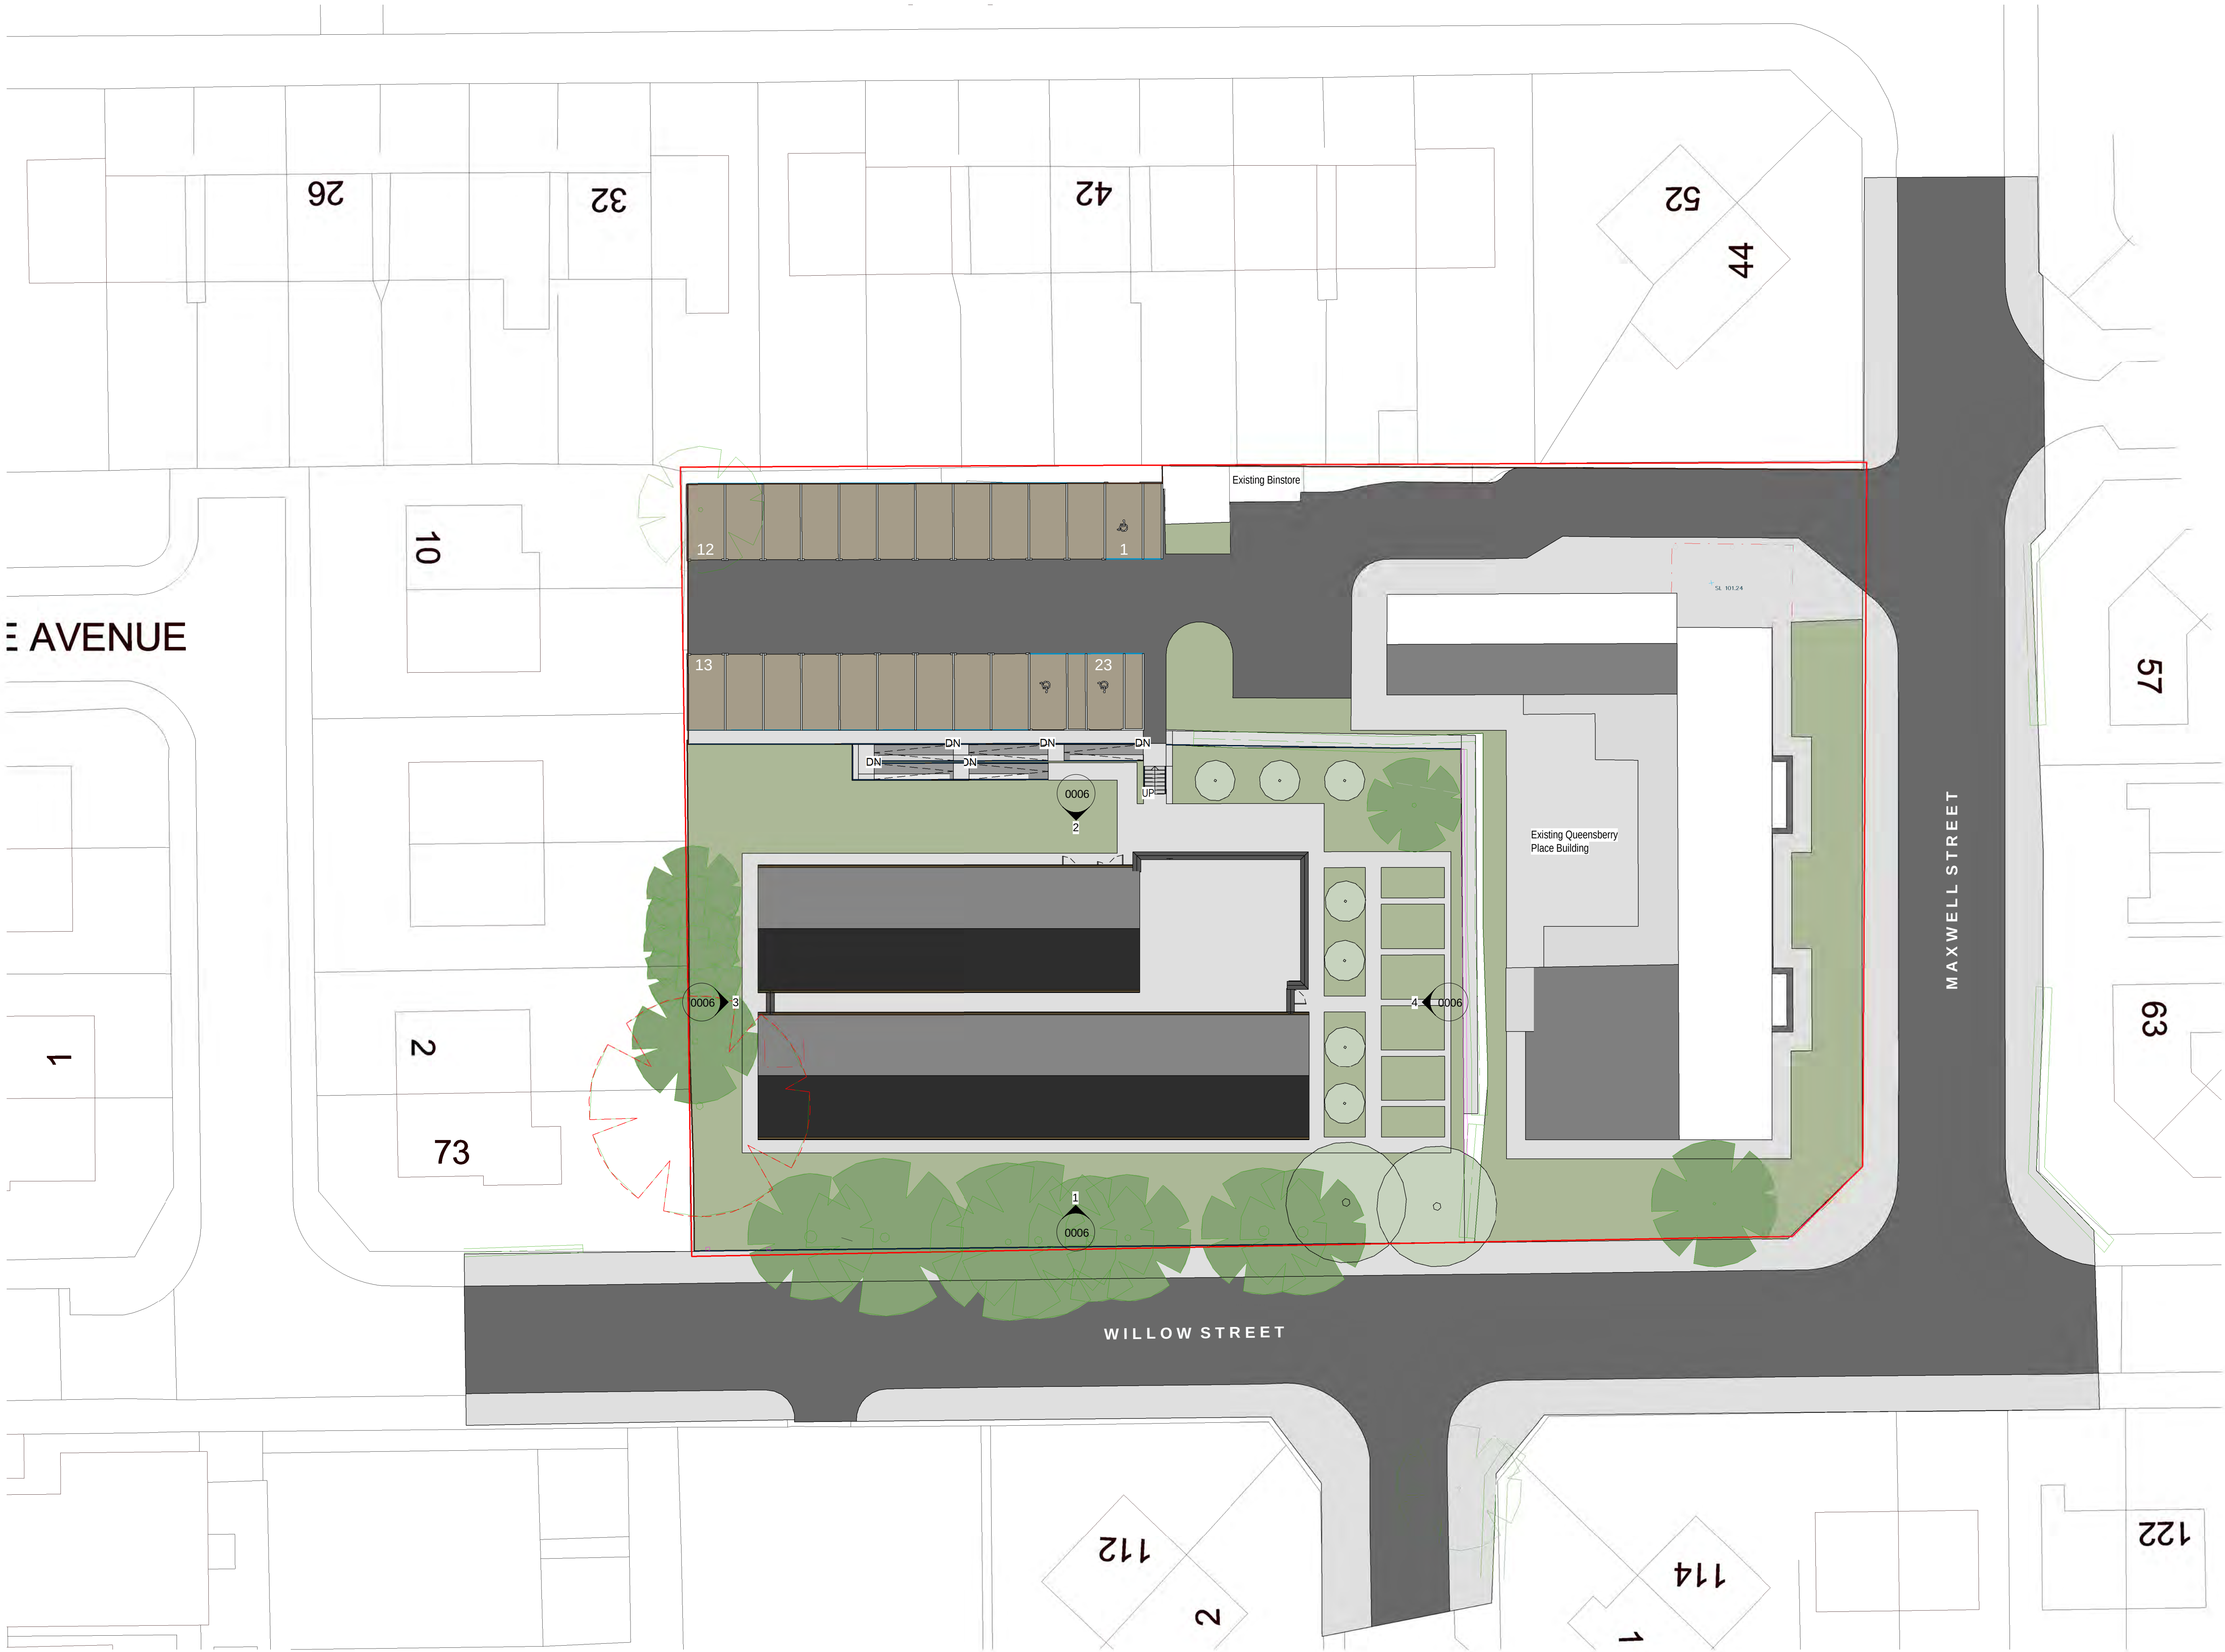
| Description: | | Proposed Site Plan | |

Proposed Boundary Treatment Details

- 1100mm Metal Railing
- 1800mm Timber Fence

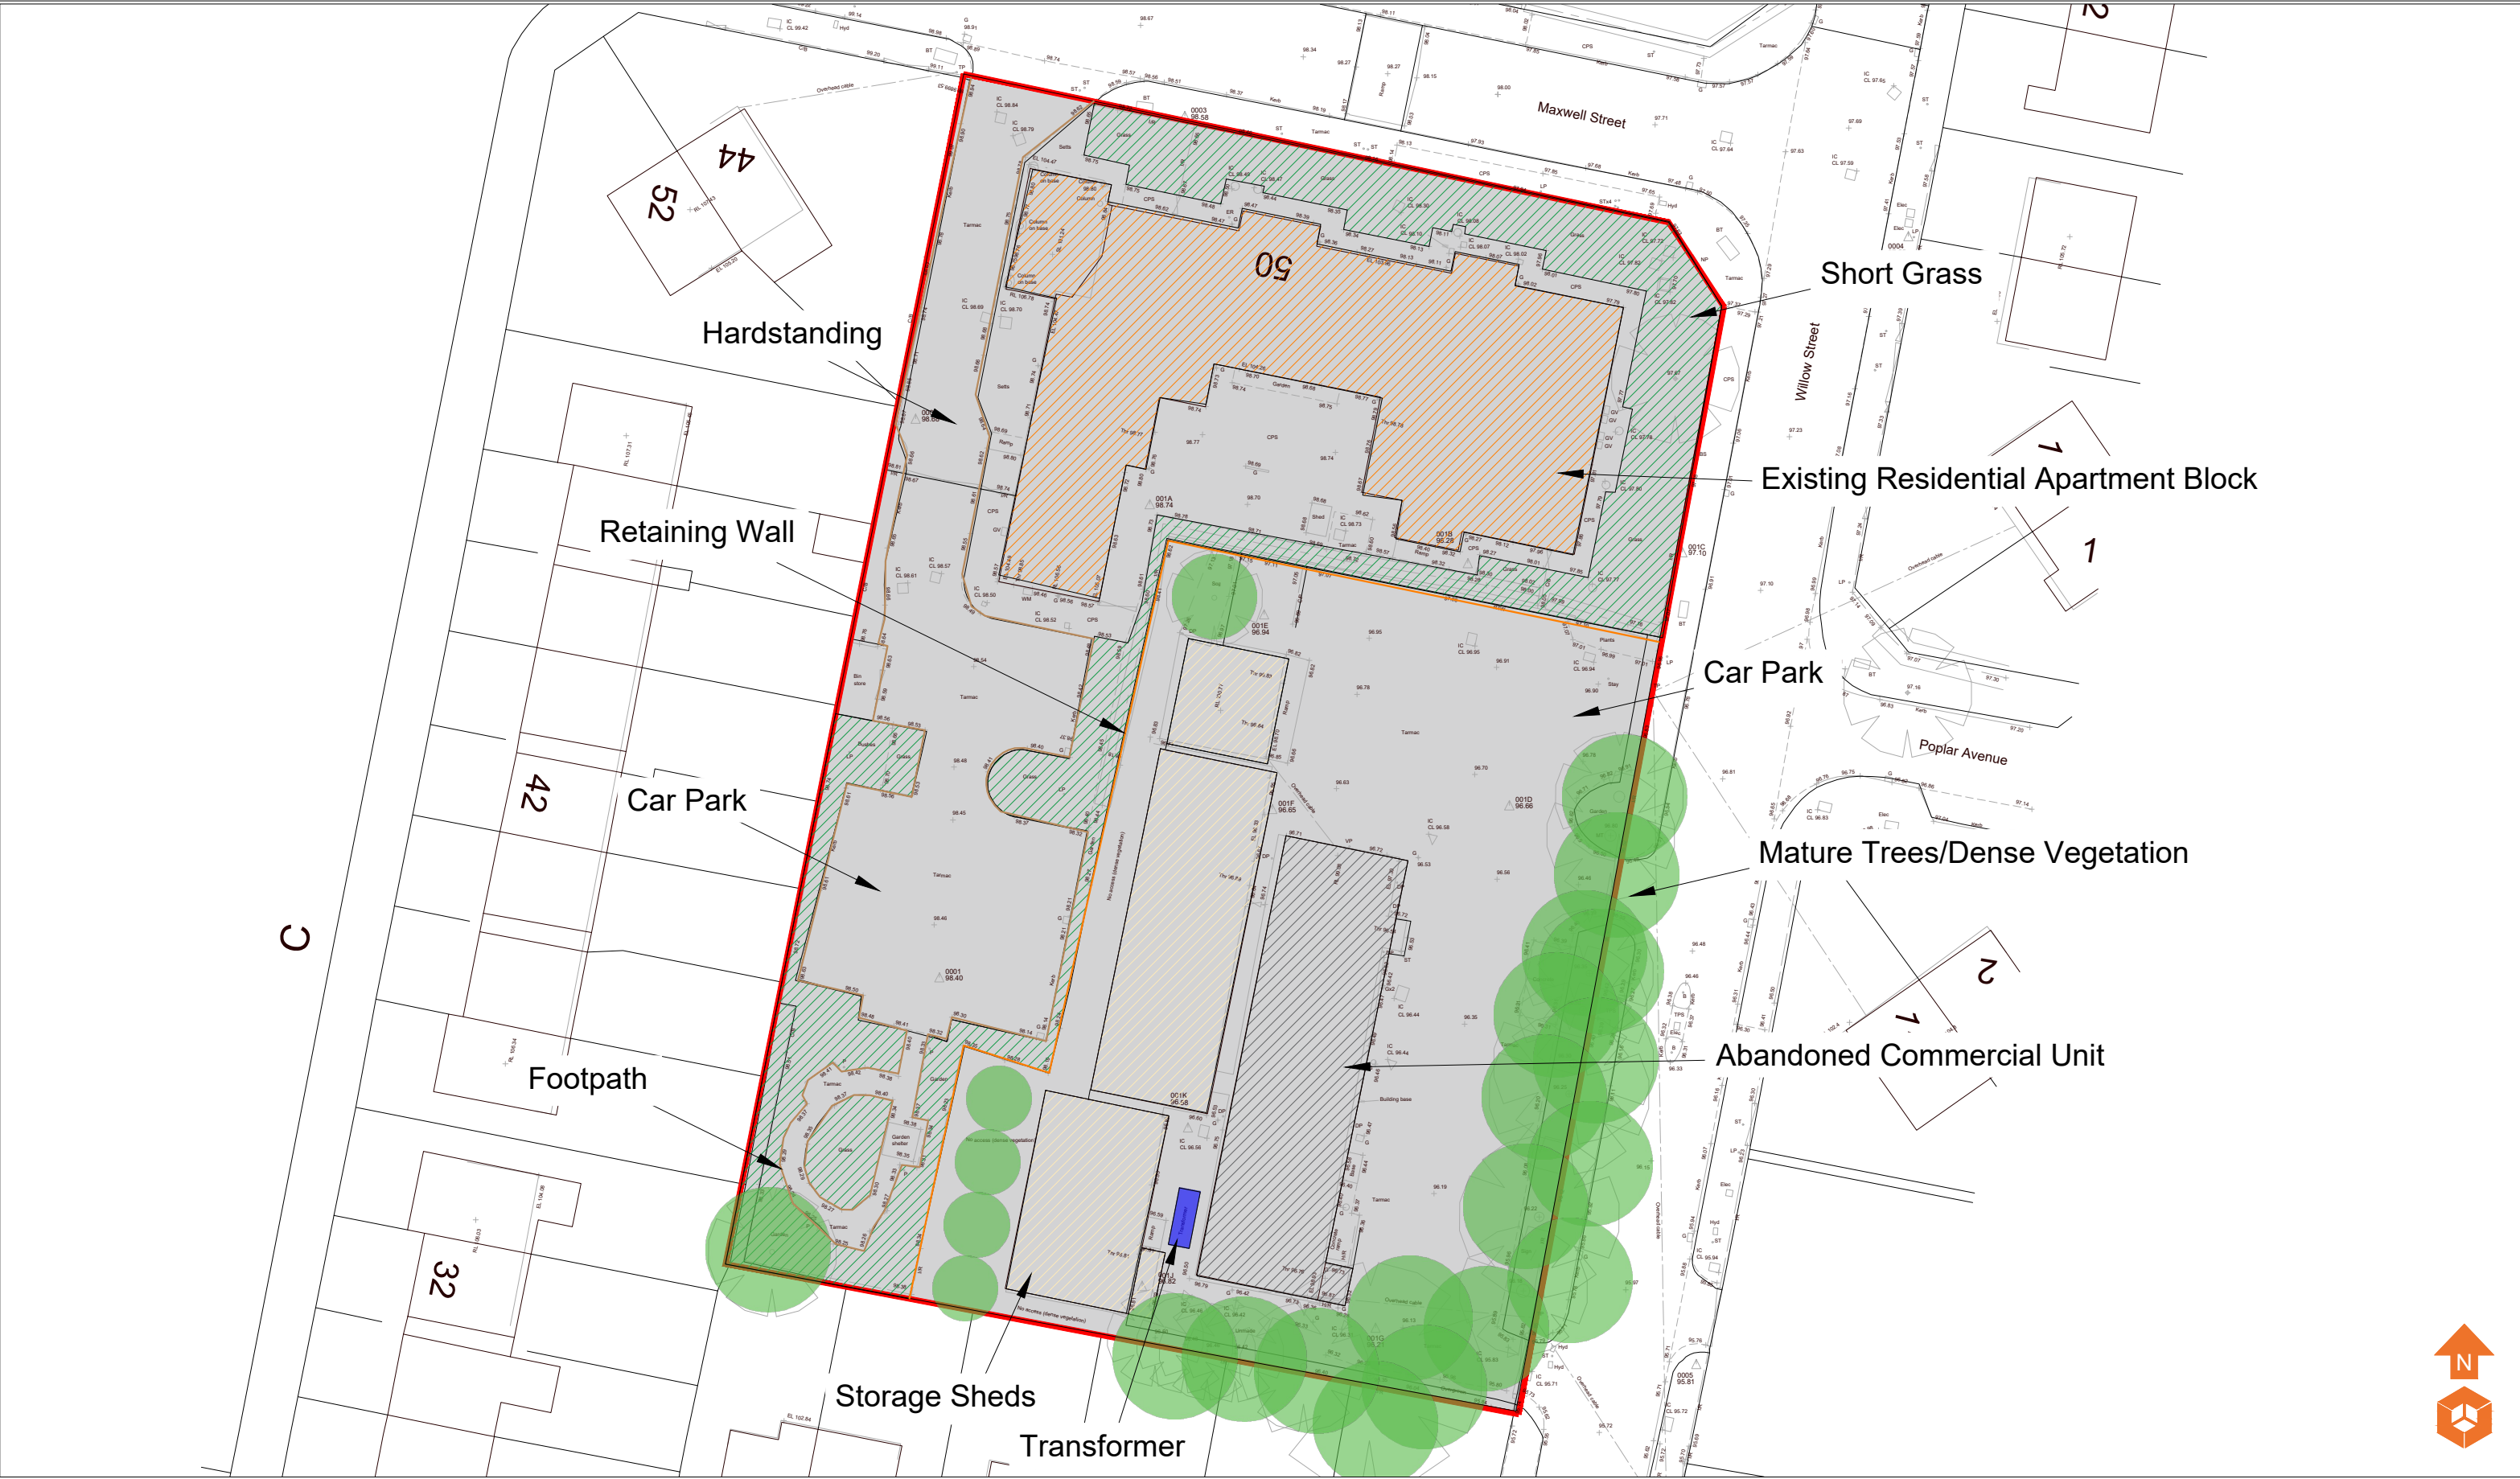
- Site Features
- Existing Residential Apartment Building
  - Abandoned Commercial Unit
  - Storage Sheds
  - Transformer
  - Footpath
  - Hardstanding
  - Short Grass
  - Mature Trees/Dense Vegetation
  - Retaining Wall

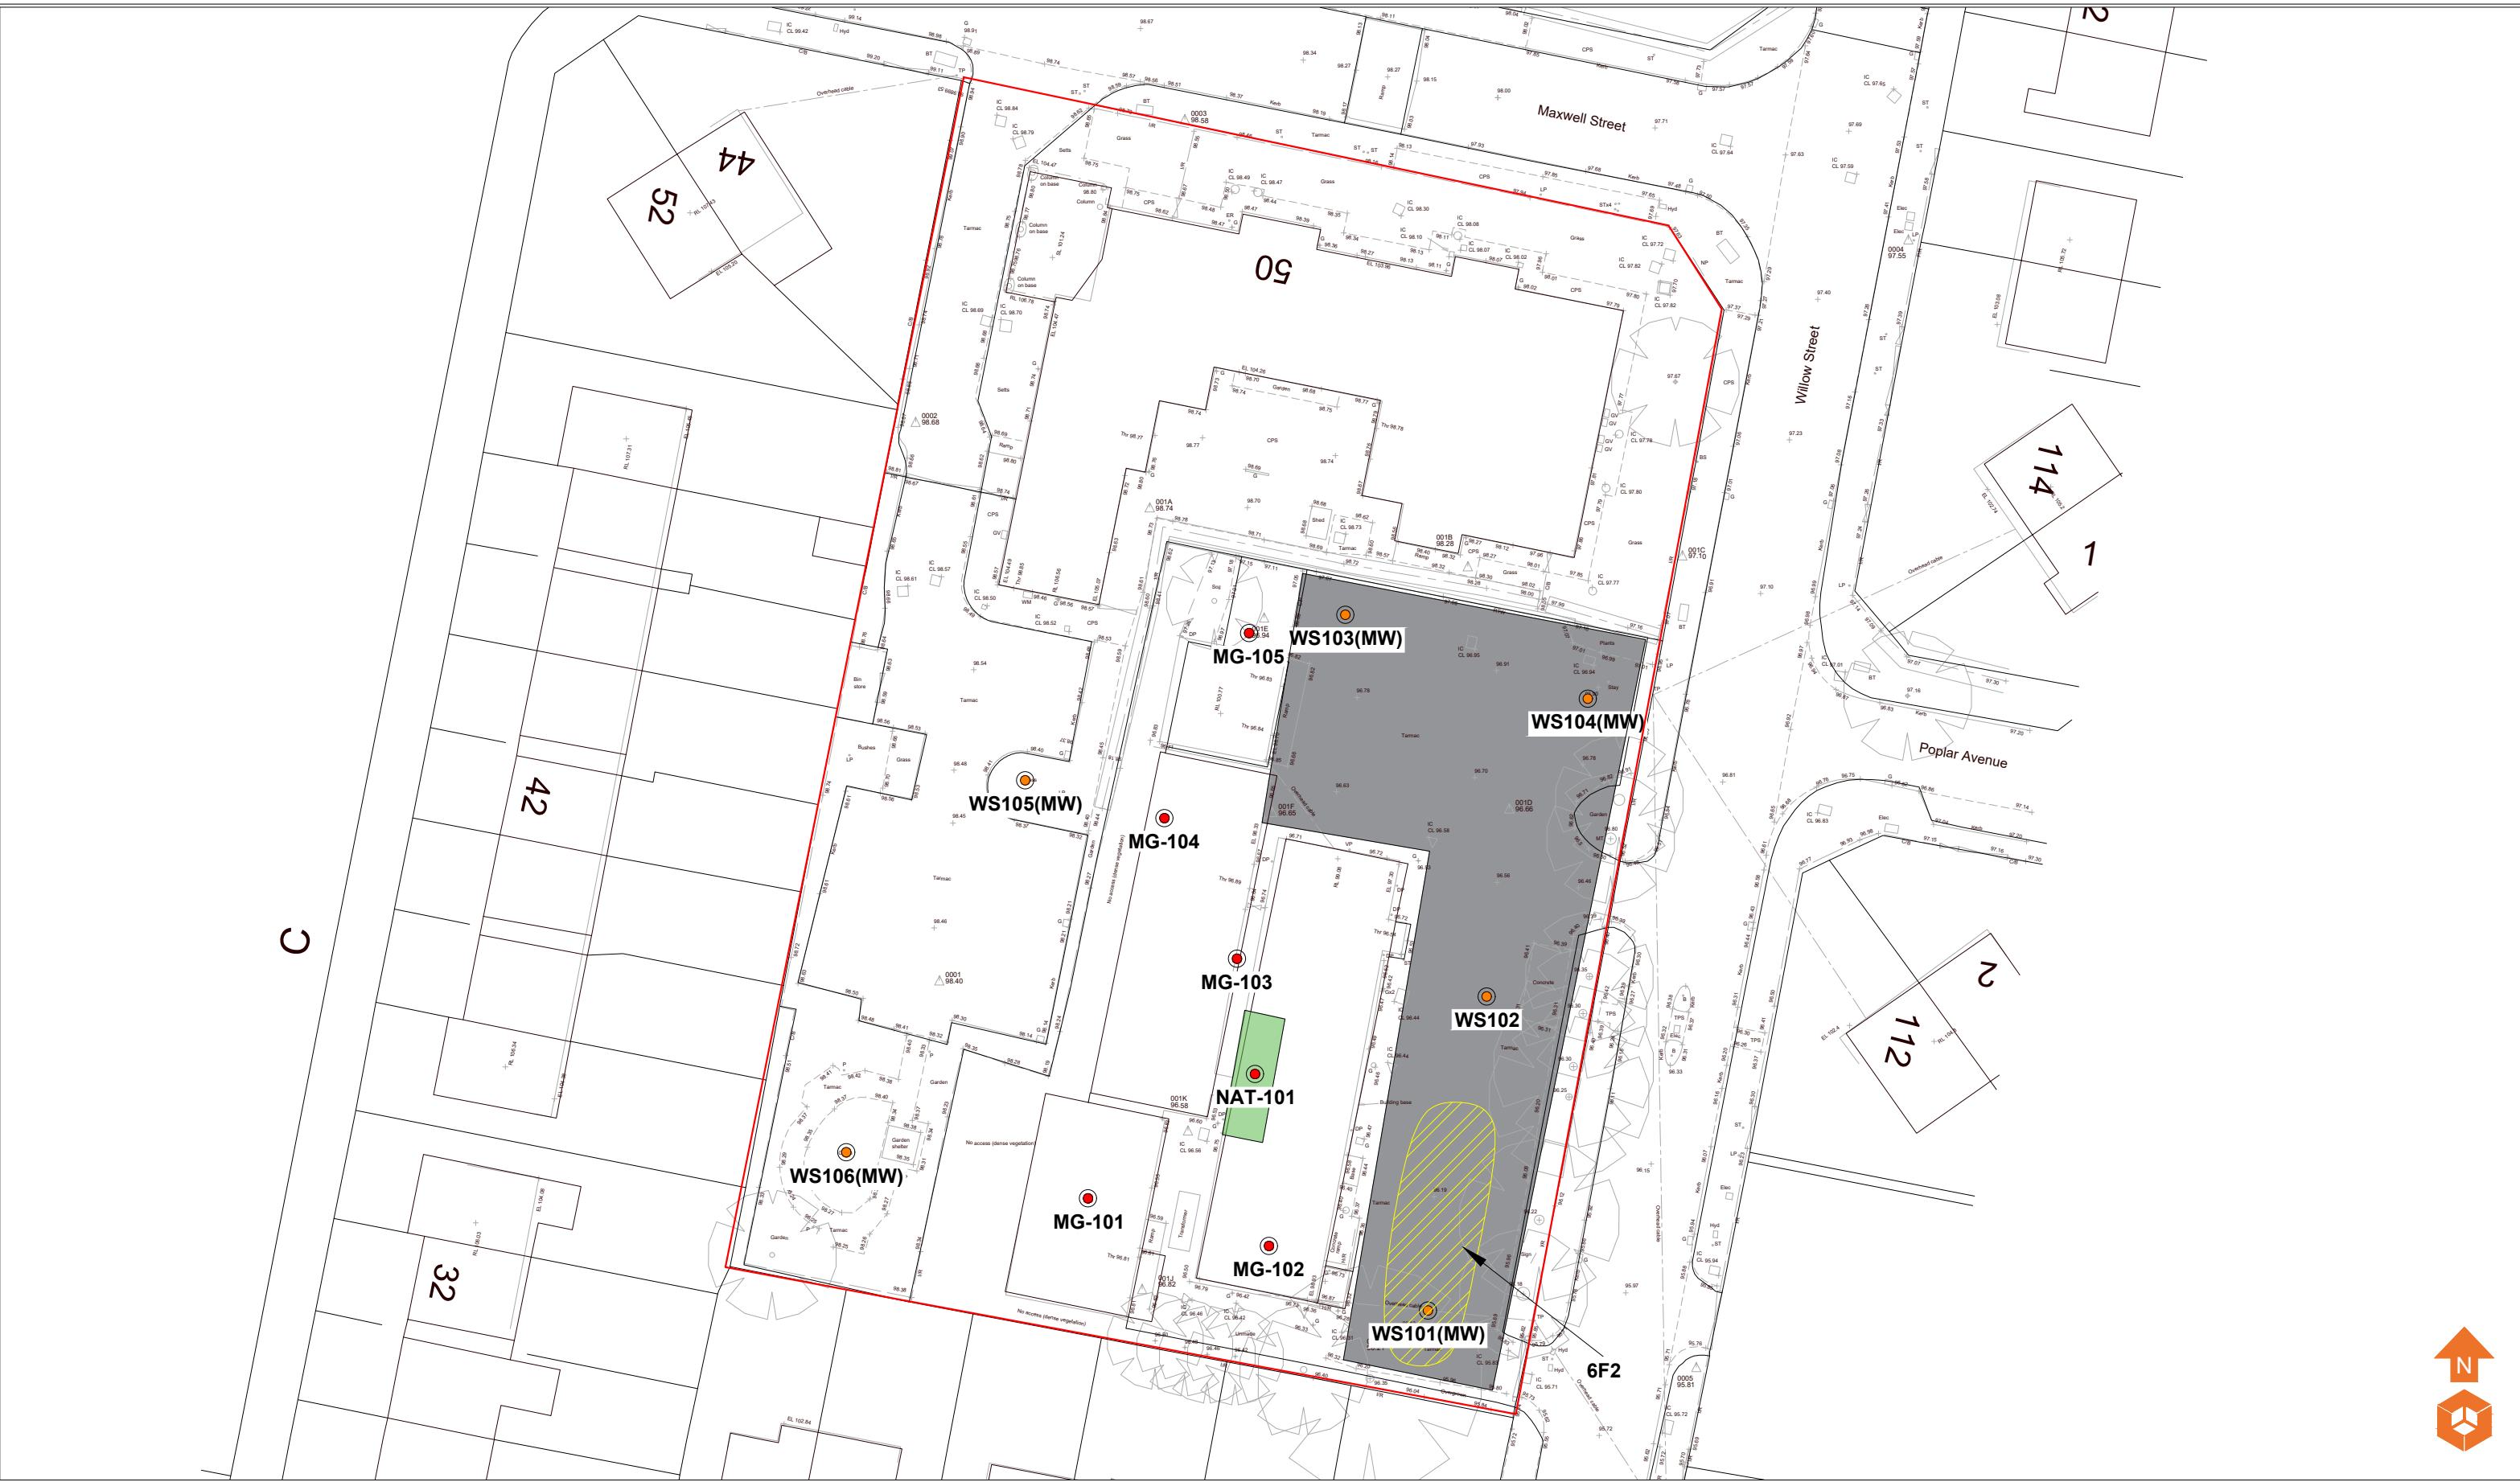
- Approximate Window Sample Probehole Location
- Approximate Window Sample Probehole Location with Install
- Approximate Window Sample Probehole Location
- Hardstanding
- 6F2

The sampling locations are illustrated in Drawing 17-285-005 (APPENDIX IV). The ground conditions encountered are indicated on the logs, which are provided in APPENDIX VI.

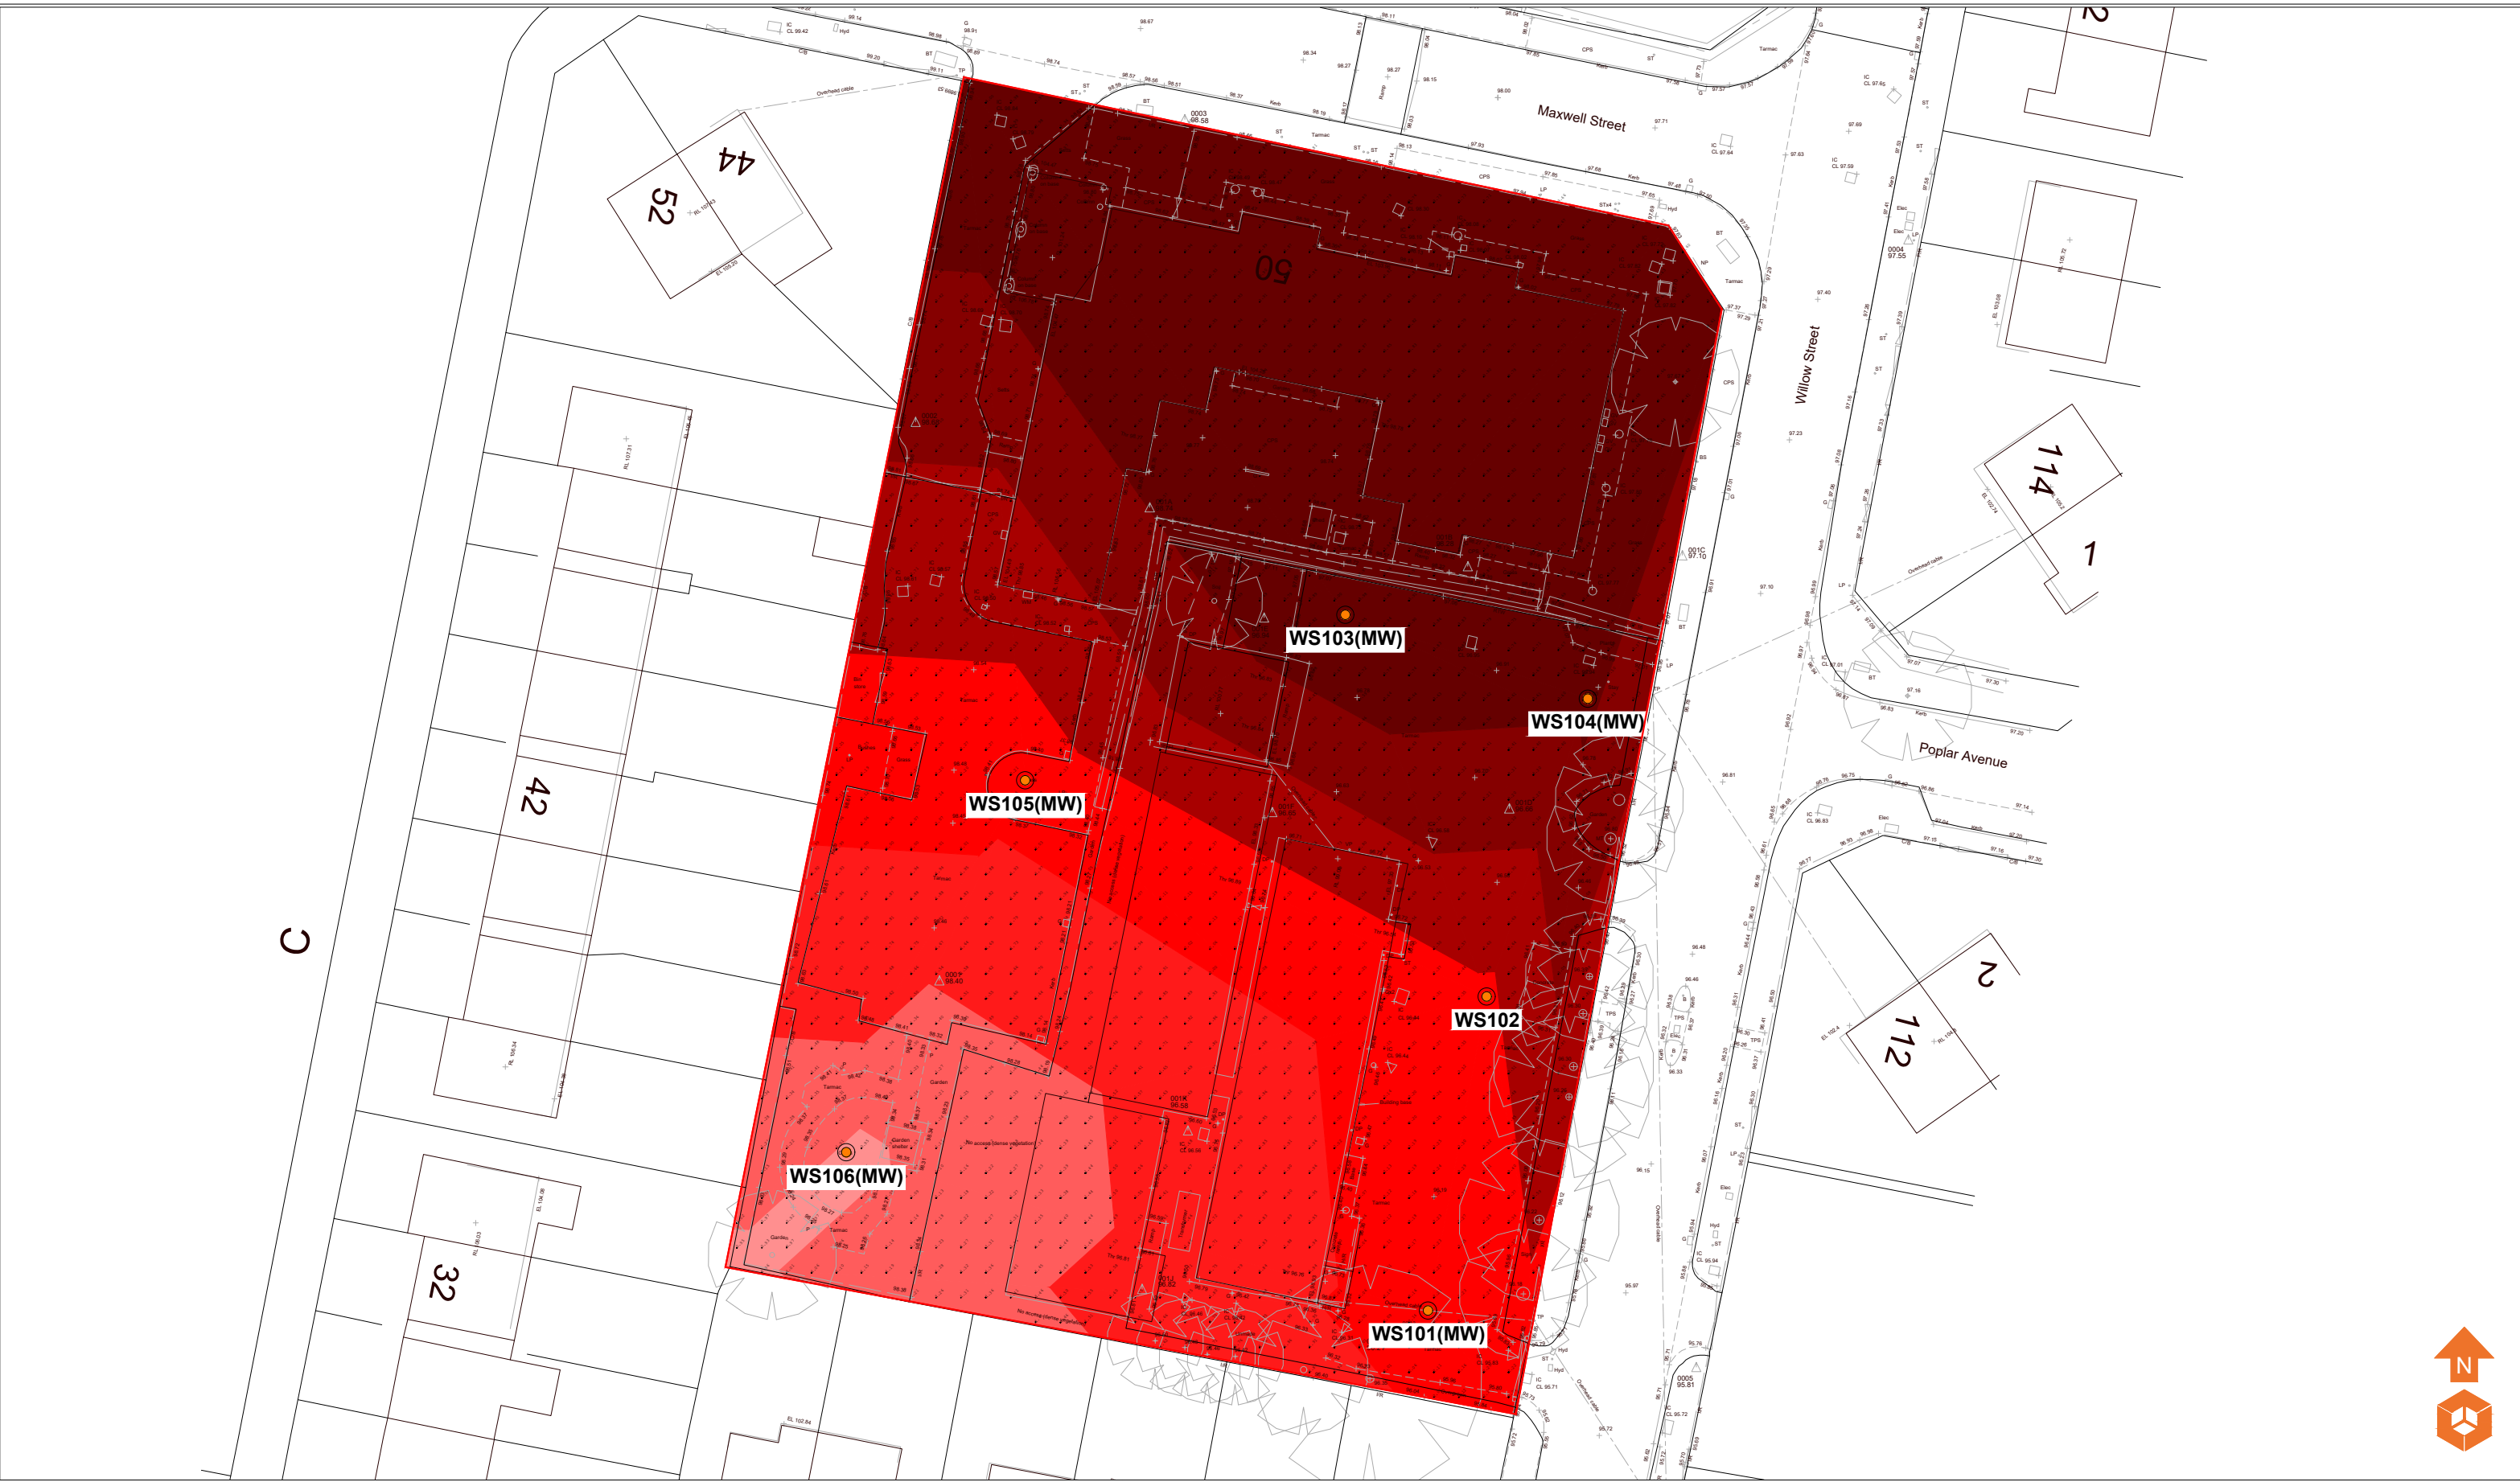
- Made Ground Depth (m)
- Depth of Made Ground 0.00 - 0.89m
  - Depth of Made Ground 0.90 - 1.39m
  - Depth of Made Ground 1.40 - 1.89m
  - Depth of Made Ground 1.90 - 2.39m
  - Depth of Made Ground 2.40 - 2.89m
  - Depth of Made Ground 2.90 - 3.39m
  - Depth of Made Ground > 3.40m

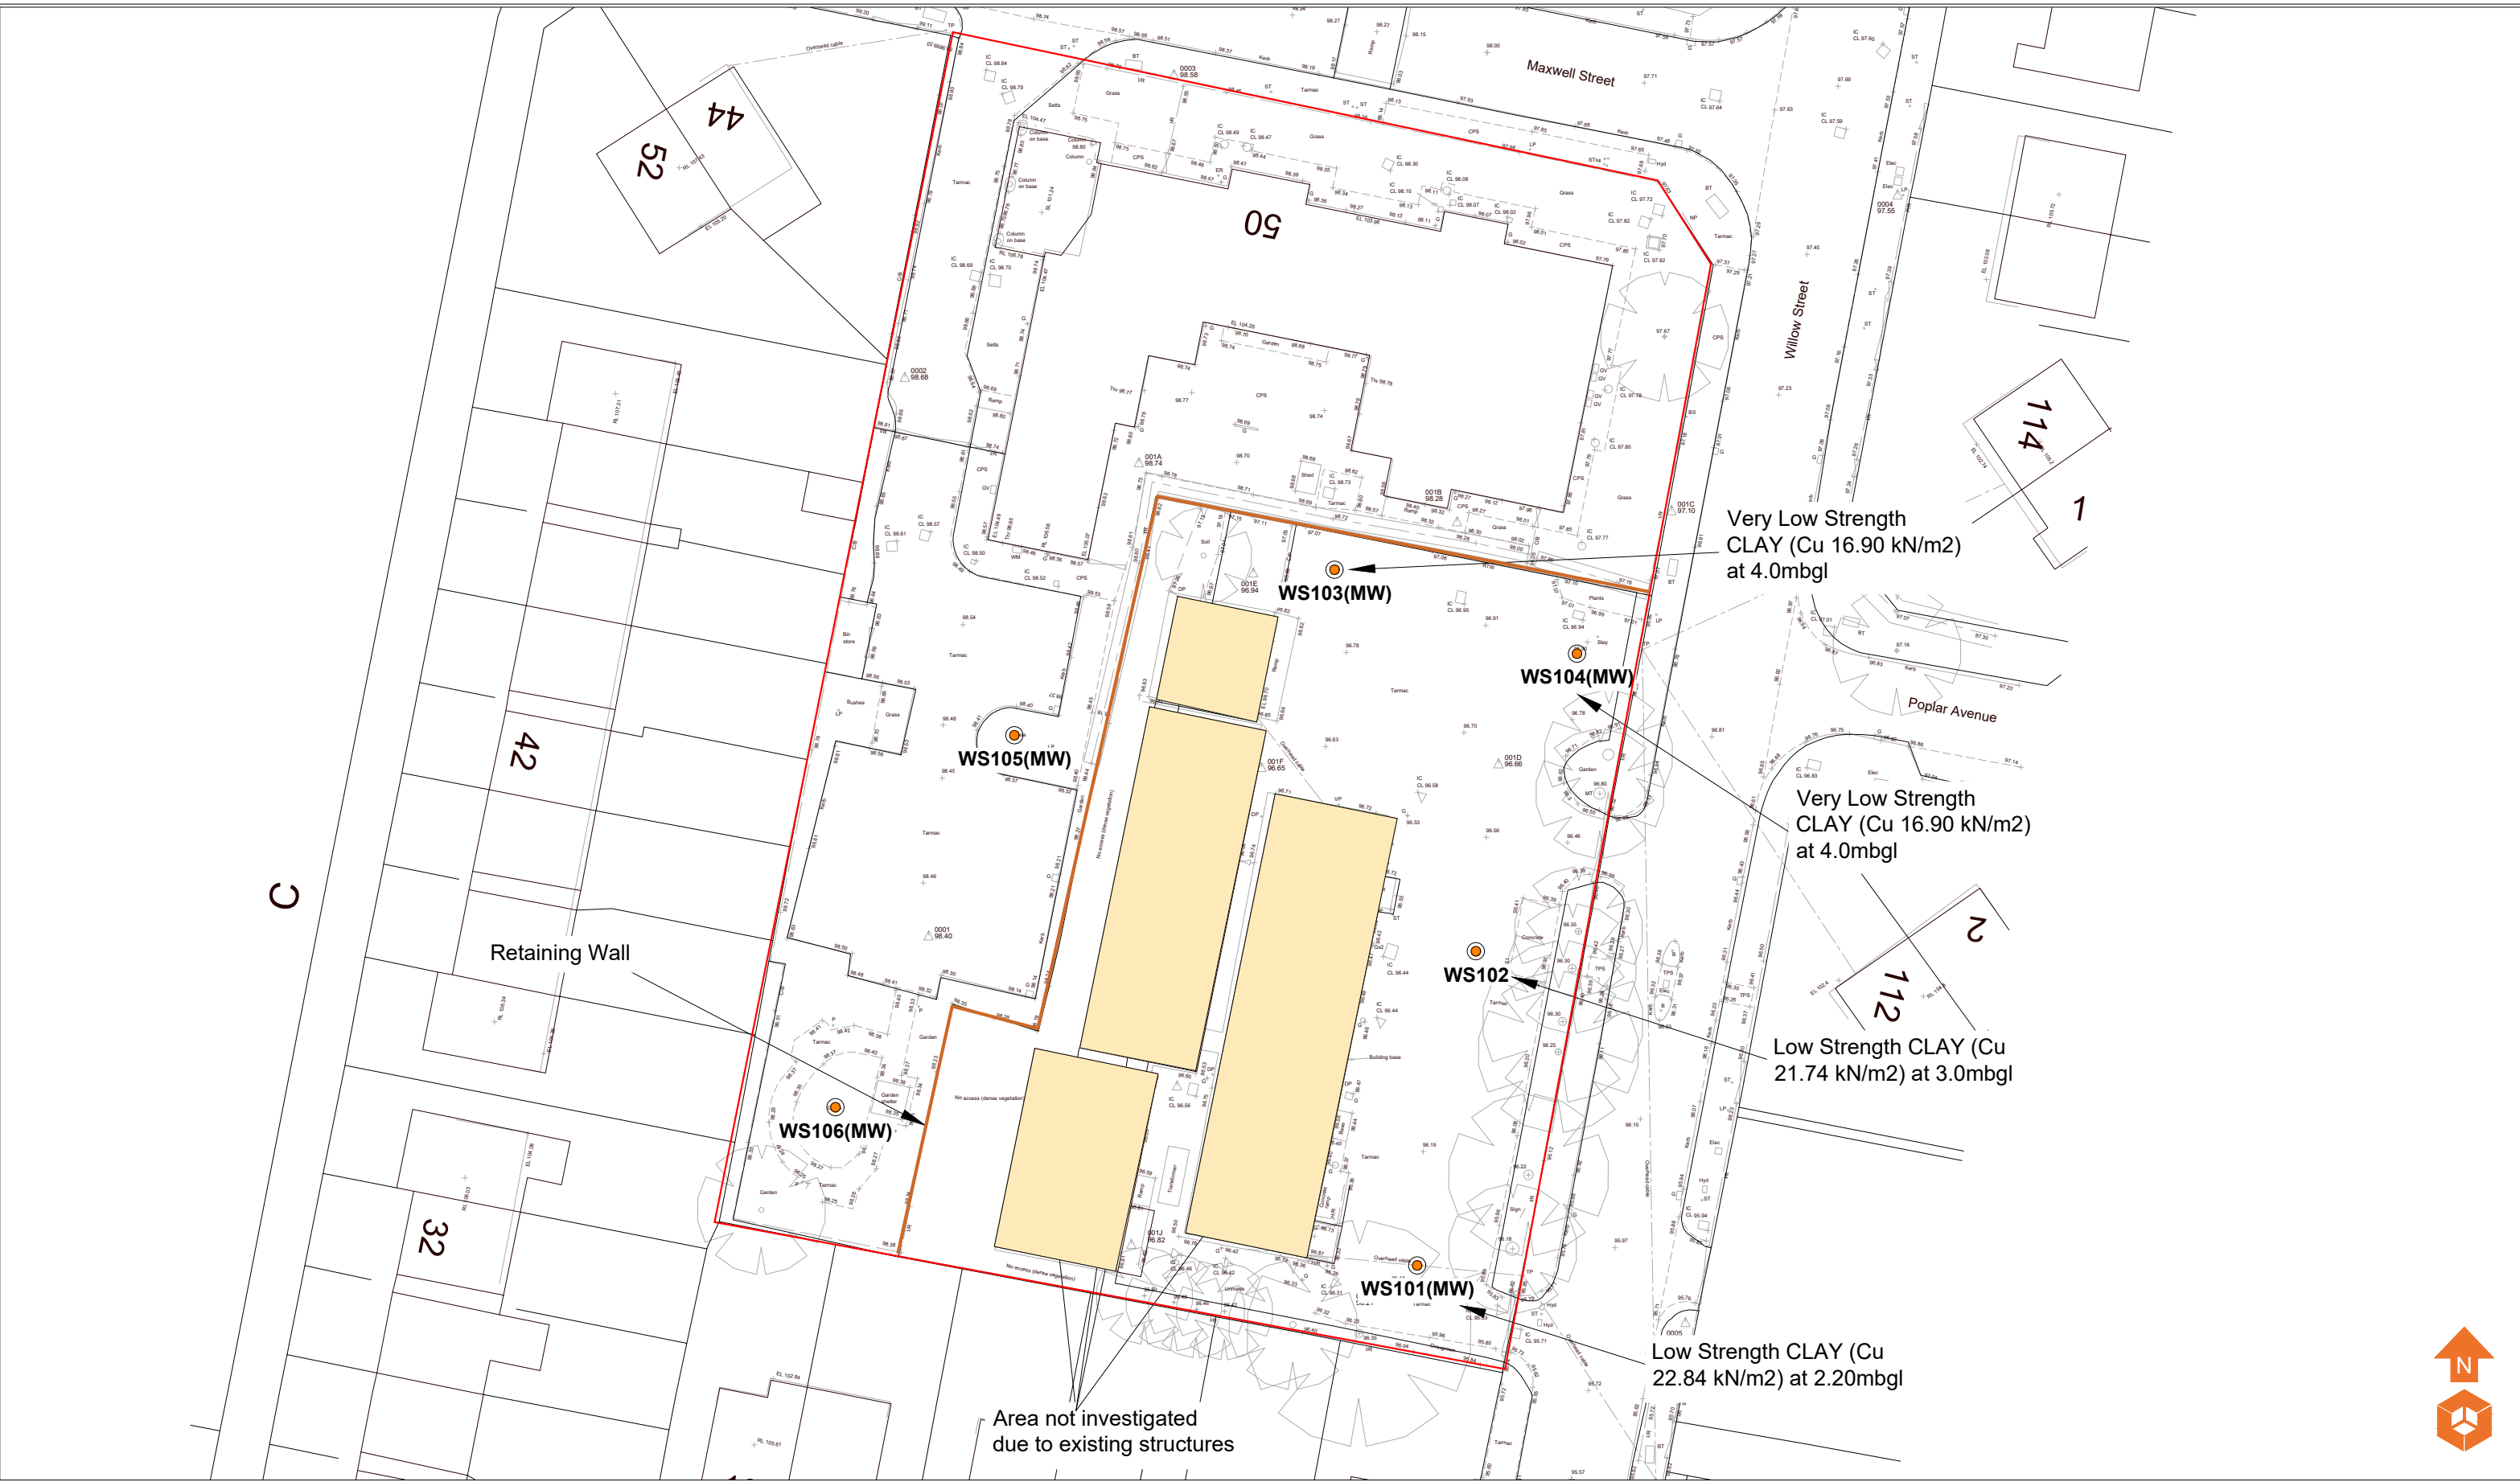
- Approximate Window Sample Probehole Location
- Approximate Window Sample Probehole Location with Install
- Area Not Investigated Due To Existing Structures
- Retaining Wall

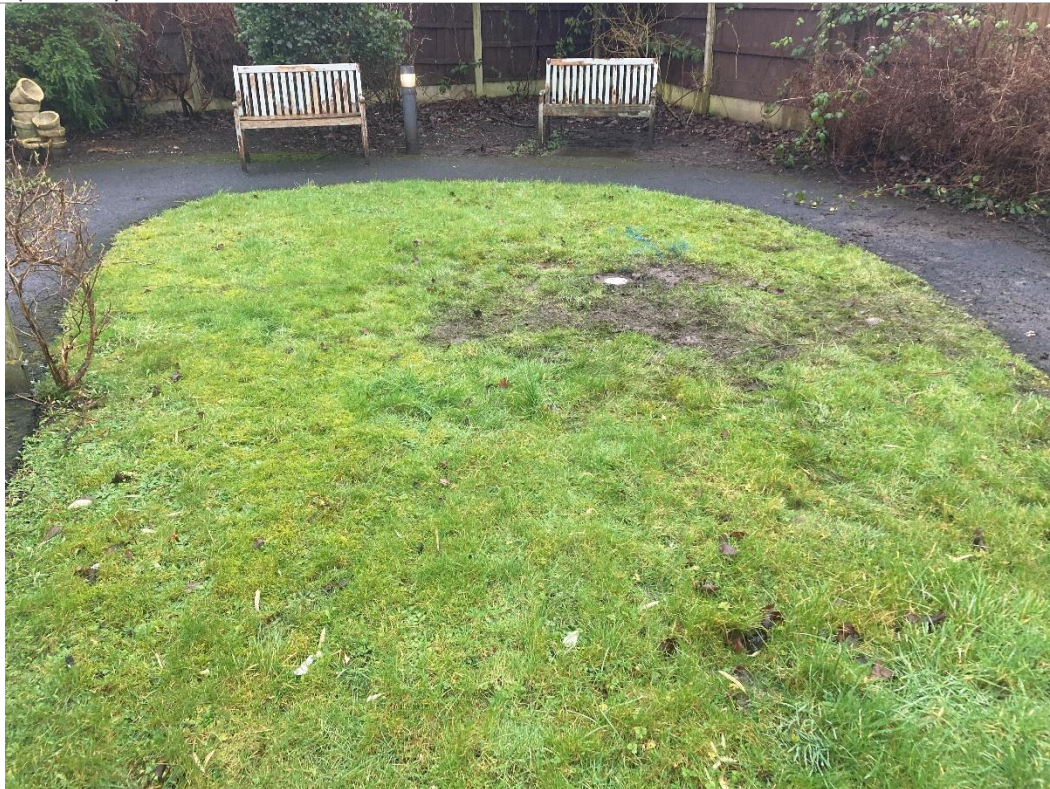
PLATE 3      SOFTSTANDING AREA AND WINDOW SAMPLE INSTALL IN SOUTHWEST OF SITE (WS106)
