# Phase II Geoenvironmental Site Assessment

Site: Willow Street, Bury

Reference: 17-285-R1-2

Date: January 25

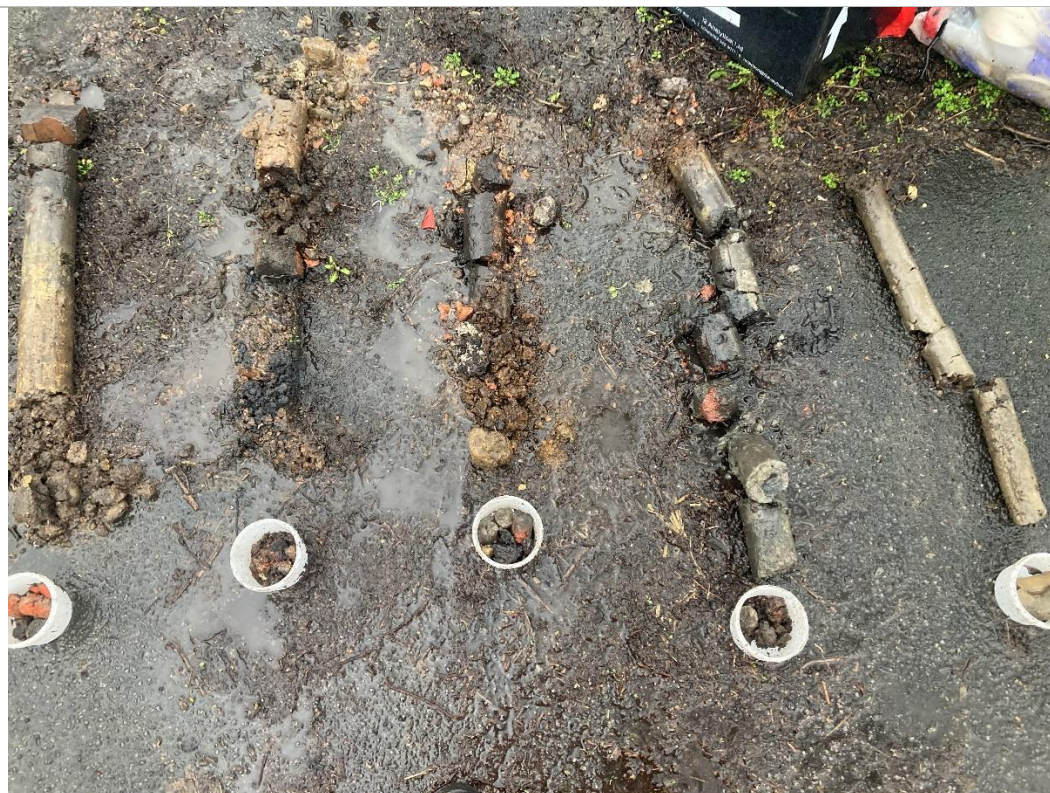
PLATE 4      WINDOW SAMPLE CORE (WS104)

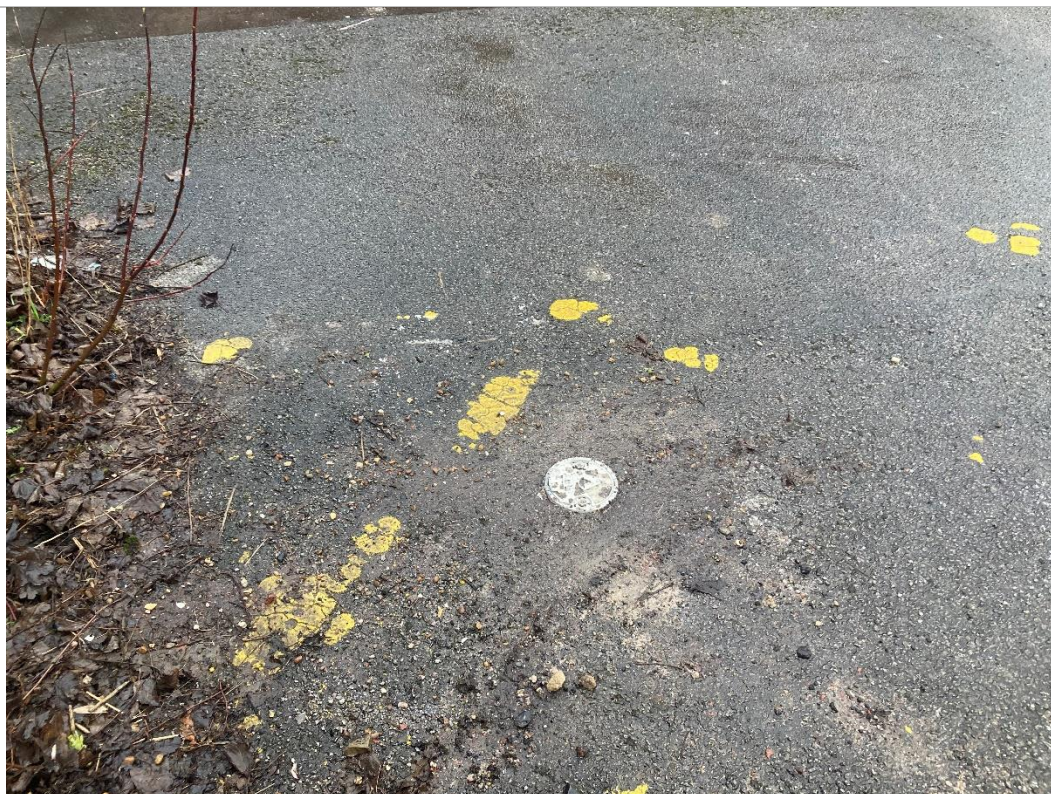
**PLATE 6**      **WINDOW SAMPLE INSTALL CARPARK (WS103)**

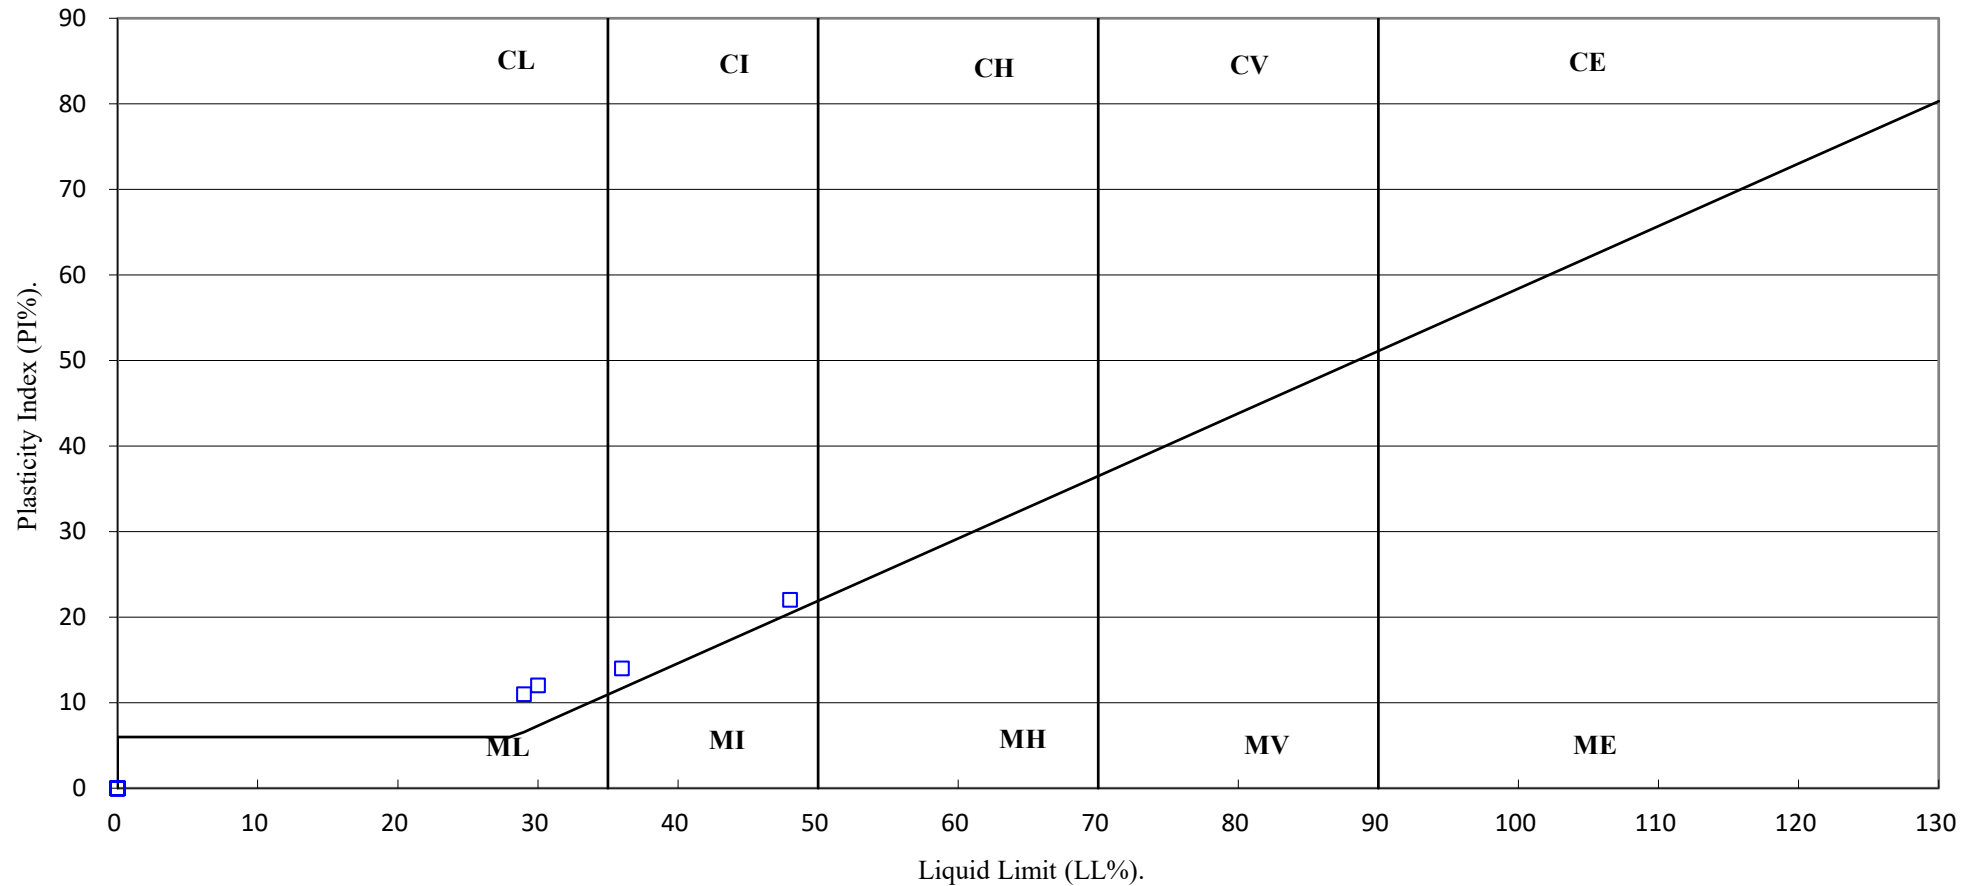
# PLASTICITY CHART FOR CASAGRANDE CLASSIFICATION.

PI can be related to shrinkability (low, medium or high) and then to minimum founding depth.

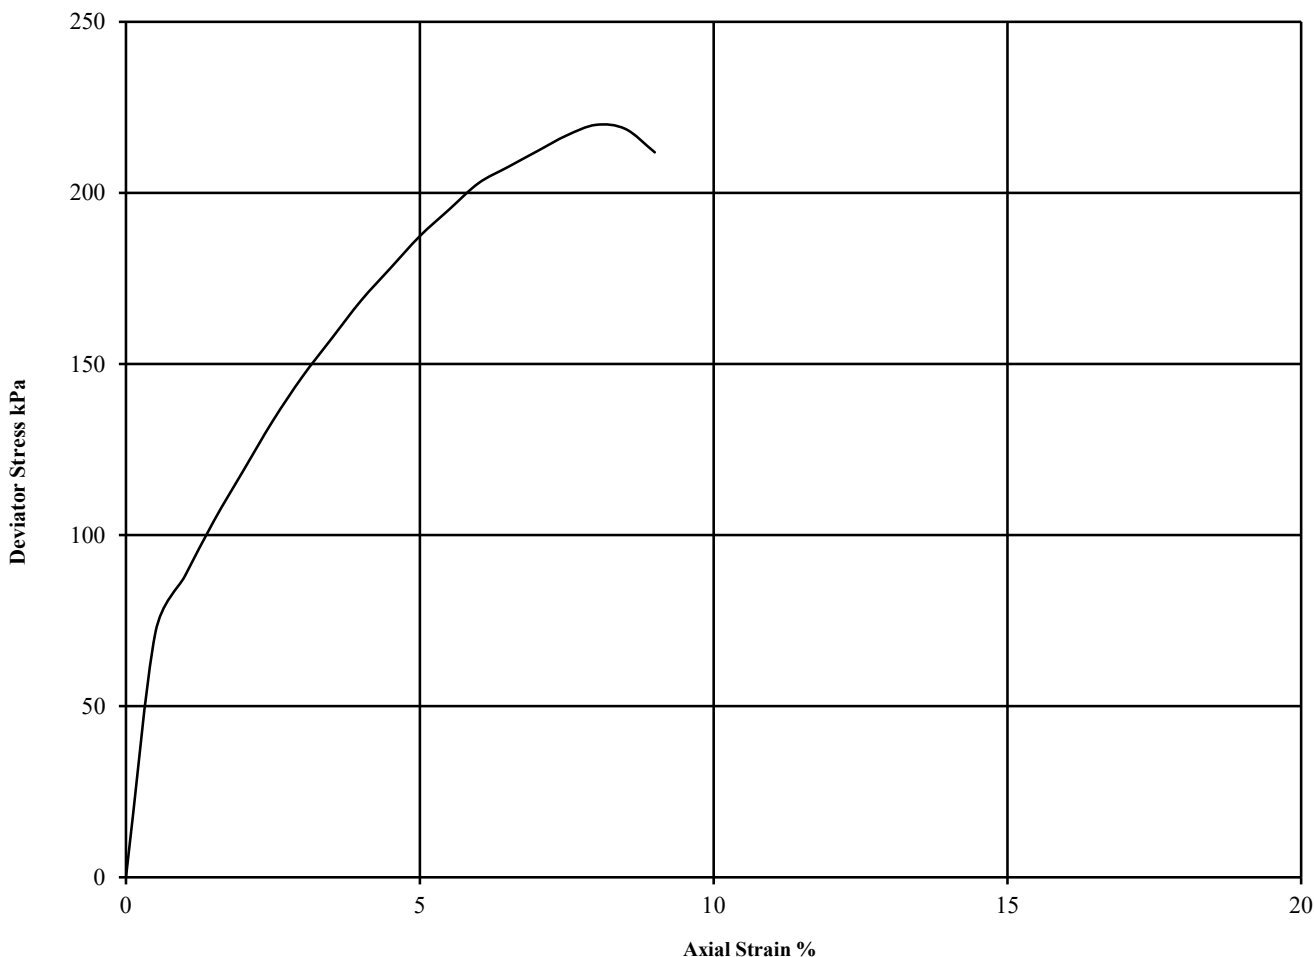
| Diameter (mm): | | 38 | Height (mm): | | 76 | Test: | UU Single Stage | | Remarks: |
