# **PHASE II GEO-ENVIRONMENTAL ASSESSMENT**

**BURNT HOUSE FARM, TOTTINGTON, BURY  
FOR  
BURNT HOUSE FARM AGRICULTURAL LTD**

**GA/1007/00**

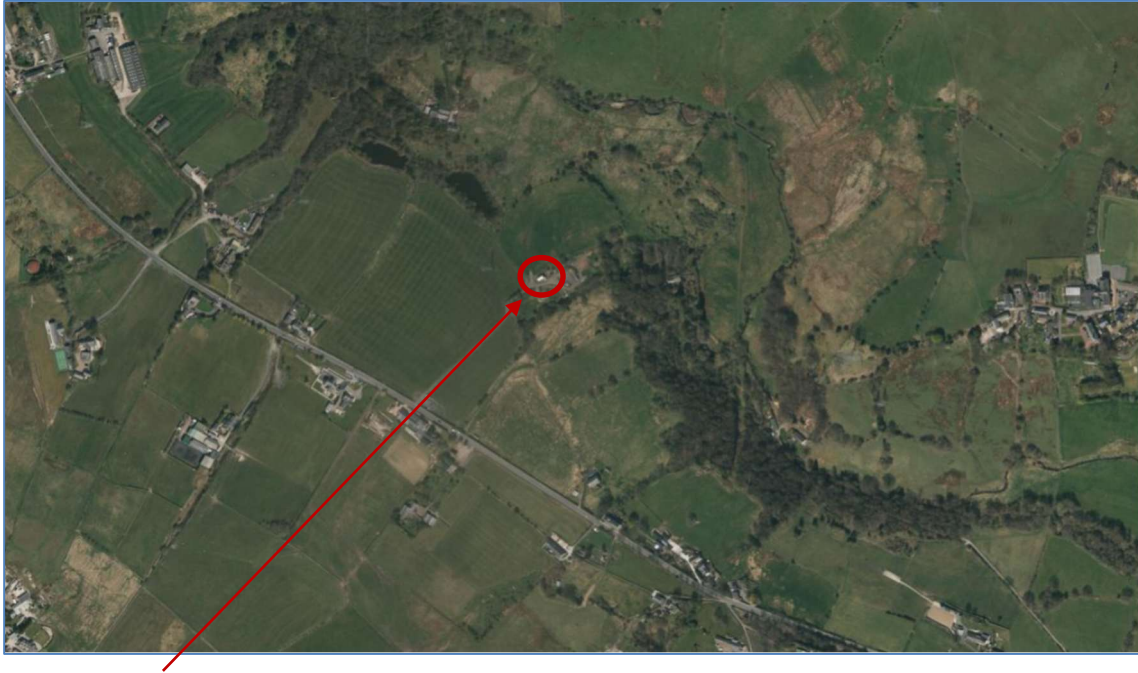
The development site is located roughly 6.00km northwest of Bury Town Centre, located down an access track off Turton Road. The centre of the site is located at the approximate National Grid Reference SD 76209 14260, with the proposed development area circa 0.05 hectares. The location of the site is shown in figures 1 below.

*Figure 1: Site Location (Aerial Imagery)*
