# COAL MINING INVESTIGATION

**BURNT HOUSE FARM, TOTTINGTON, BURY  
FOR  
BURNT HOUSE FARM AGRICULTURAL LTD**

**JUNE 2025  
CMI/1007/00**

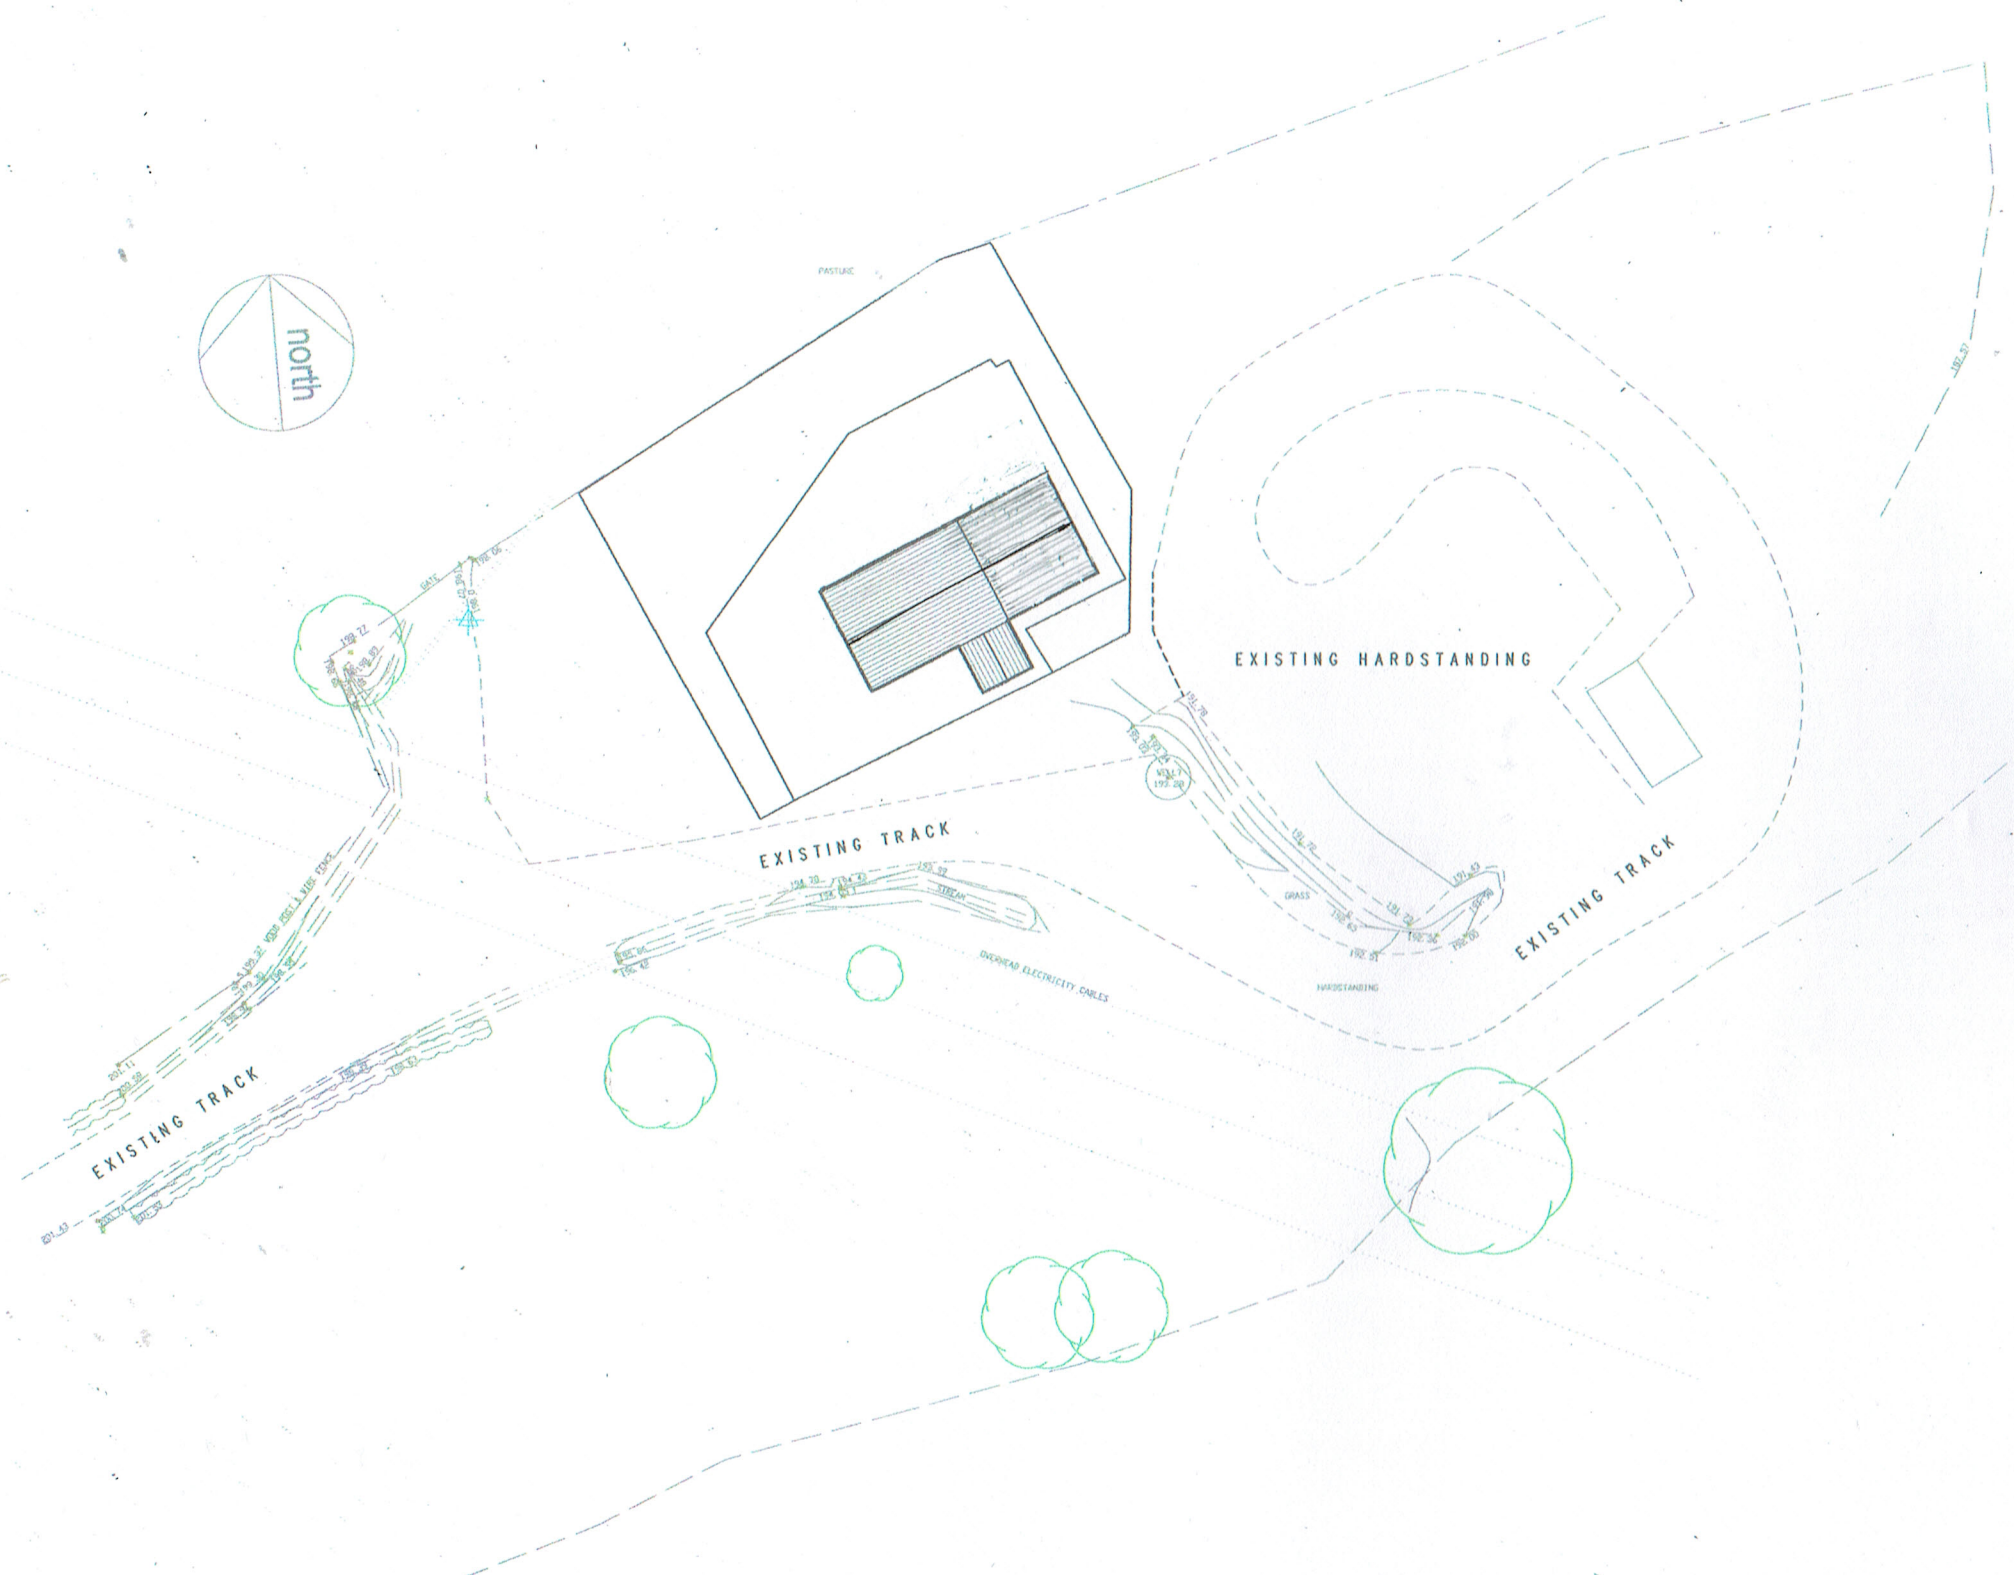
drawing number BHF-24-03-22-E

proposed site plan illustrating  
access track and field boundaries

proposed replacement farmhouse at  
**Burnt House Farm**  
**Turton Road**  
**Tottington**  
**Bury**
