## **ECOLOGY ASSESSMENT REPORT**

### **WHITEFIELD FIRE STATION**

**NOVEMBER 2022**

**Greater Manchester Combined Authorities  
Greater Manchester Fire and Rescue Service**

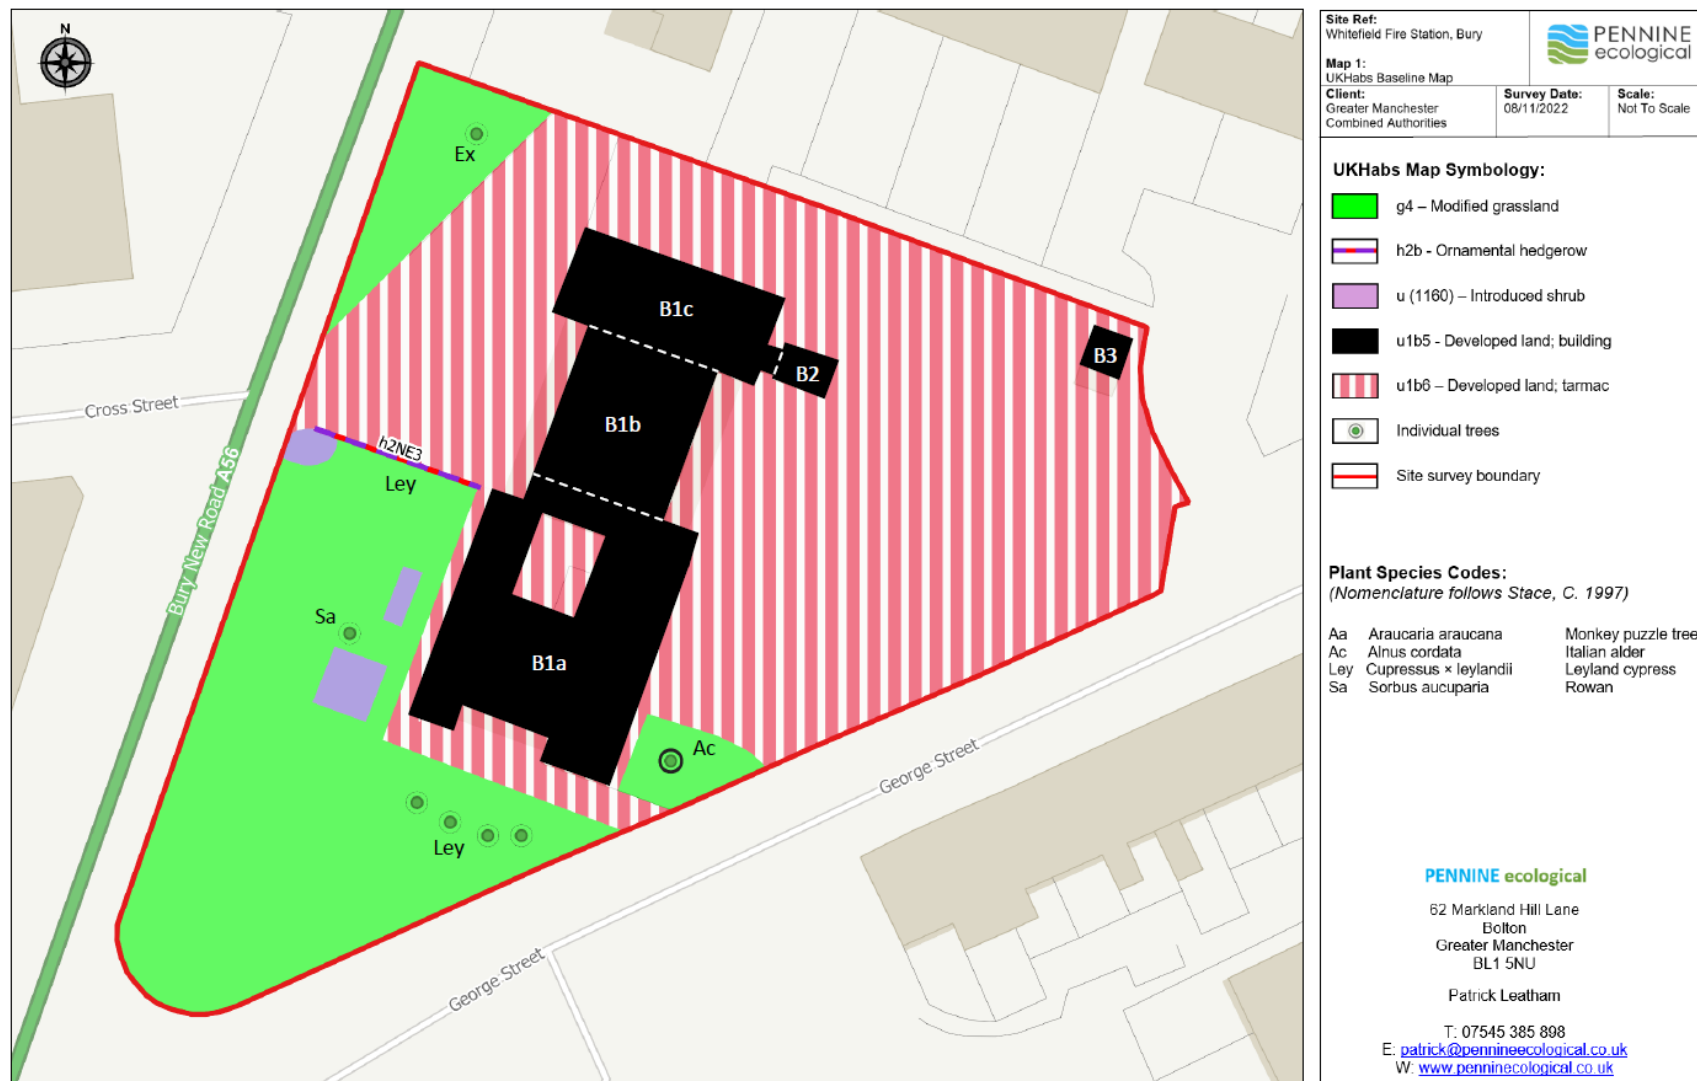
The proposal site includes the main fire station building. The building varies in structural formation and this has been detailed in the description below. There is a training tower which is adjoined to the main fire building. A small shed which is used for storage is also located within the training yard. All buildings were assessed for bat roosting potential as well as a number of trees within the site. The trees were all assessed from ground level for bat roost potential. The buildings and trees are shown on Map 1, Appendix A.

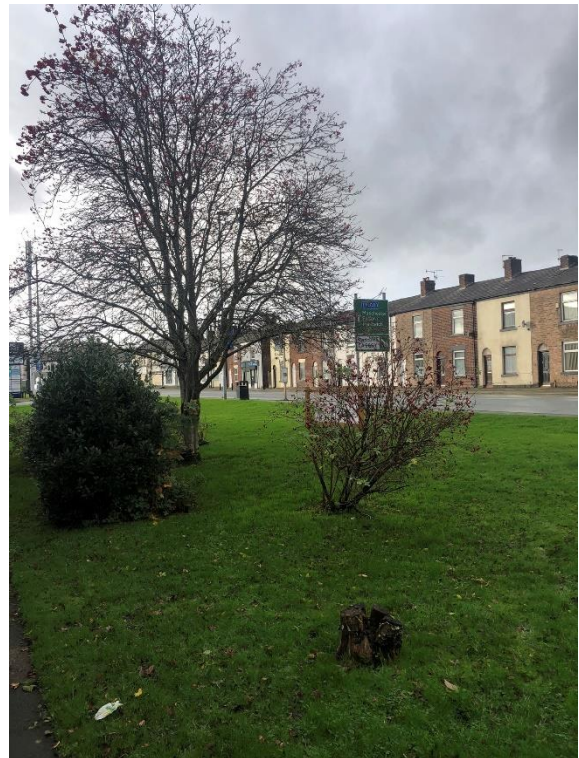
The site is an active fire station and comprises primarily the fire station buildings and tarmac training yard. An area of landscaped habitat is located in the south section of the site and abuts Bury New Road / George Street. The landscaped habitat includes a row of mature *leylandii* trees near to the fire station entrance, a mature Italian alder, modified grassland (frequently mown amenity grassland) and a number of raised flower beds and semi-mature individual trees. The site is deprived of any semi-natural habitats.

**Photograph 3: Landscaped areas in the southwestern section of the site. Young rowan tree.**

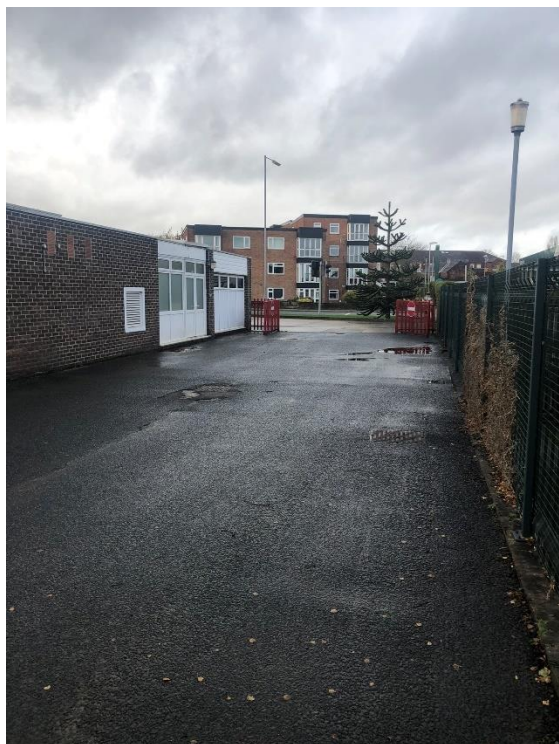
**Photograph 5:** View looking along northern boundary of the site. North elevation of Building 1.

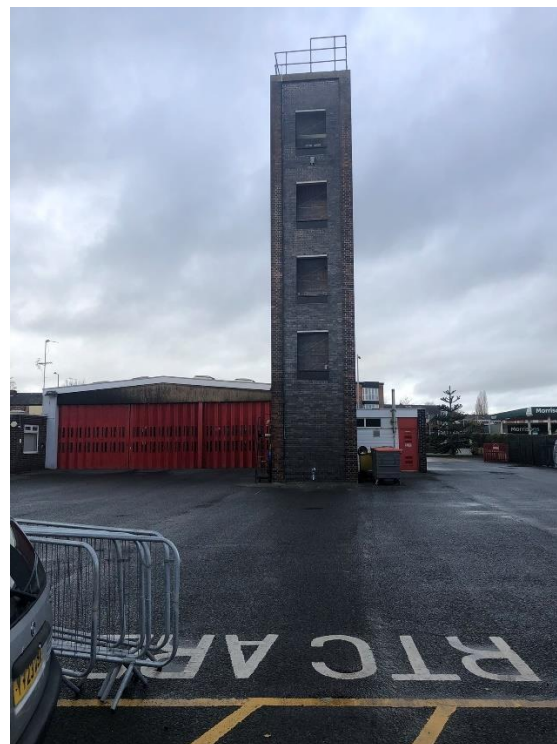
The training tower is built from brick and is open. There are no obvious gaps suitable for use by bats. Furthermore, this building is likely to be subject to frequent disturbance from fire training drills which would reduce the suitability of the tower to be used by bats.

Building 2 is considered to possess '**Negligible**' bat roost potential.

**Photograph 7:** Overview of the training yard with the training tower in the background.

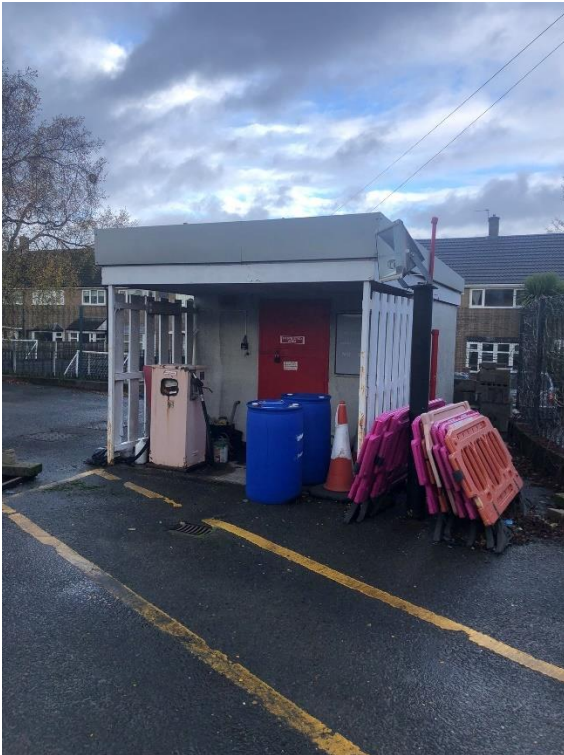
The storage shed located in the training yard is a concrete shed with a metal sheet roof. The roof is finished with wooden soffits. The shed is a very simple structure and is absent of any suitable cavities which could be used by bats.

Building 3 is considered to possess '**Negligible**' bat roost potential.

**Photograph 9: Building 3 is a storage shed within the training yard. Negligible bat roost potential.**

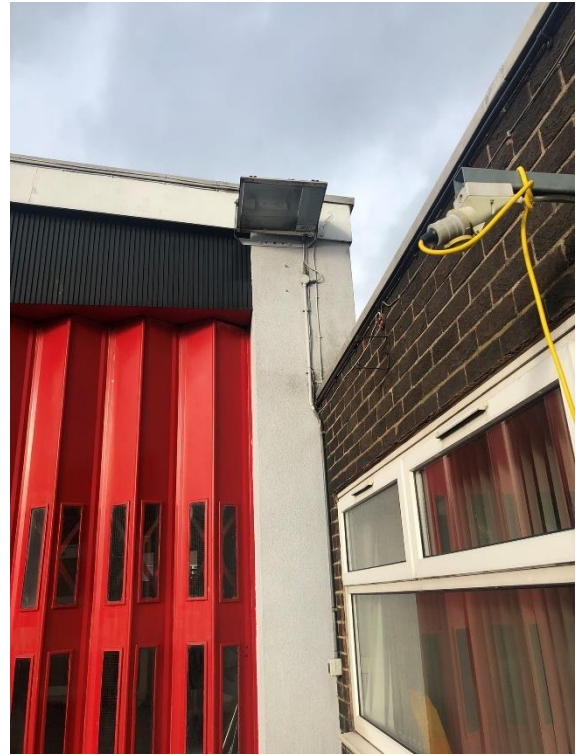
Building 1b is the fire engine parking unit. This is a breeze block building with an (assumed) corrugated metal sheeting roof. The roof is finished with wooden soffits. Again this building is tightly sealed and there are no obvious gaps suitable for use by bats. What's more, this section is a very simple frame structure with no internal roof voids or cavities.

Building 1c is an office / communal area and is of the same structure as Building 1a. Again this section of building is in good structural condition and no suitable potential roost features are present.

**Photograph 11: Close up view of Building 1b and 1c in good structural condition. Negligible bat roost potential.**

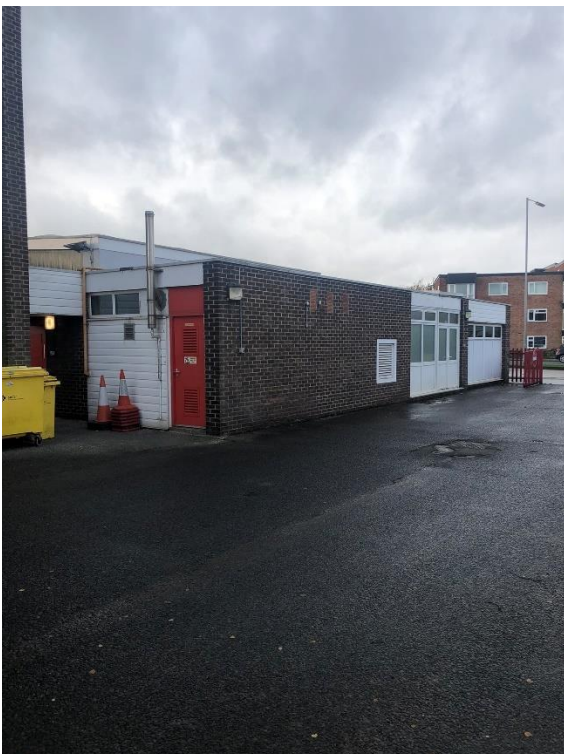
The building is made up of three sections that are all adjoined. The first section (Building 1a) is the office / communal building. The building is a single storey, flat roof building. The walls are brick and partly cladded

with plastic. The building is in good structural condition and there are no obvious gaps suitable for use by bats.

Building 1 is considered to possess '**Negligible**' bat roost potential.

**Photograph 10: Building 1, a flat roof single storey brick building. Negligible bat roost potential.**

It is recommended that a minimum of two bat boxes are erected on the new building or retained trees within the site. These bat boxes should ideally be positioned on an eastern elevation and away from well-lit areas (i.e. away from security lighting). These enhancement measures would contribute to achieving an overall biodiversity net gain for this proposal.
