# DAYTIME BAT SURVEY

474 BOLTON ROAD, BURY,  
GREATER MANCHESTER

December 2021

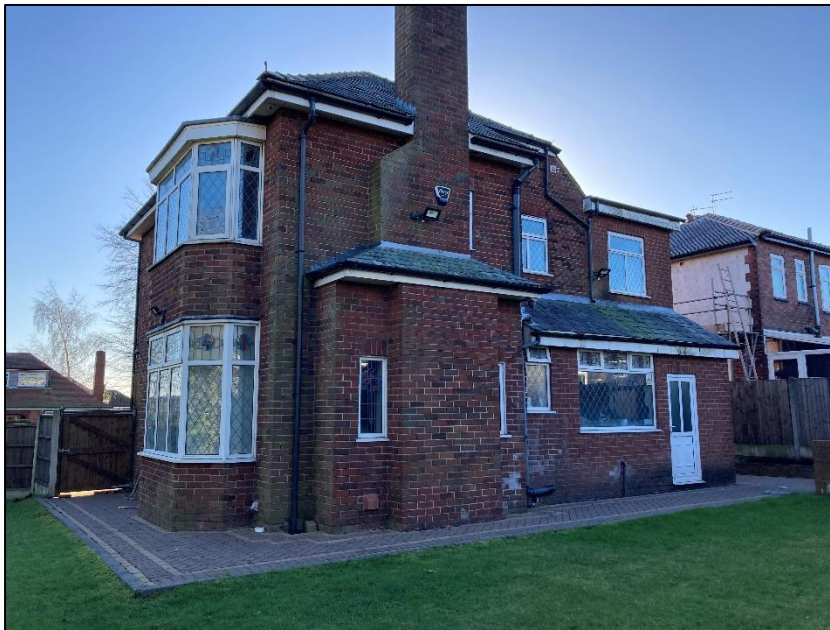
- 3.2 The external brick work is complete and intact (see Photograph 1), with only small sections of recessed mortar occurs on the front elevation of the property, the spaces are too shallow and exposed to offer suitable bat roosting opportunities. The property has uPVC windows and doors throughout, these are flush to the surrounding brickwork, with the exception of some of the bay windows, where small gaps occur between the uPVC boarding and the brickwork, these do not appear to lead to any significant cavities or present suitable roosting opportunities for bats (see Photograph 2). The brick chimney stack is complete and sealed with lead flashing where the brickwork meets the roof tiles.

*Photograph 1 showing the rear of the building*

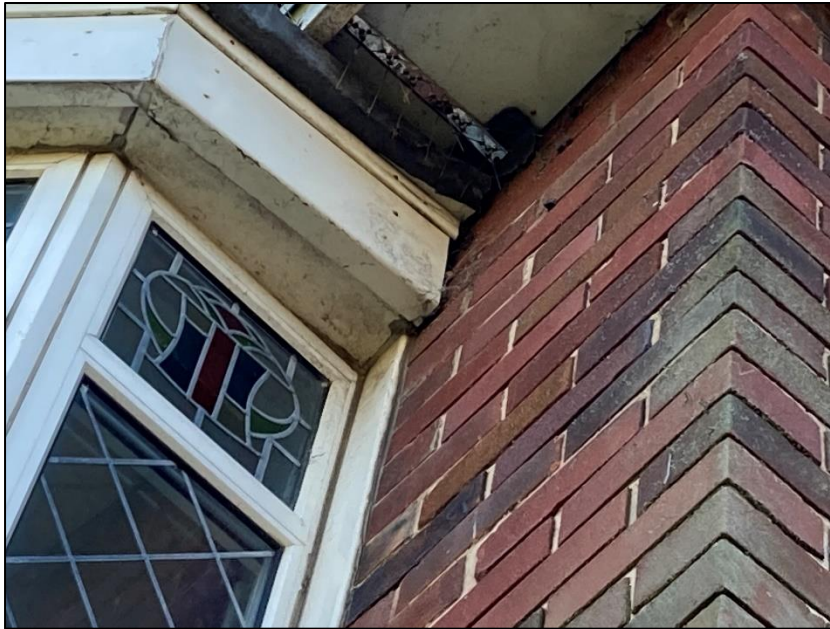
*Photograph 2 showing the small gap on the bay windows*

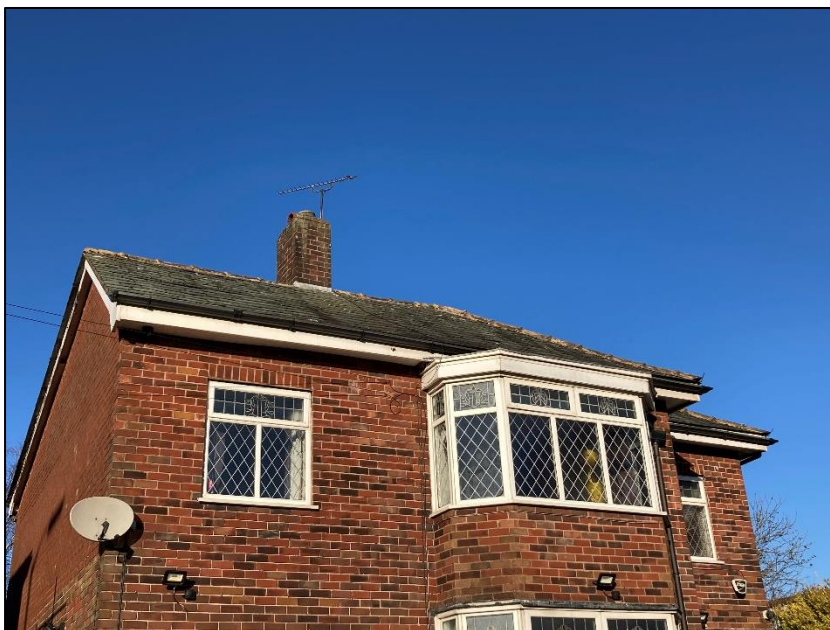
- 3.3 The roof of property is part hipped and part pitched, covered with slated tiles. The ridge tiles are all intact and mortared (see Photograph 3). The roof tiles are generally in good condition al complete and intact, a small number of tiles are lifted on the front facing elevation of the property, the resulting gaps are considered too shallow to provide roosting opportunities or access to the internal space. A large single skylight is present on the eastern elevation, this is all complete and intact and well-sealed within the roof structure.

*Photograph 3 showing the roof at the front of the property*

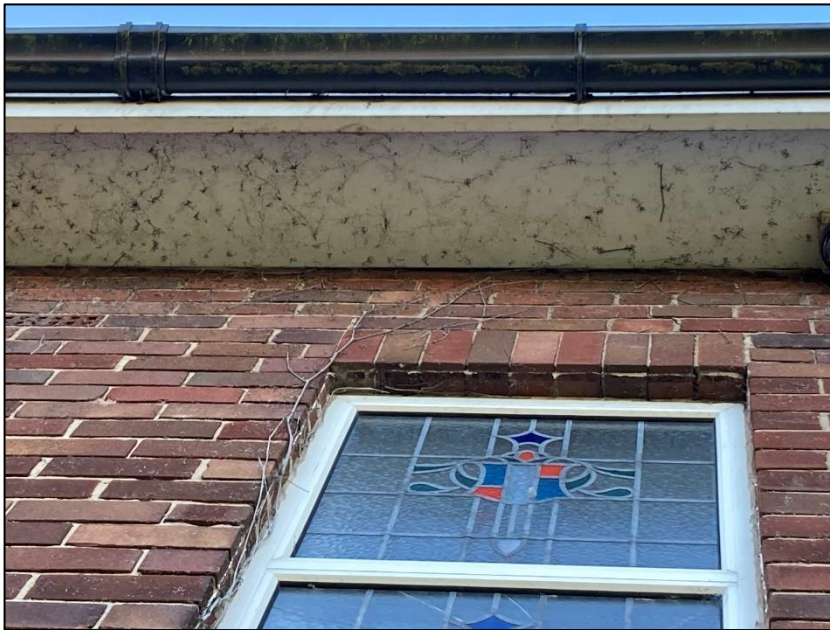
- 3.4 The edges of the roof are sealed with uPVC soffit and bargeboards and mortar on the gable ends of the pitched sections these are all complete, intact and lie flush to the brickwork (see Photograph 4). Some of the panels show signs of weather damage, with

the panels becoming slightly distorted in places, these do not provide potential access to the internal space or provide any cavities suitable for roosting bats. The mortar on the gable ends is all complete and intact with only one area of damage occurring (see Photograph 5), the cavity is shallow and not suitable for roosting bats, nor does it provide access to the internal space.

*Photograph 4 showing the uPVC soffit and bargeboards*

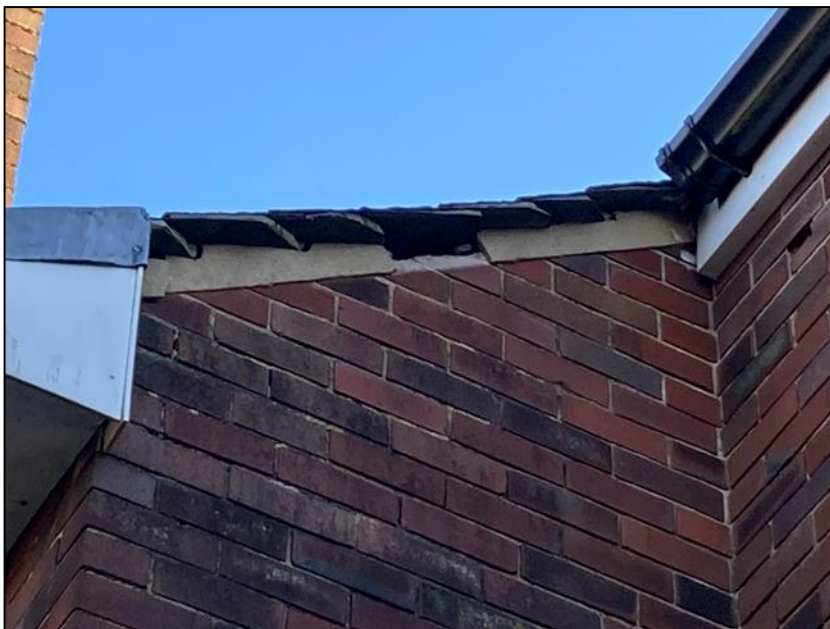
*Photograph 5 showing the area of the damage on the mortared sections of the roof*

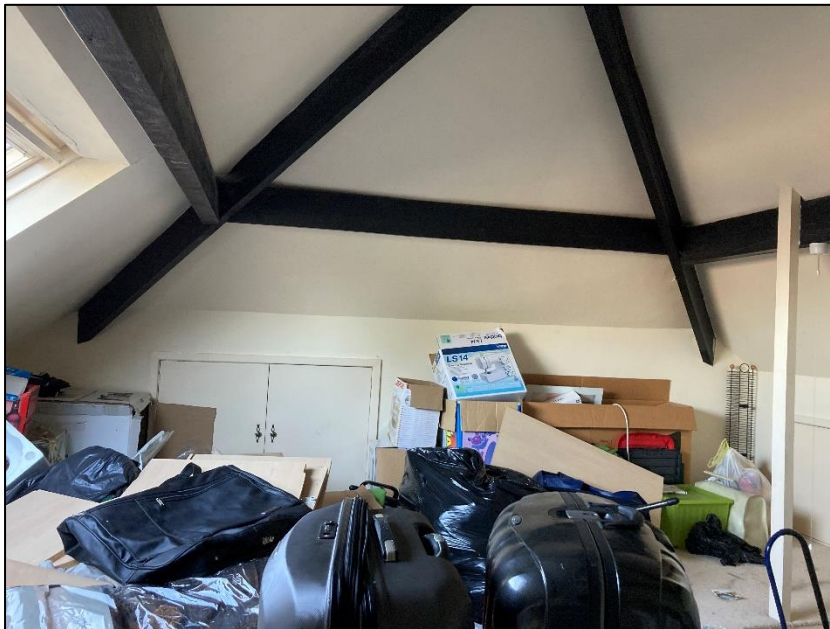
- 3.6 A single roof void occurs on the property this too is partly boarded out as a finished storage space, while the space under the eaves is used for the boiler and water tank. The storage space is plastered throughout and well-lit by the skylight (see Photograph 6), on evidence of bat activity was found within the finished section of the roof. The spaces under the eaves are accessed through doors on each wall (see Photograph 7). The wooden roof frame is exposed here, it is all in good condition within no cracks or crevice that could be used bat bats for roosting. The roof is lined within traditional roof felt which has only one small tear otherwise is in good condition. Only minimal amounts of daylight could be seen entering the property suggesting it is well-sealed. The space is dusty and cold with no evidence of bat activity or cavities suitable for roosting found within the void.

*Photograph 6 showing the section of roof void used for storage*

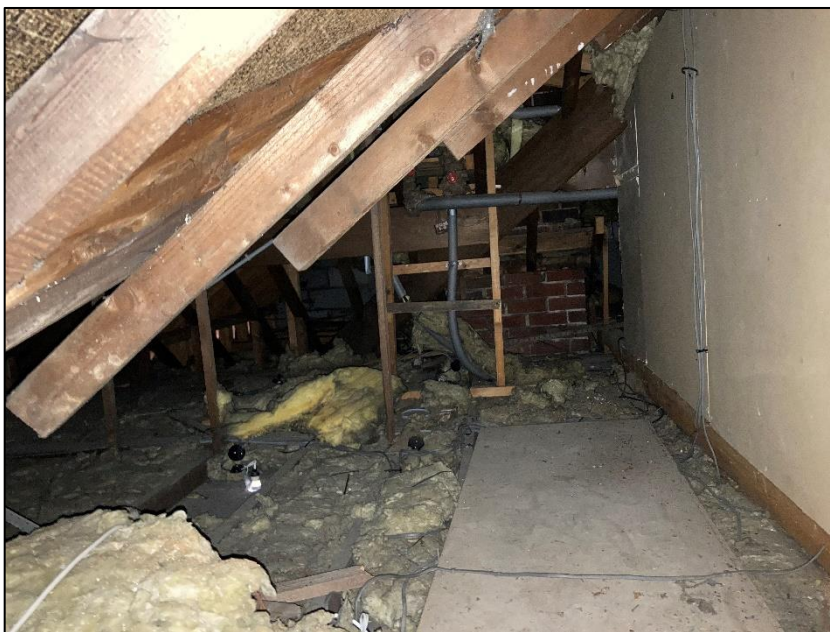
*Photograph 7 showing the space under the eaves*
