# BAT PRELIMINARY ROOST ASSESSMENT (PRA) REPORT

**Garages  
Hawk Close & Porritt Street  
Bury**

Bury Council

Date: 5<sup>th</sup> February 2026

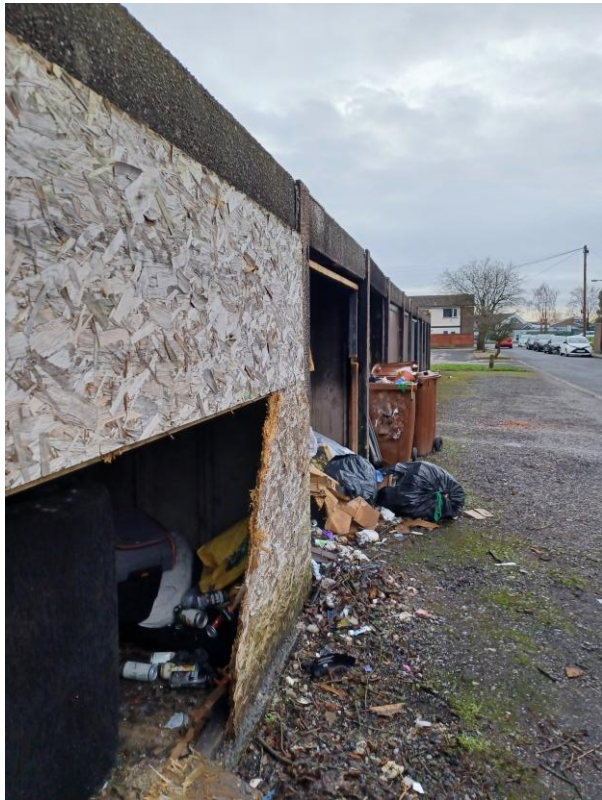
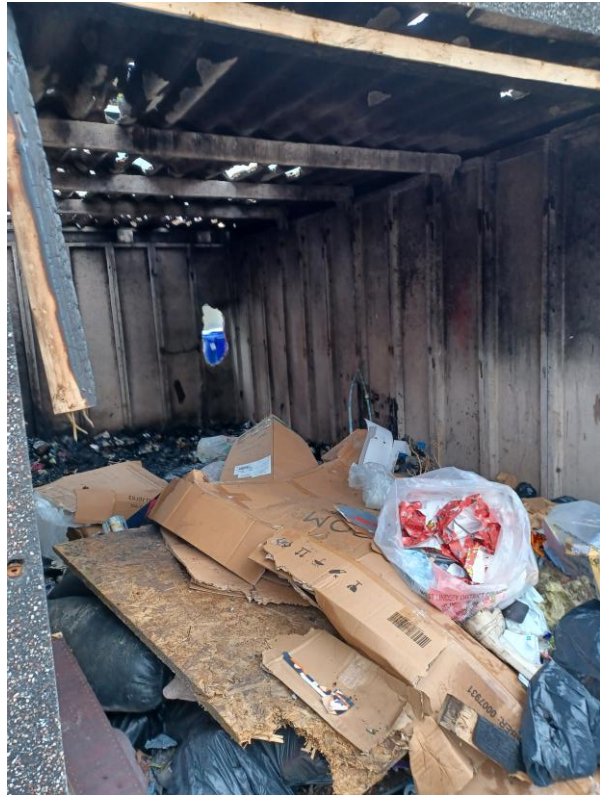
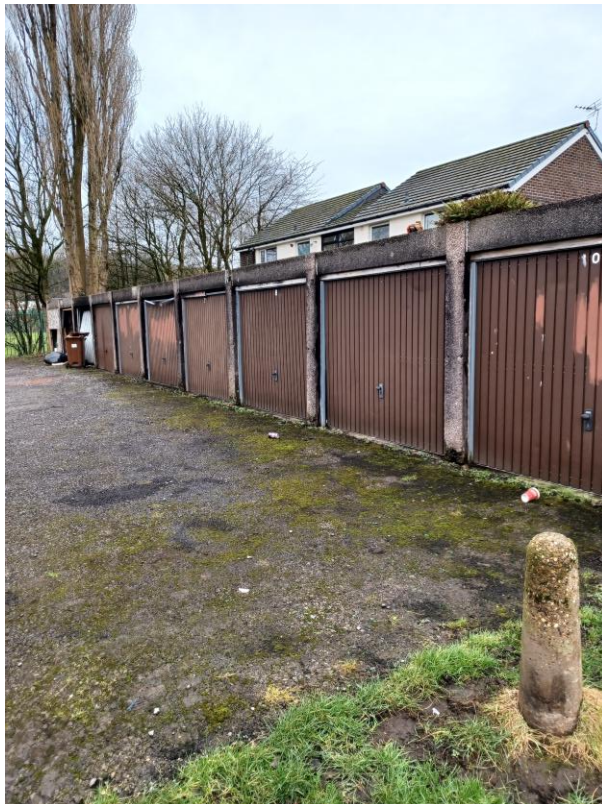
### Hawk Close Garages

An inspection of the garages at both sites was undertaken on 4<sup>th</sup> February 2026. The Garages were in a state of disrepair, with roofs and doors missing, some heavily vandalised and showing signs of fire damage.

- 4.1** The results of the desktop search are shown in Appendix A. There are a number of bat records of bat signs or sightings and roosts mostly relating to common pipistrelle (*Pipistrellus pipistrellus*) or *pipistrelle* sp, there is also one record of a whiskered bat and one Soprano pipistrelle bat.
- 4.2** The garages are single storey buildings with flat corrugated roofs and metal doors. The barge boards do not support internal cavities; the cavities lead straight into the garage interior. The garages have holes in the roofs and walls and in some cases no roofs. They will have light ingress, damp and be cold and drafty.

- 4.3 Most of the garages have been vandalised with holes in the walls and roofs, and some were showing signs of fire damage.
- 4.4 The sites are in an urban residential location, however there is good habitat to the north of the sites, providing good bat foraging and commuting habitat.

- 5.1 The garages were considered to have a very low potential to support roosting bats.
- 5.2 It should also be noted that bats are mobile and cryptic in their habits and can turn up in unlikely locations. All contractors should be reminded of their legal responsibilities regarding bats prior to works commencing. If bats are found at any time, work must stop and advice sought from a suitably qualified person about how best to proceed.

- 6.1 The garages were found to have a very low potential to support roosting bats, and no further survey work for bats was considered to be necessary.
- 6.2 No bats or signs of bats were found during the inspections, although there are bat records present in the area.
- 6.3 The surrounding habitat to the north of the sites was considered to be good for bat foraging and commuting bats. However, there were a number of buildings close by the sites with more potential to support bat usage.
