## Invasive Plant Species Management Plan

| SITE | Former East Lancs Paper Mill, Rectory Lane, Radcliffe, Manchester M26 2PQ |
| REPORT REFERENCE | JK23-8787-230524 |

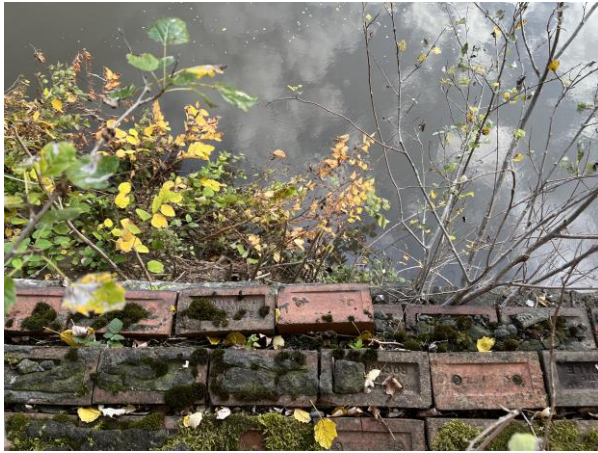
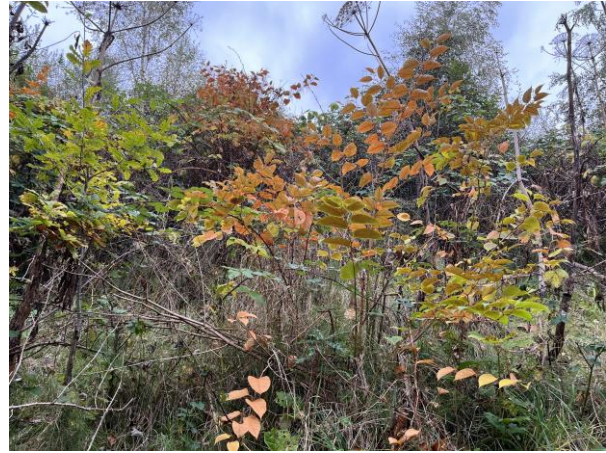
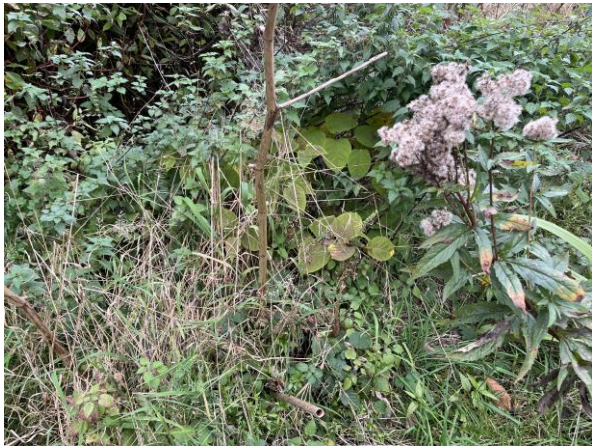
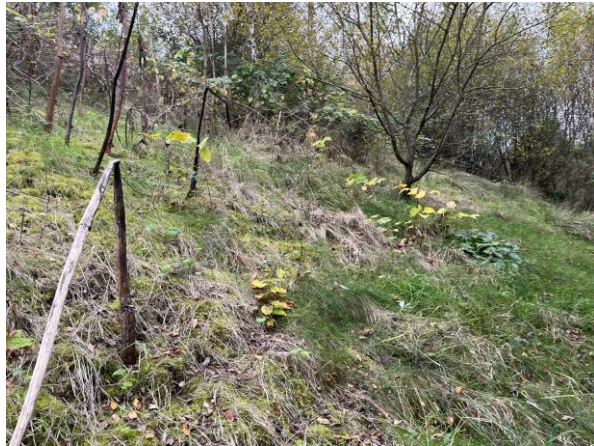
### Japanese knotweed

During our latest site survey walkover (undertaken on 7<sup>th</sup> and 15<sup>th</sup> Oct '24), 6 no. areas containing Japanese knotweed, 36 no. areas containing Himalayan balsam, 49 no. areas containing Giant hogweed, 6 no. areas containing Cotoneaster sp, 1 no. area containing Montbretia and 23 no. areas containing horsetail were recorded within/on/along the development boundary, denoted as JK1-JK6, HB1-HB36, GH1-GH49, CT1-CT6, M1 and HT1-HT23, respectively, on the attached drawings. Some of the areas of infestation extended onto neighbouring land, as well as there being separate additional off-site areas of infestation recorded in close proximities to the development boundary (includes areas JK7-JK13, HB37, GH50).
