## **12a Rectory Avenue, Prestwich Preliminary Risk Assessment**

Job Number  
**LKC251607**

Report Date  
**6<sup>th</sup> October 2025**

| <b>Report Title</b> | Phase 1 Preliminary Risk Assessment |

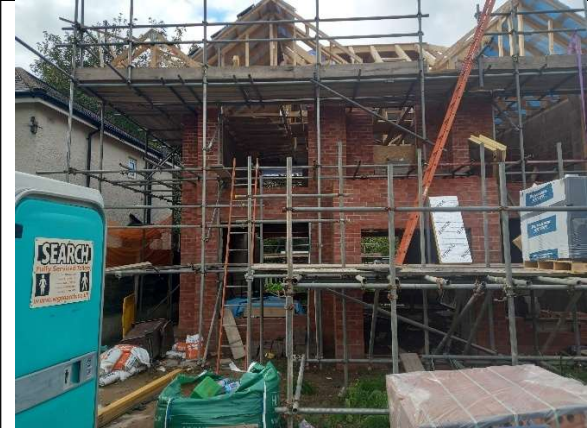
| <b>Photograph 1:</b> View of site from E facing W. | <b>Photograph 2:</b> View of site from W facing E. Note vegetation and 30cm step down. |

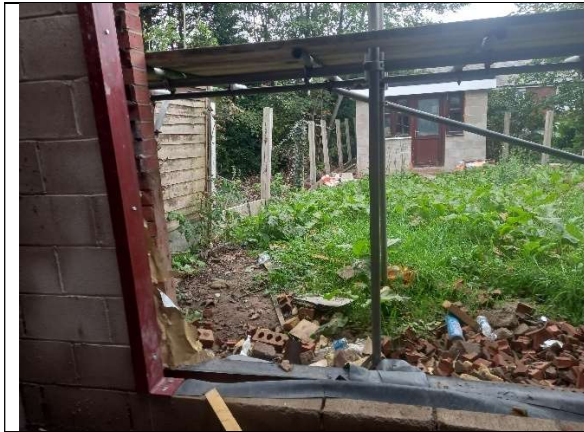
**Photograph 3:** View of rear garden. Note shed on concrete base.

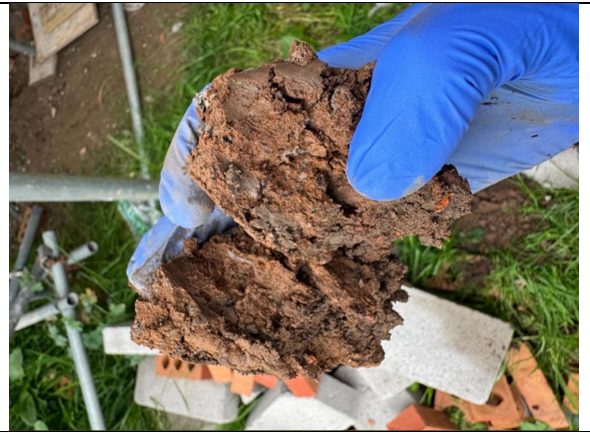
**Photograph 4:** View of soil from hand dug pits, note rare / infrequent anthropogenic content.

| HD101 | HD102 | HD103, HD104, HD105 |
|---|---|---|
| 0.00-0.20m Made Ground (gravelly sandy silt with rare brick fragments) | 0.00-0.30m Made Ground (gravelly sandy silt with rare brick fragments) | 0.00-0.25m Made Ground (gravelly sandy silt with rare ash and brick fragments). |
| 0.20-0.40m Made ground (gravelly silty sand with rare ash and brick fragments). | 0.30-0.80m Made ground (gravelly silty sand with rare ash, clinker and brick fragments). | Refusal on concrete at 0.25m. |

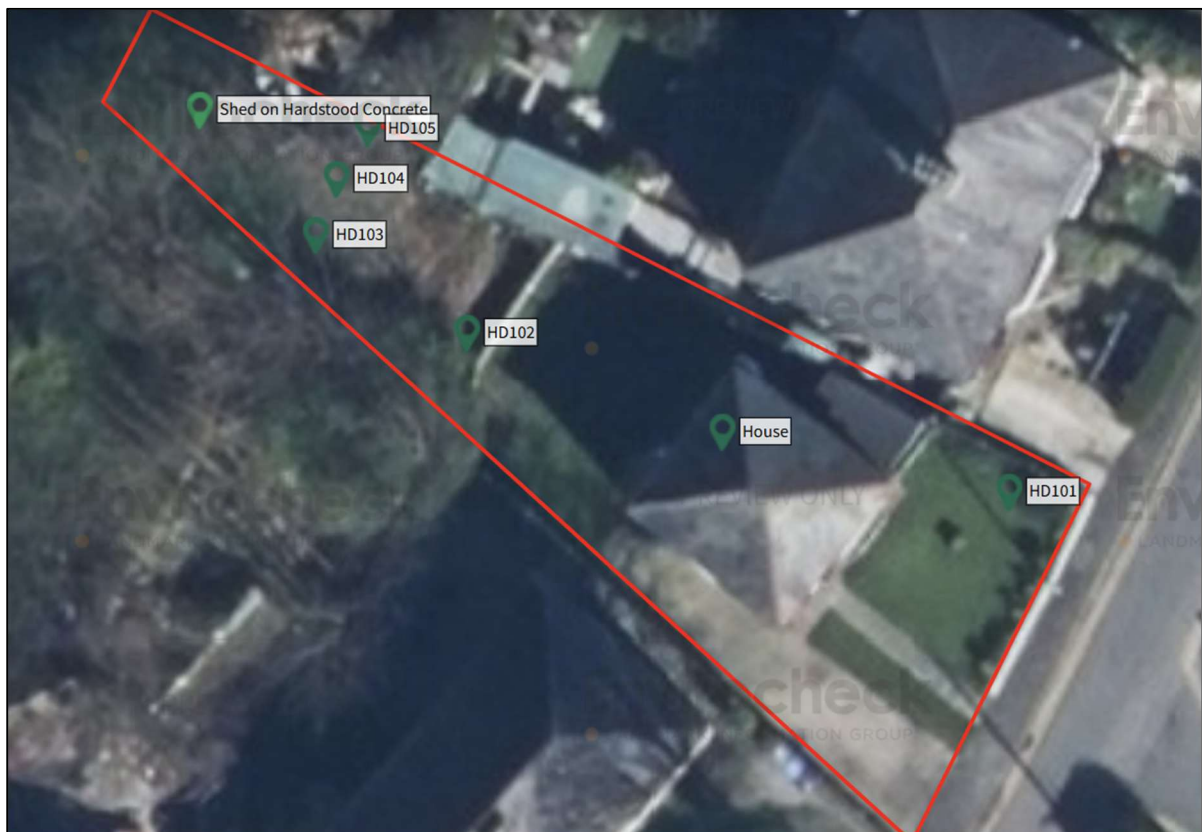
Plate 4-1: Envirocheck Aerial photograph showing site features.
