# VALIDATION REPORT

| Site: | Willow Street, Bury |
| References: | 17-285-R3 |

## POS (public open space) Cover System Validation

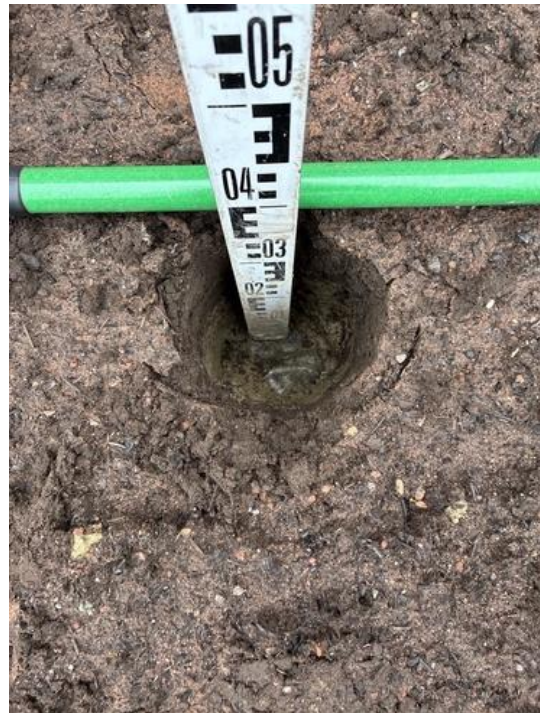
Photo 1

| <b>Depth of Cover System Materials (record the depth and support with Photo down the hole)</b> | | 300 |
| <b>Depth of Topsoil (mm)</b> | | 150 |
| <b>Depth of Subsoil (mm)</b> | | 150 |

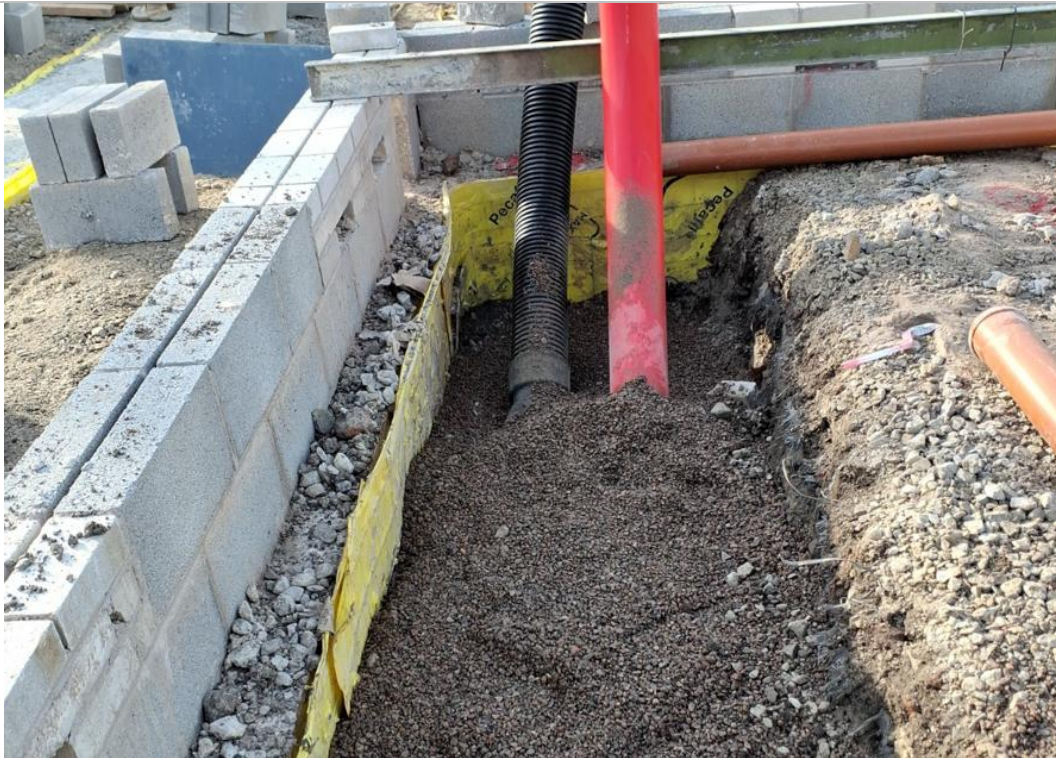
FIGURE 4.1 INSTALLED BARRIER (TYPE A) PIPEWORK

E3P can confirm that Barrier (Type A) Pipework has been installed. Figures 4.1 and 4.2 below record the installation of the pipework.
