## Bury Market

# Stage 1 and 2 Arboricultural Impact Assessment Report.

2484105

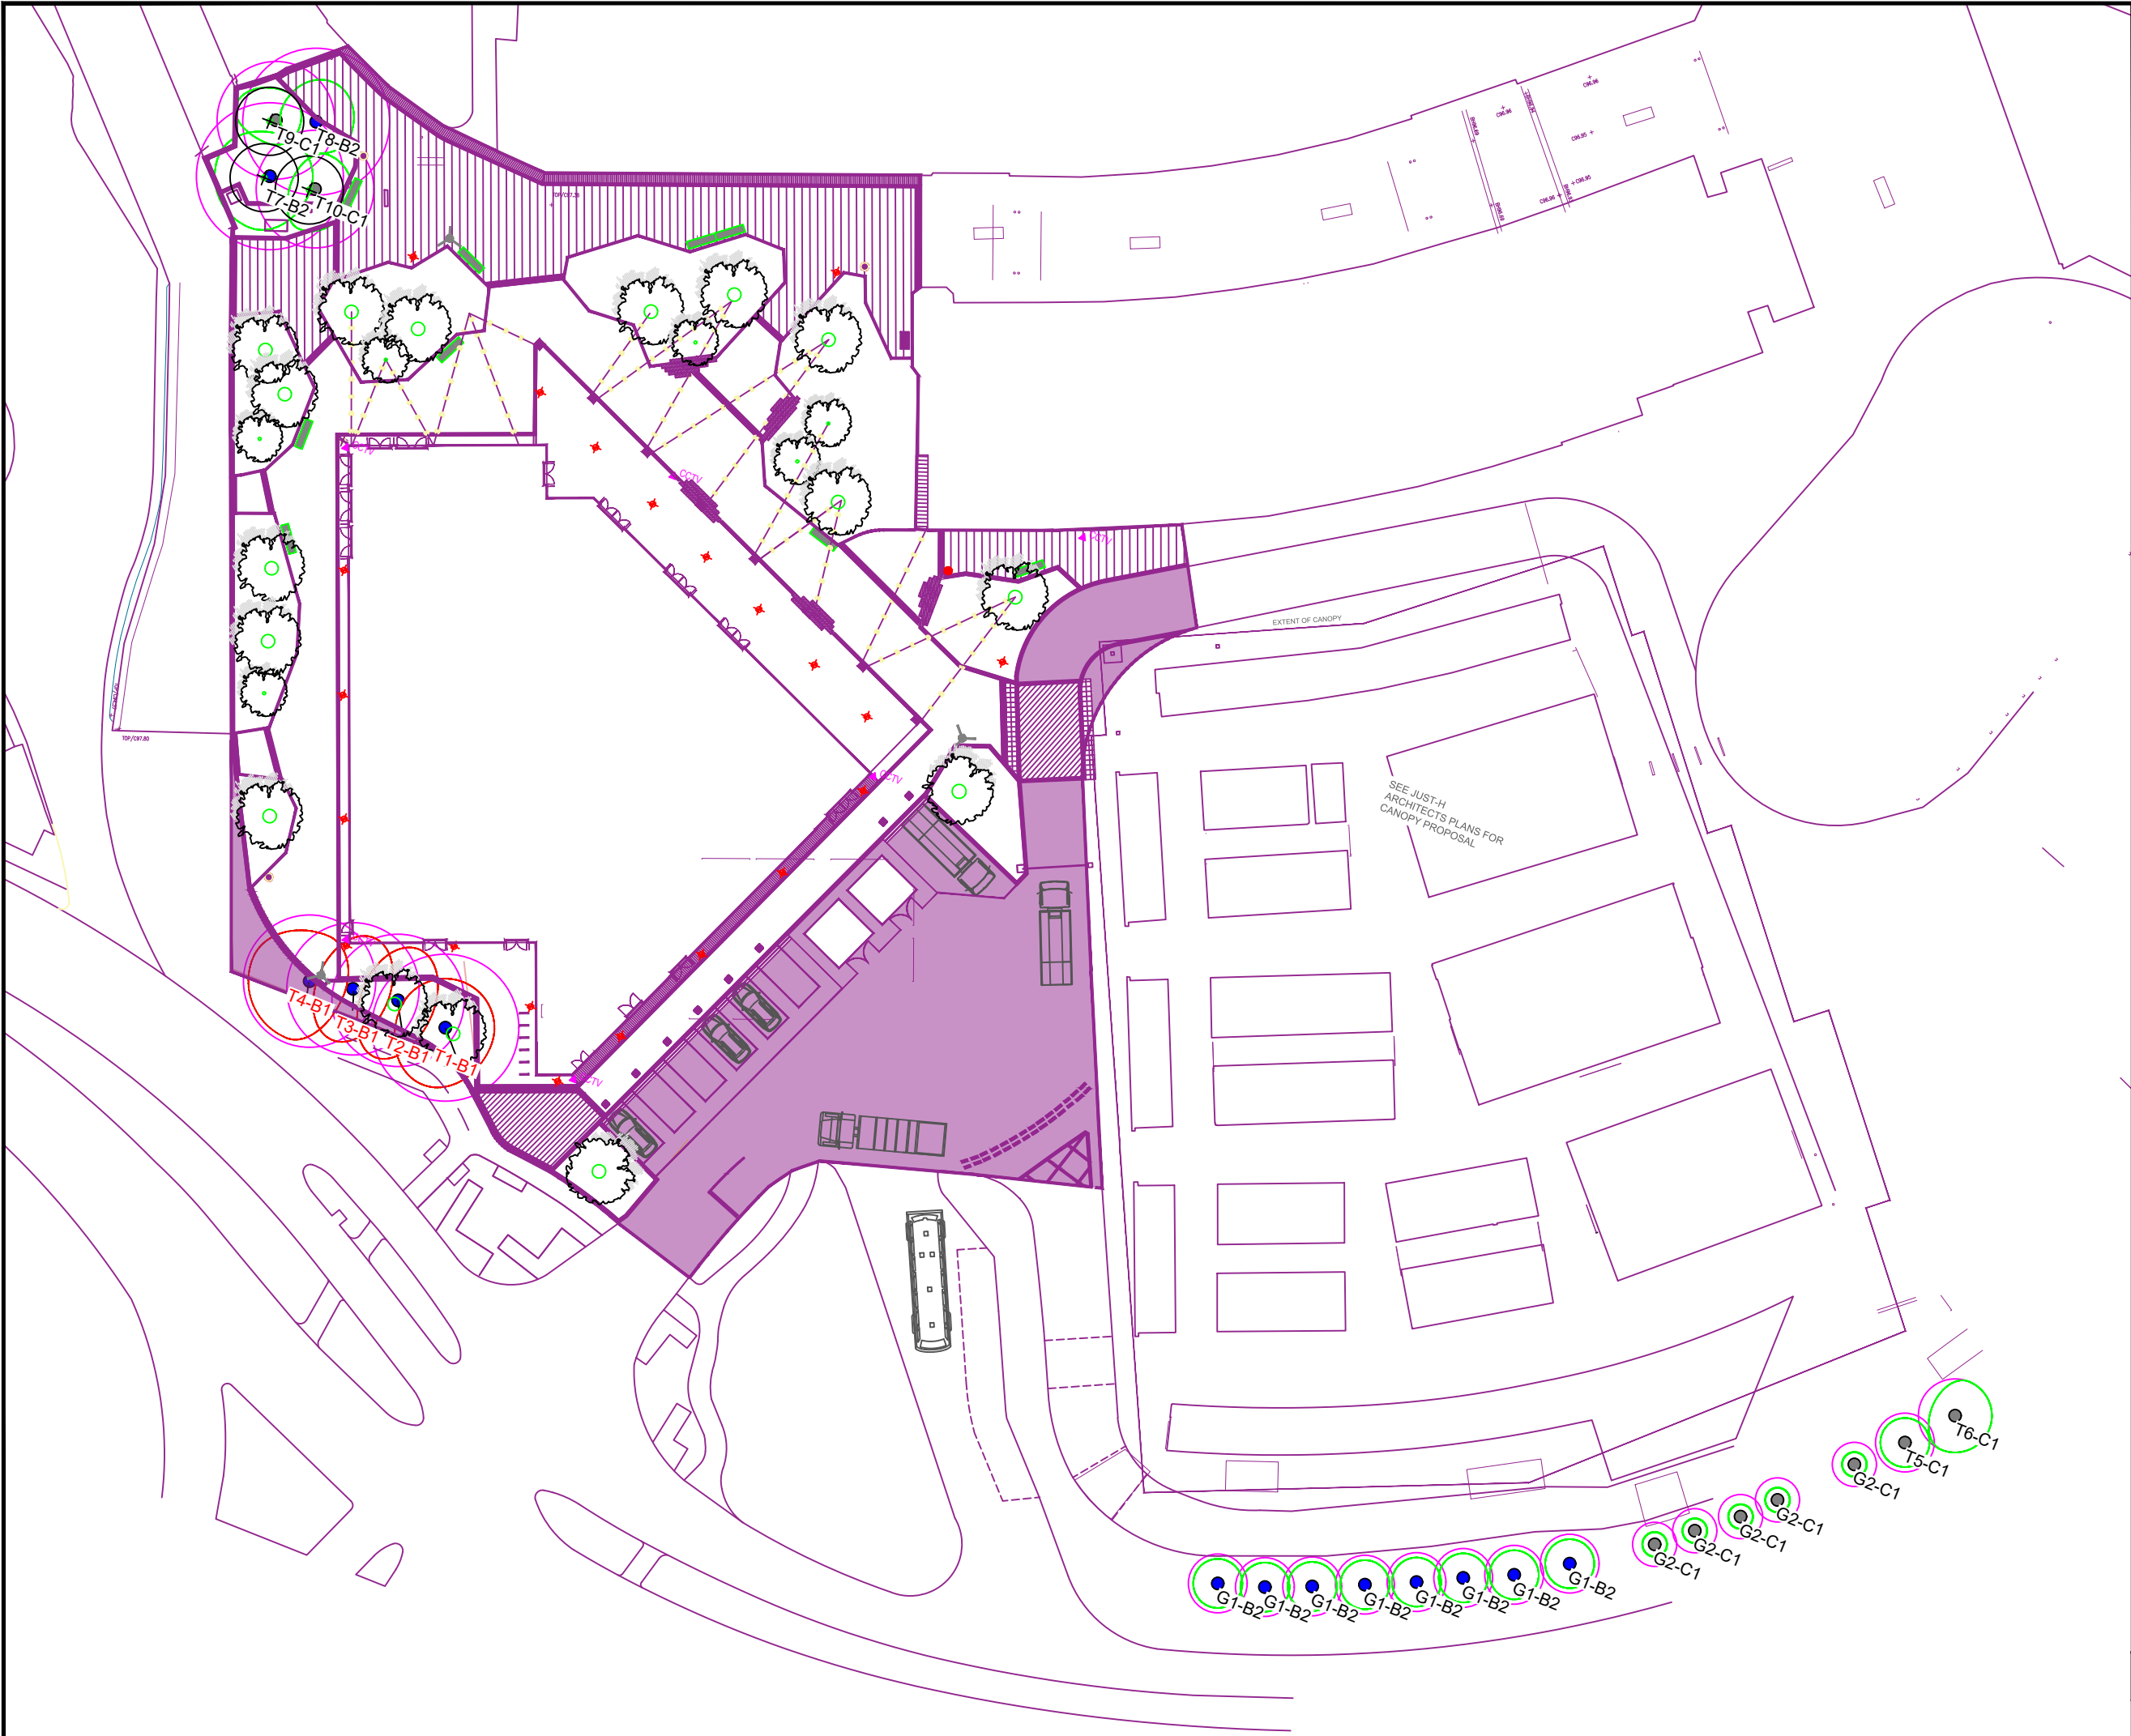
## **APPENDIX 4: FIGURE 2 TREE RETENTION PLAN**

Under the current proposed layout, four trees are required for removal as well as potential for some impacts to RPA's as shown in Table 2.2 (below) and on the tree retention plan (TRP; Appendix 5).

| Tree id | Species | BS5837:2012 Categories | Reason for <b>removal</b> and <b>impact</b> |
|---|---|---|---|
| T1-4 | <i>Sorbus intermedia</i><br>(Swedish Whitebeam) | B | Conflict with new building proposal and hard surfacing layout. Removal required. |
| T7-T10 | <i>Acer platanoides</i><br>(Norway Maple),<br><i>Acer pseudoplatanus</i><br>'purpureum'<br>(Sycamore) | B, C | RPA conflict with new hard surfacing layout. Existing levels to be retained for all hard surfacing areas within RPA's and supervision required. |

All trees and groups apart from T1- T4 are able to be retained.
