**Prestwich Village  
Prestwich  
Manchester  
M25 1AY**

**Ground Investigation**

The Prestwich Regeneration LLP

J23254  
Rev 1

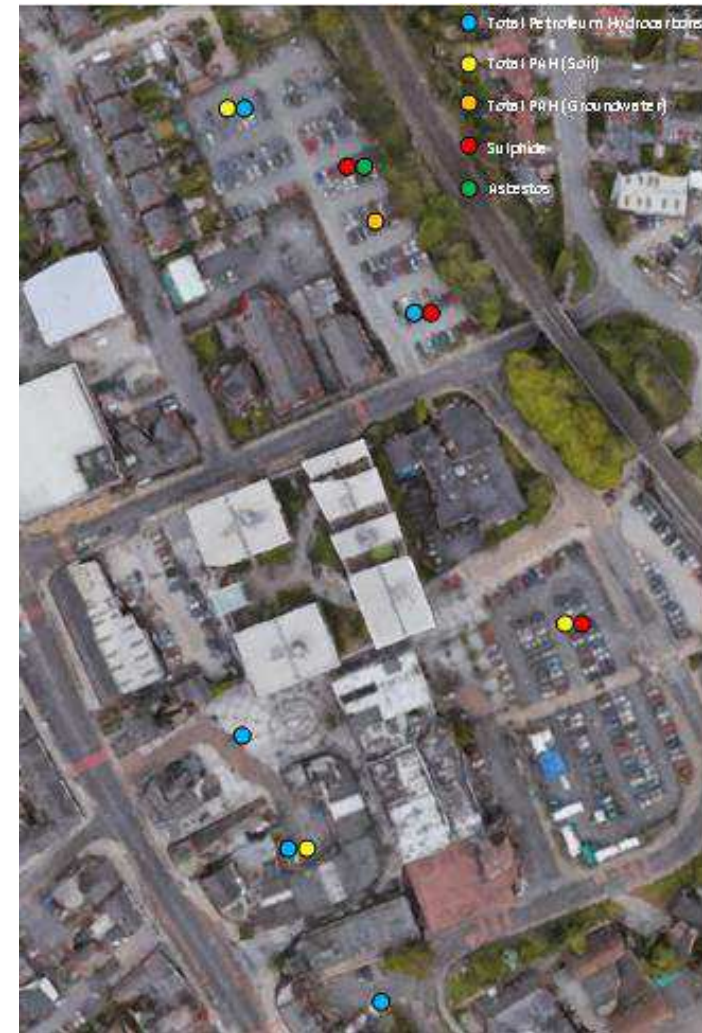
The desk study findings indicated that the majority of the site does not have a contaminative history, but the former presence of a railway yard in the southeastern corner between 1891 and some time prior to 1974 was a potential source of contamination. The results of the chemical analyses of the made ground has indicated the presence of asbestos in one sample and locally elevated concentrations of sulphide, total petroleum

hydrocarbons and total PAH; more specifically benzo(b)fluoranthene, dibenz(a,h)anthracene and benzo(a)pyrene as shown in the map extract below.
