Document name: 211196-EDGE-XX-XX-RP-G-0007_PLOTS 6-30 VERI [P01]

VERIFICATION REPORT FOR GARDENS AT PLOTS 6 to 30 FOR 211196 – SCHOOL STREET, RADCLIFFE

Prepared for:
Seddon Construction Ltd.
Plodder Lane
Bolton
BL4 0NN

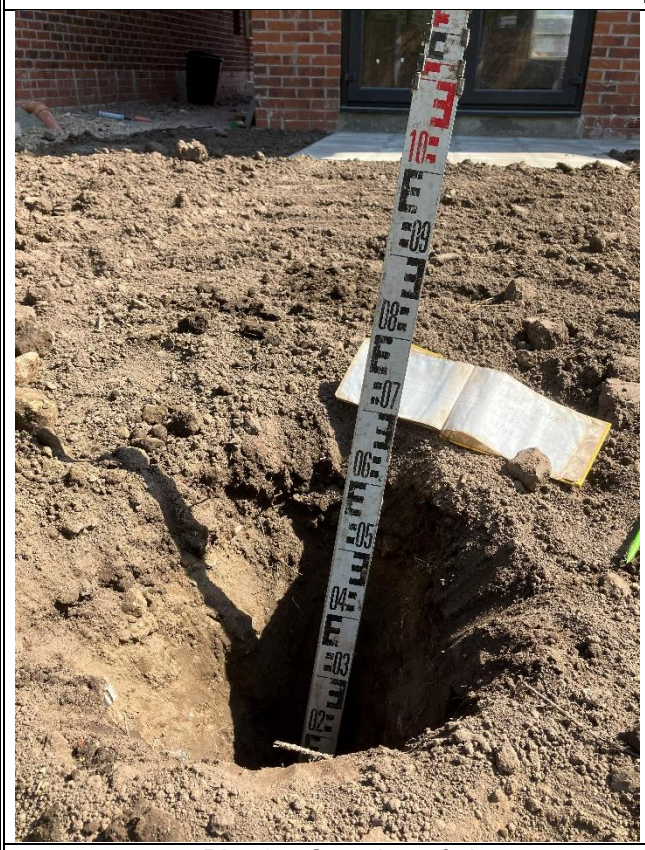
Plot 27: Overview of plot

Plot 27: Internal View of excavation
