# Soil vapour and ground gas risk assessment: Topping Mill, Topping Street, Bury

**Report reference** 4332R1

**Date of reporting** 24<sup>th</sup> January 2024

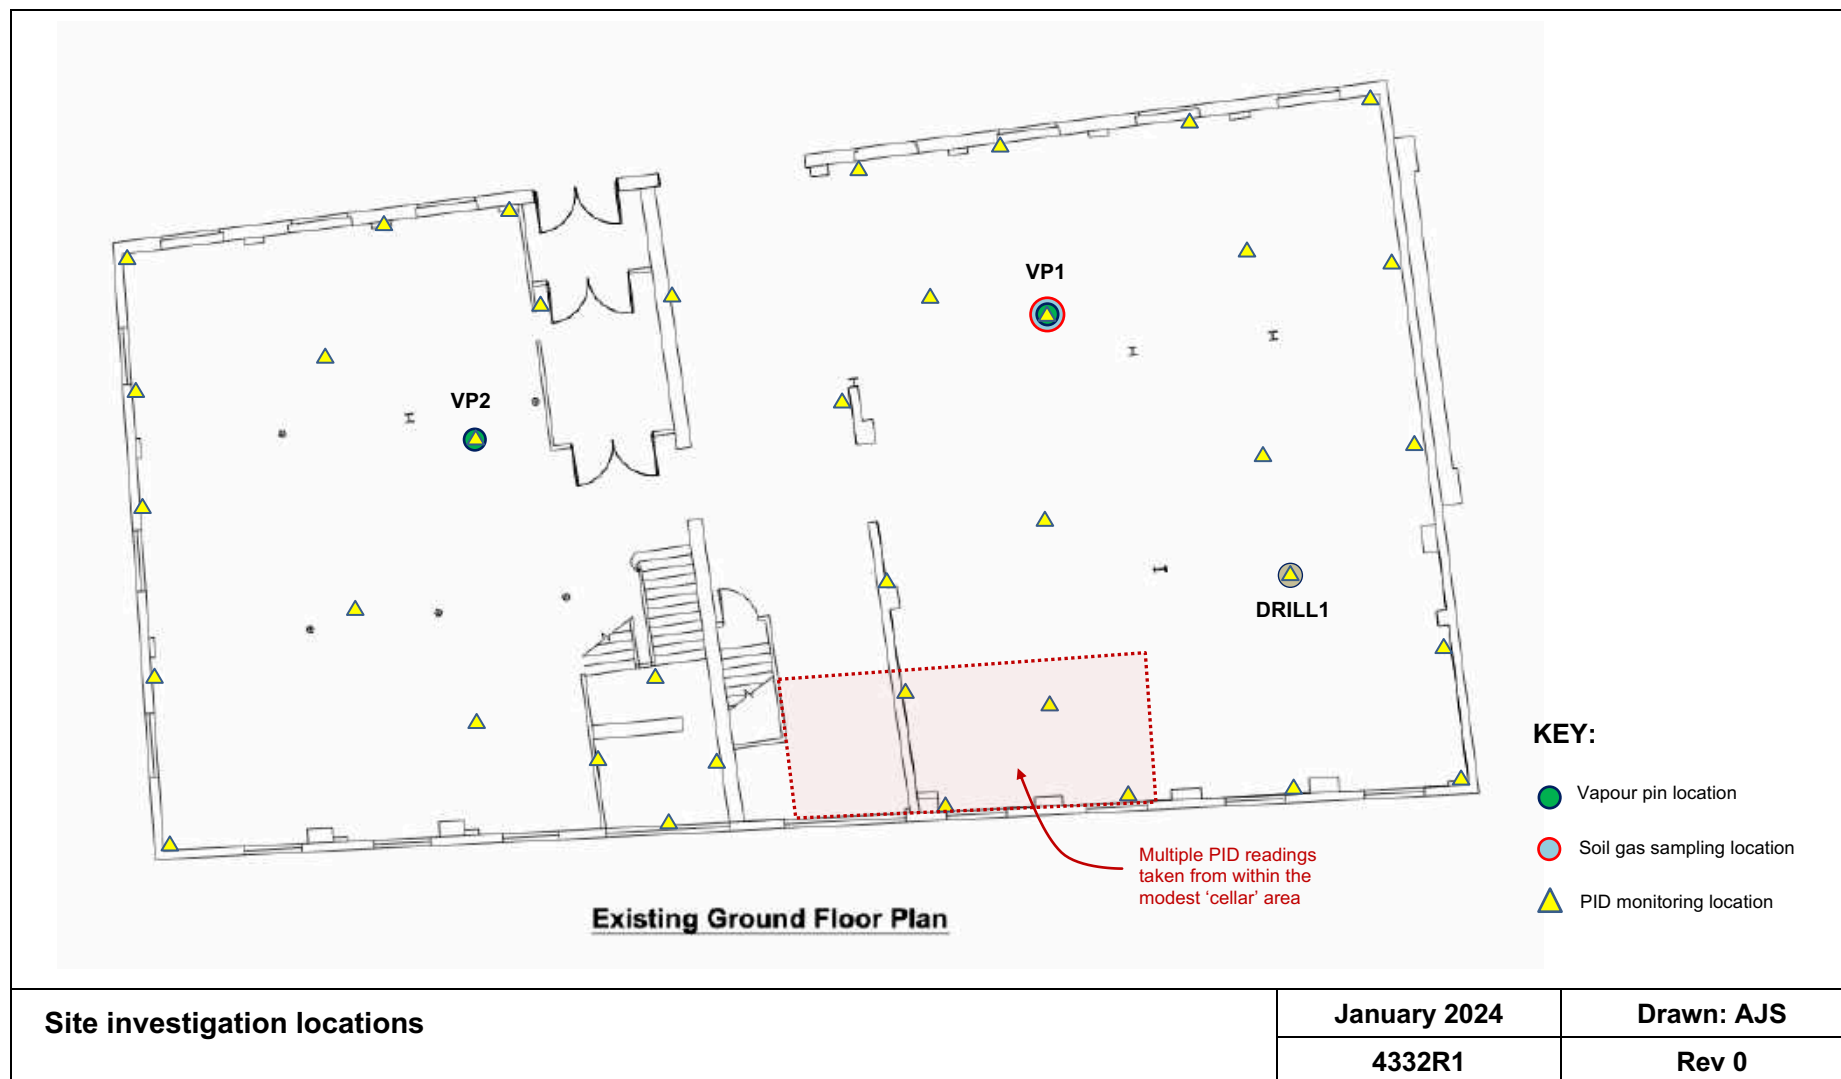
Figure 3.1 Site investigation monitoring locations

Three 16 mm holes were drilled through the ground floor foundation slab (see Figure 3.1 and also Photograph 23 in Appendix B).

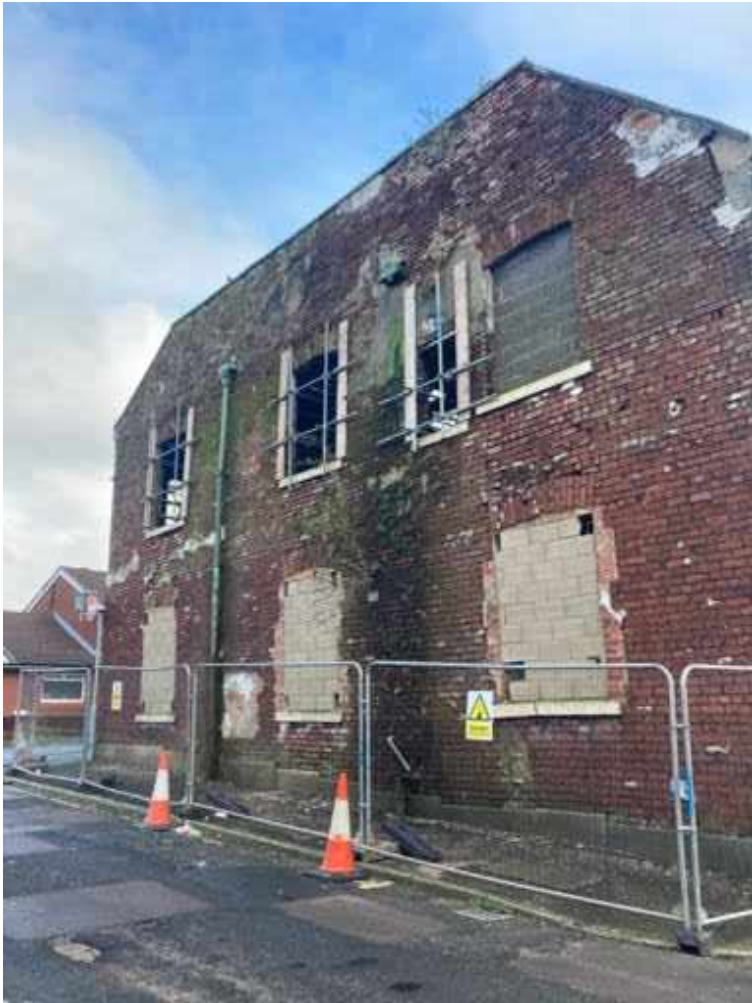
**Photograph 3**

- The majority of the window openings on the western elevation were infilled / bricked-up (see Photograph 3 in Appendix B).
- The property was vacant and had previously been cleared of all fixtures and fittings. Internal scaffolding was present across the building footprint.

**Description:** Western Site elevation

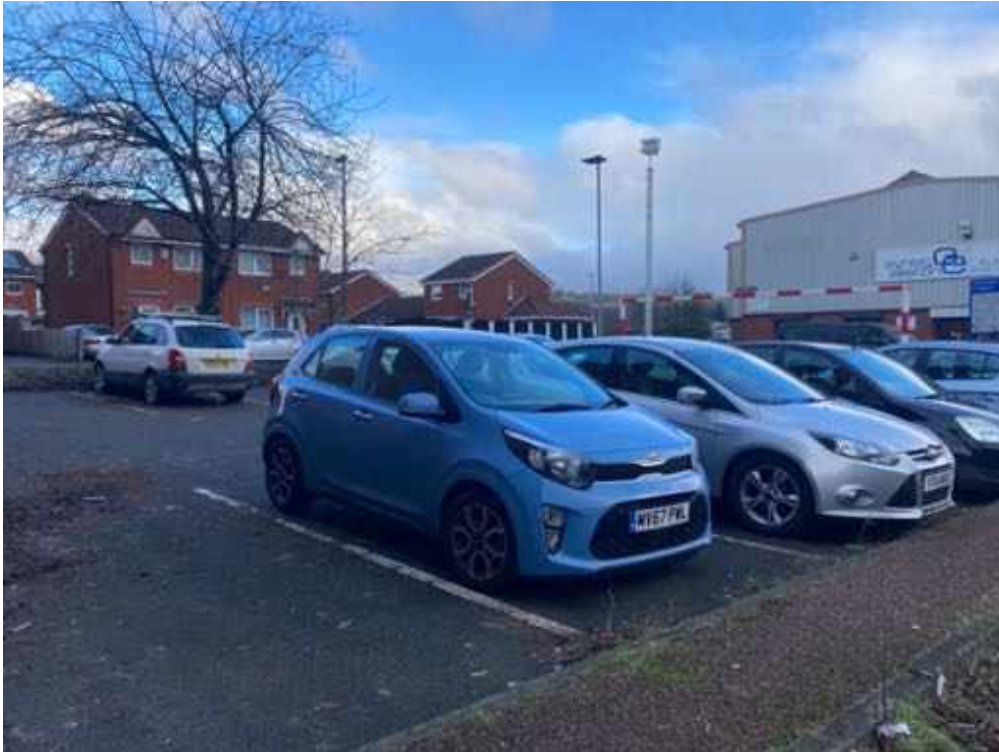
**Photograph 7**

- An adjoining car park (surfaced with tarmac) was present directly to the east of the Site (see Photograph 7 in Appendix B).
- The on-Site building was in a poor state of repair. Glass was absent from the majority of the window openings (see Photographs 2 and 5 in Appendix B) and sections of the roof were missing.

**Description:** Neighbouring land use – car park  
**Date:** 10/01/2024  
**Location:** Land directly to the east of the Site

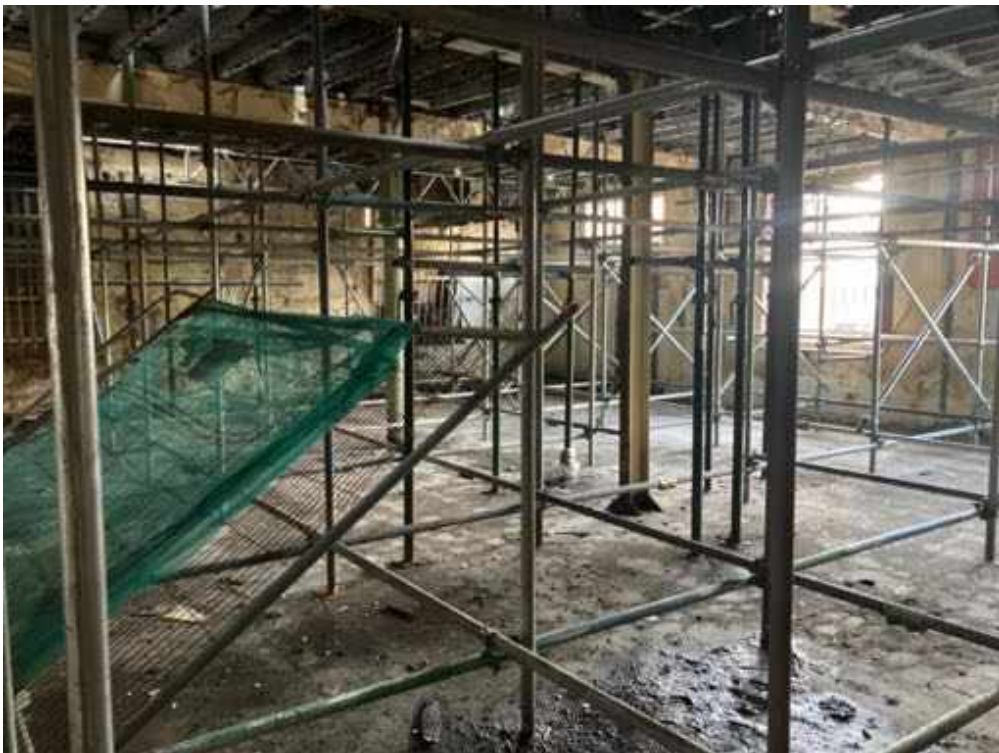
**Photograph 8**

- Concrete flooring was present across the ground floor level (see Photographs 8, 9, 12 and 14 in Appendix B). Some residual tile adhesive was present across the majority of the floor area (see Photograph 10 in Appendix B). The exposed concrete appeared to be in a reasonable state of repair.

**Description:** Ground floor level within on-Site building  
**Date:** 10/01/2024  
**Location:** North-western part of the building

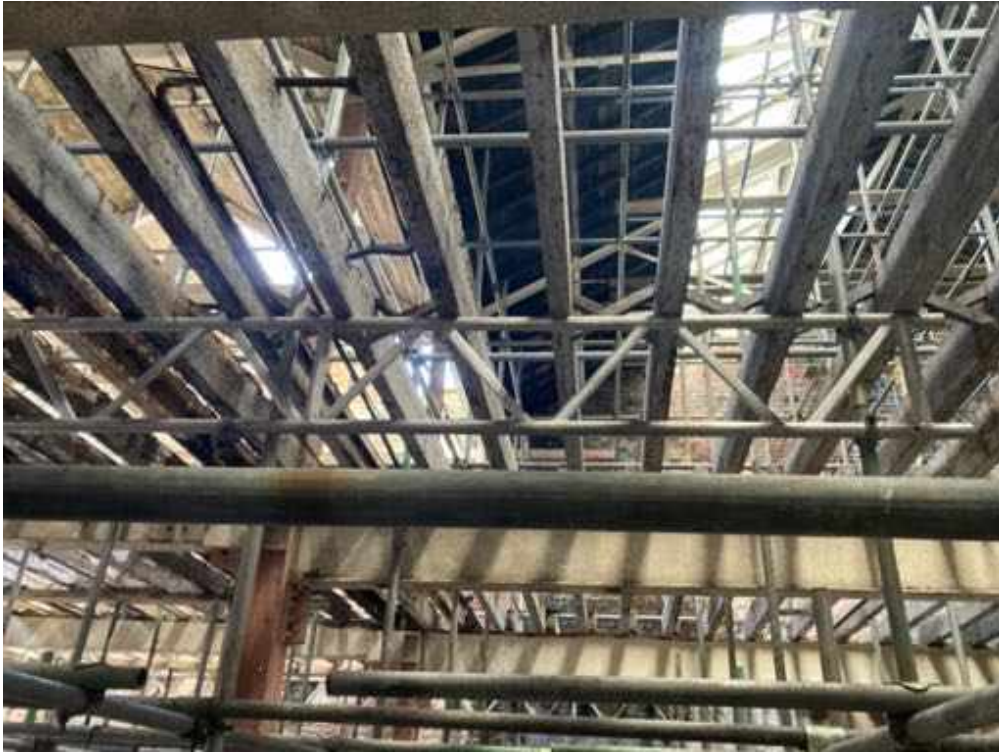
**Photograph 13**

**Description:** Exposed first floor flooring / joists within on-Site building

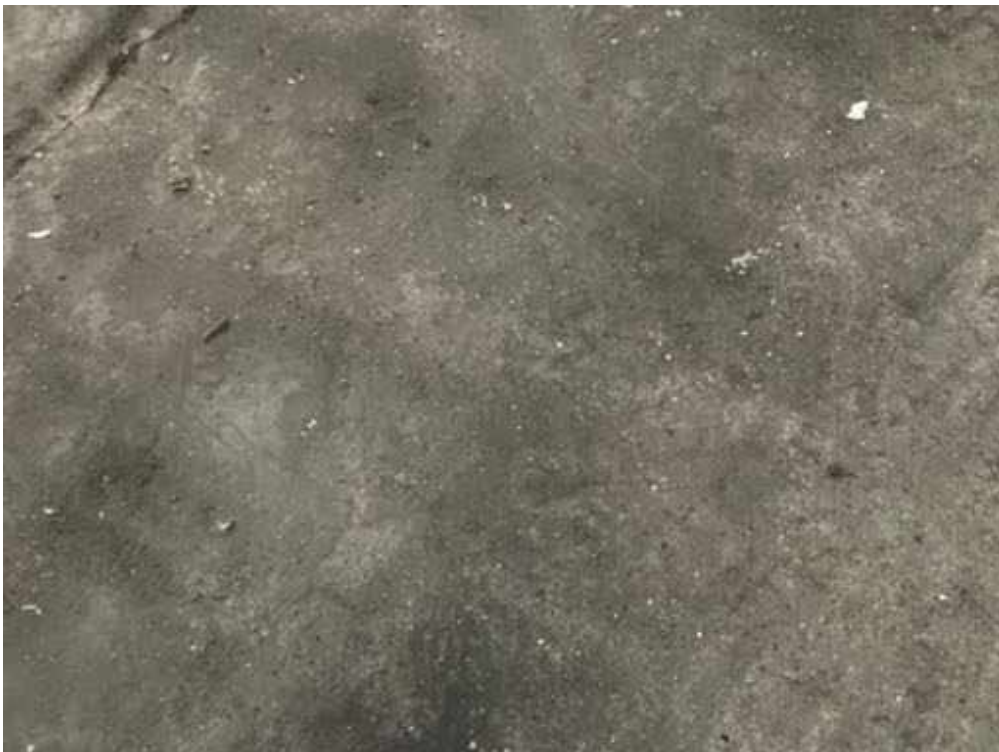
**Photograph 14**

**Description:** Typical flooring surface (concrete slab)

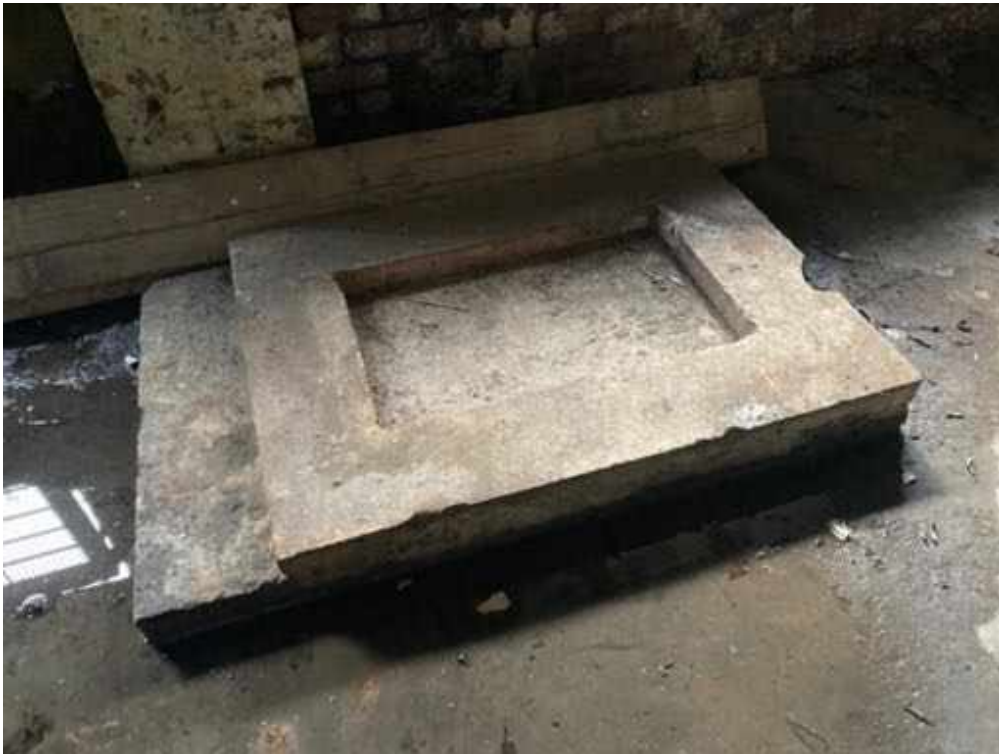
**Photograph 18**

- The 'cellar' was constructed from brick walls with solid concrete flooring (see Photograph 16 in Appendix B). Several window openings were present along the southern edge of the 'cellar' (see Photograph 20 in Appendix B). A former boiler plinth and flue opening were evident within the 'cellar' (see Photographs 18 and 19 in Appendix B).

**Description:** Former boiler plinth within 'cellar' area

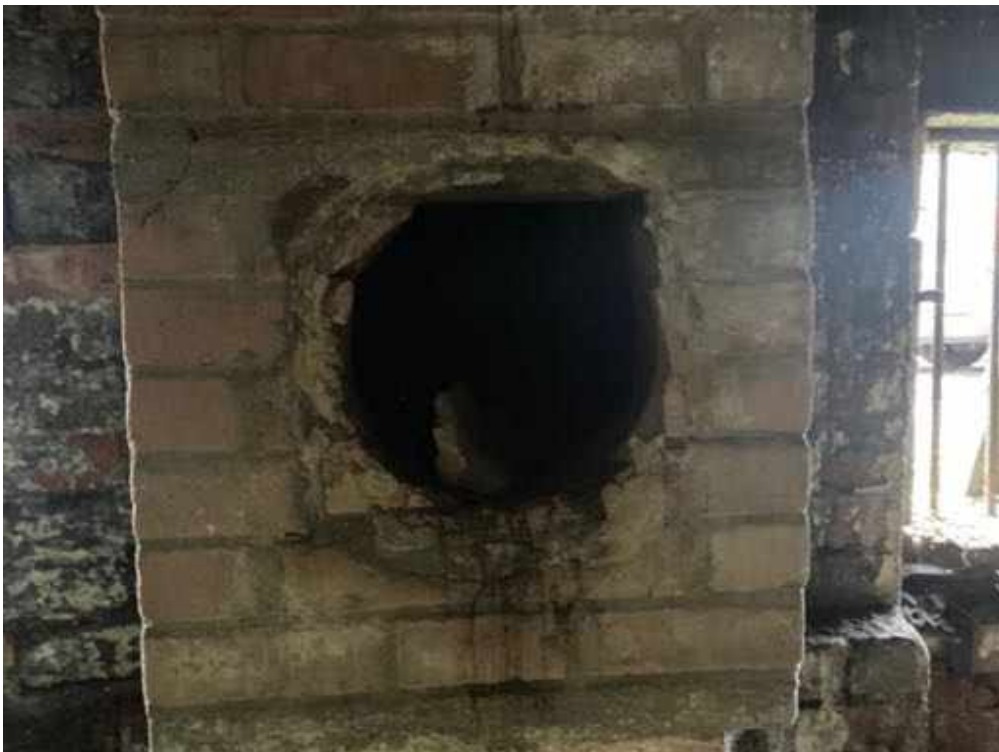
**Photograph 19**

**Description:** Former boiler flue within 'cellar' area

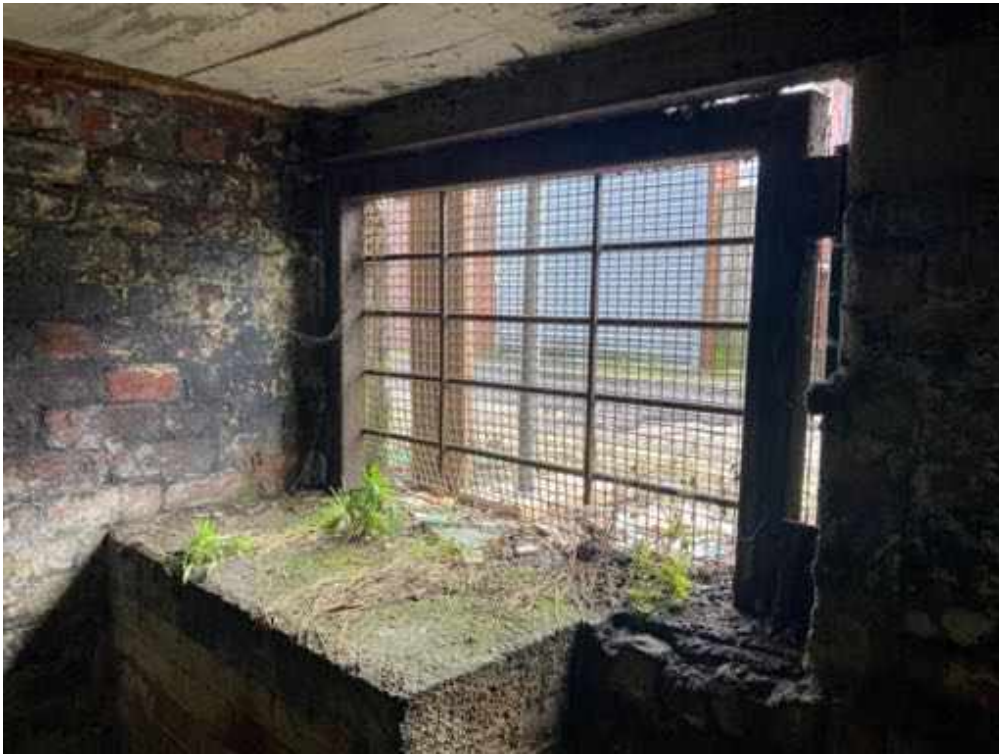
**Photograph 20**

**Description:** Window present within the 'cellar' area

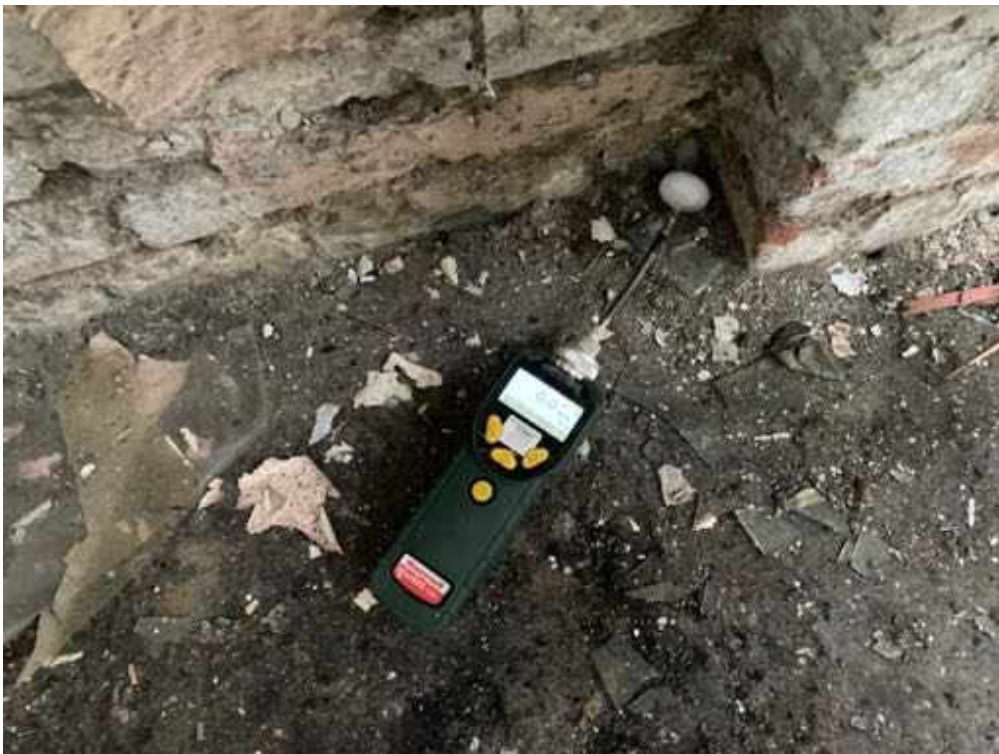
**Photograph 21**

Total VOC concentrations within the building air space were measured at multiple locations across the ground floor and also within the cellar area of the property on 10<sup>th</sup> January 2024, using a hand-held PID meter (see Photographs 21 and 22 in Appendix B). All in-situ total VOC measurements were below the instrument limit of detection (< 0.01 ppm).

**Description:** Example of internal PID survey

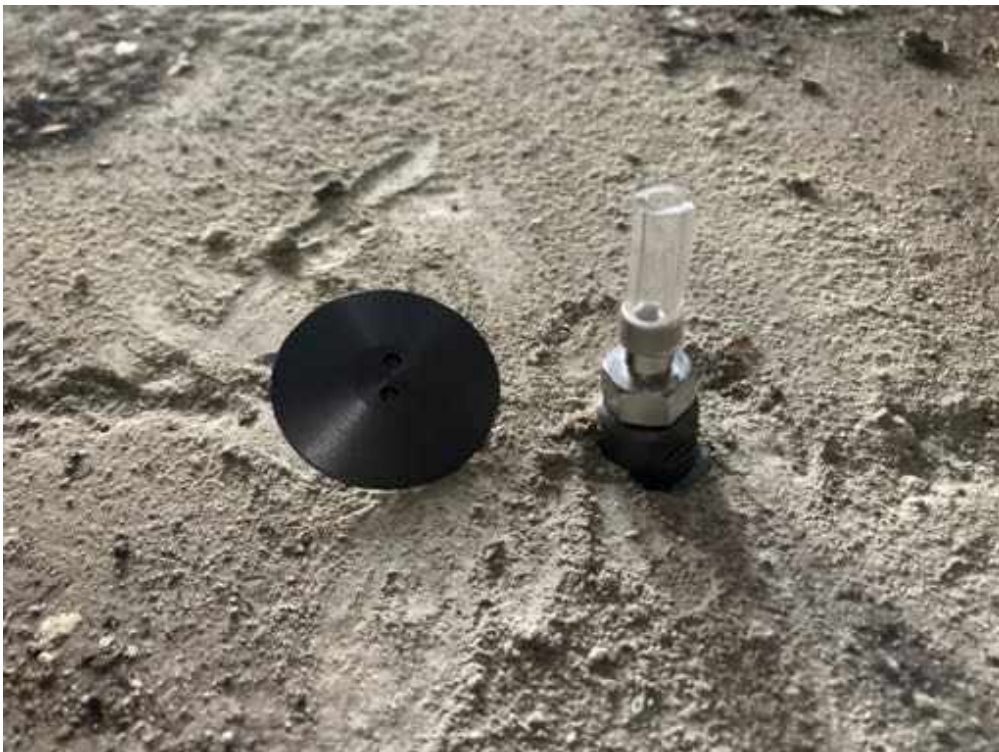
**Photograph 25**

**Description:** Vapor Pin installed within the in-situ concrete slab (VP2)

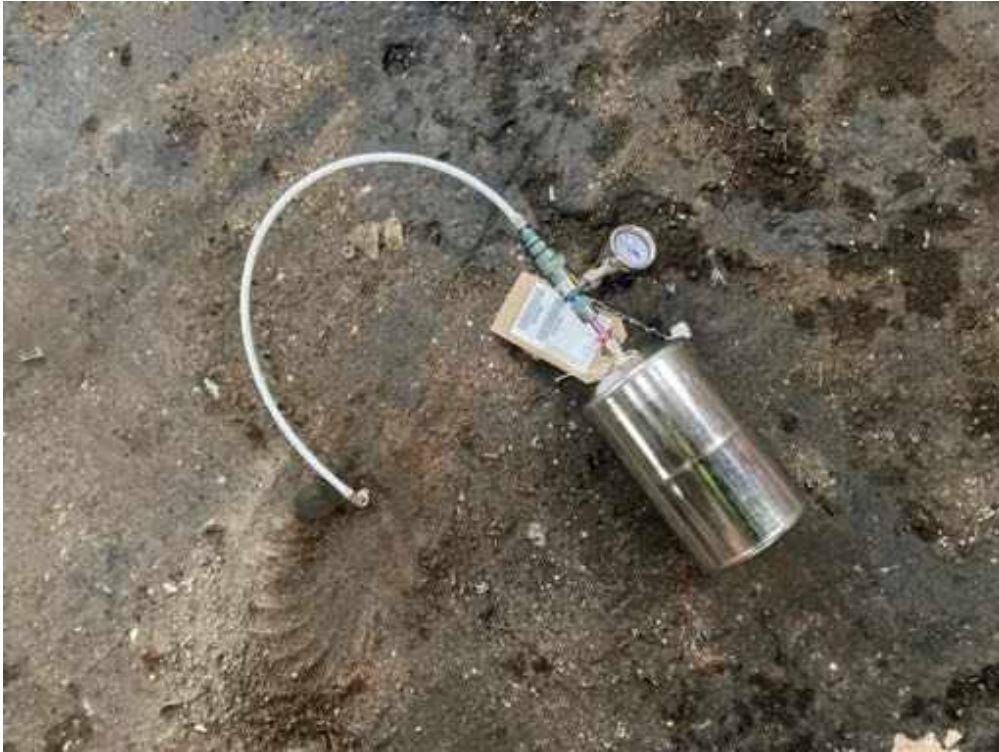
**Photograph 28**

**Description:** Sub-slab air sampling at Vapor Pin VP1
