# EXTENDED PHASE 1 HABITAT SURVEY & DAYTIME BAT SURVEY

## LAND AT MILLER STREET, RADCLIFFE, BURY

JANUARY 2021

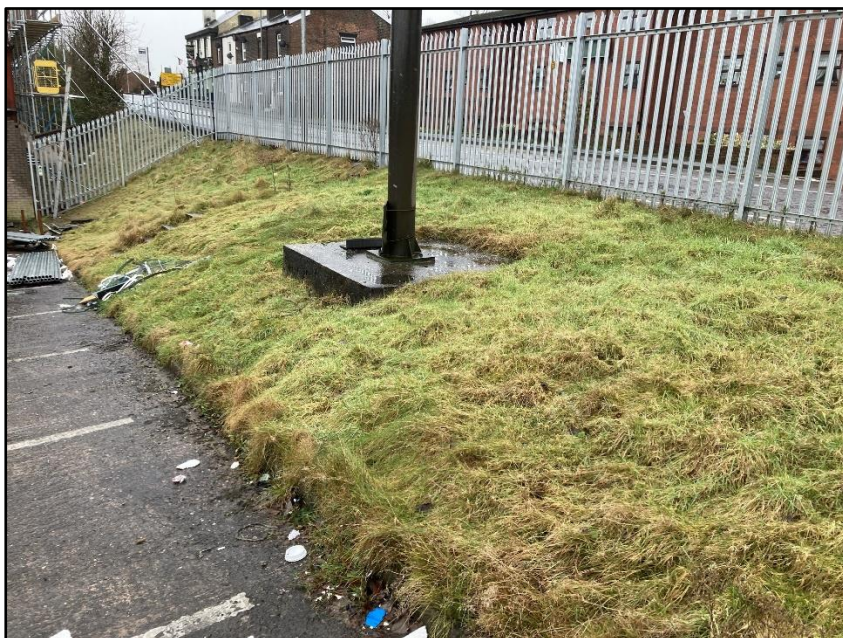
- 3.2 This habitat is present as a linear area along the western boundary of the site (see Photograph 1). The grassland is unmanaged resulting in a tall sward height. Dominant grass species include Perennial Rye-grass *Lolium perenne*, Creeping Bent *Agrostis stolonifera* and Cock's-foot *Dactylis glomerata*. Commonly occurring herbaceous species include Creeping Buttercup *Ranunculus repens*, Dandelion *Taraxacum officinale* agg., Ribwort Plantain *Plantago lanceolata*, Broad-leaved Dock *Rumex obtusifolius*, Meadow Buttercup *Ranunculus acris* and mosses.

Photograph 1 showing the poor semi-improved grassland

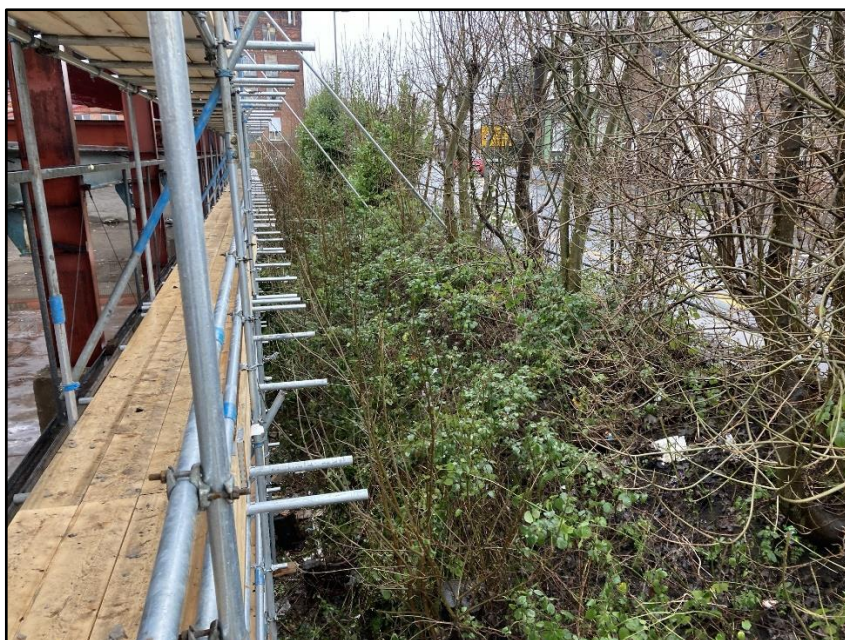
Photograph 2 showing the area of continuous scrub

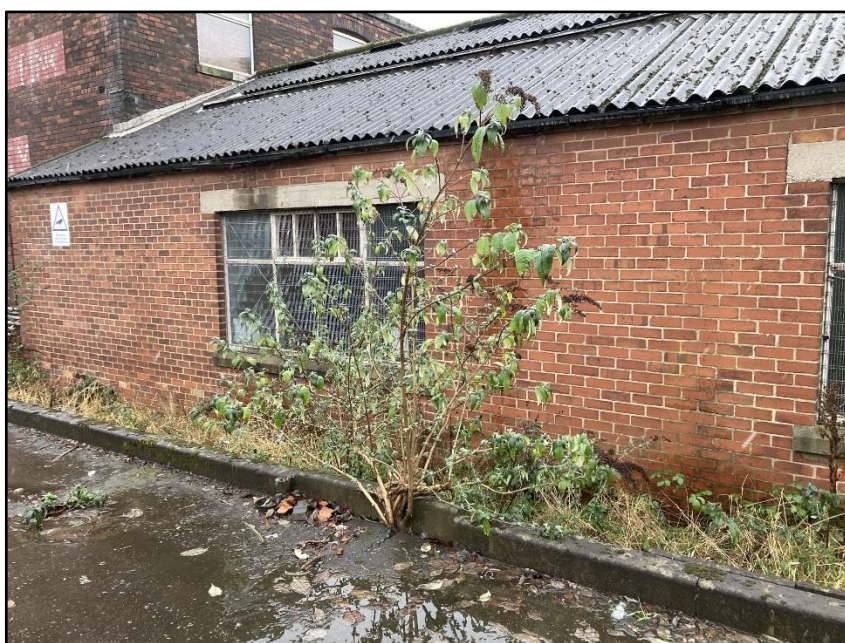
Photograph 3 showing a stand of scattered scrub

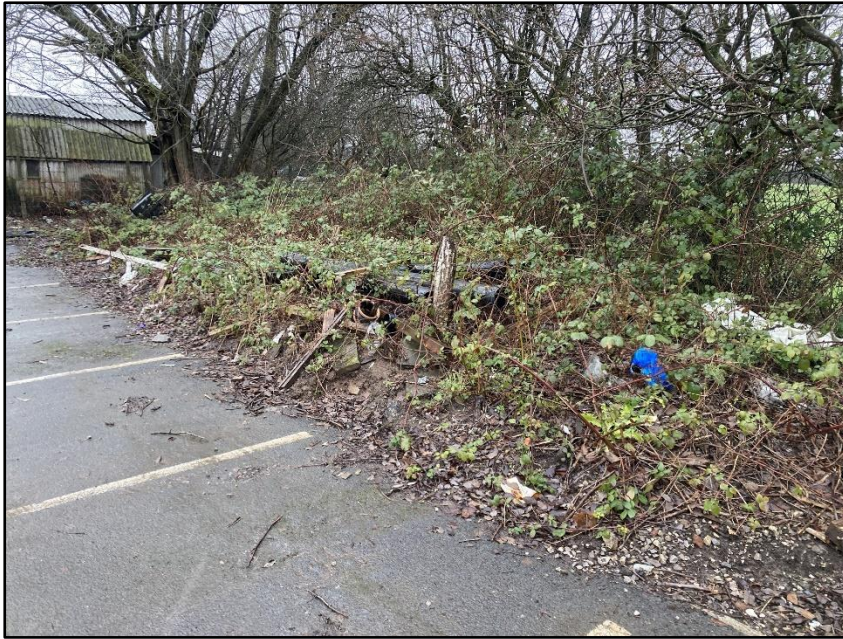
- 3.4 Tall, ruderal herb is present along the western, northern and eastern boundaries, as well as a linear area adjacent to one of the buildings (see Photograph 4). This habitat is dominated by Bramble *Rubus fruticosus* agg. and Stinging Nettle *Urtica dioica* with Willowherb species *Epilobium* sp., Ivy *Hedera helix*, Japanese Knotweed *Reynoutria japonica*, Hedge Bindweed *Calystegia sepium*, Spear Thistle *Cirsium vulgare*, Hogweed *Heracleum sphondylium*, Cock's-foot *Dactylis glomerata* and Broad-leaved Dock *Rumex obtusifolius* also abundant.

Photograph 4 showing an area of tall, ruderal herb

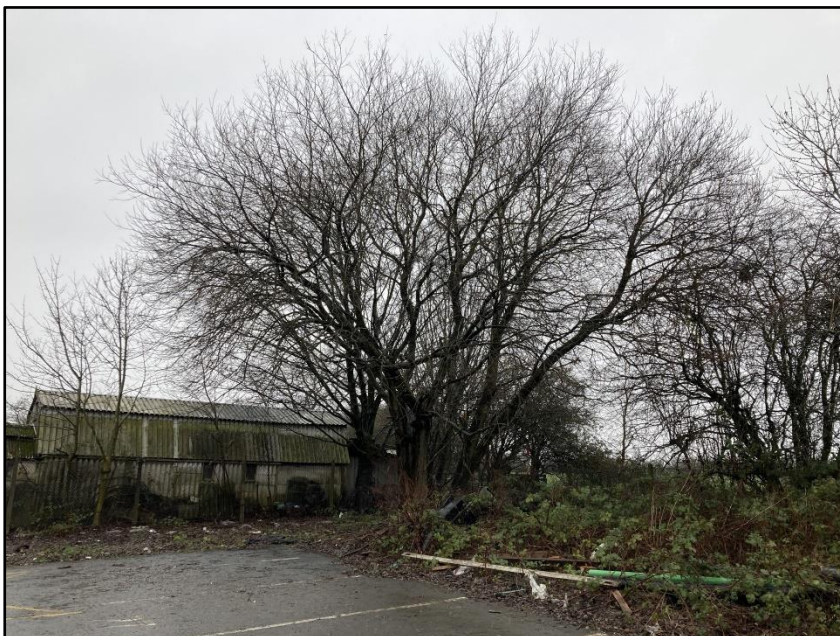
- 3.5 Scattered trees are found across the site peripheries, with a high concentration along the western boundary. One early-mature tree is located in the northern corner of the site and the remaining trees are of a juvenile age (see Photograph 5). Tree species are Sycamore *Acer pseudoplatanus*, Ash *Fraxinus excelsior*, Elder *Sambucus nigra* and Goat Willow *Salix caprea*.

Photograph 5 showing the early-mature tree on site

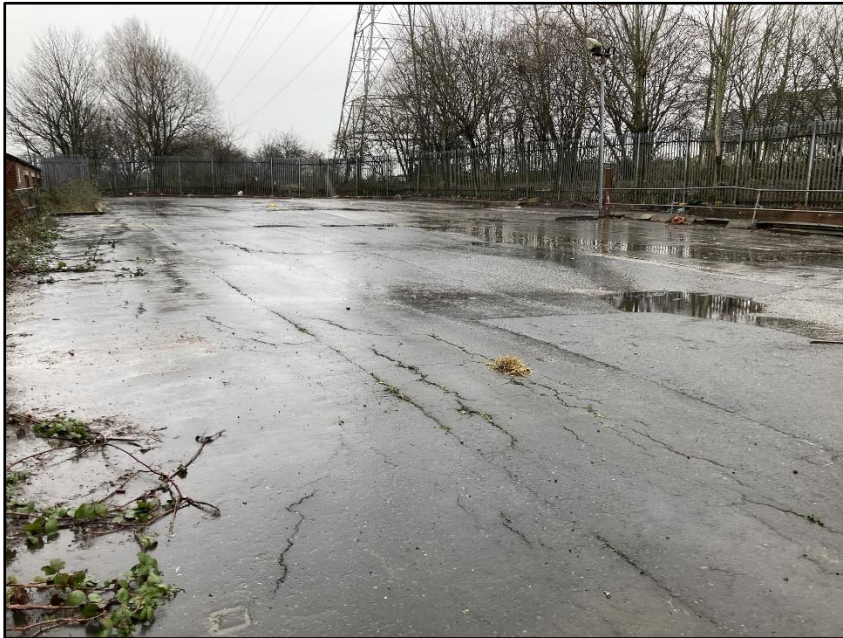
- 3.6 This habitat is present across the site comprising hardstanding access roads and paths, parking and loading areas (see Photograph 6). Ephemeral/short perennial species have established within cracks and crevices and around the peripheries of the hardstanding areas.

Photograph 6 showing an area of hardstanding bare ground

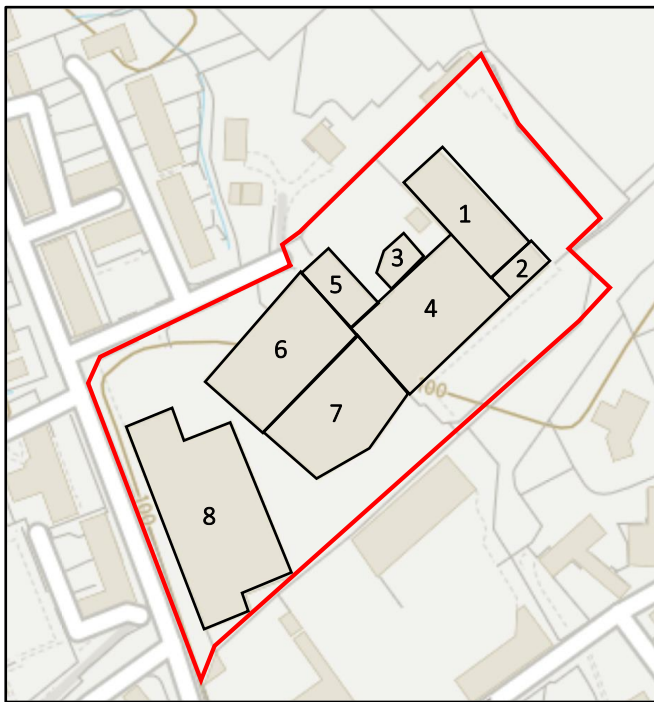
- 3.12 The buildings proposed to be affected by the development were the subject of a daytime bat survey and the results are detailed below. The buildings were fully accessible and could be easily surveyed. The buildings were split based on their construction type for ease of surveying and reporting. Please see Figure 2 for the building locations and reference numbers.

Figure 2 showing the building locations and the reference numbers
