## DEMOLITION ASBESTOS SURVEY

**Rainsough Cottage  
Rainsough Brow  
Prestwich  
M25 9SU**

REF: BC/RA/590

**6<sup>th</sup> November 2020**

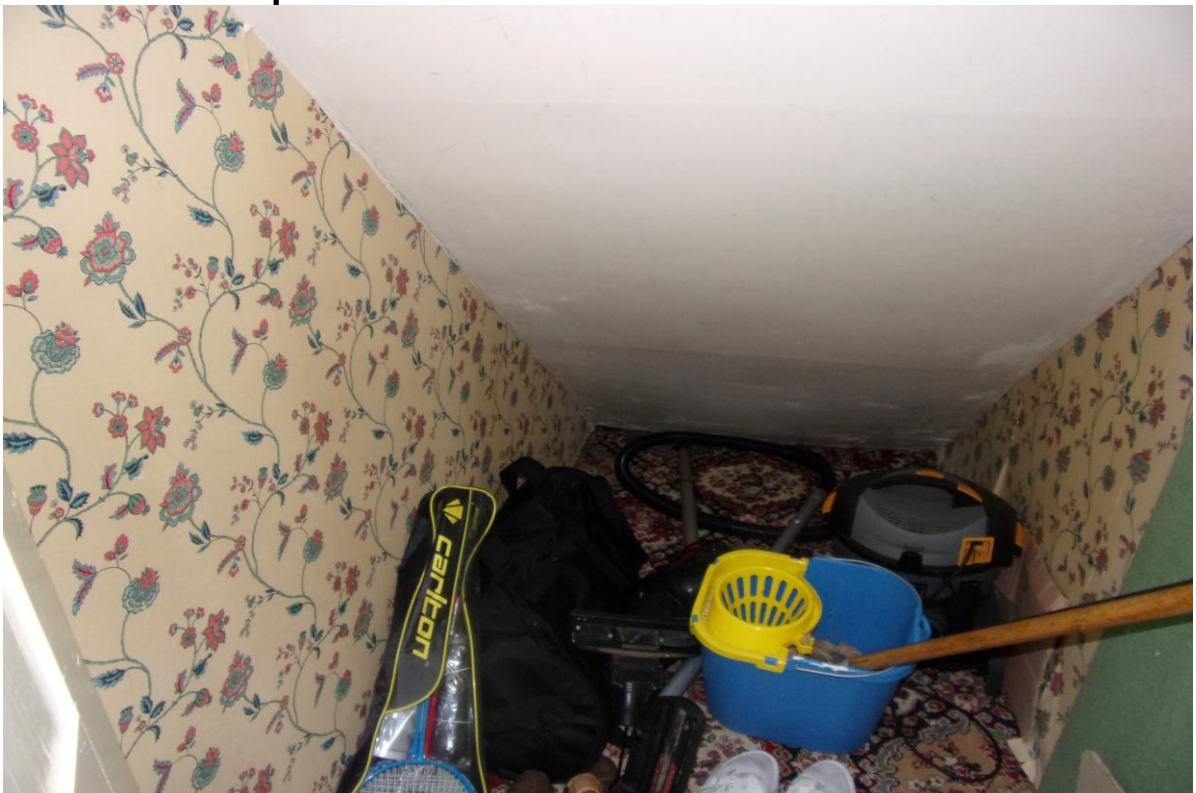
### **Understairs Cupboard**

There is a storage cupboard under the stairs, with a painted plaster ceiling, wallpapered walls and a carpeted floor.

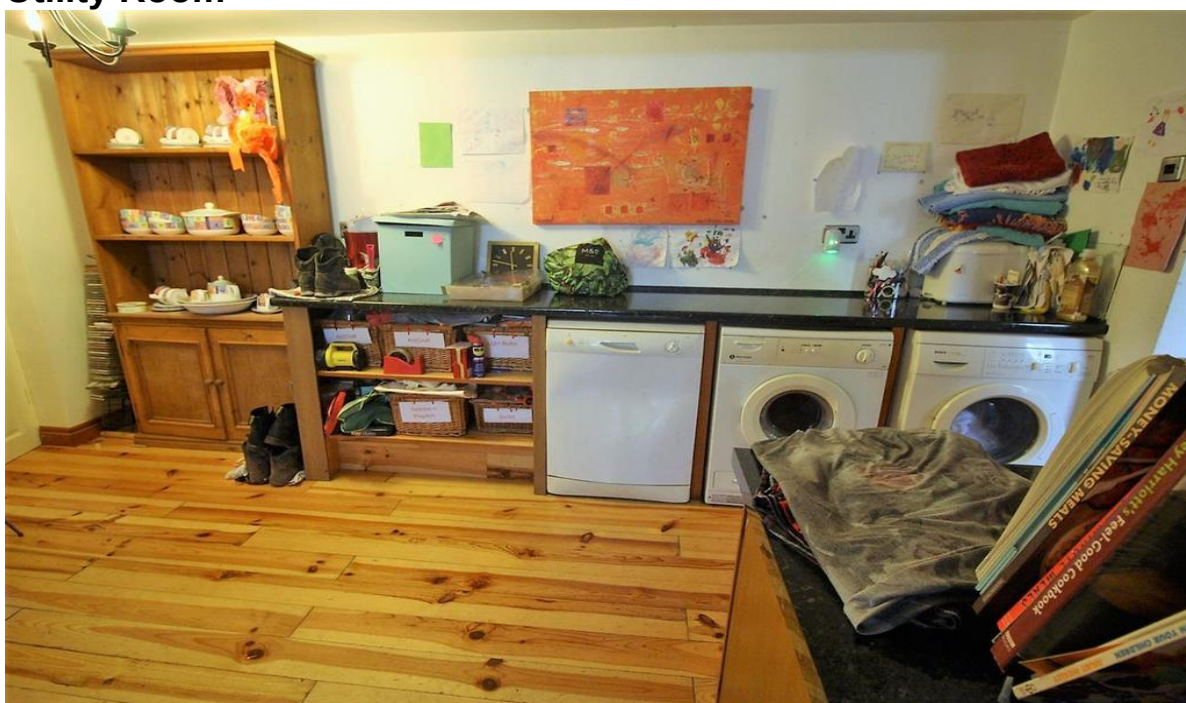
### Utility Room

On the other side of the dining room is a utility room, with painted plaster walls and ceiling, and laminate flooring,

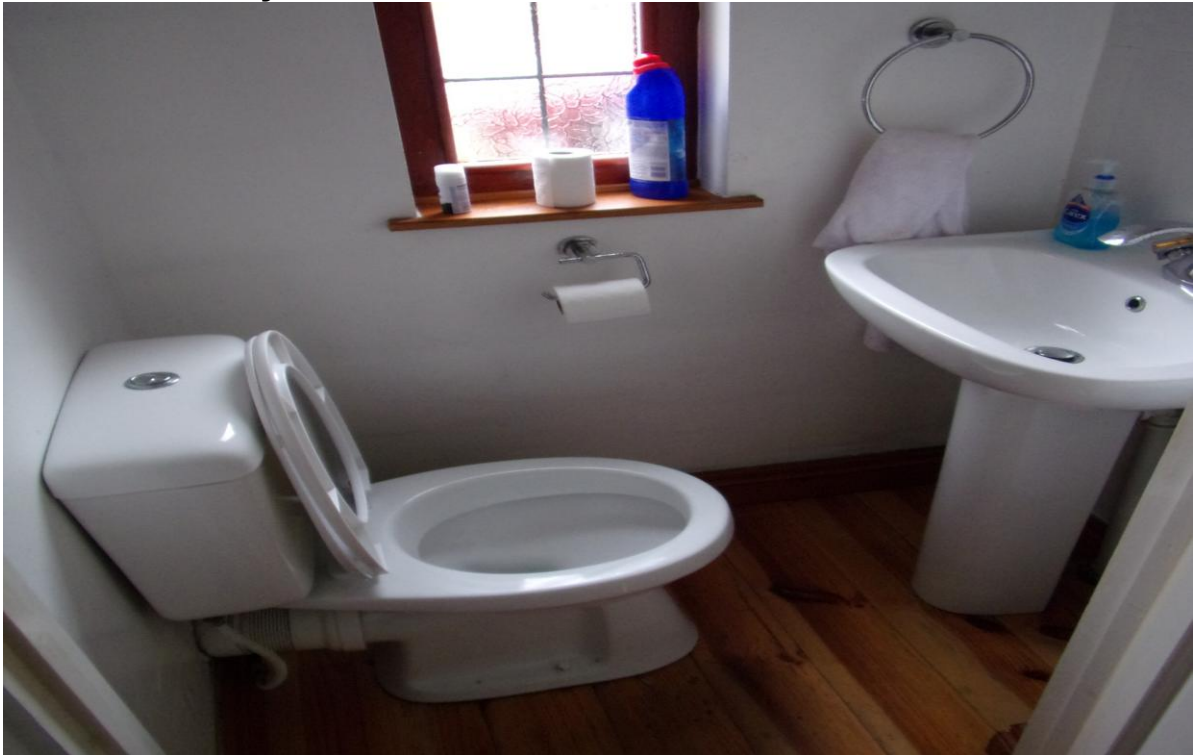
### **Toilet Off Utility Room**

In one corner of this is a toilet, with a modern vitreous suite, painted plaster walls and ceiling, and laminate flooring.

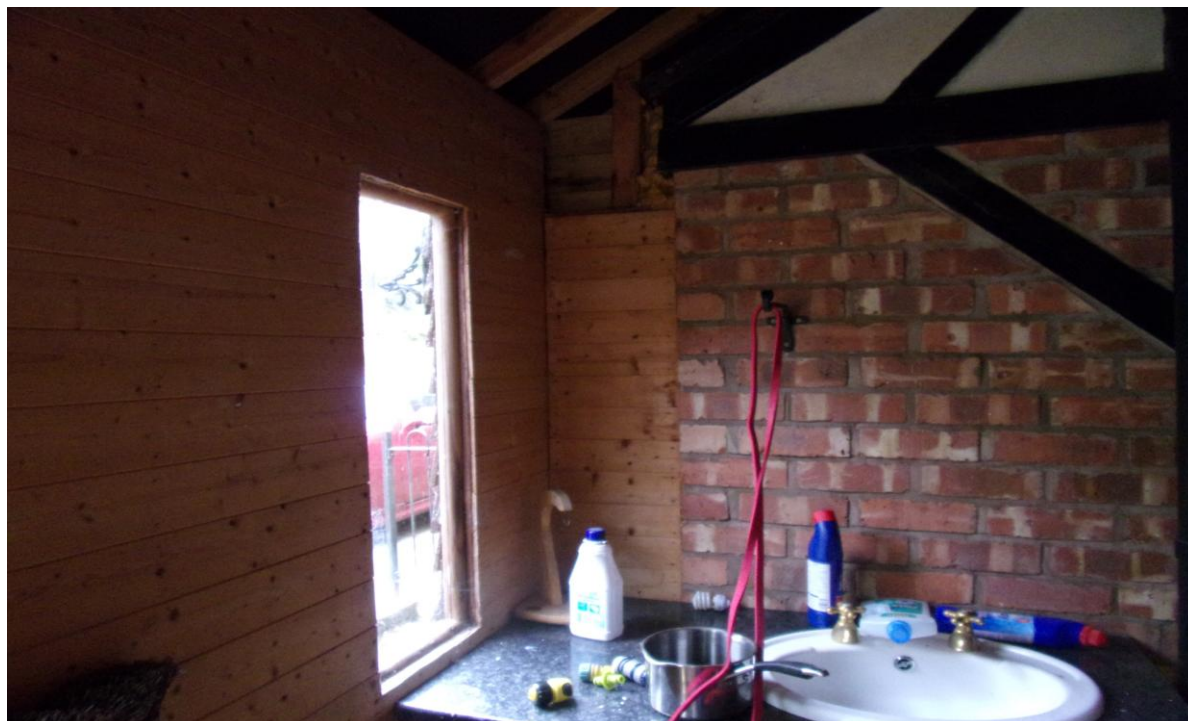
### Porch

In one corner of the kitchen is a brick-built porch leading to the side entrance, with a slate roof and partial tongue and groove timber panelling, a flagged floor and a modern ceramic washbasin and wash stand.

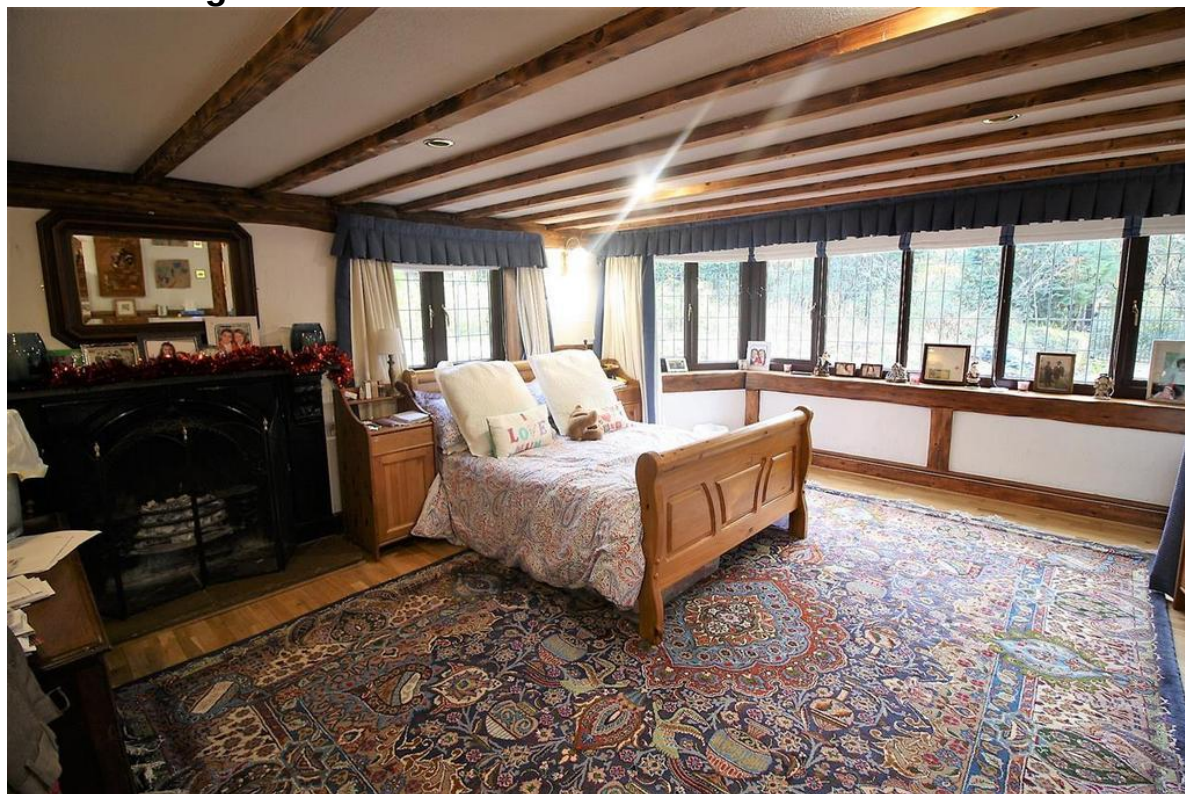
### Front Lounge

Back to the hall, a door leads through into a lounge, formerly used as a bedroom, with a part timber-beamed and part painted plaster ceiling, painted decorative plaster walls, and a cast iron feature fireplace.

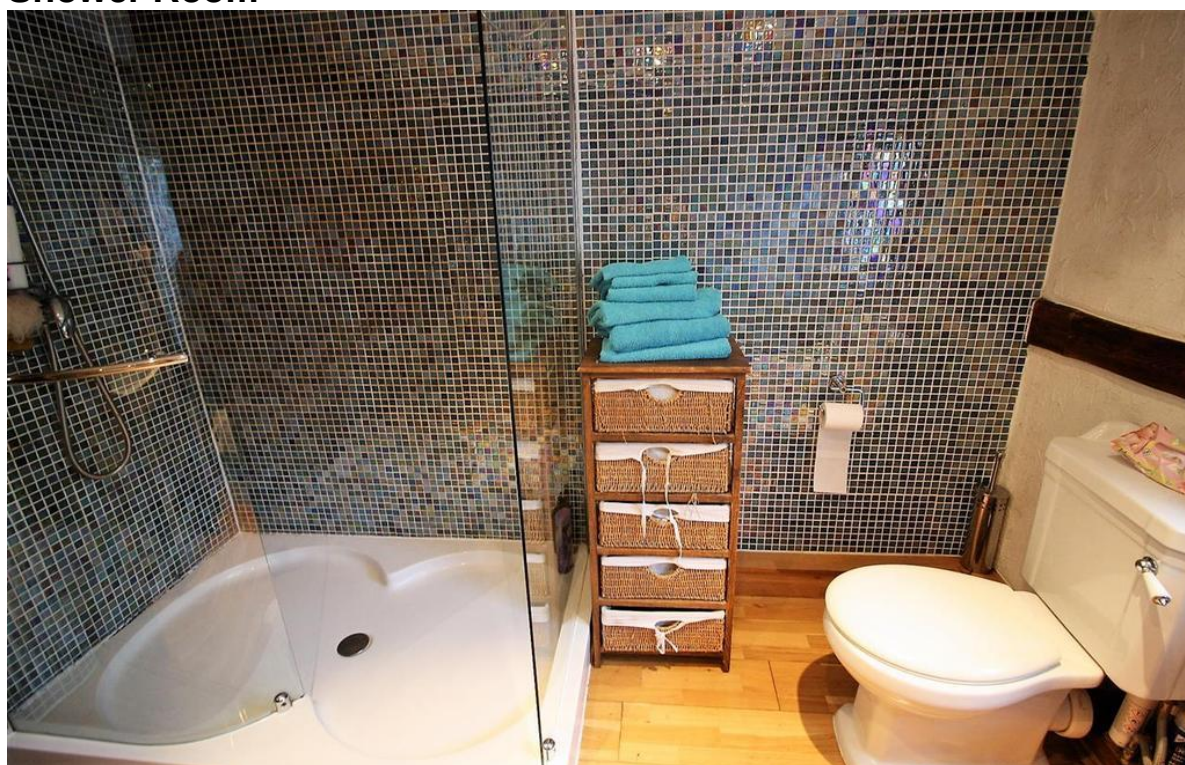
### Shower Room

Behind that is a shower room, with mosaic-tiled walls, laminate flooring and painted plaster ceiling.

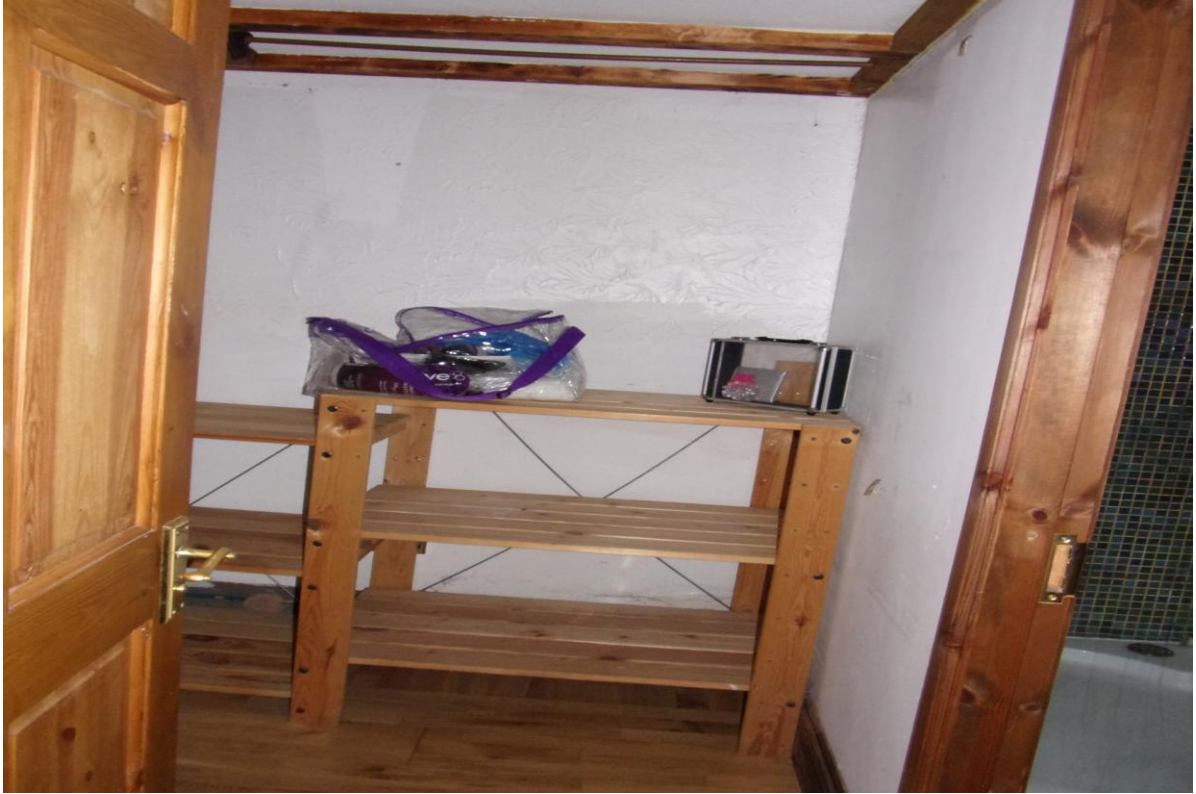
### **Storage and Dressing Room**

Adjacent to that is a storage and dressing room, with laminate flooring and painted plaster walls and ceiling.

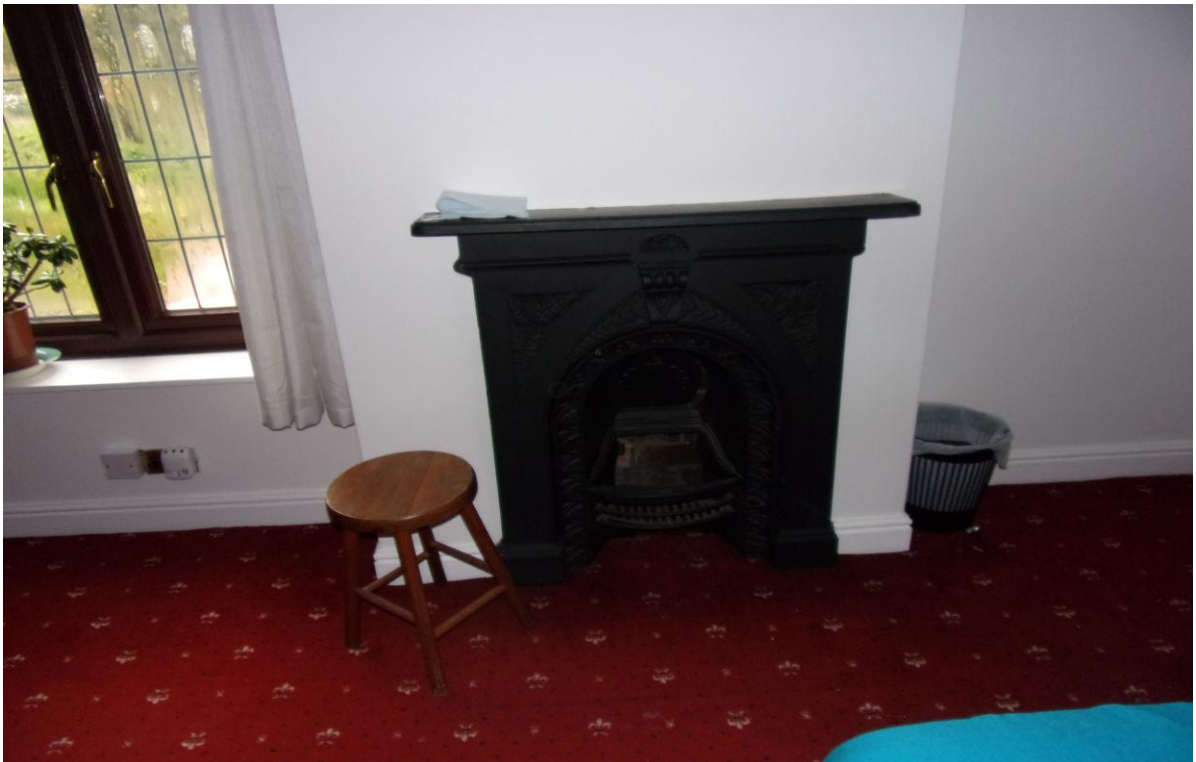
### **Bedroom 1**

Back in the hall, a set of wooden carpeted stairs leads up to a carpeted landing and on to bedroom number one, with painted plaster walls and ceiling, a cast-iron feature fireplace and a carpeted floor.

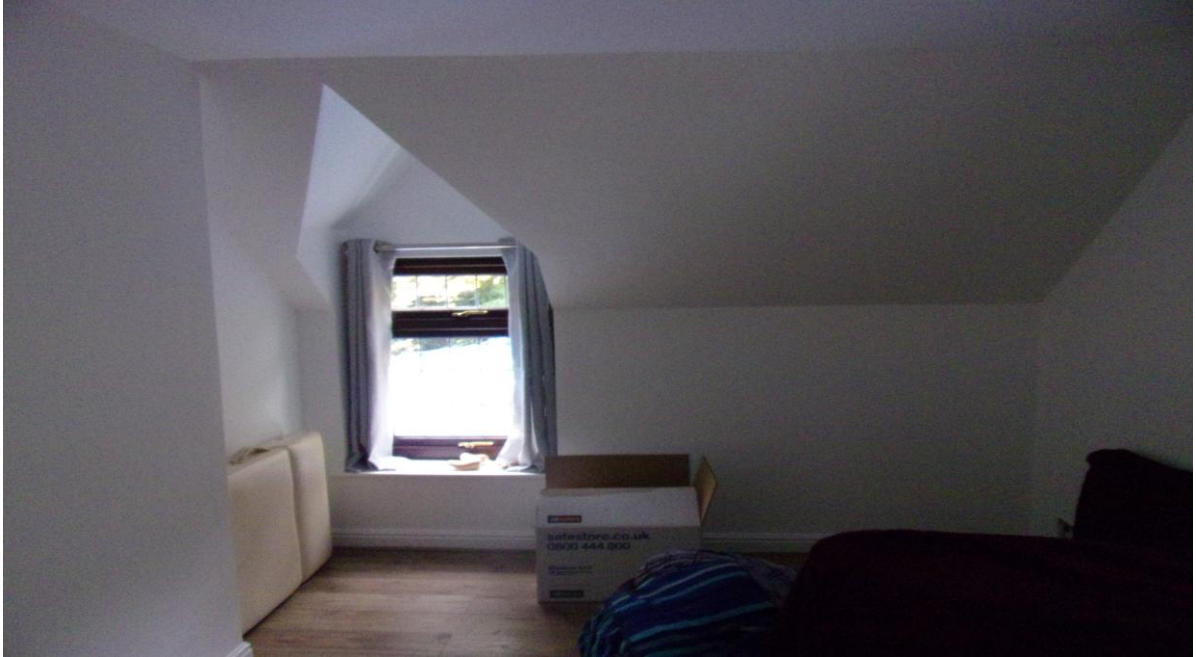
### **Bedroom 2**

The bedroom has painted plaster walls and ceiling, and laminate flooring.

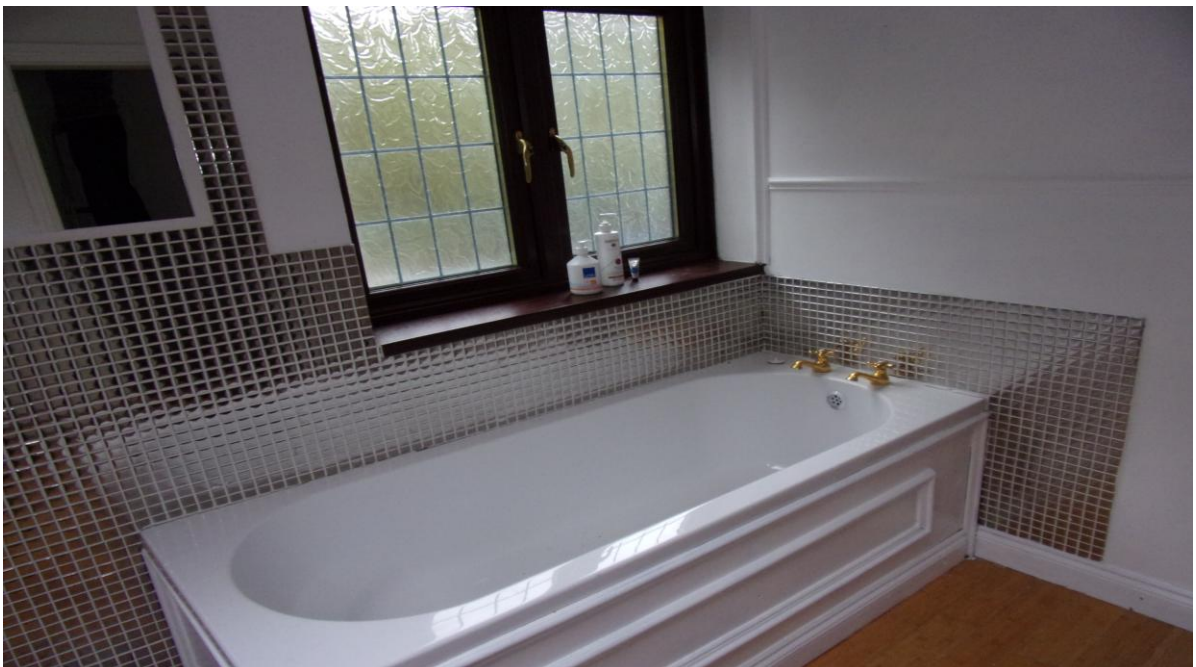
### **Bathroom**

Next to that is a bathroom, with laminate flooring, part painted timber panels and plaster, and part mosaic-patterned ceramic tiles on the walls.

All fittings are of modern manufacture.

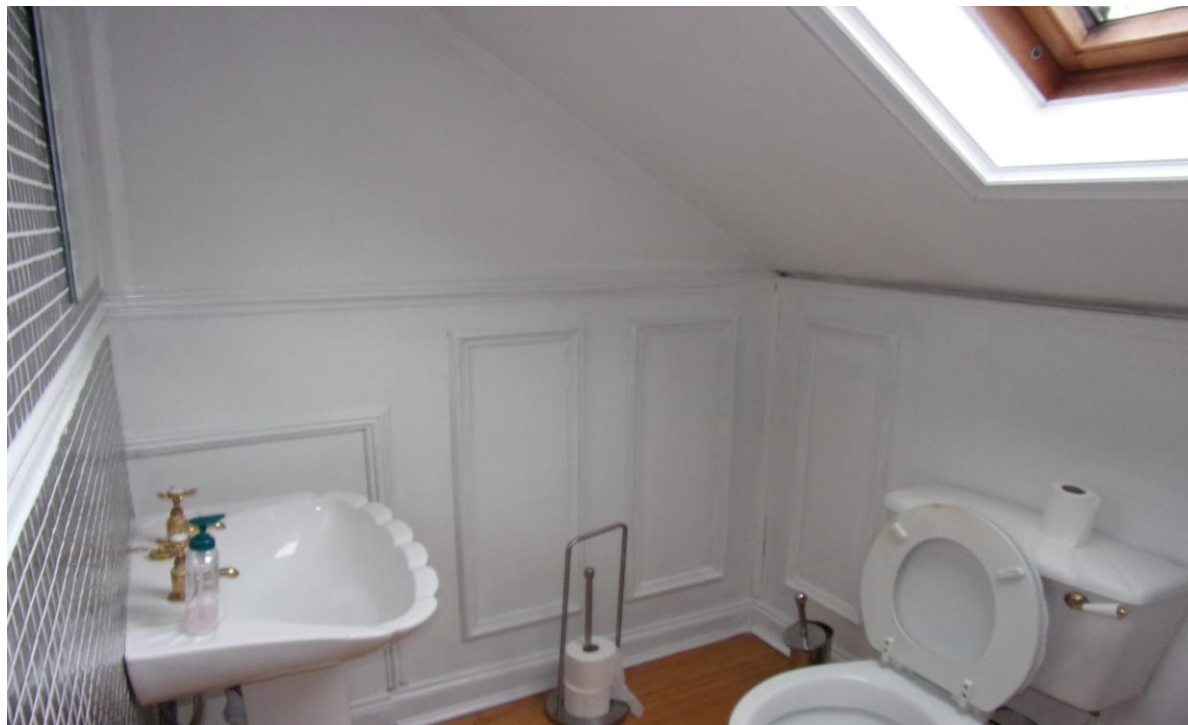
### **Toilet**

To the rear of the bathroom is a separate toilet, with 3 part painted plaster and part painted timber-panelled walls, one with mosaic-patterned ceramic tiles, a painted plaster ceiling and laminate flooring.

The sanitary suite is modern ceramic.

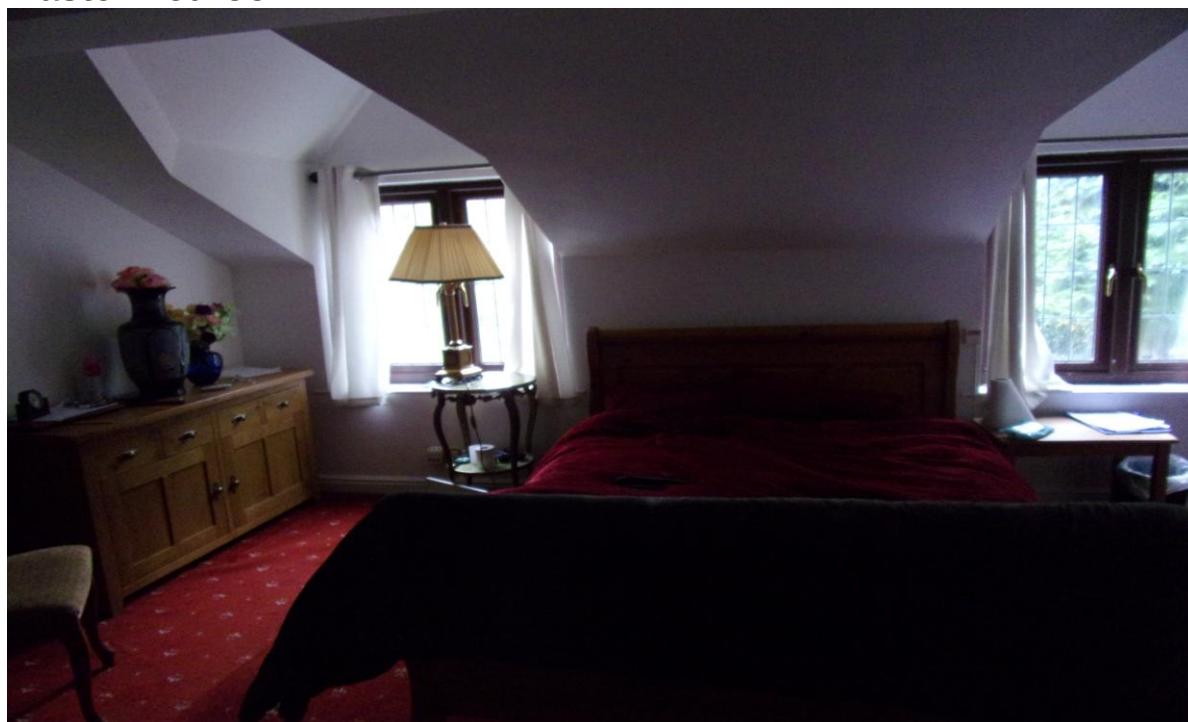
### **Master Bedroom**

Back out on the landing, a door leads into the master bedroom, which has painted plaster walls and ceiling, plus a carpeted floor.

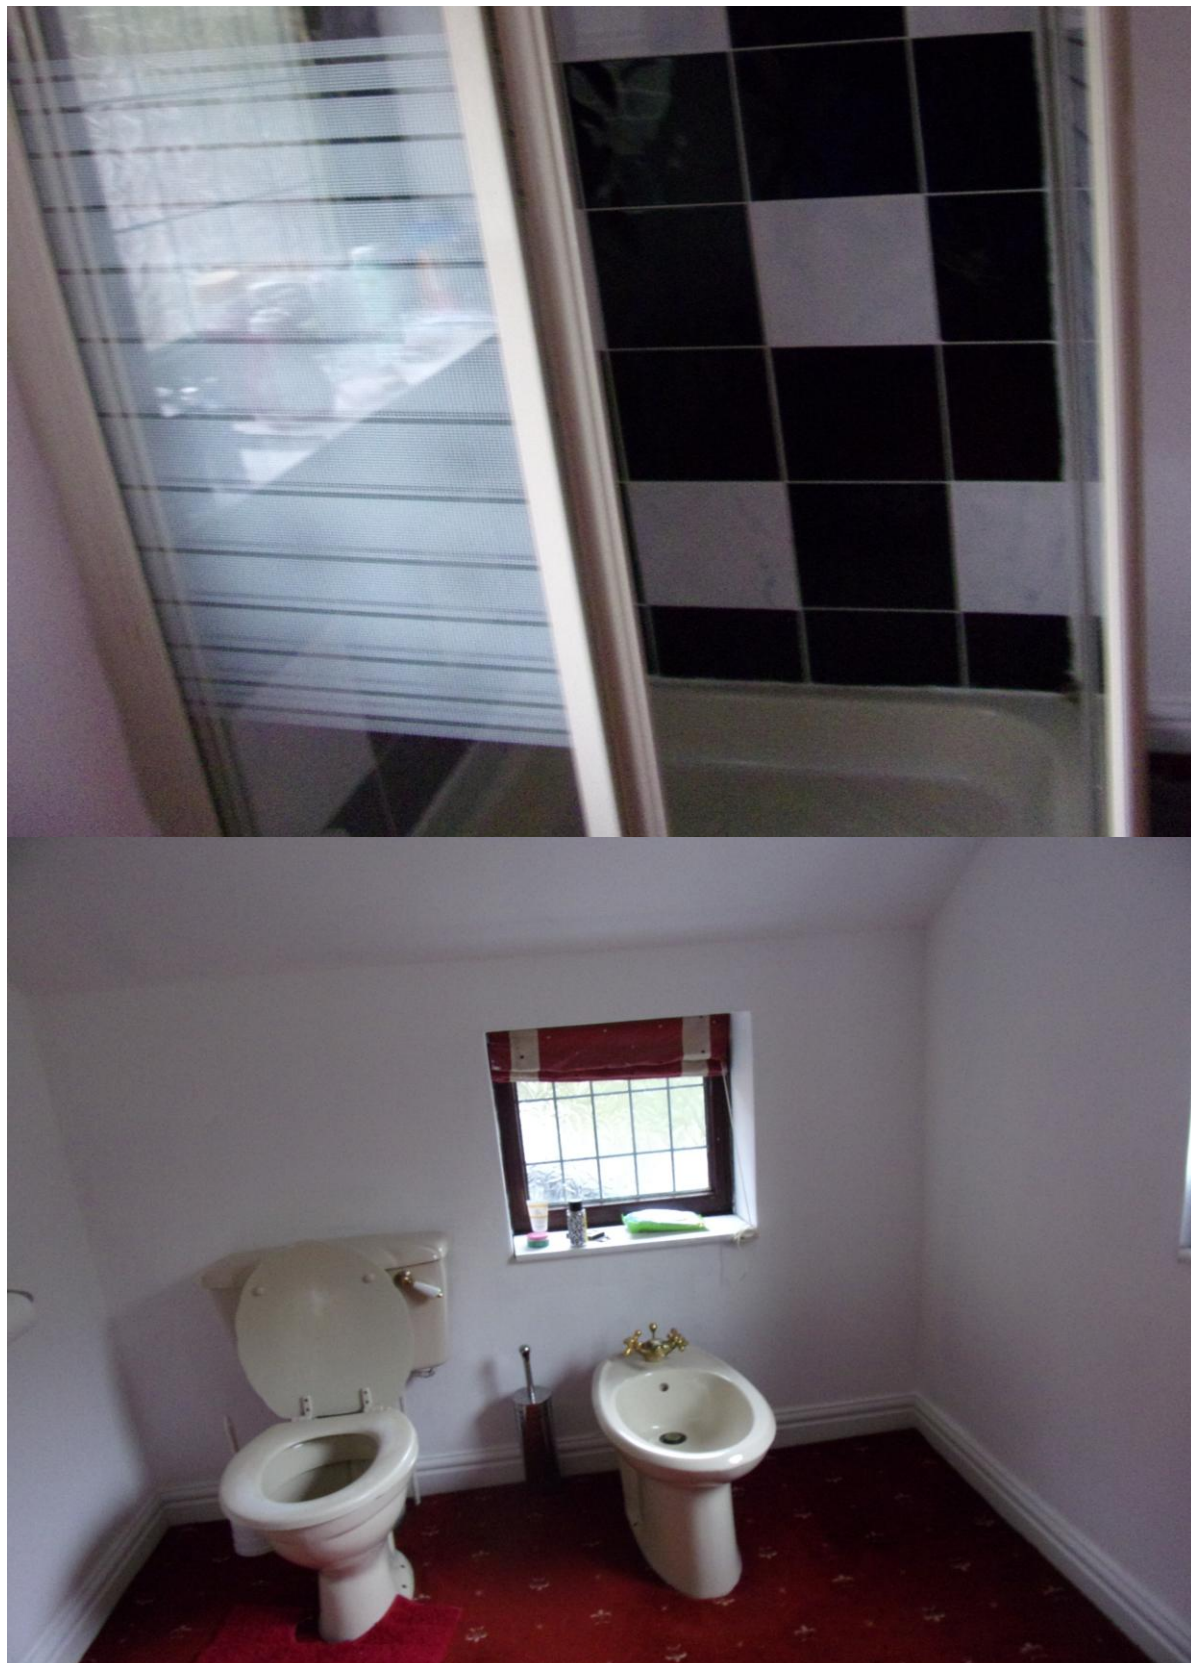
### **En Suite Shower Room**

The shower room has a shower with ceramic-tiled walls, painted plaster to the remaining walls and ceiling, and a carpeted floor.
