# **CONDITION REPORT**

## **PERIMETER FENCING**

### **St. Stephen's CE Primary School**

**OVERALL CONDITION/PRIORITY RATING: D1**

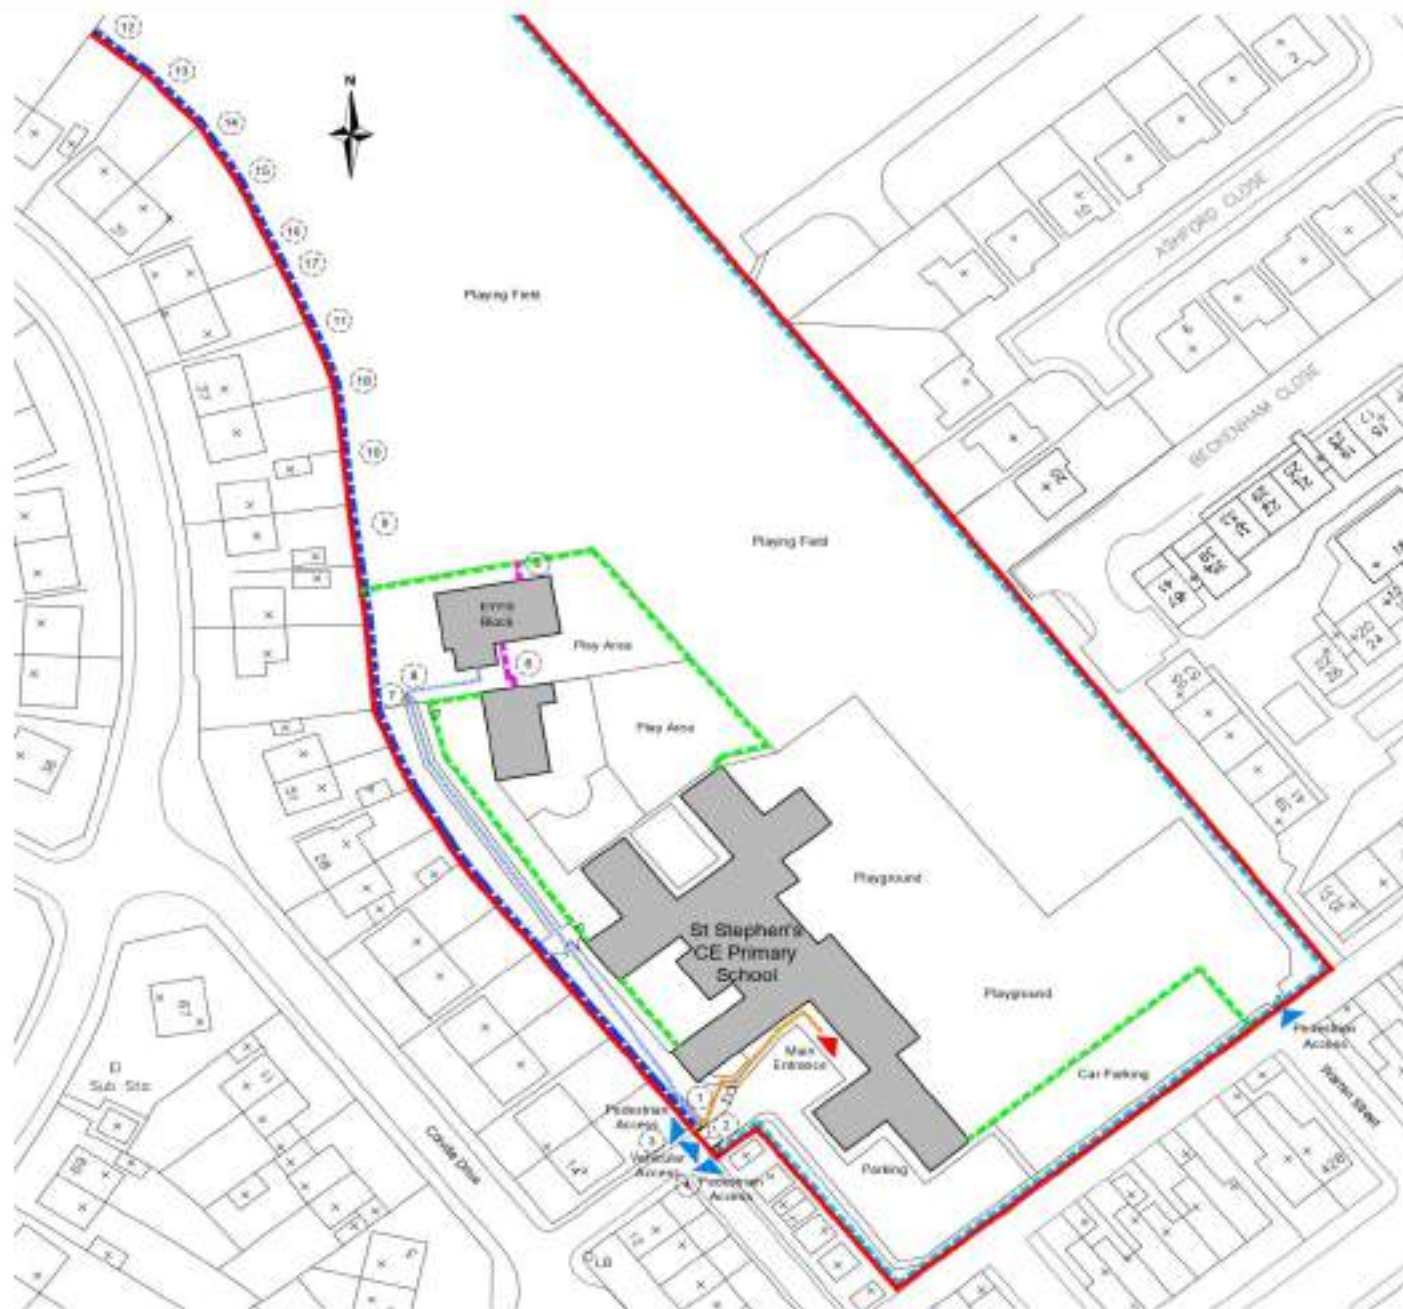
The boundary, height and location of existing and proposed fencing is shown on this plan. It is the responsibility of the client to ensure that the fencing is installed in accordance with the relevant standards and regulations. The client is responsible for obtaining all necessary permissions and consents for the proposed fencing. The client is also responsible for ensuring that the fencing is installed in accordance with the relevant standards and regulations.
