Phase I Geoenvironmental Site Assessment  
Fairways Lodge, Prestwich

Reference: 17-206-R1-1  
Date: September 2023

# PHASE I GEOENVIRONMENTAL SITE ASSESSMENT

Fairways Lodge  
George Street  
Prestwich  
Greater Manchester  
M25 9WS

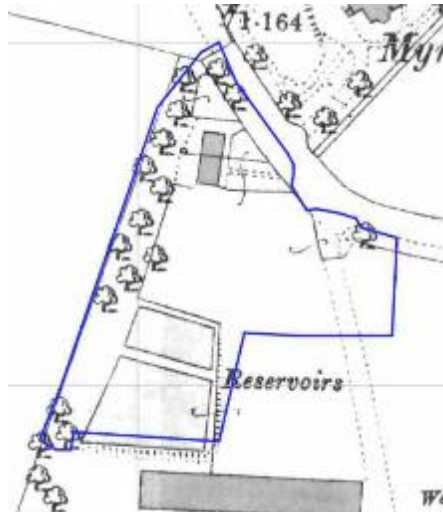
| MAP EDITION | HISTORICAL LAND USE | HISTORICAL MAP EXCERPT |
|---|---|---|
| 1893<br>1:2,500 | <p>Reservoirs are recorded in the south of the site.</p> <p>A rectangular structure is present in the northern sector.</p> <p>Tracks are present in the north and east of the site.</p> | |

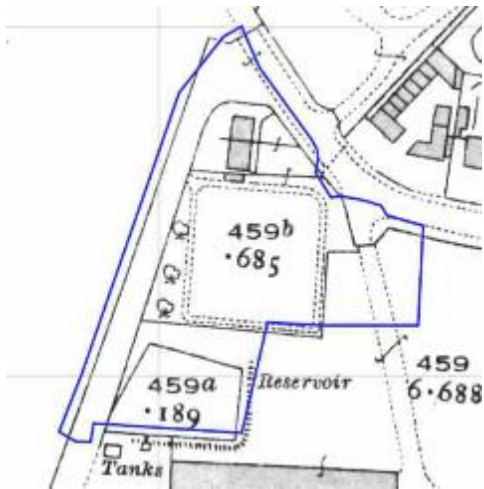
| MAP EDITION | HISTORICAL LAND USE | HISTORICAL MAP EXCERPT |
|---|---|---|
| 1932<br>1:2,500 | <p>The reservoir furthest north is no longer recorded.</p> <p>A Bowling Green is recorded in the centre of the site with a small Pavilion.</p> <p>Small tanks are recorded at the southern site boundary associated with the adjacent Bleach and Dye Works.</p> | |

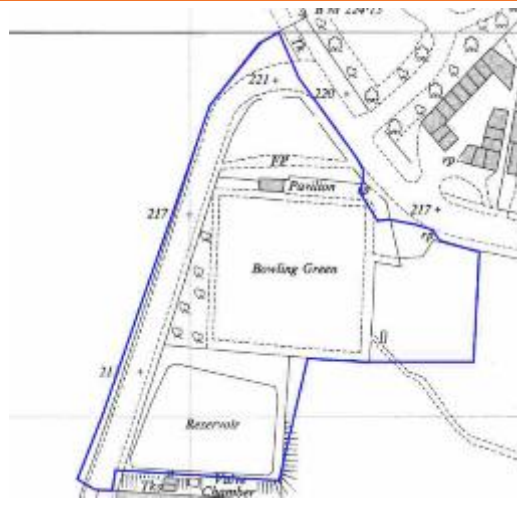
| MAP EDITION | HISTORICAL LAND USE | HISTORICAL MAP EXCERPT |
|---|---|---|
| <p>1952<br/>1:1,250</p> | <p>The buildings in the north of the site are no longer present. A footpath is recorded to the north of the Bowling Green.</p> | |

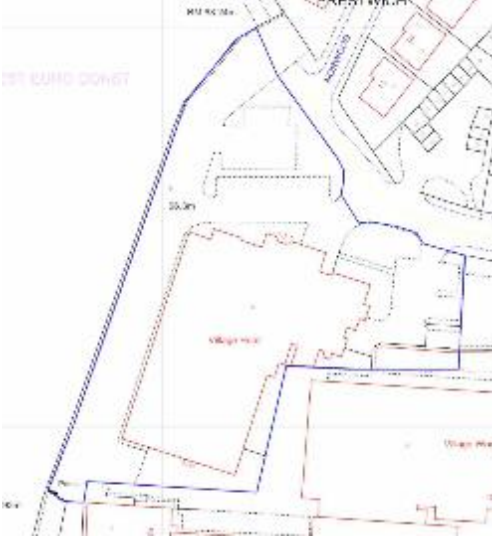
| MAP EDITION | HISTORICAL LAND USE | HISTORICAL MAP EXCERPT |
|---|---|---|
| <p><b>2003</b><br/><b>1:1,250</b></p> | <p>The Club building is now recorded as the Village Hotel.</p> | |

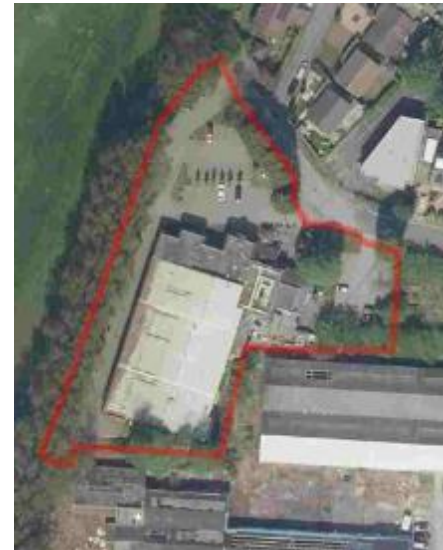
| MAP EDITION | HISTORICAL LAND USE | HISTORICAL MAP EXCERPT |
|---|---|---|
| 2019<br>Aerial<br>Photograph | There are no significant changes. The area to the north of the hotel is utilised as a car park. | |

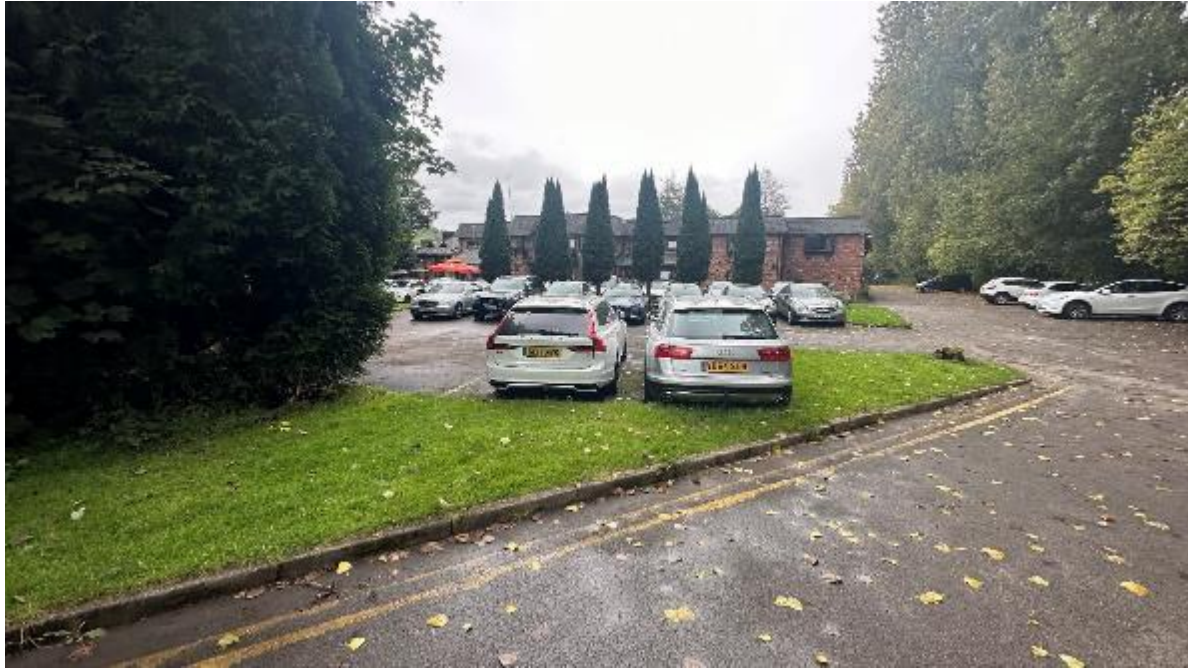
PLATE 1      VIEW OF CAR PARK IN THE NORTH (FACING SOUTH)

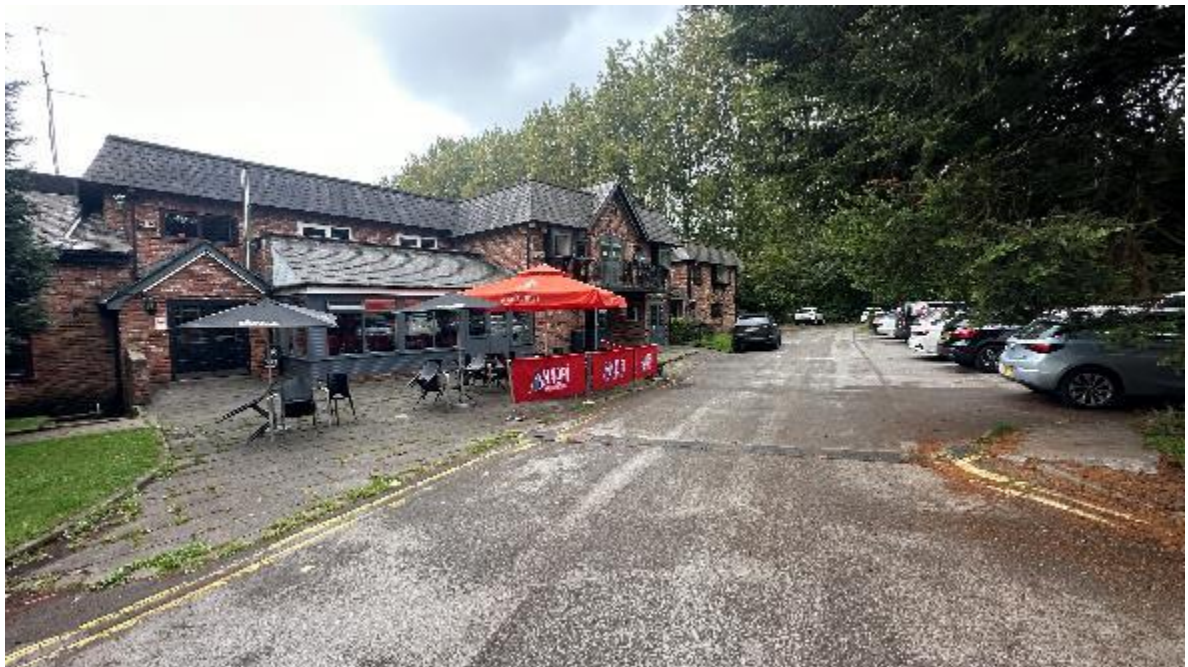
PLATE 2      VIEW OF FAIRWAYS LODGE FROM GEORGE STREET IN THE NORTH

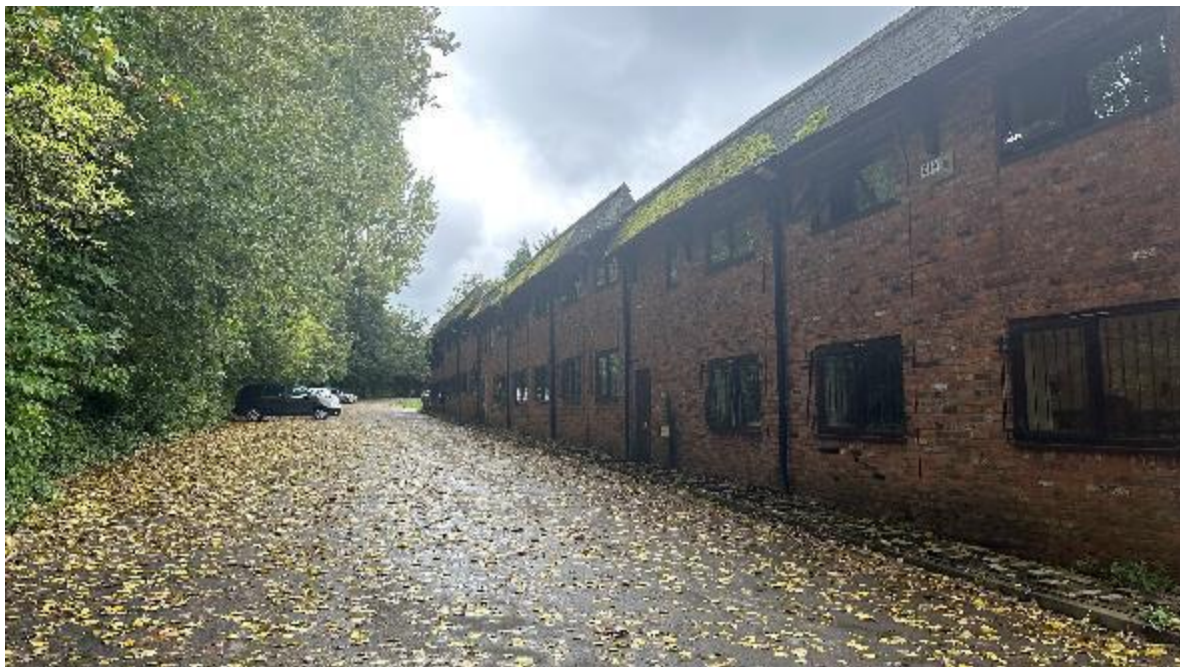
PLATE 4 VIEW OF FAIRWAYS LODGE AND TREES ALONG THE WESTERN BOUNDARY
