R4240

CLOUGH FARMHOUSE, CLOUGH LANE  
PRESTWICH

JANUARY 2025

# REPORT ON STRUCTURE

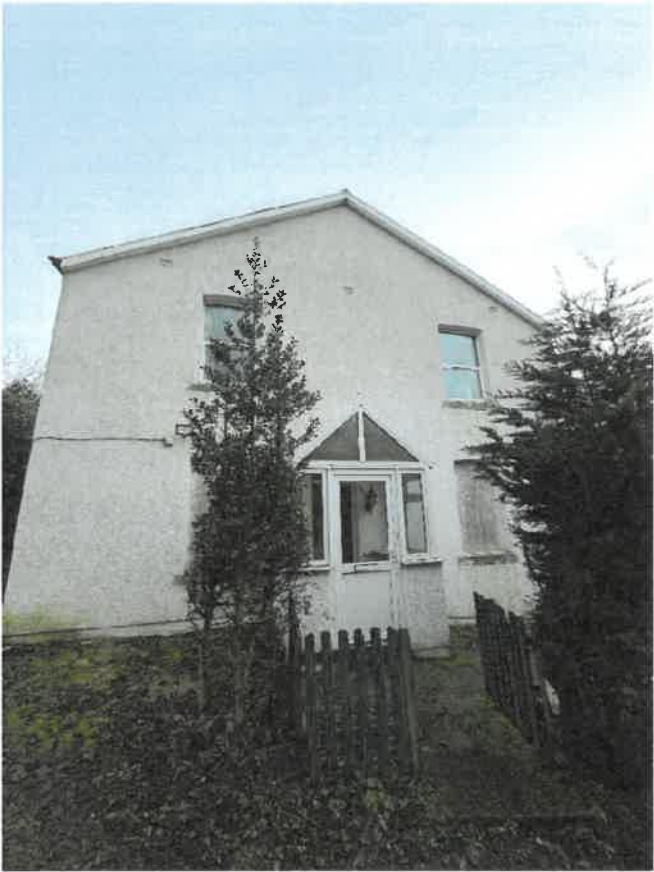
Photograph 2

**West-Facing Elevation (Photographs 1-4):** The principal elevation faces Clough Lane and presents as a rendered symmetrical gable with a centrally positioned entrance porch. The render appears to be a relatively recent application and was observed to be in very good condition, exhibiting no visible cracking or debonding. Window openings are symmetrically arranged at both ground and first-floor levels. These have stone cills and arched heads. The latter likely a brick arched soldier.

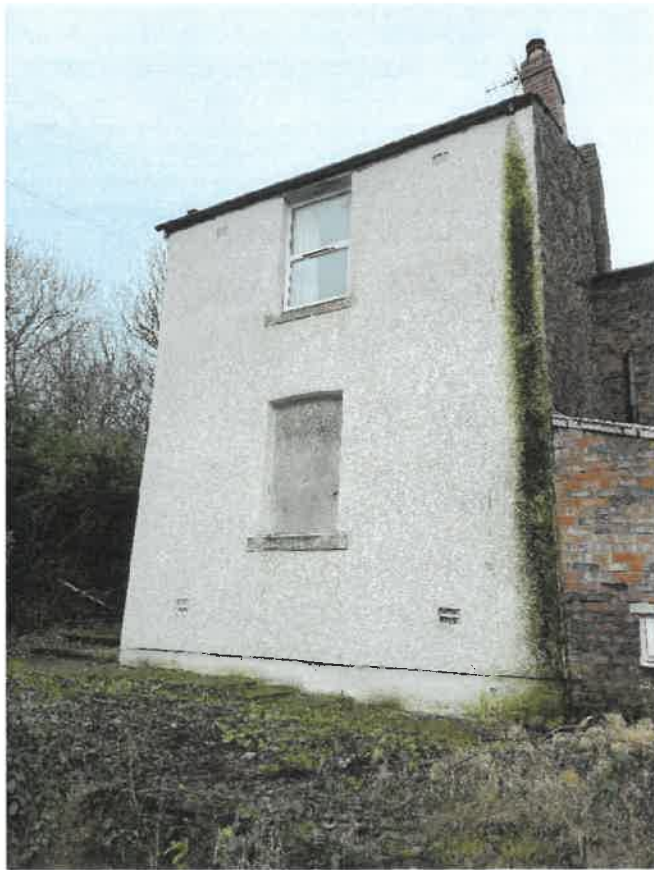
Photograph 19

South-Facing Elevation – Main Building (Photographs 18 & 19): The rear elevation of the principal dwelling is rendered. The render is in very good condition and free from cracking, suggesting the underlying masonry is also largely intact. Green staining is evident toward the right-hand corner, attributed to the absence of effective rainwater drainage.

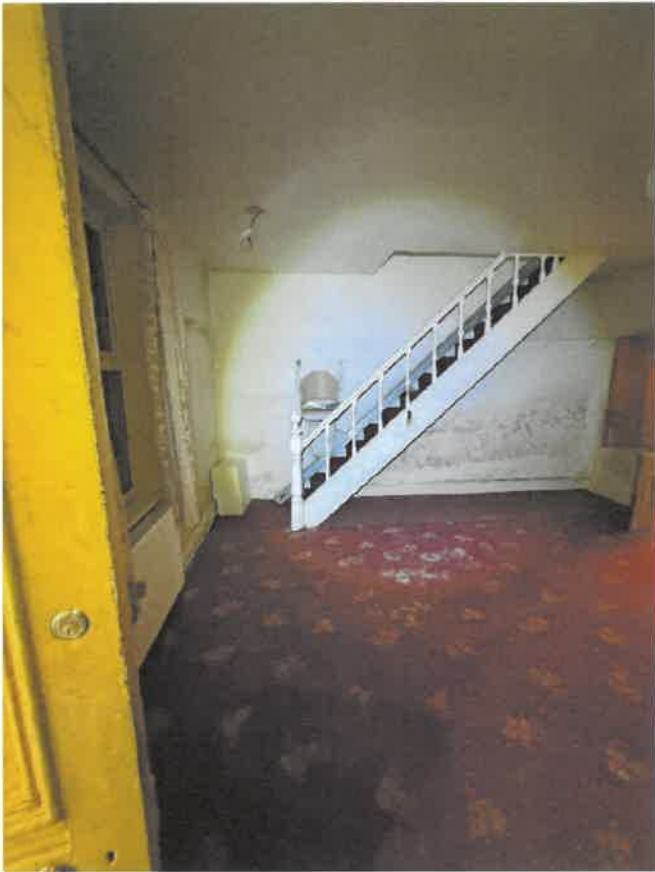
Photograph 53

Ground Floor – General Arrangement: Access is gained via the front entrance porch into a reception / dining room (photograph 51) positioned at the North of the property. This room contains a chimney breast located within the internal wall (photograph 52) and a timber staircase rising left to right against the north-facing elevation. (Photographs 53).

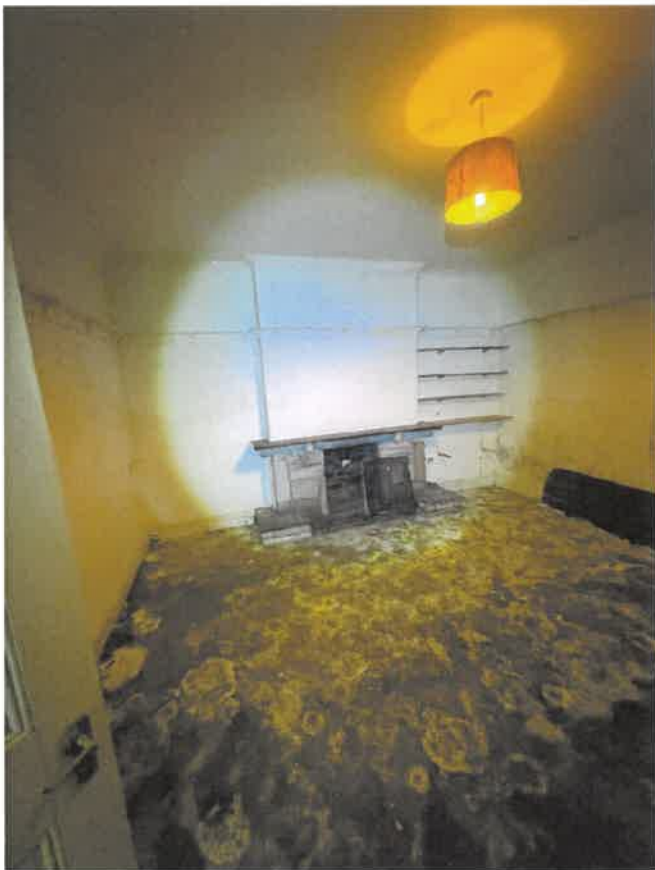
Photograph 55

Lounge (Photographs 54 & 55): The lounge is located to the rear South of the property and incorporates both left-facing and South-facing windows, providing dual aspect daylight. A chimney breast is located against the right-hand side wall.

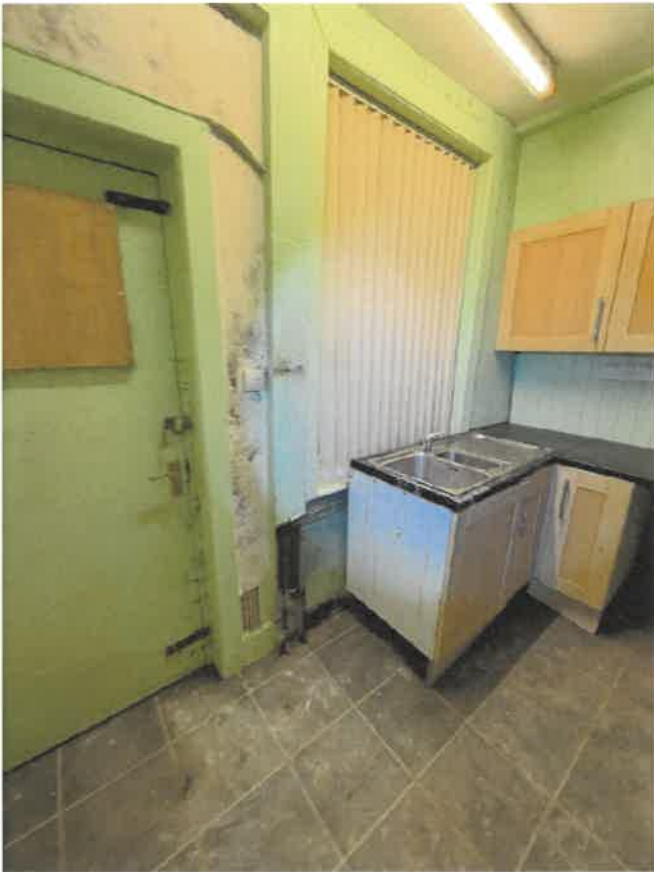
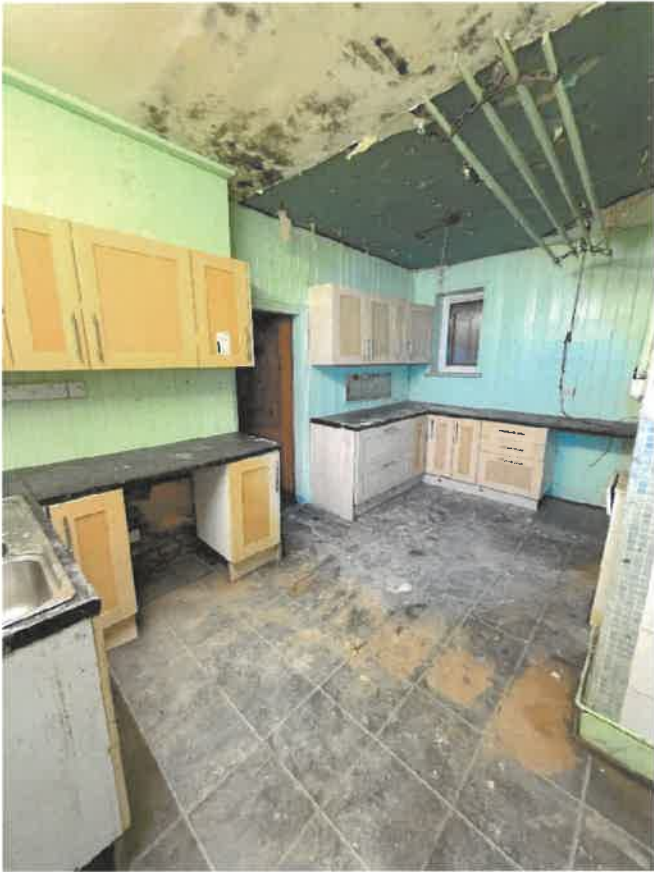
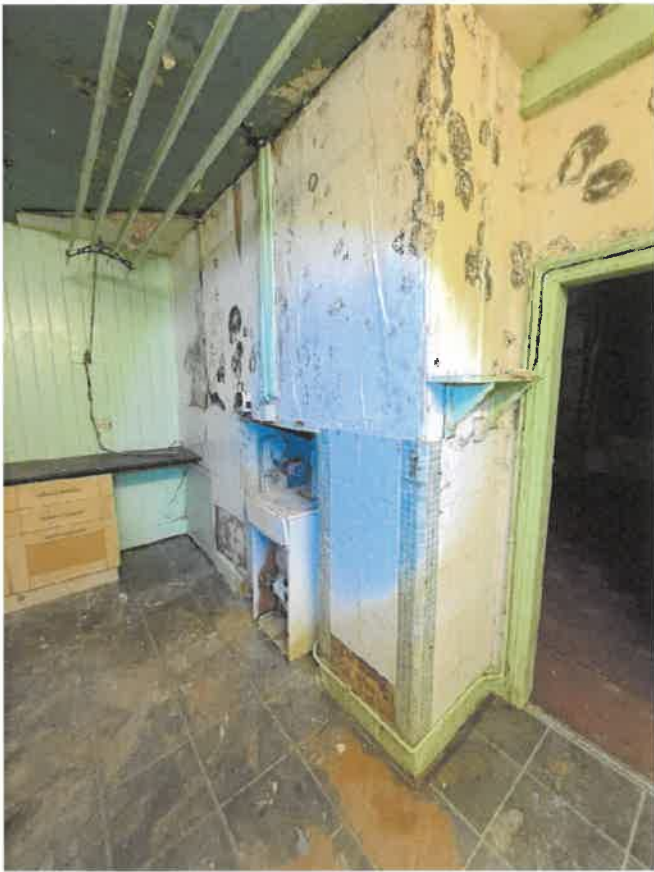
Kitchen (Photographs 56 – 59): The kitchen is accessed from the reception / dining room and contains a large chimney breast along the left-hand wall, separating it from the reception space. The room incorporates North and South-facing windows together with a forward access door. A further door provides access to a store and WC.

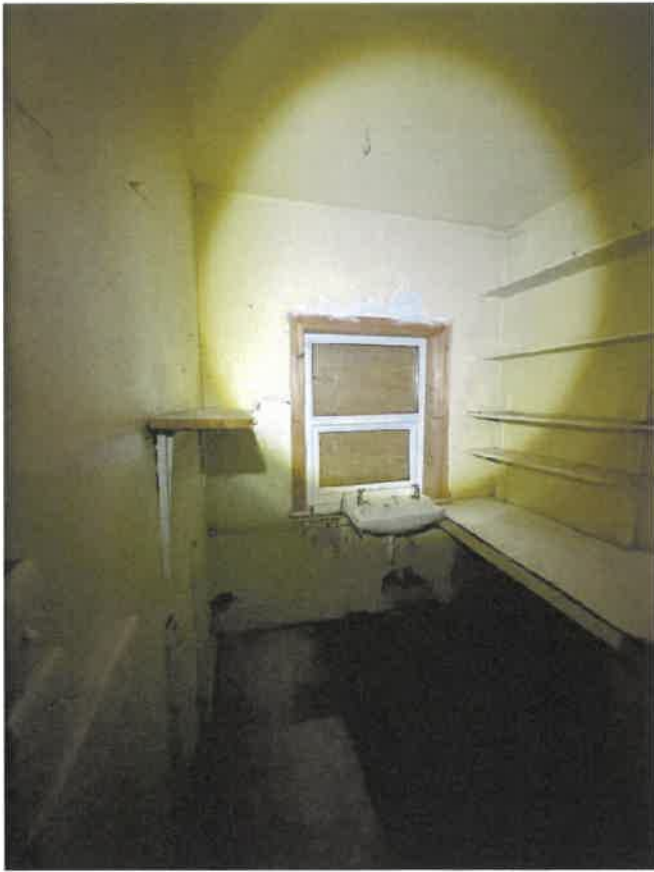
Photograph 60

Store and WC Areas (Photographs 60 – 63): The storeroom and WC occupy the far right-hand side (East) of the property. These spaces include north and south facing windows. Walls and ceilings exhibit cracked plaster finishes throughout, i.e. failure of finishes probably due to damp.

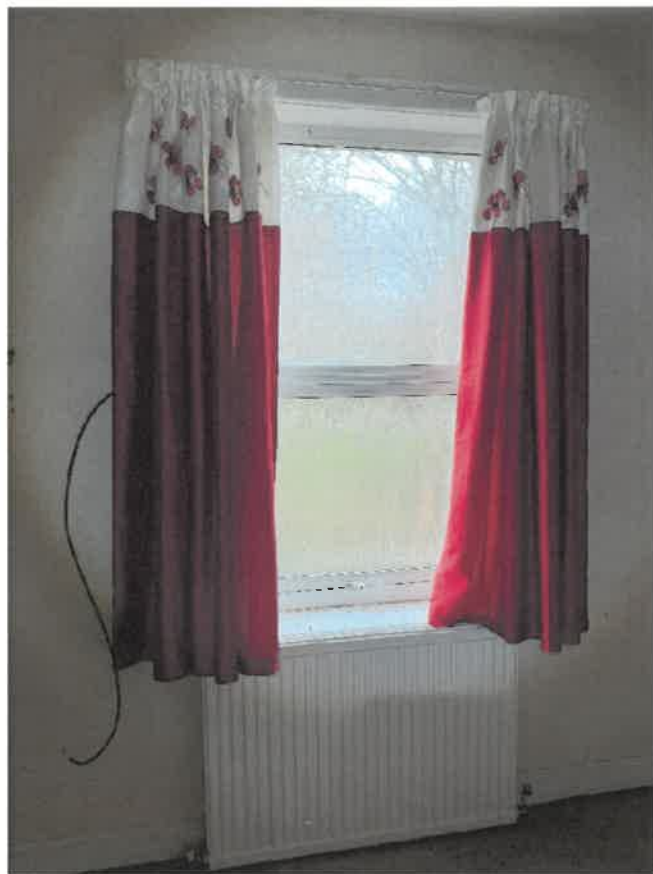
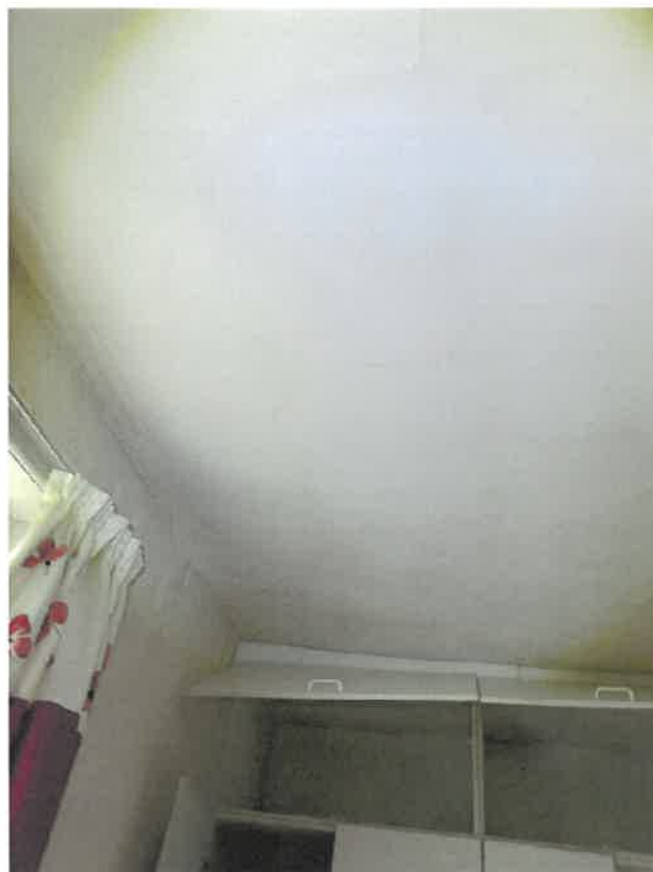
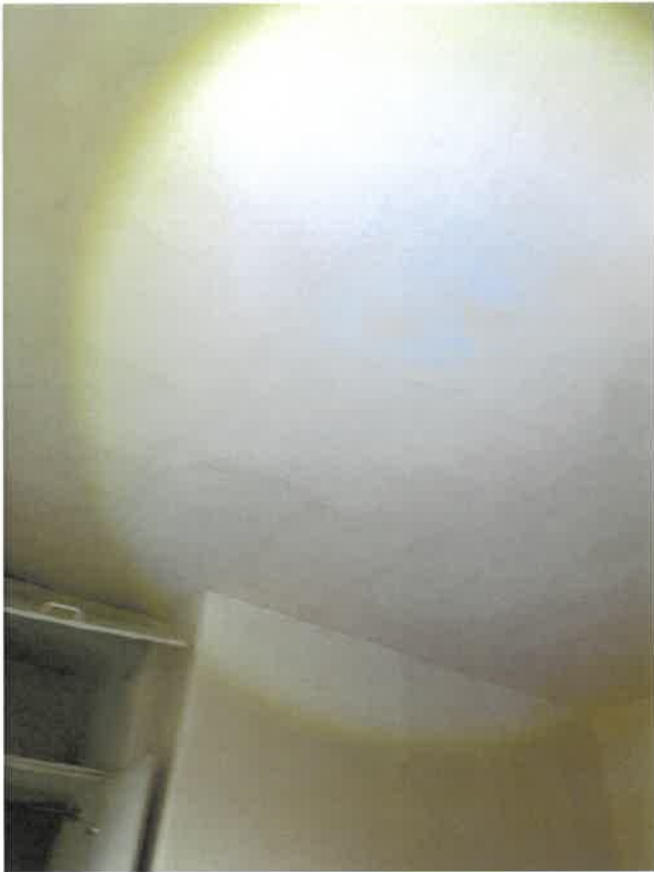
Bedroom 1 (Photographs 65 – 69): Located at the front North-West corner of the property, incorporates suspended timber flooring. The left facing window opening exhibits slight falls consistent with historic settlement in a North to South direction.

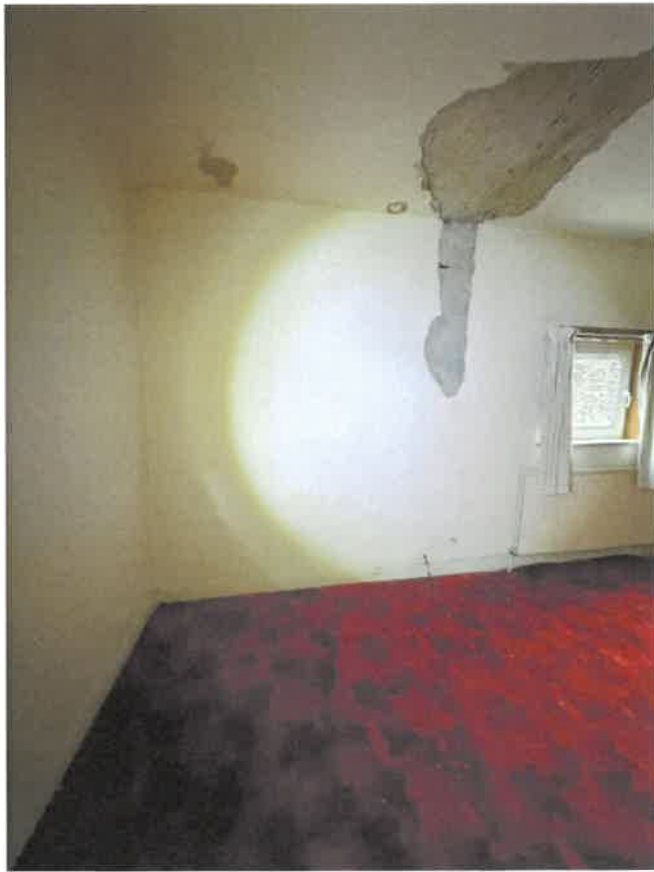
Bedroom 2 (Photographs 70 – 72): Bedroom 2 is located toward the right-hand (East) side of the property and is accessed via a small internal lobby. (Photographs 73 & 74). The room incorporates suspended timber flooring and is served by the rebuilt east-facing gable. The ceilings are suffering from partial collapse.

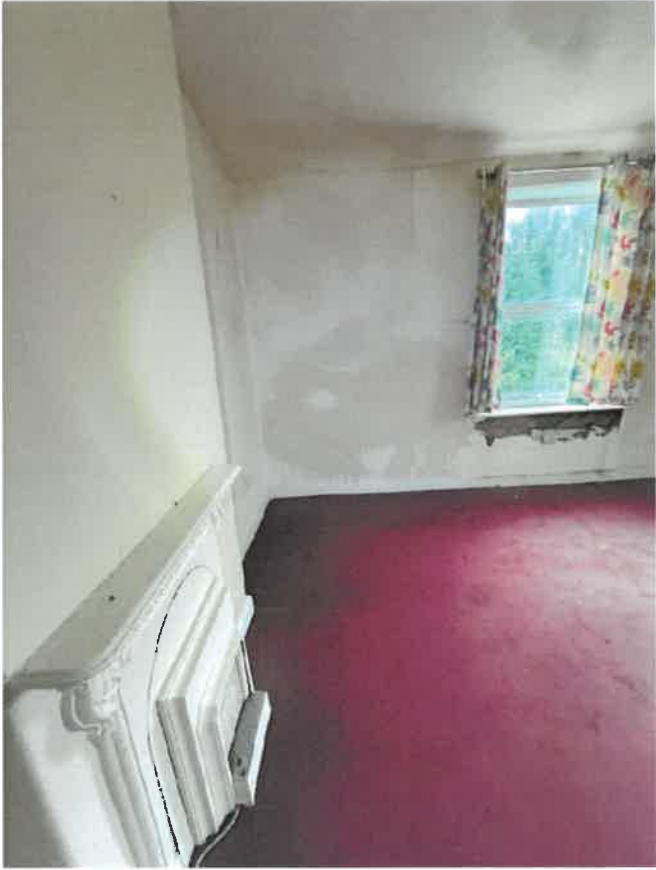
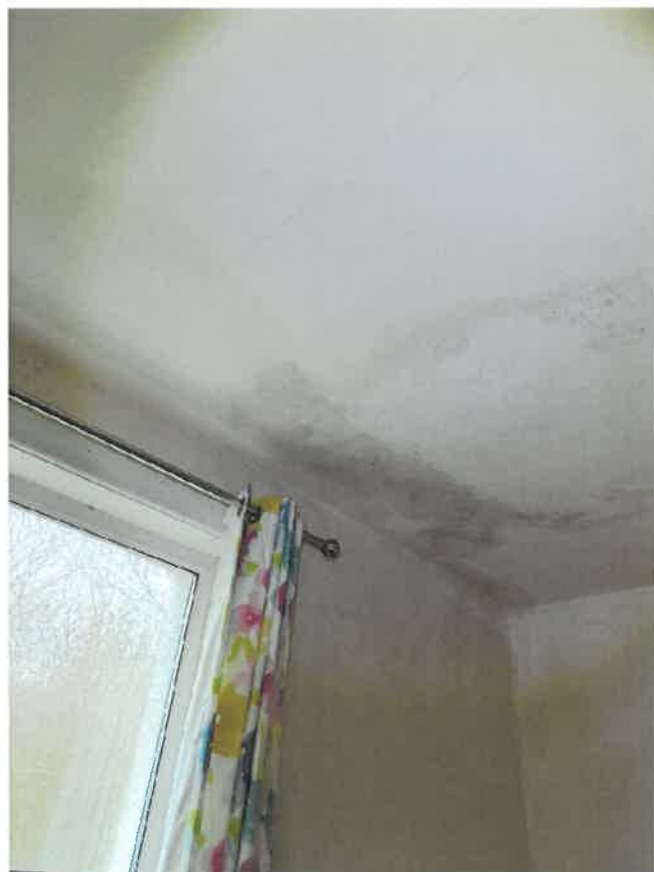
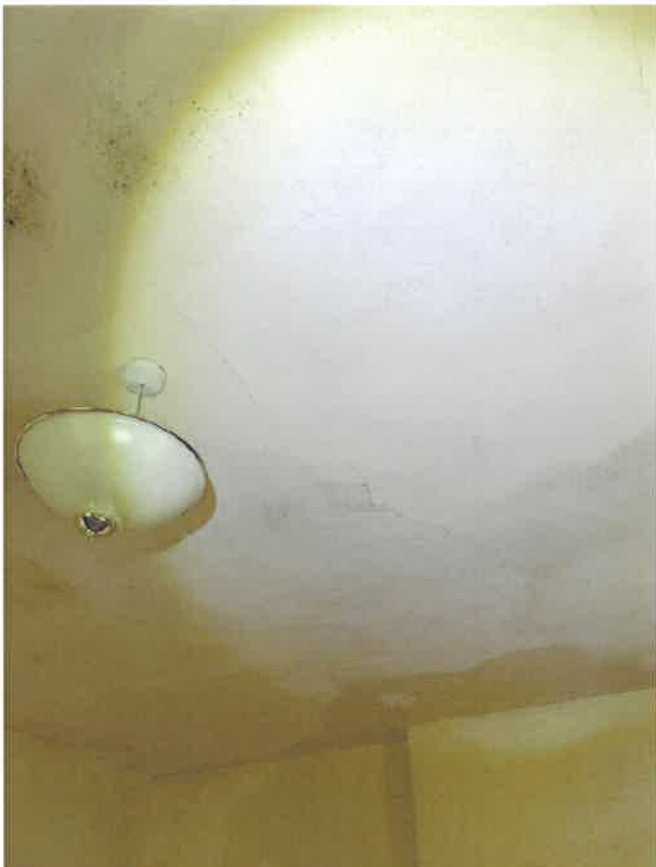
Bedroom 3 (Photographs 75 – 85): Bedroom 3 occupies the south-west corner of the property and incorporates west-facing and South-facing windows together with a chimney breast on the right-hand wall. A slight vaulted ceiling is present along the South elevation, reflecting the underside of the roof slope, presumably uninsulated. There is damp staining evident, collapsed plaster finish beneath the South facing window cill and a crack north of the chimney breast. (Photograph 79). Ceiling cracking is commensurate with ceiling joists exhibiting excessive sagging distortion.

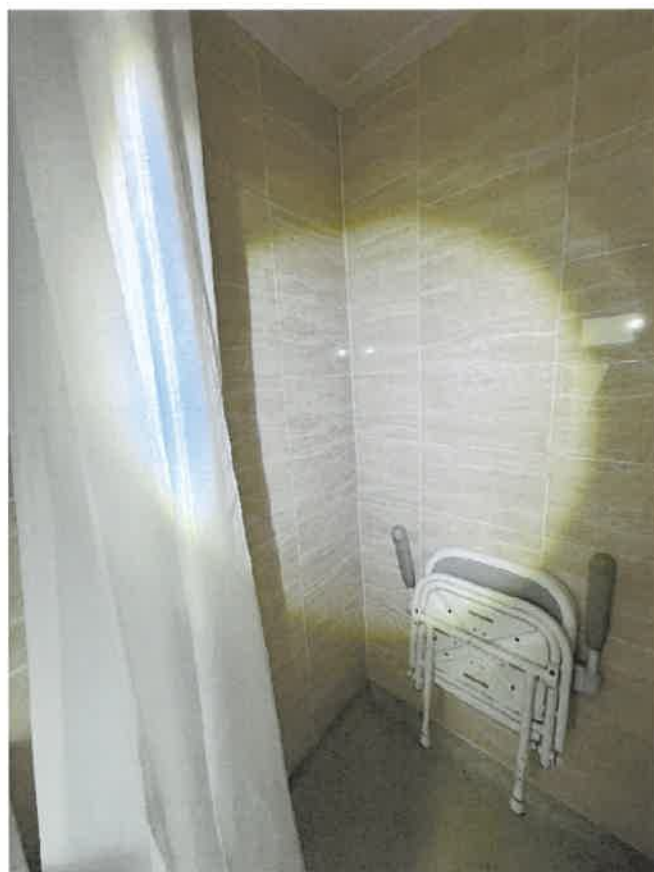
Photograph 88

Bathroom and WC (Photographs 86 – 89): The bathroom is located centrally along the north elevation at first-floor level and is finished with ceramic wall tiling. The main bathroom walls are free from cracking at the time of the survey.

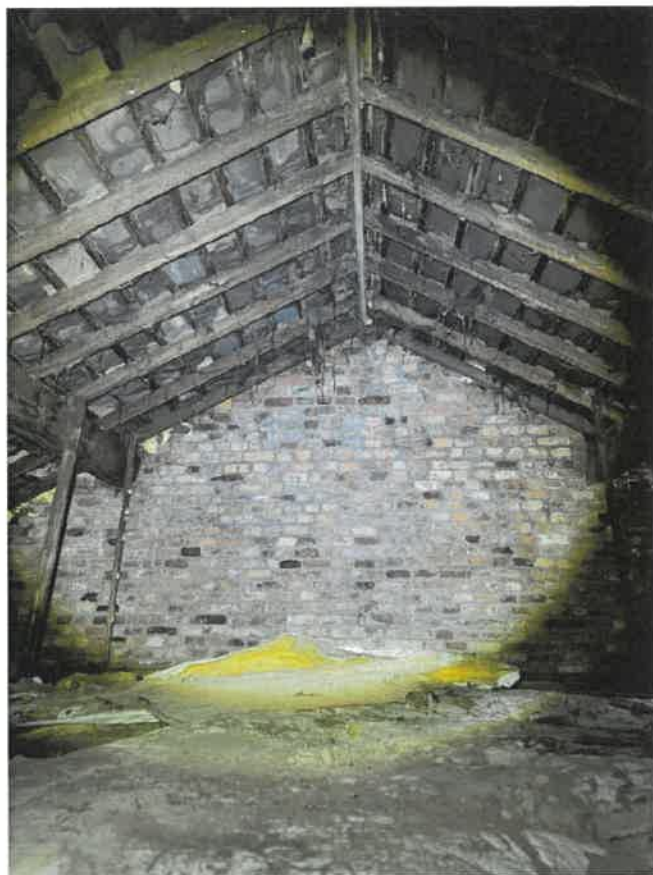
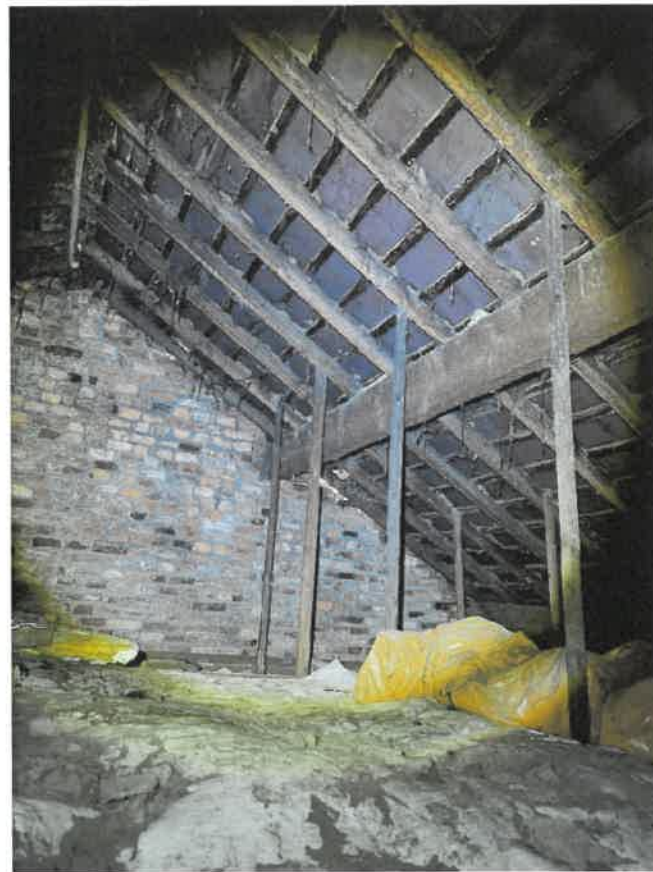
The roof structure (photographs 90 – 95) is of traditional form with a nominal ridge board and reliance on ceiling joists for restraint. Although the roof space appeared relatively dry at the time of inspection, the combination of roof sagging, chimney instability, lack of under-slate membrane, and internal damp staining indicates that comprehensive roof reconstruction would be required. There were a few areas of the roof where daylight was visible.
