# Contaminated Land Phase Three Report; Validation of Remedial Works undertaken in Relation to potential contamination for Proposed Residential Development at, Land adjacent 6 Bentley Lane, Bury, BL9 6RZ.

August 2025

## GeoShield Verification Report 001

PROJECT: Land Adjacent to 6 Bentley Lane

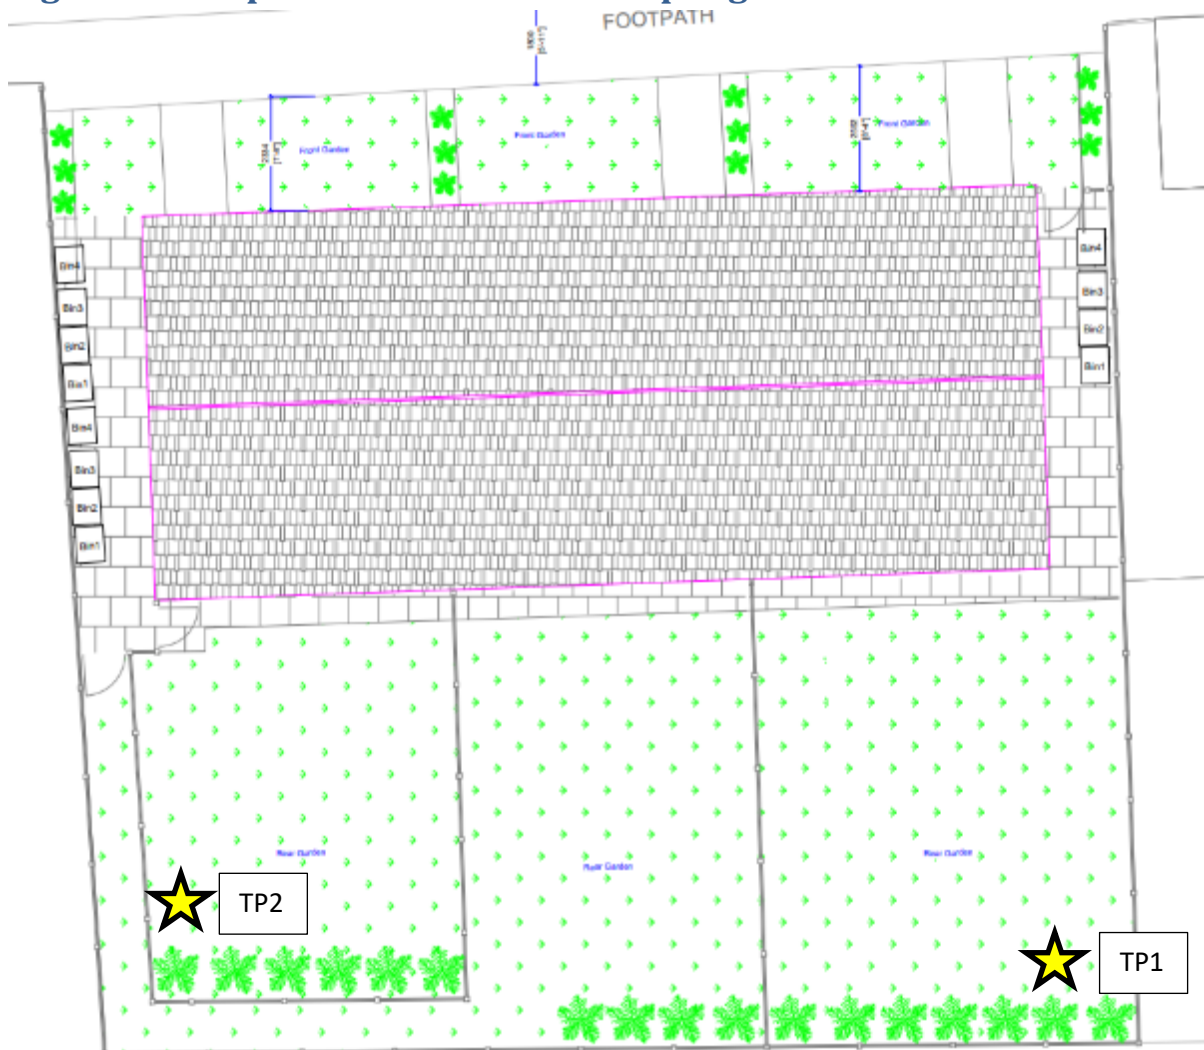
**Figure 2 – Proposed Site Plan and Sampling Locations**

An intrusive investigation was planned consisting of three trial pits across the proposed garden areas. Due to access issues and a wasps nest only two sample locations were possible on the day. Figure 2 details these locations at either end of the site.
