## **BUILDING SURVEY REPORT AND REPAIR STATEMENT**

### **LOWER CHESHAM HALL BURY**

**Dated June 2020**

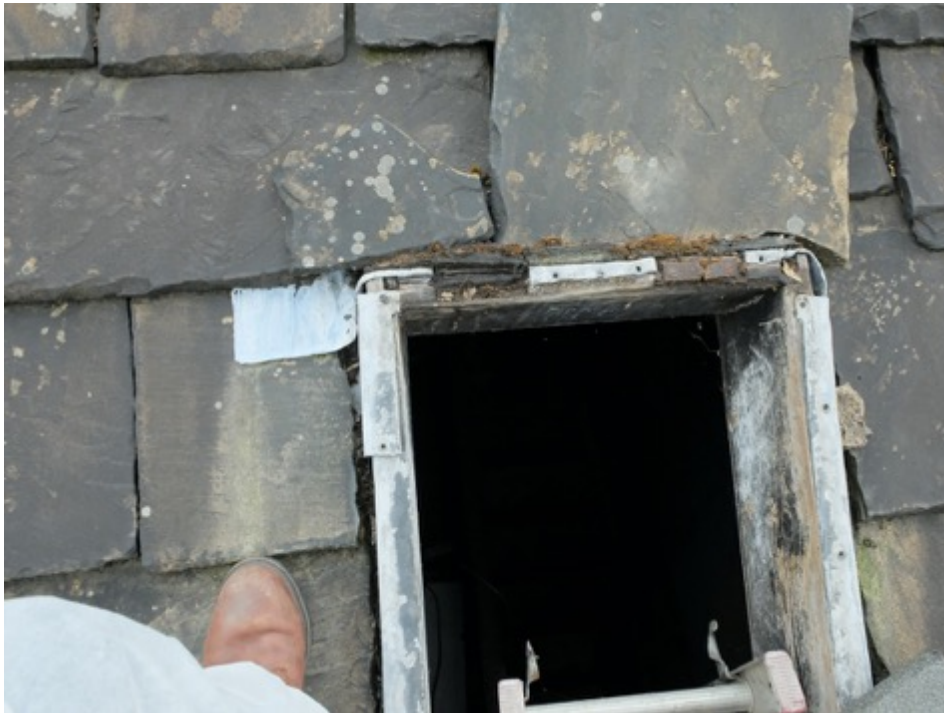
The access trap to the rear slope of the main roof was poor.

Photo, Access trap on to roof

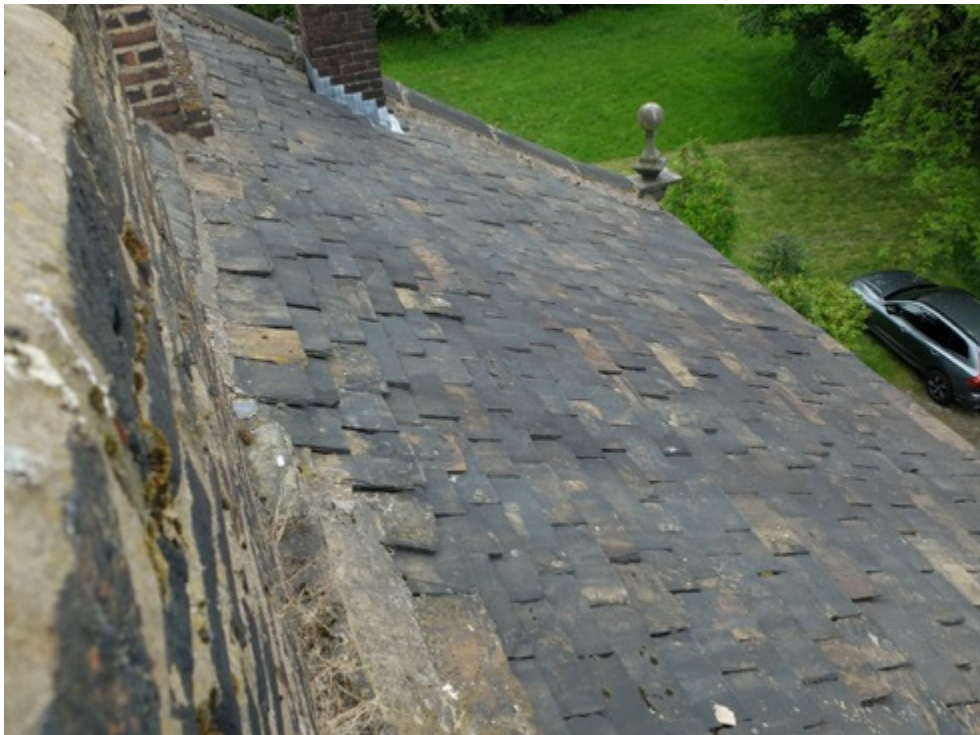
Photo, front slope

There is evidence of slipped broken and tabbed stone slates to both slopes.

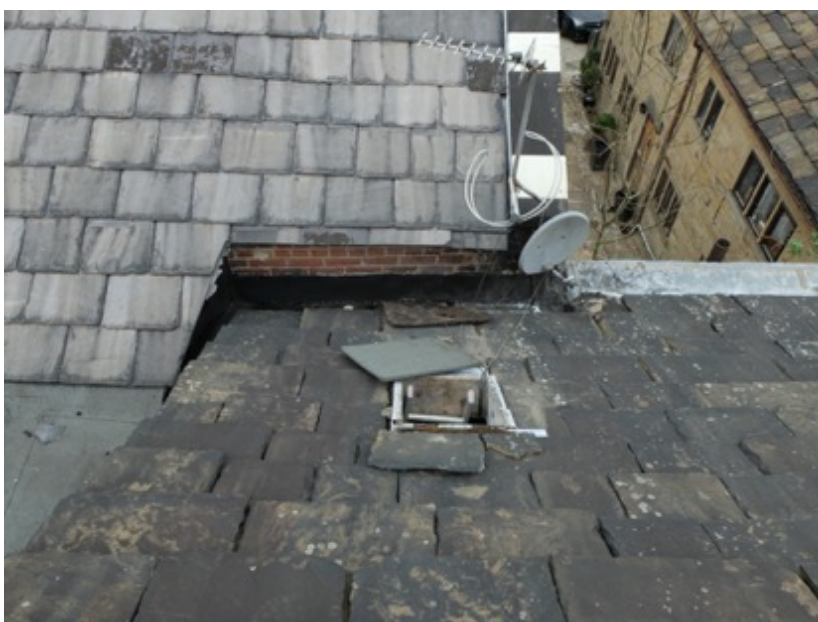
Along the rear left section of the gutter the eaves detail changes to a lead parapet gutter where a section of newer building has been constructed. The lead work appears to be overlaid with a type of paint or bituminous material. There are no visible joints of drips within the lead.

Photo, abutment with rear building

It was noted that rear gutter services the main rear slope roof and flat roof of the adjoining building, however, there is no visible rainwater outlet to any sections of the gutter. The rainwater appears to flow over the stone gutter and down the rear elevation walls.

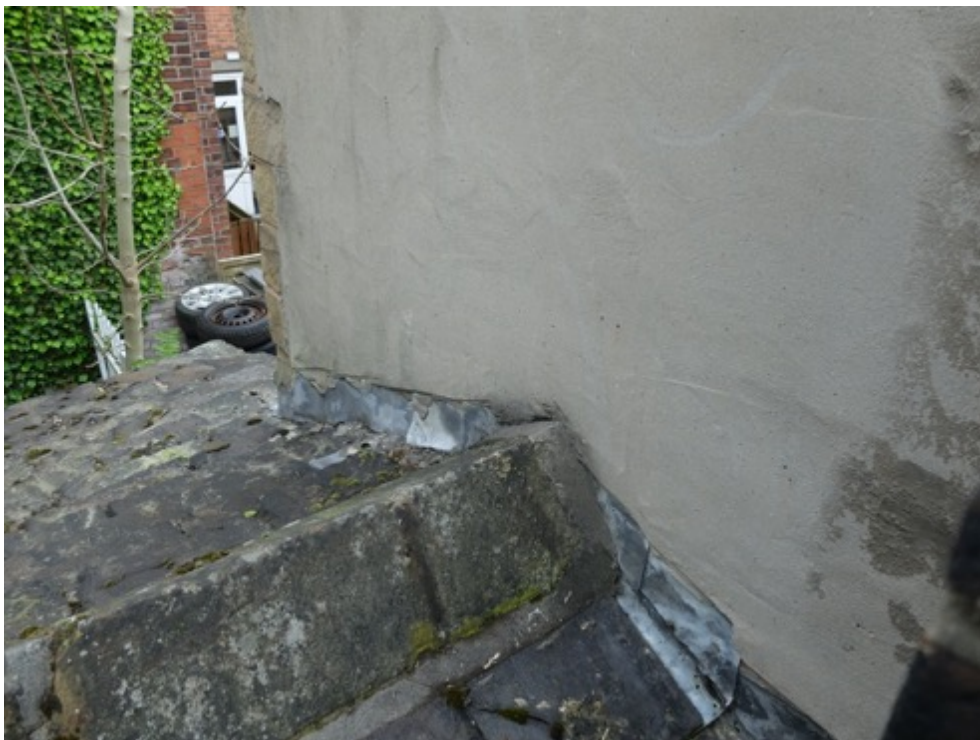
Over the dining room, the roof is pitched and overlaid with stone slates at a pitch of approximately 20°. This appears fair however the lead and render abutment detail with the cottage is poor.

Photo, poor abutment detail with rendered cottage building

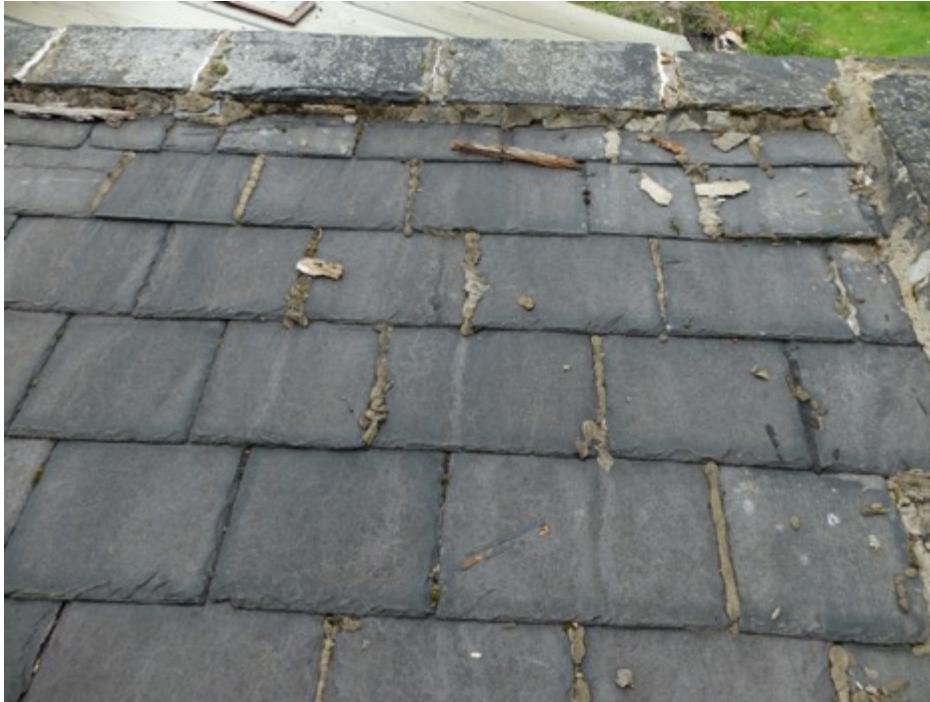
The pitched roof to the east slope is approximately 15° pitch and this is on the margin of the acceptable levels as the standard minimum pitch for slate is 20°. This may be contributory to the problems of water ingress.

Photo, east slope of roof

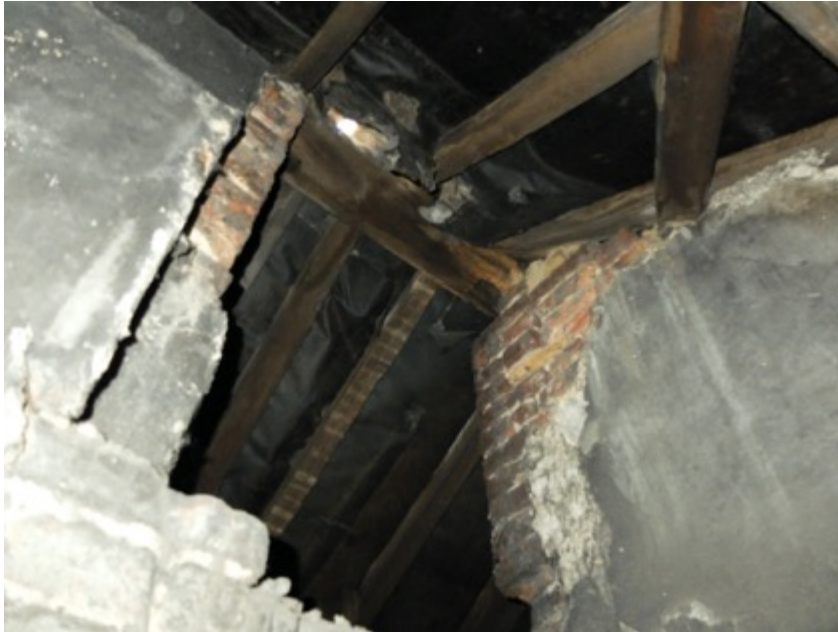
Photo, view of roof space

The roof appears to be under drawn with a bitumen impregnated roofing felt which indicates that some reroofing work had been undertaken, however, it is considered that this may have been done on a reactive basis doing one small area at a time as required to undertake a repair rather than a wholesale replacement.

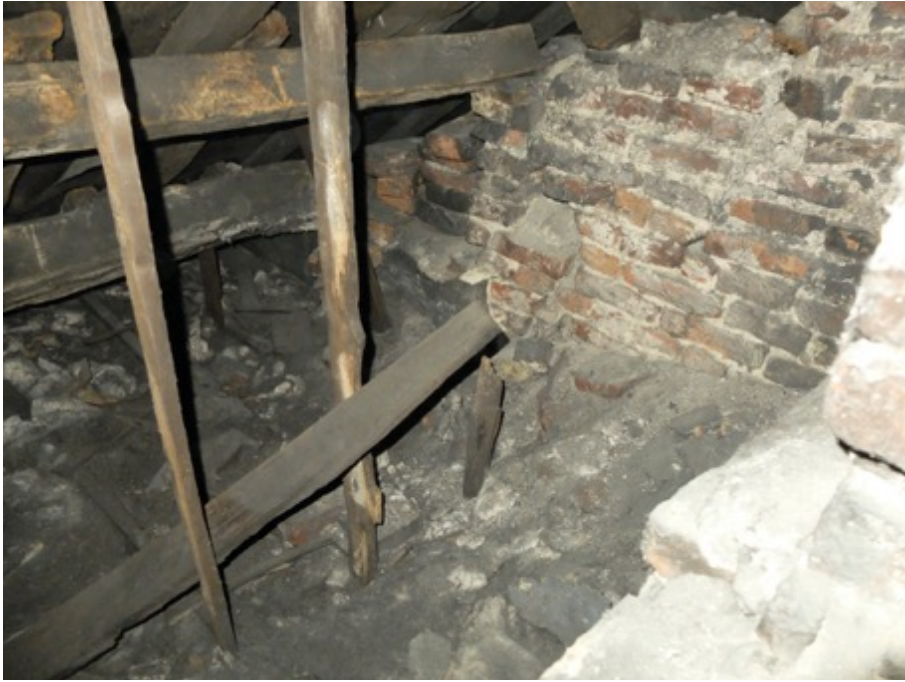
Where the purlins bear on the central wall the packing detail of brickwork is poor and there is evidence to suggest that sections may have slipped and moved over time.

Photo, debris on ceiling and poorly packed purlins on spine wall.

There is considerable debris and other materials to the topside of the ceiling. This is likely to be the lime mortar parging which will have been disturbed and allowed to fall onto the ceiling when the building was reroofed. This is heavy and will require removal.

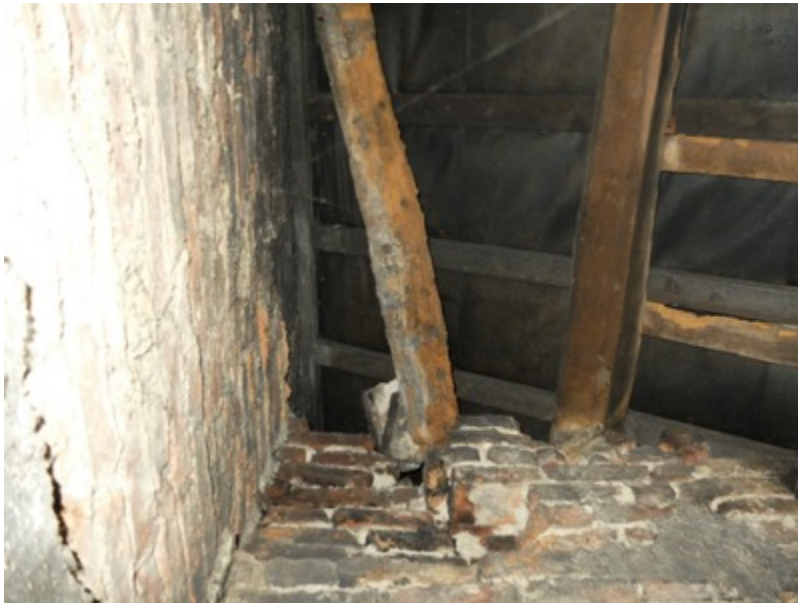
In the roof space above the rear right room there is an oak ridge piece which is thought to have supported the ends of the rafters where they used to abut the chimney. This is balancing precariously between two masonry walls and requires removal before it falls onto the ceiling. This piece has peg holes indicating that the original rafters would have been oak pegged into the purlins.

Photo, old oak ridge requires securing

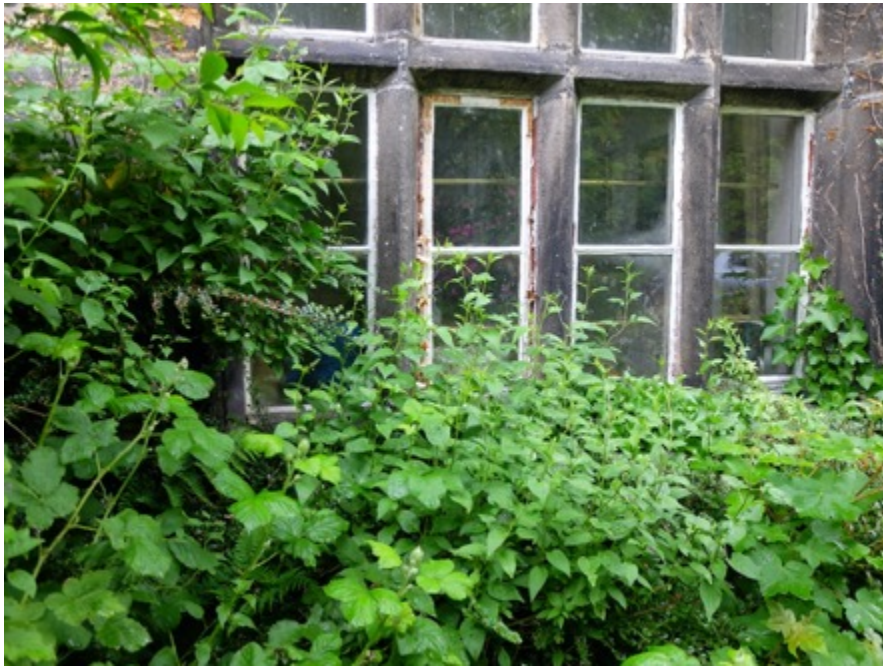
it was difficult to view the low-level sections of the walls due to the level of plant and weed growth around the building. This growth is being fuelled by the water flowing over the gutters.

Photo, overgrown at base of walls

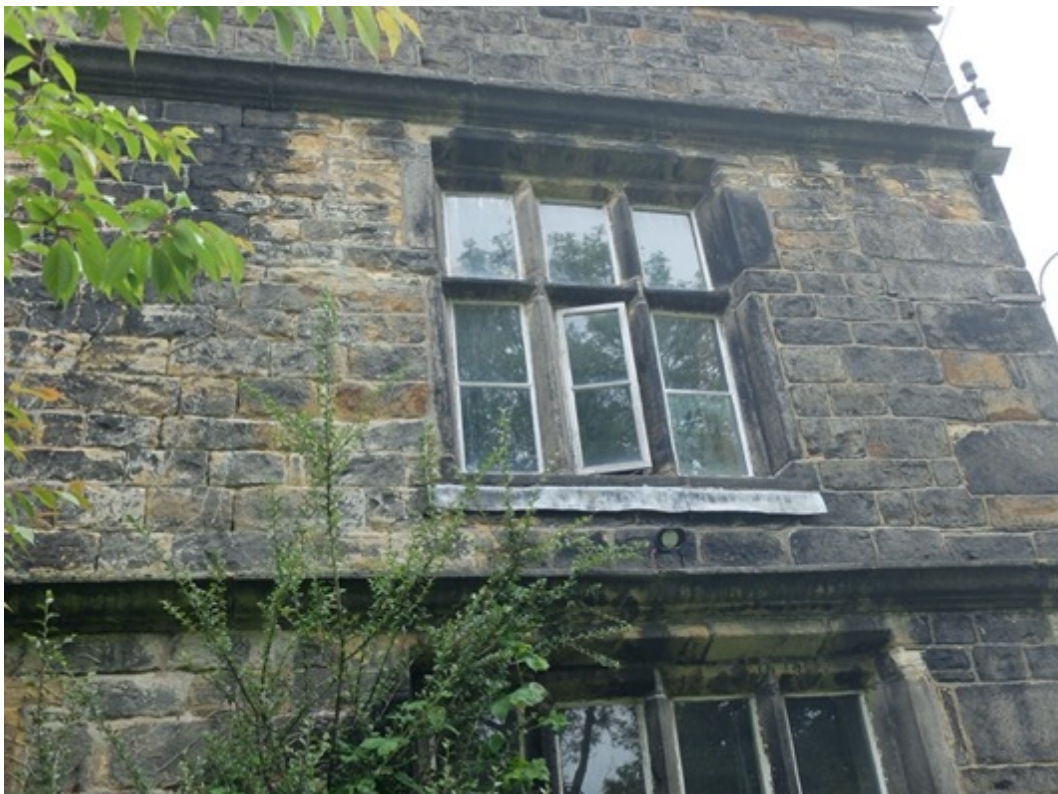
There was widespread evidence of sand and cement pointing.

Sections of lead work had been inserted to beneath sill positions this would have been done as a measure to improve the water tightness of the wall beneath the window.

Photo, front elevation

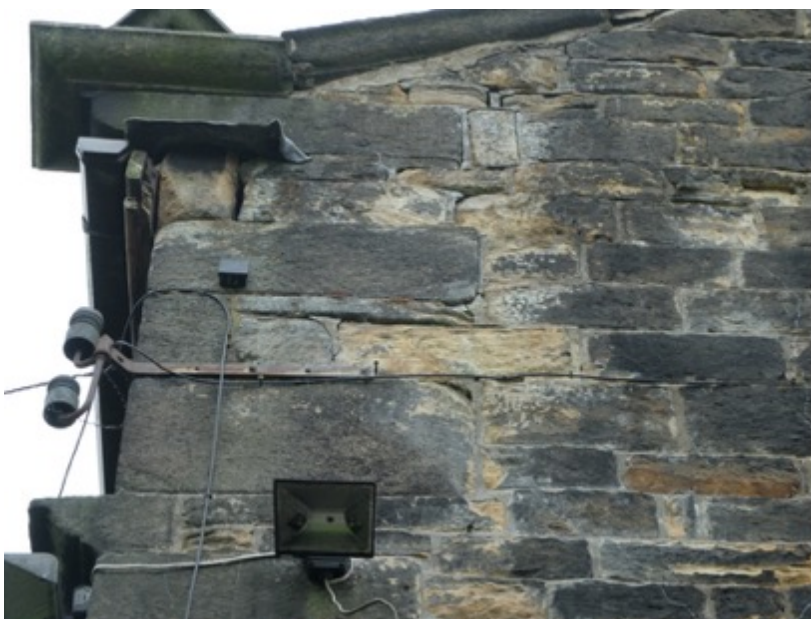
There is evidence of some outward movement at the kneeler positions to both the front and rear corners.

Photo, cracking and frost damage to front kneeler

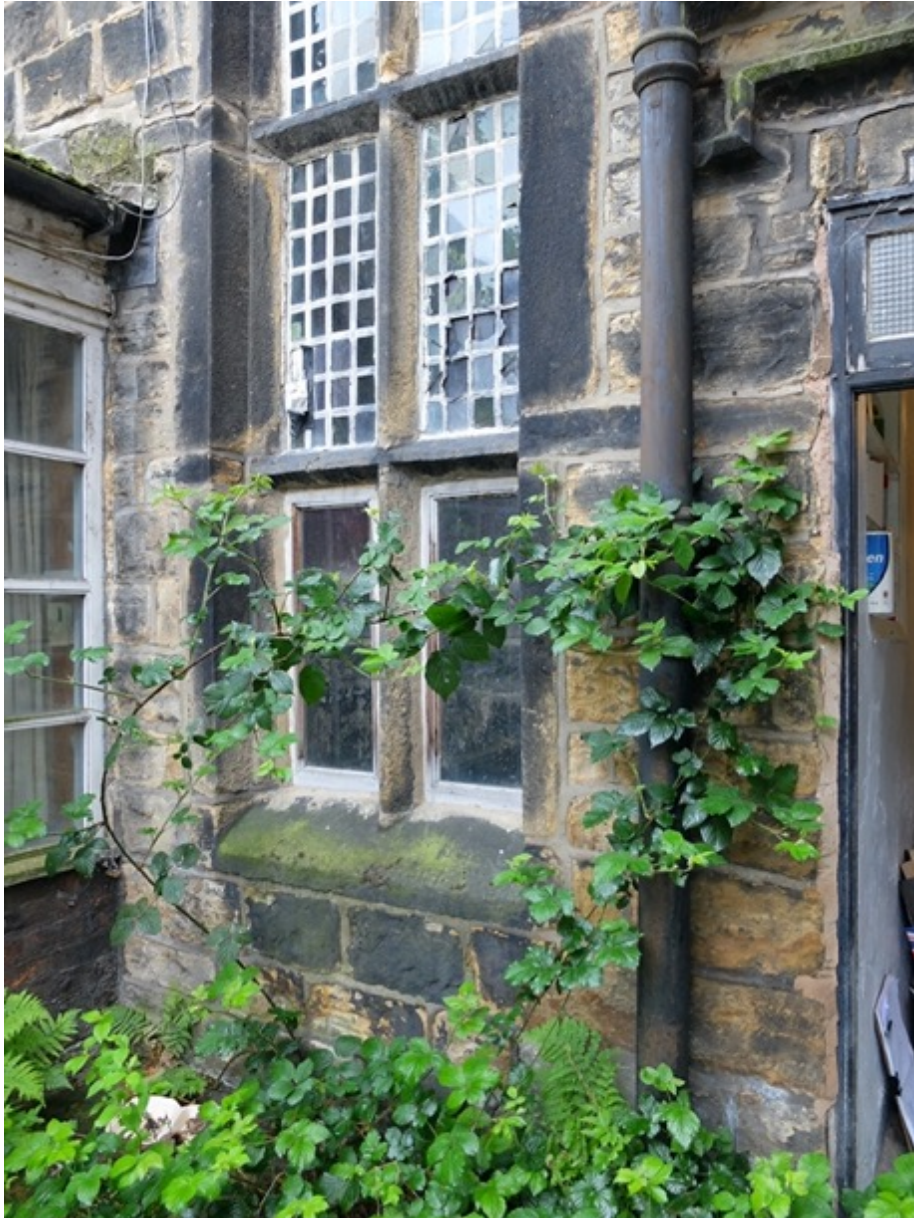
There is widespread evidence of sand and cement pointing. Some areas of stonework have been strap pointed.

It was difficult to view the lower sections of the wall due to the growth of weeds and other plants which is being fuelled by overflowing gutters at high level.

Photo, strap pointing and low level vegetation

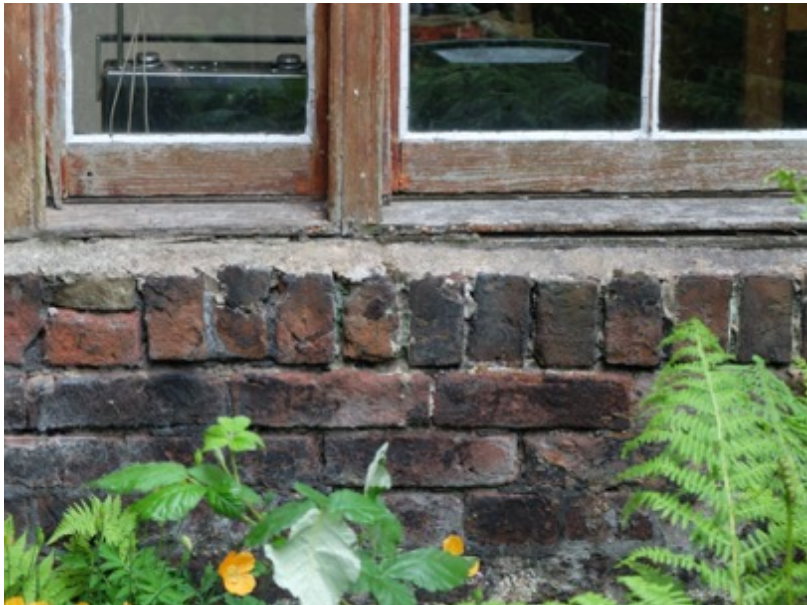
The sill detail to this windows is brick on edge which has been mortar parged and water will soak into the horizontal surfaces.

Photo, cill detail

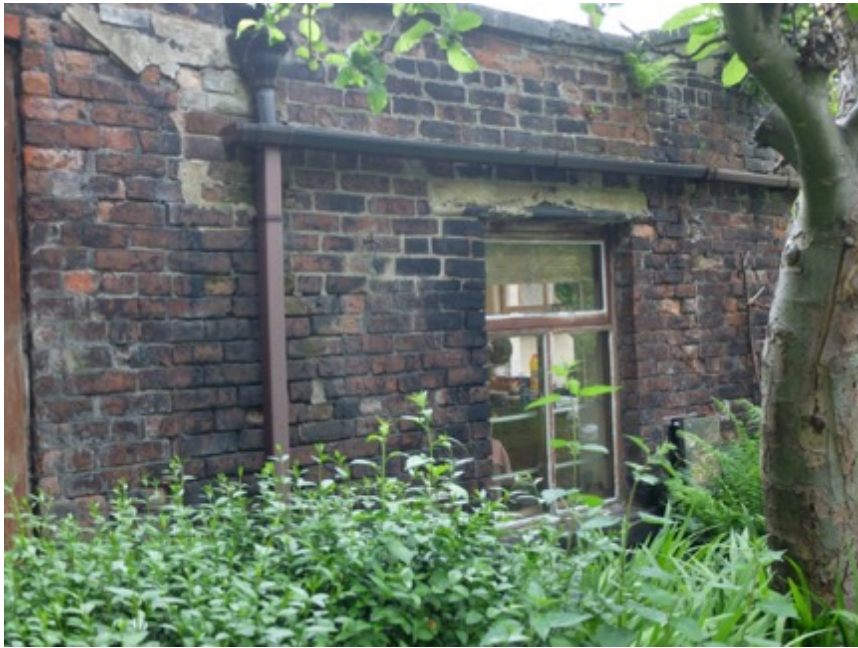
The left side window to the kitchen has a stone lintel which may be a piece of stone gutter salvaged from the front elevation.

Photo, window with salvaged stone lintel

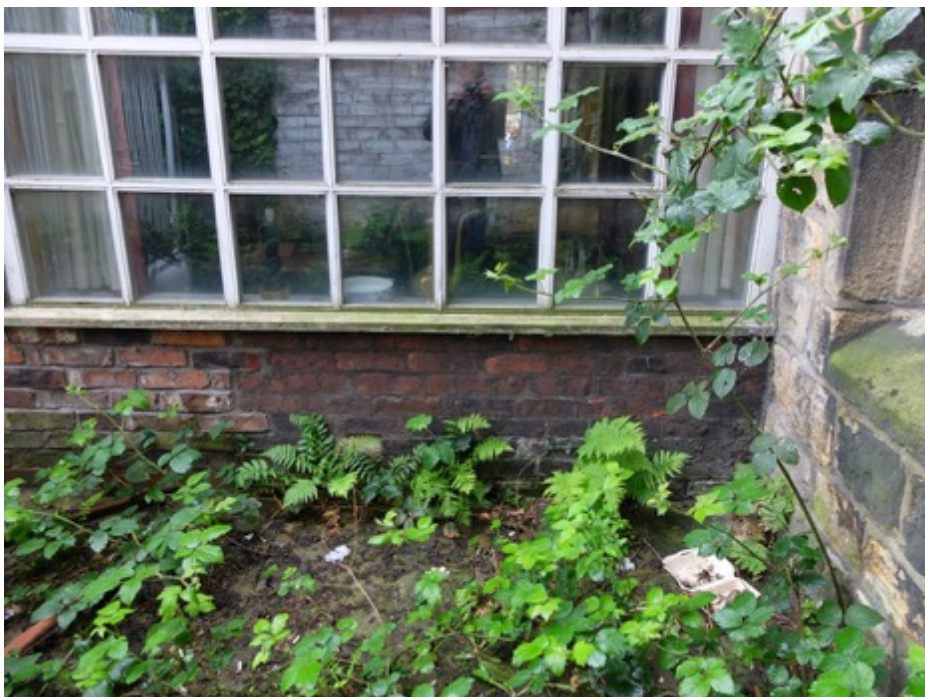
This is a small wall below a large timber window which has been constructed in old and new brickwork. The walls appear to have been repointed using sand and cement. The toothing-in between the old and new brickwork is poor.

Photo, old and new brickwork

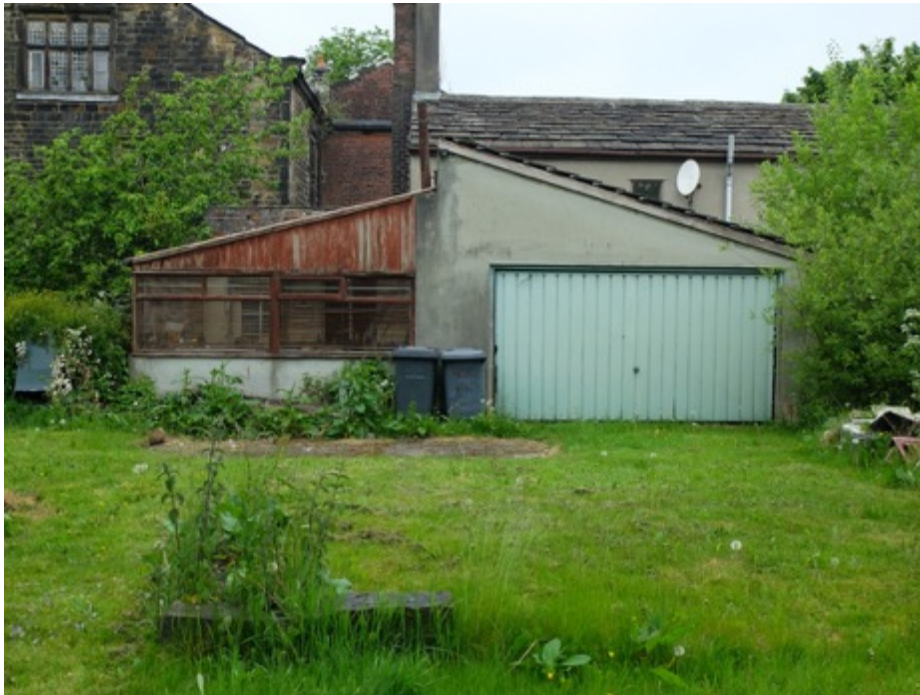
Photo, east elevation

At high level there is considerable frost damage to the roof parapet wall which extends over the roof to the workshop. This is constructed in original brickwork and is capped with a rough York stone coping. The mortar repointing would appear to be too hard for the porosity of the brick and is accelerating damage and decay.

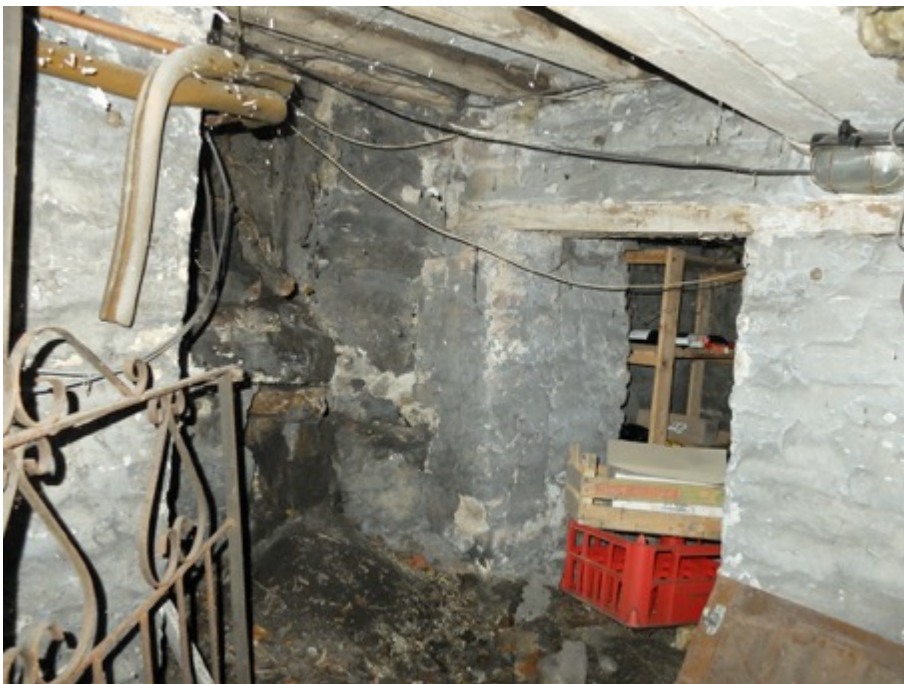
There is concern regarding the bearing ends of timbers which are in contact with walls.

Photo, part view of cellar

Timber props have been used to provide extra support to the floors. The bases of the props are in contact with the cold damp floor and will be prone to timber decay.

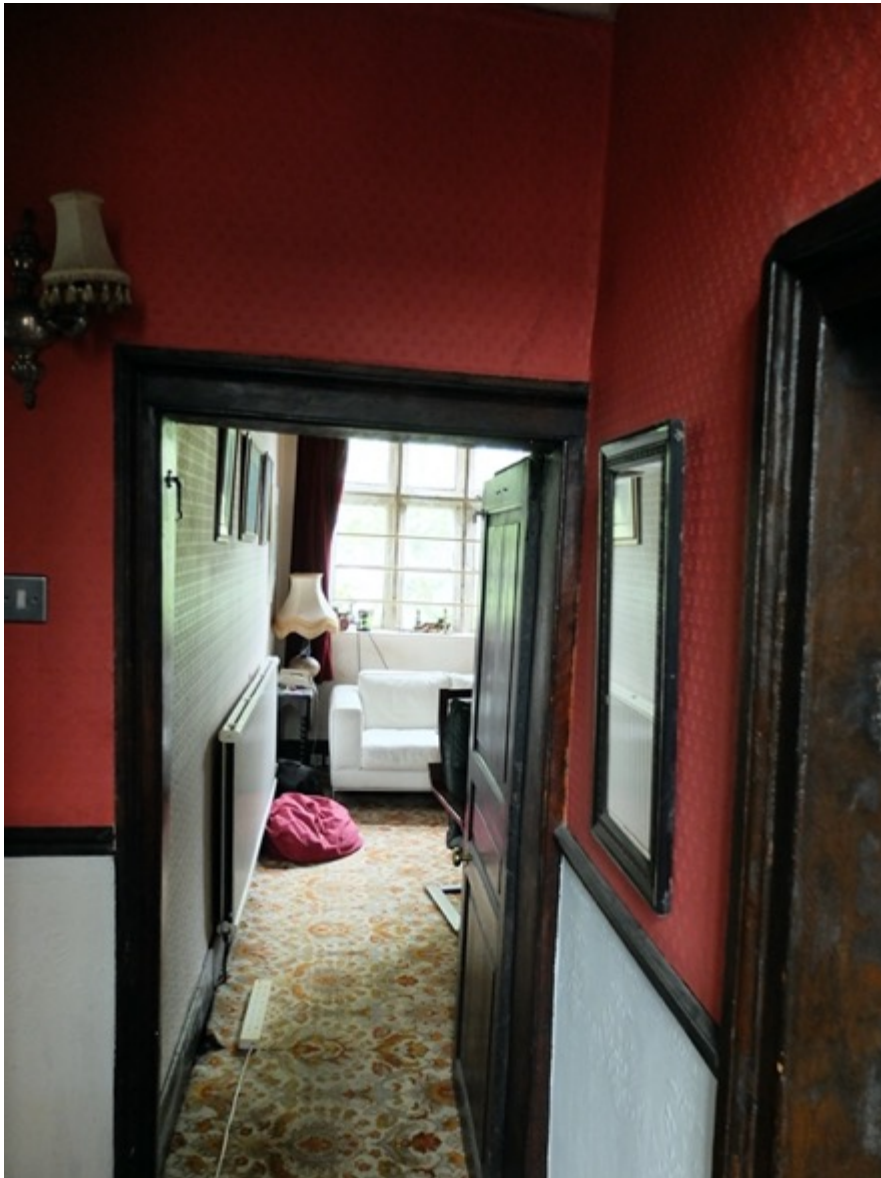
The walls would appear to be hard plastered on masonry overlaid with heavy decoration. When looking from the stairs there is some deflection within the door head to the door of the lounge. This indicates possible settlement to this wall which is likely to be historic.

Photo, door casing head out of plumb

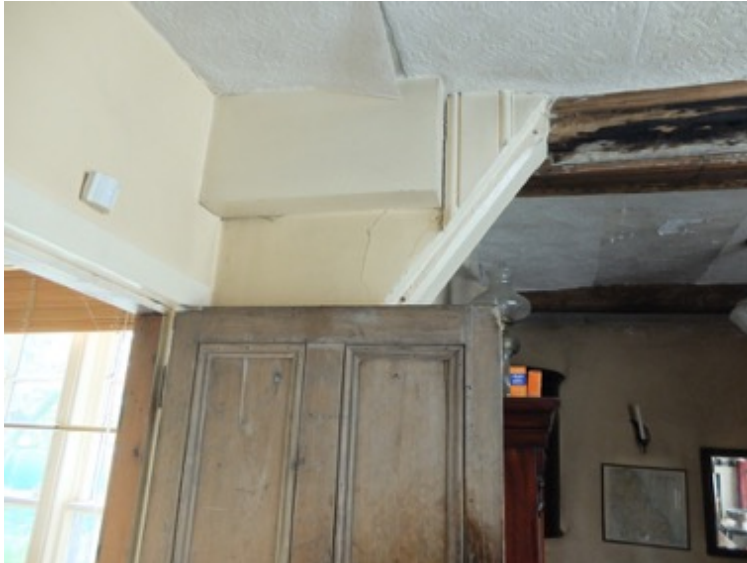
Photo, cracking and brace to other side of beam

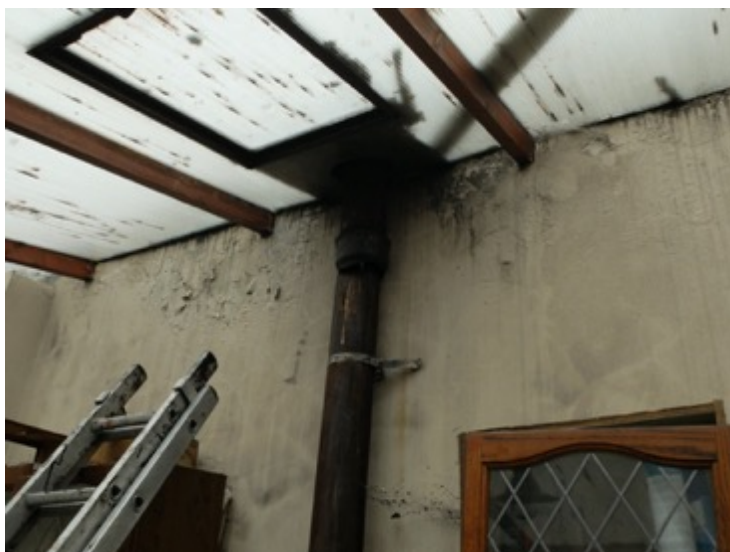
The ceiling /roof above would appear to be Perspex roof sheeting which is fixed directly to timber purlins. This was noted to be leaking in particular at roof abutments and had been temporarily repaired using flash band.

Photo, leaks from ceiling

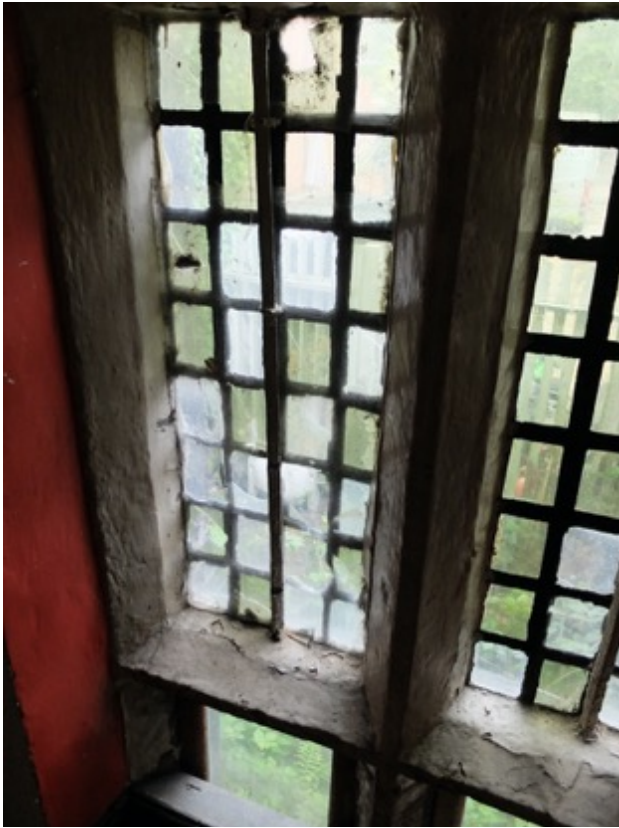
There is a large stone mullioned window which extends the height of the staircase on the rear elevation. The stone window components have been painted. This will restrict evaporation of moisture and will encourage deterioration.

Photo, mullioned window poor condition

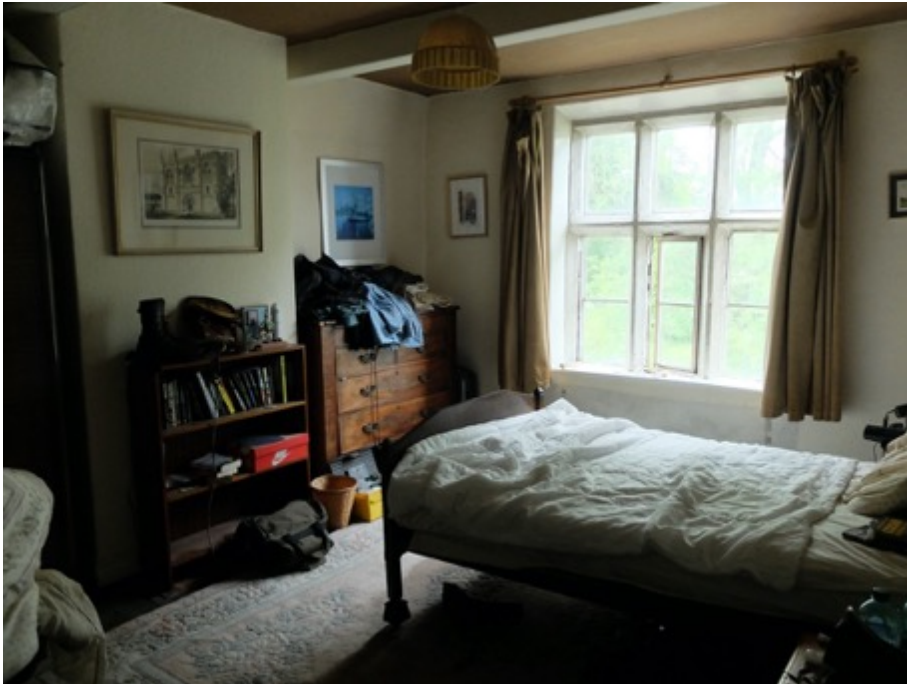
#### 4.11.11 Front right bedroom

Observations were restricted by stored items.

Photo, front right room

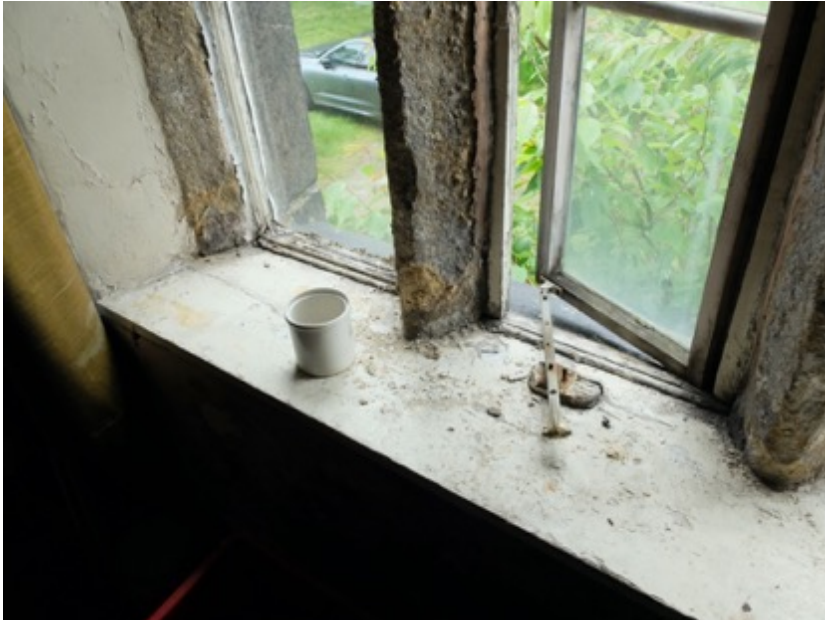
There is some visual deterioration to the stone mullions, this will be due to the level of water ingress in this location. Sections of the stone mullions have been dressed to open up the grooves to facilitate the introduction of timber windows.

The condition of the timber sashes is poor.

Photo, timber sashes

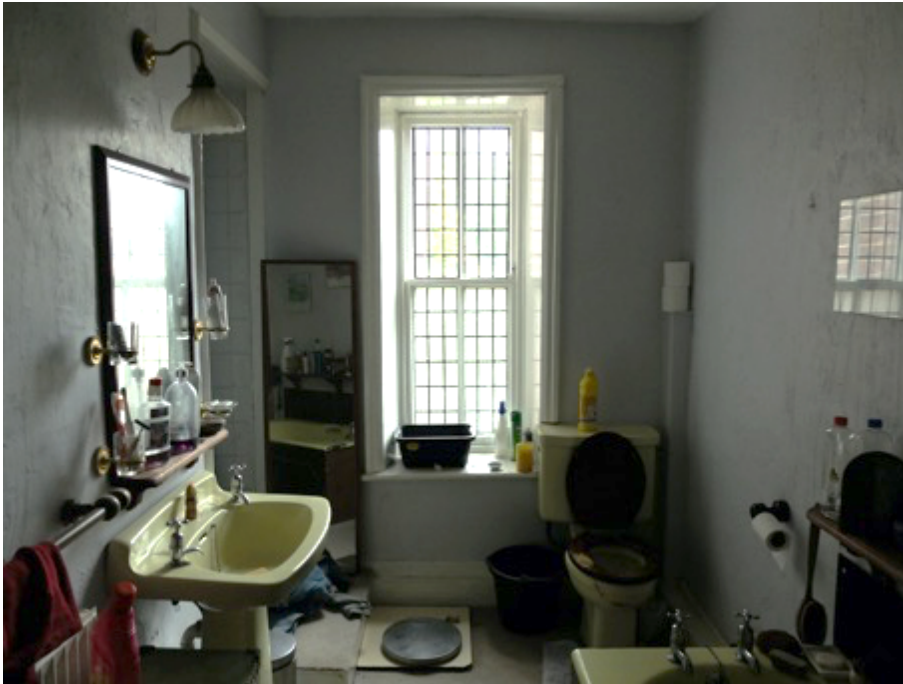
#### 4.11.13 Bathroom

Photo, bathroom

The walls would appear to be hard plastered however there is a lightweight wall to the left-hand side which hides the staircase to the second floor. This has been part removed to facilitate the introduction of a shower to the rear left corner.

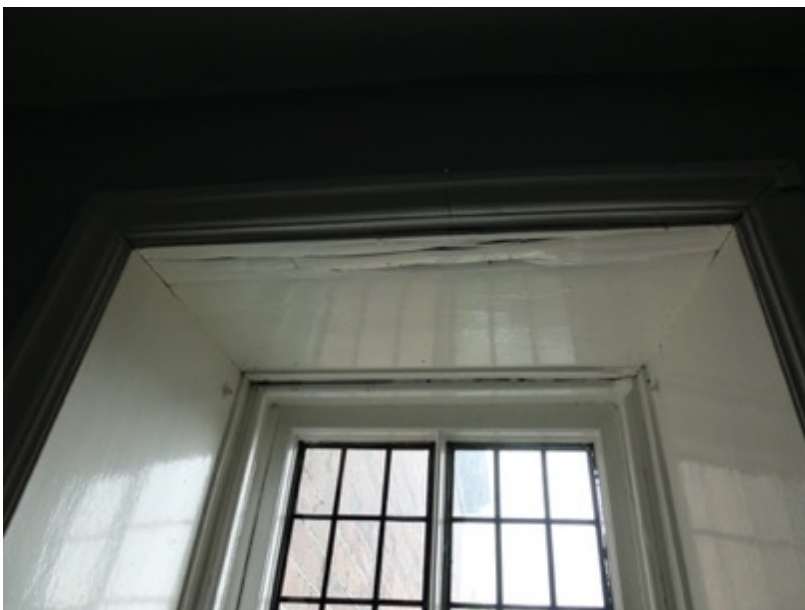
There is dry rot evident to the architrave and timber linings to the window on the rear elevation high level. The cause of this dry rot is overflowing stone gutters on the rear elevation.

There is concern that this dry rot may have spread into window, window board, lintel, skirting and joists at floor level and further investigation is required.

Photo, dry rot to window linings

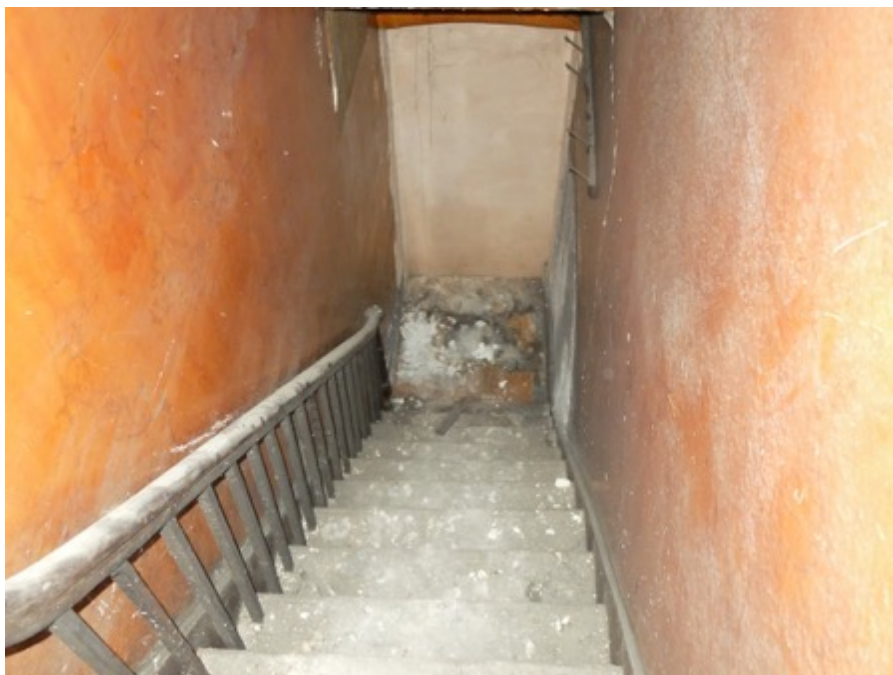
Within the shower area there were tiles missing due to water ingress. There is concern regarding the sections of hidden staircase beneath this area which were not accessible from the ground floor.

Photo, hidden staircase

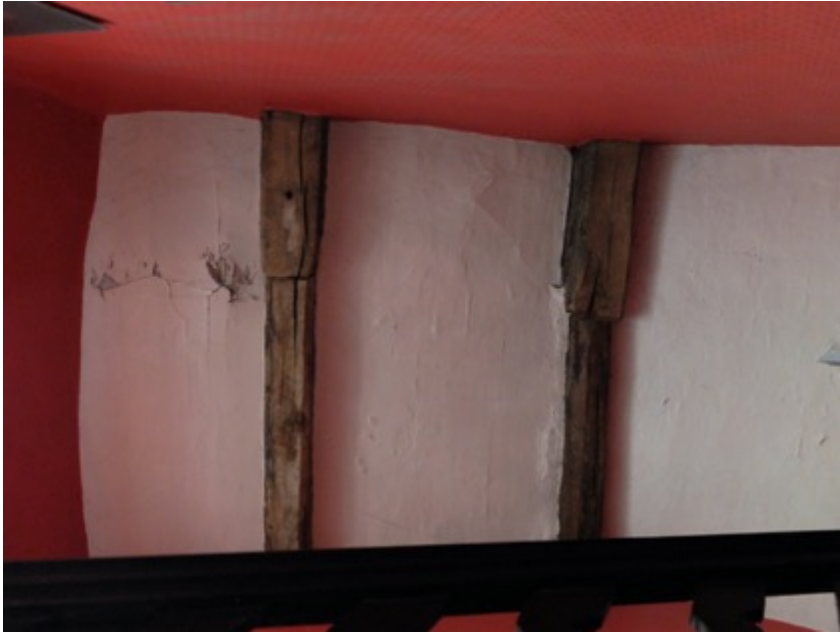
The sloping ceiling to the second floor landing above the stairs would appear to be lath and plaster. There is evidence of cracking indicating past deterioration. There are two exposed oak purlins between the lath and plaster. These are jointed over the staircase.

Photo, ceiling over stairs

There is damage to plasterwork within the ceiling which is indicative of roof leaks.

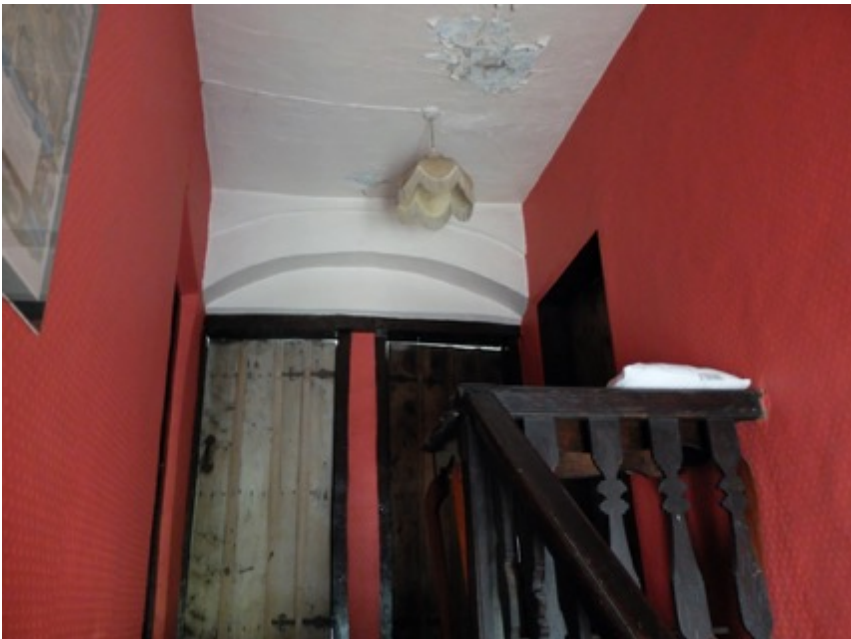
At the landing there is a plastered brick arch which spans over the top of both doors to the front attic rooms.

Photo, plaster arch at landing

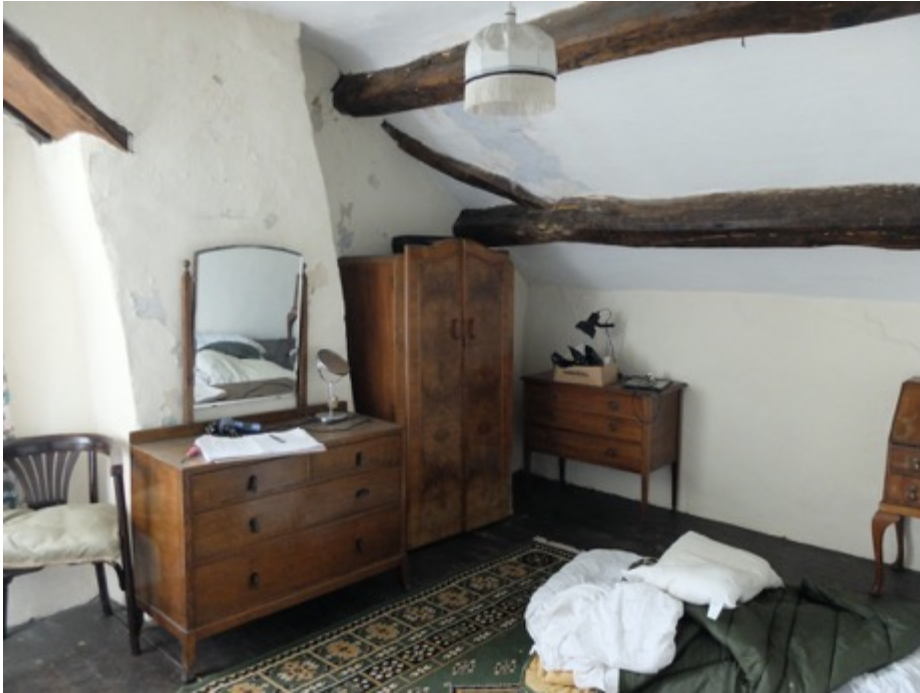
#### **4.11.16 Bedroom to front right**

The walls would appear to be plastered with original lime plaster and overlaid with lime wash paint. There is some white staining along the right hand gable wall and the chimney breast. These salts to the chimney breast could be ammonium salts.

Photo, front right room

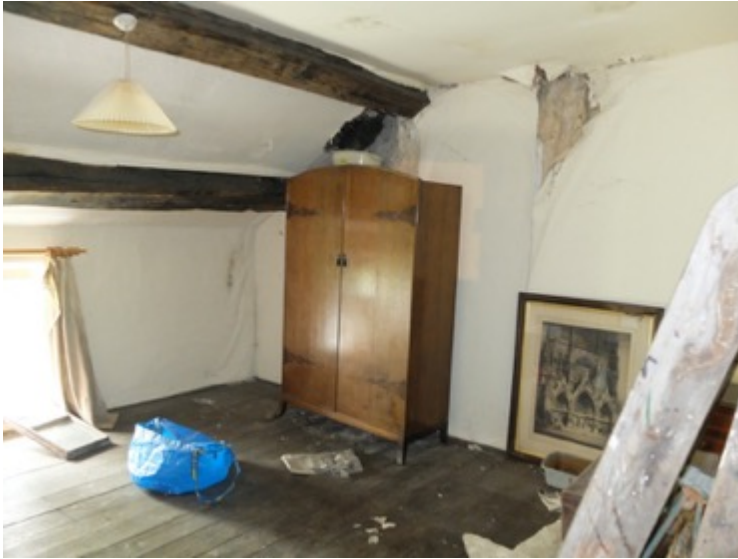
The walls would appear to be plastered and heavily papered and decorated however much of the paper is hollow and is falling away.

Photo, front left room

There is evidence of dampness along the front wall adjacent the gutter in particular to the front left hand corner.

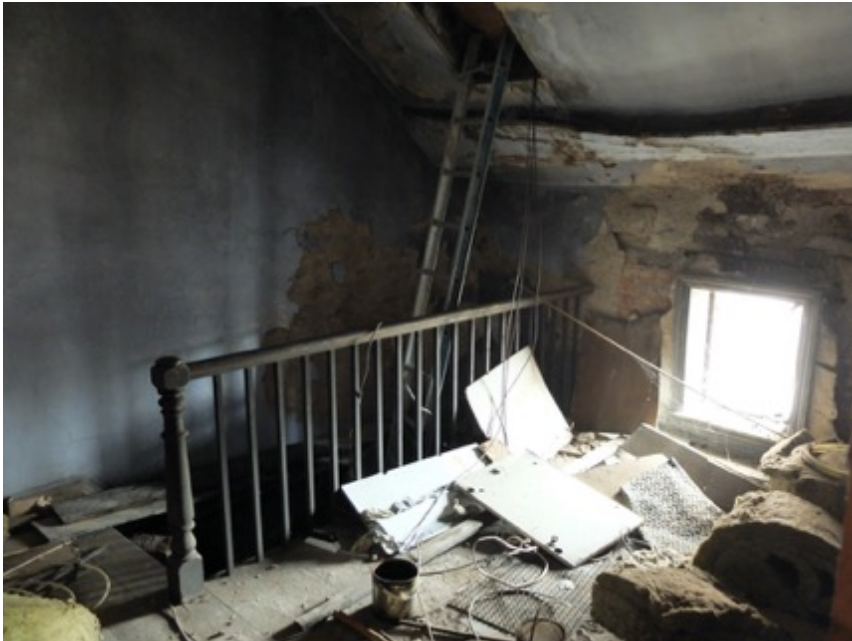
#### 4.11.17 Rear left room

Photo, rear left room

Within this room there is a trap within the sloping ceiling which provides access onto the roof. The door to this was not secure and could blow off during inclement weather.

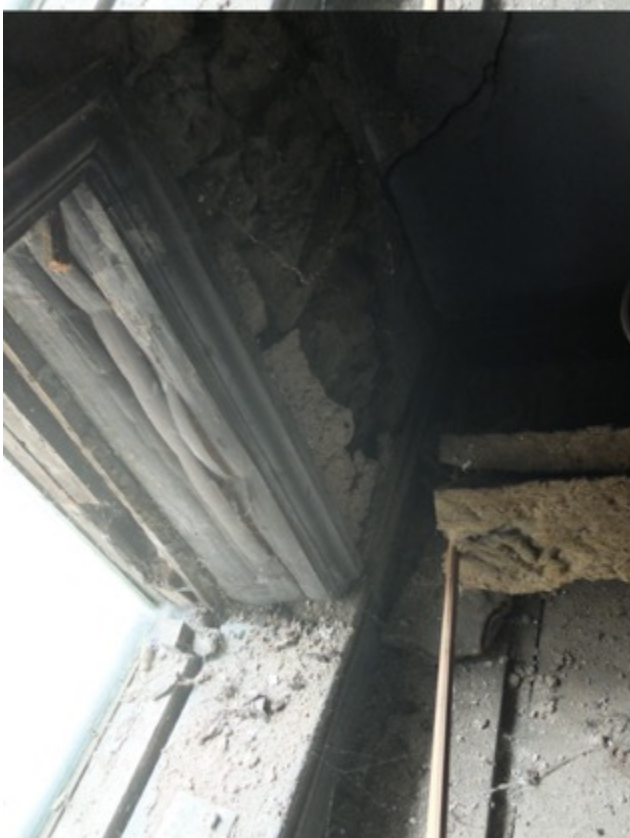
There is a considerable amount of added plaster along the rear elevation walls, around the window and at the base of the stairs.

There is evidence of dry rot within these areas which has affected the timber window, linings and lintel over the window.

Photo, dry rot in window

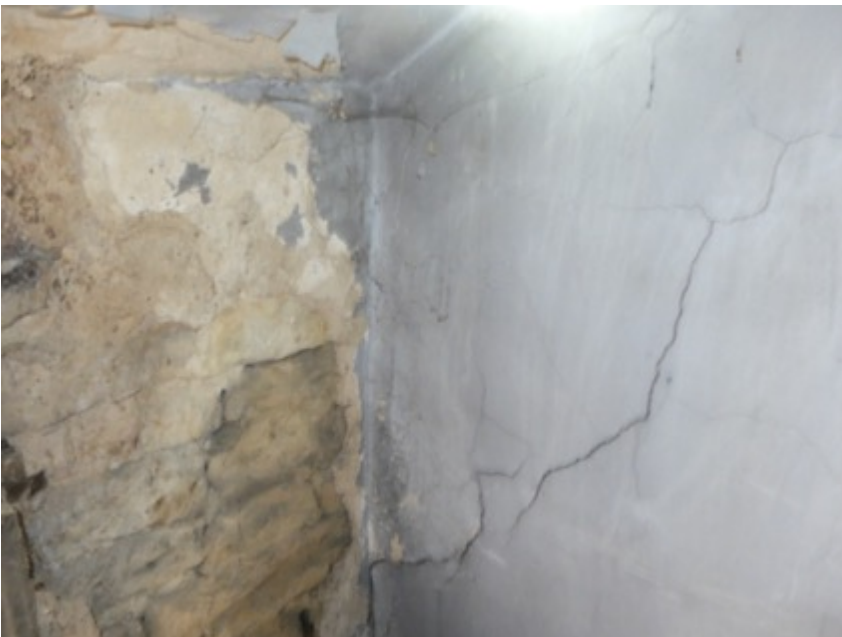
There is evidence of cracking and movement at locations where the central spine wall bears into the rear elevation wall which indicates a lack of bond as previously noted.

Photo, cracking where spine wall meets with rear external wall

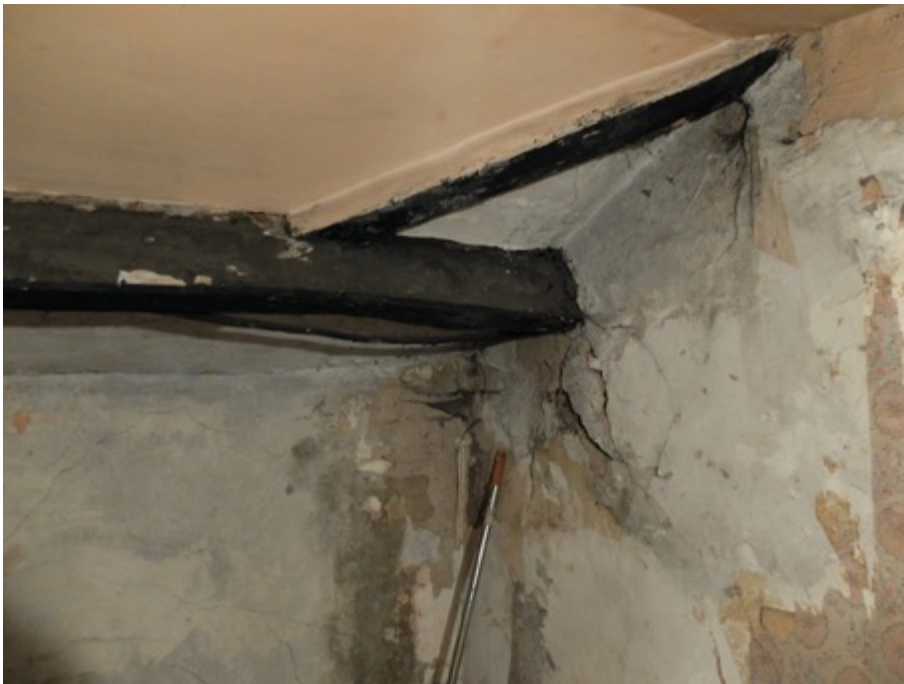
The walls would appear to be hard plastered there is evidence of cracking to the rear wall which is indicative of movement and further investigation is required.

Photo, roof and rear wall abutment
