## **BUILDING SURVEY REPORT AND REPAIR STATEMENT**

### **LOWER CHESHAM HALL BURY**

**Dated June 2020**

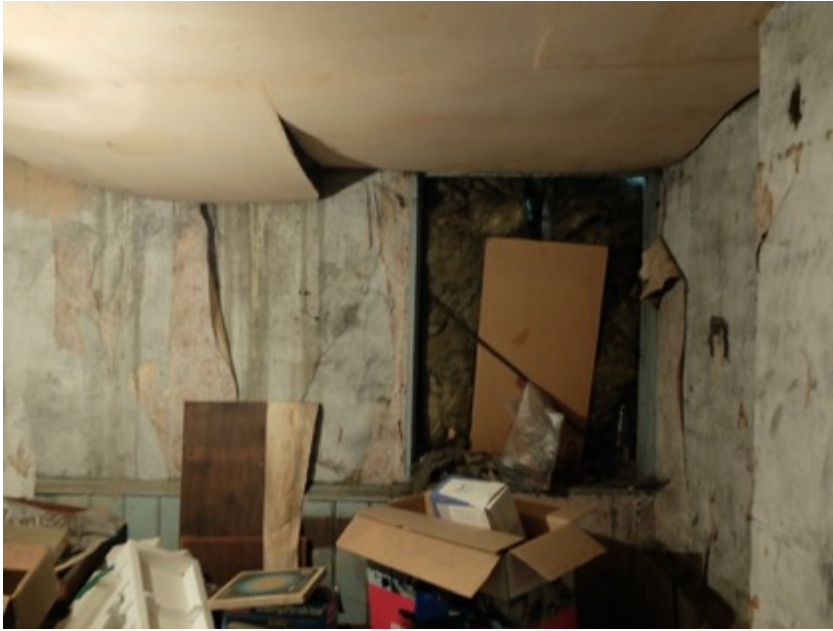
In general, all plaster was noted to be in a poor condition.

The window to the right-hand wall has been blocked of using mineral wool.

Photo, poor condition of room and blocked window

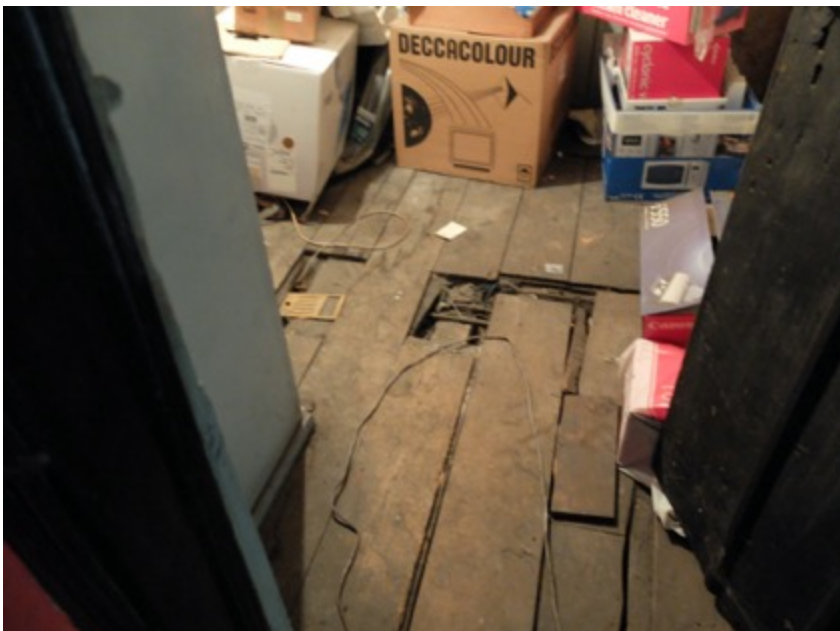
The floor is of a suspended timber construction. The floorboards are softwood, several of these have been lifted and not replaced after repairs.

Photo, lifted floorboards

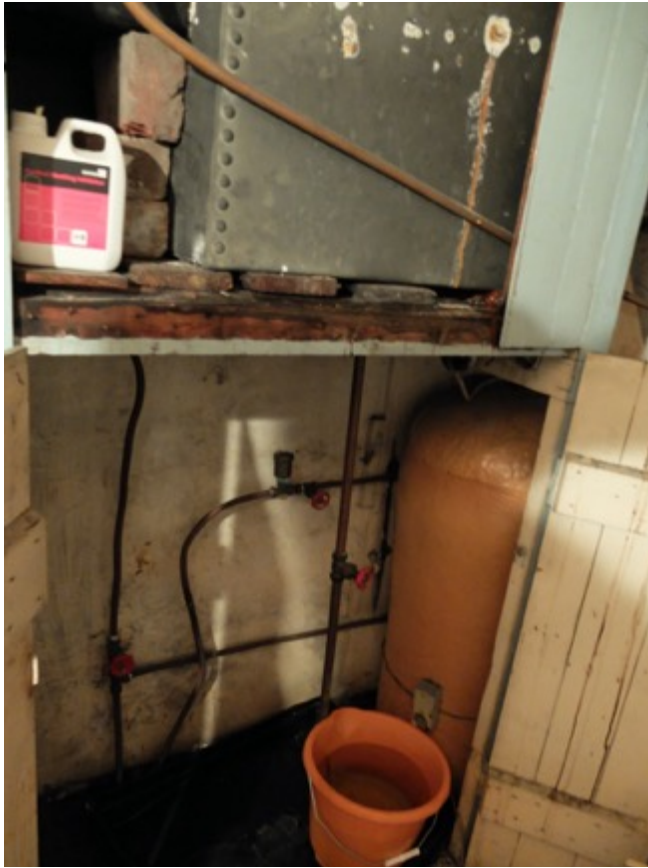
It would appear that the hot water cylinder is located within this room. Although the pipework is accessible there is no lagging to any of the pipework which will make this prone to problems during the winter months.

Photo, hot water cylinder

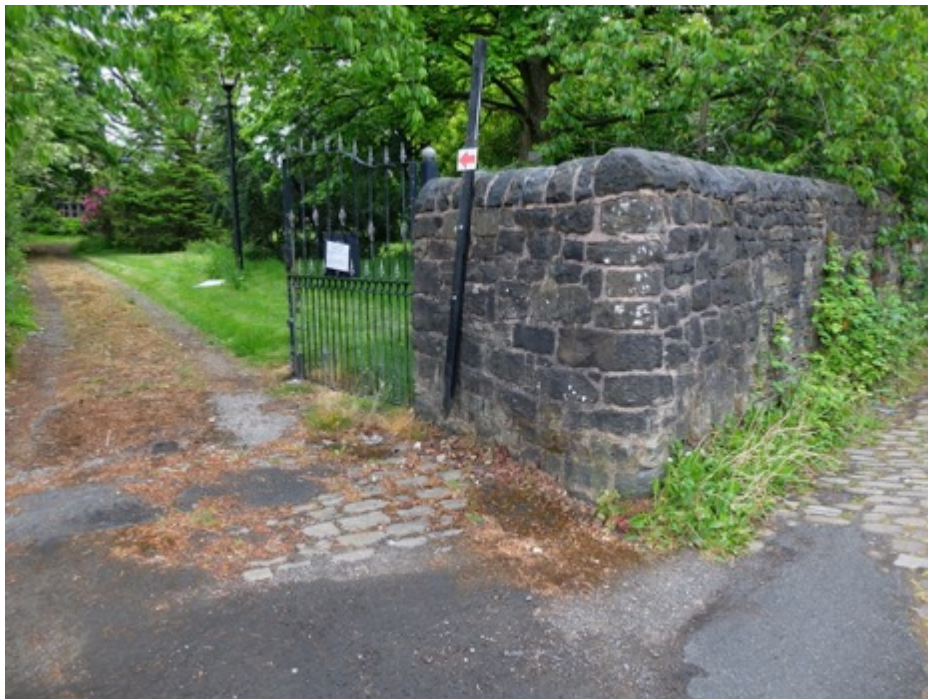
The original sandstone boundary wall to the front elevation appears in a fair condition. In the past cementitious pointing repairs have been carried out which will have accelerated decay and erosion within the soft sandstone. There are some minor undulations within the wall, which will require future attention.

Photo, stone wall at entrance

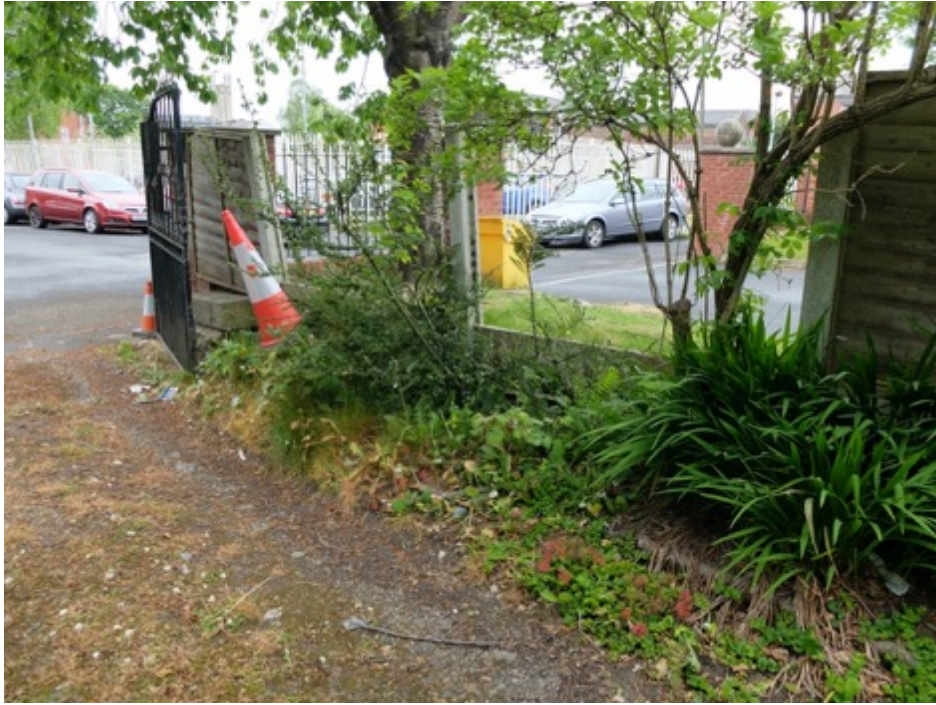
At the entrance several of the timber fence panels were missing

Photo, boundary at entrance

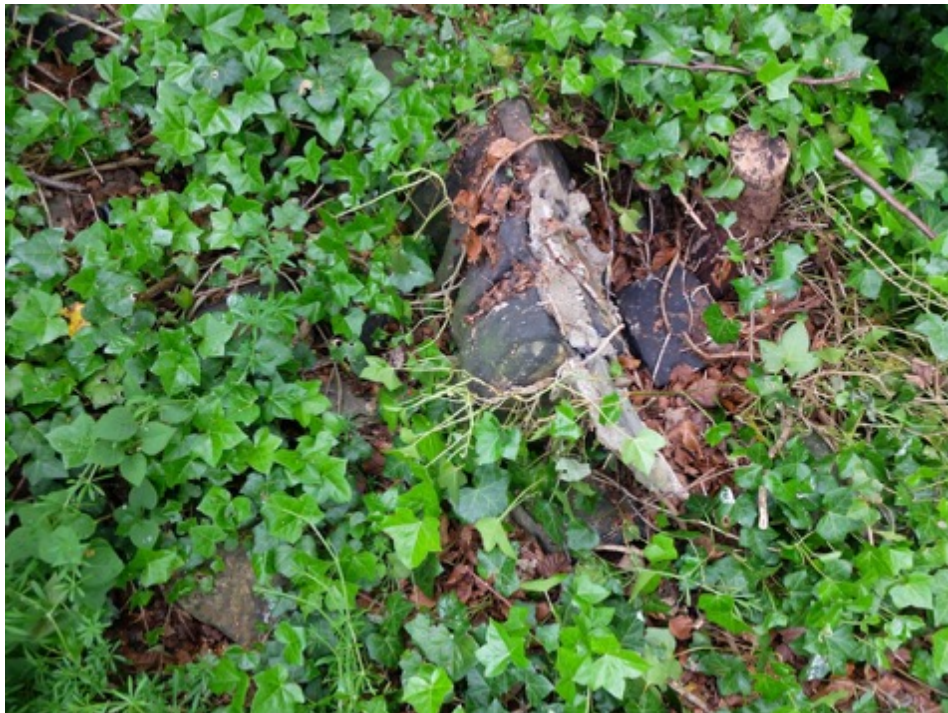
Along the east elevation I am informed the original stone wall was taken down by the local authority. The stone is still present within the garden and can be used for repairs

Photo, buried walling stone
