# REDDISH VALE

## REFURBISHMENT / DEMOLITION ASBESTOS SURVEY

| <b>Project site Address:</b> | Spurr House Residential Care home, 243 Pole Lane, Bury.<br>BL9 8QL |
| <b>Project Reference:</b> | Asbs12544 |

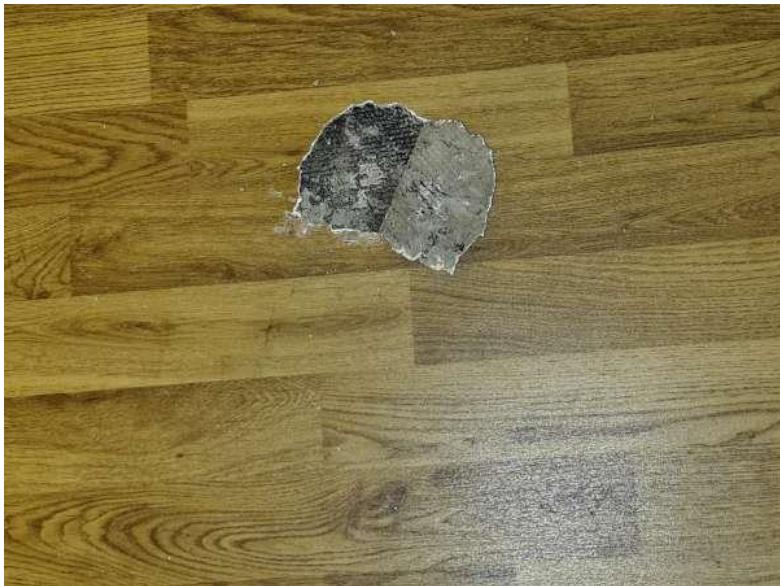
| Sample position | Adhesive to floor throughout beneath vinyl coverings and Carpet | | |
| Extent / Quantity of material | As sample 10 | | |

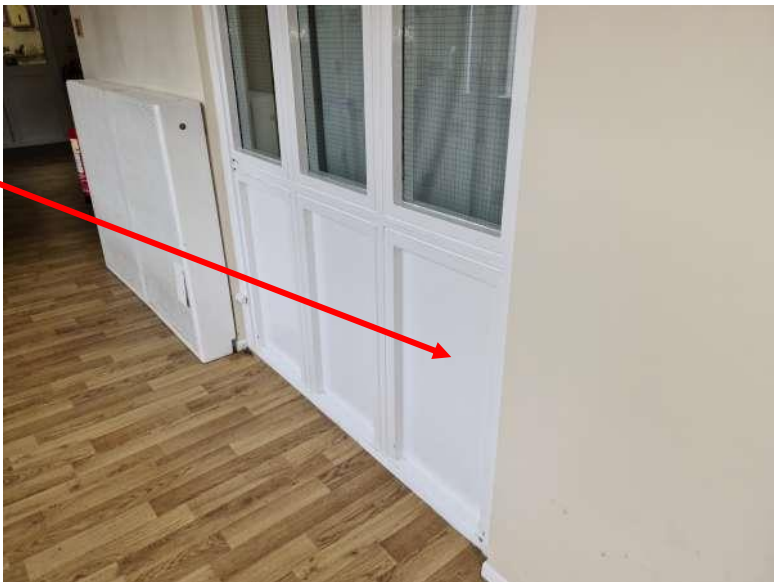
| Sample position | Small panels below window | | |
| Extent / Quantity of material | 1m <sup>2</sup> x 5 panels | | |

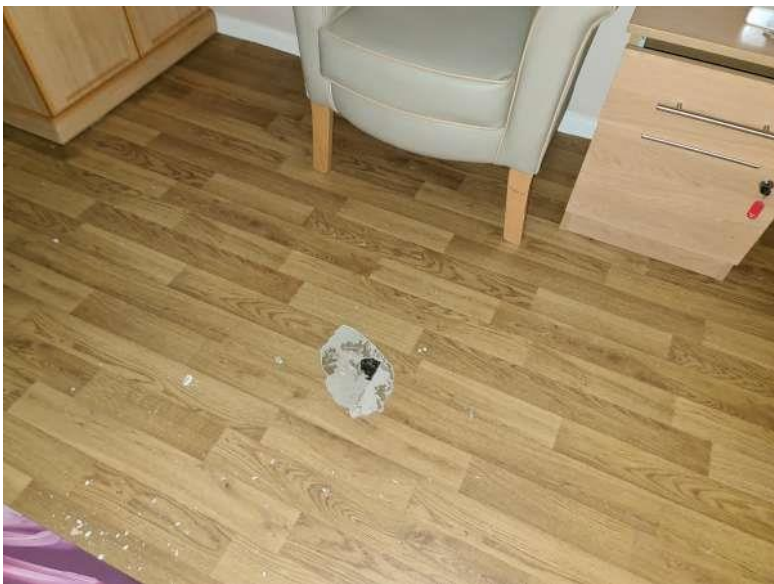
| Sample position | | Cream tiles to floor throughout beneath vinyl covering | |
| Extent / Quantity of material | | 42m <sup>2</sup> total | |

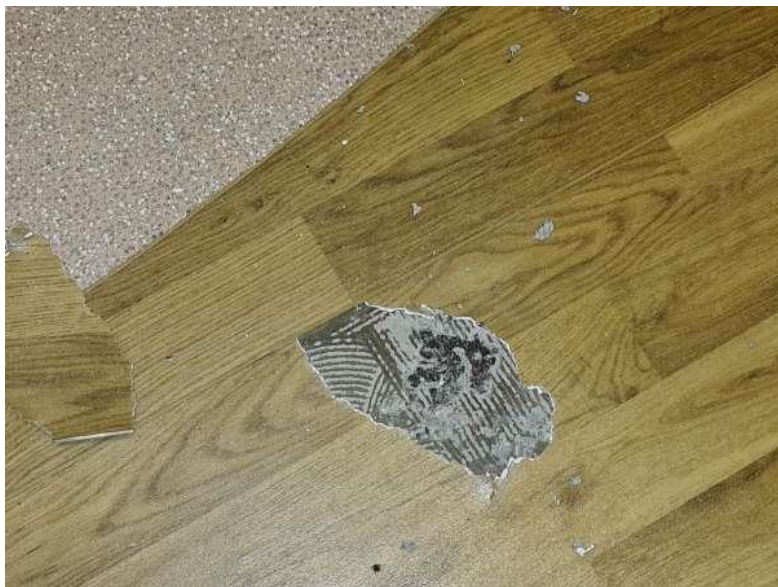
| Sample position | Adhesive to floor throughout beneath vinyl coverings and Carpet | | |
| Extent / Quantity of material | Up to 208m <sup>2</sup> total | | |

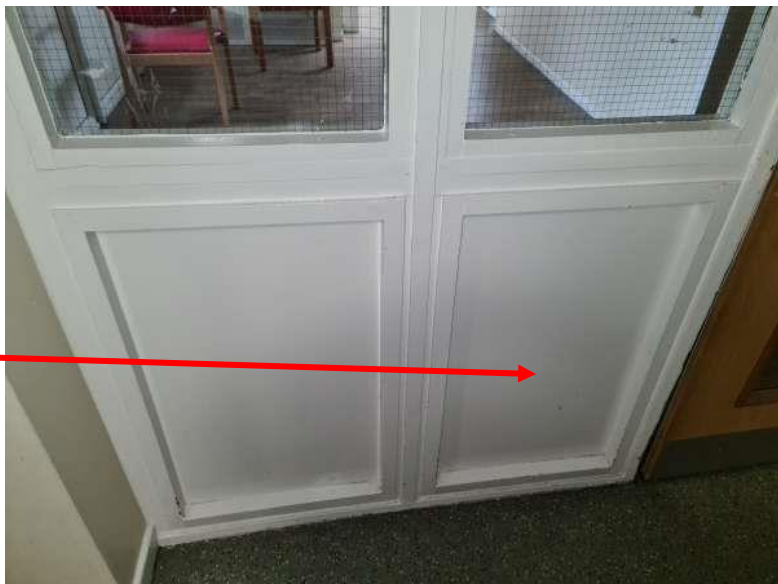
| Sample position | Small panels below window | | |
| Extent / Quantity of material | 1m <sup>2</sup> x 2 panels | | |

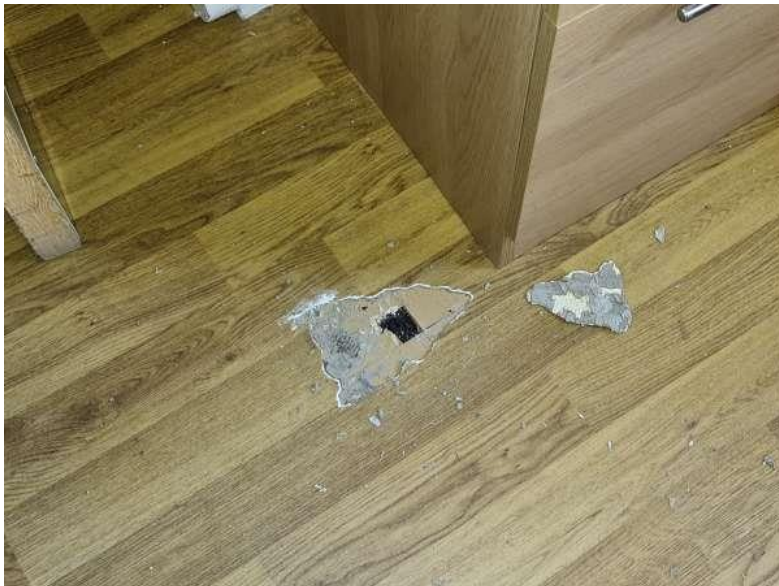
| Sample position | Cream tiles to floor throughout beneath vinyl coverings and Carpet | | |
| Extent / Quantity of material | Up to 182m <sup>2</sup> total | | |

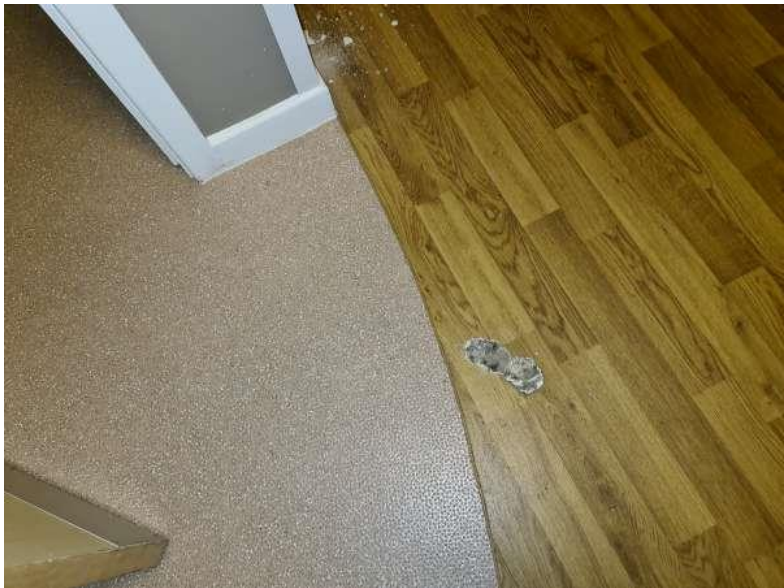
| Sample position | | Adhesive to floor throughout beneath vinyl coverings and Carpet | |
| Extent / Quantity of material | | 68m <sup>2</sup> total | |

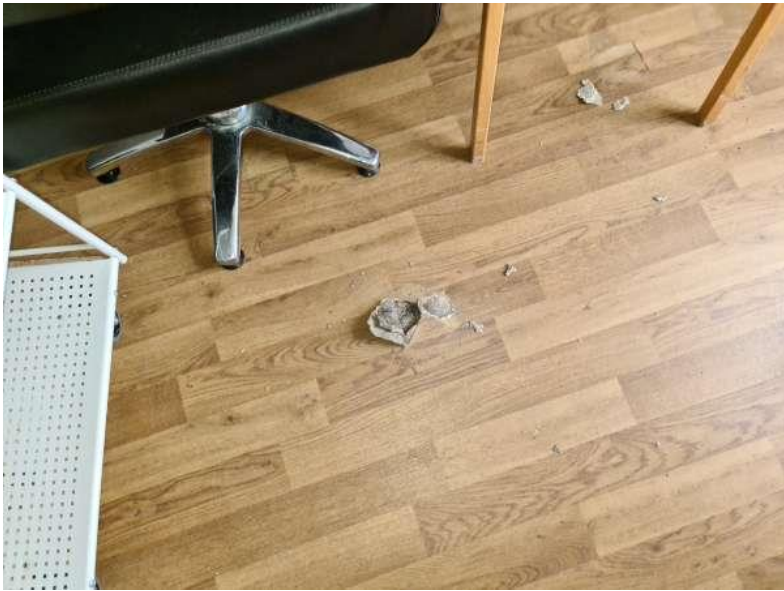
| Sample position | Adhesive to floor throughout beneath vinyl covering | | |
| Extent / Quantity of material | 7m <sup>2</sup> | | |

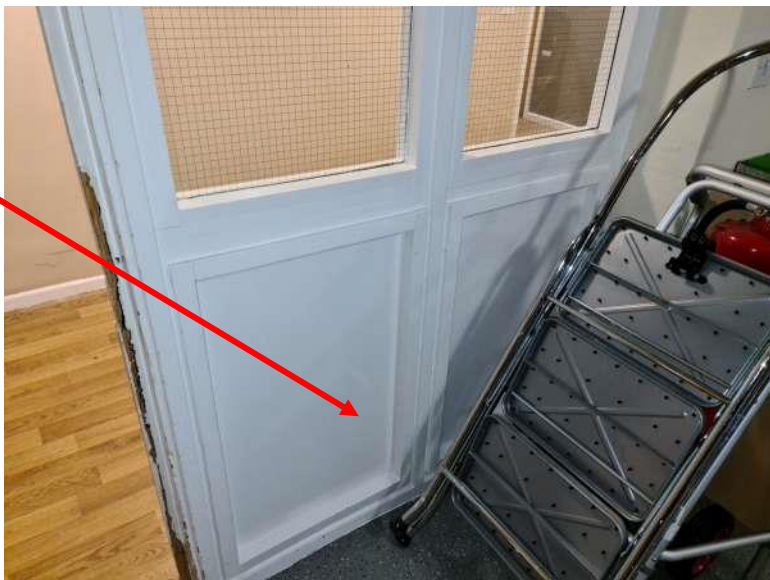
| Sample position | Small panels below window | | |
| Extent / Quantity of material | 1m <sup>2</sup> x 2 panels | | |

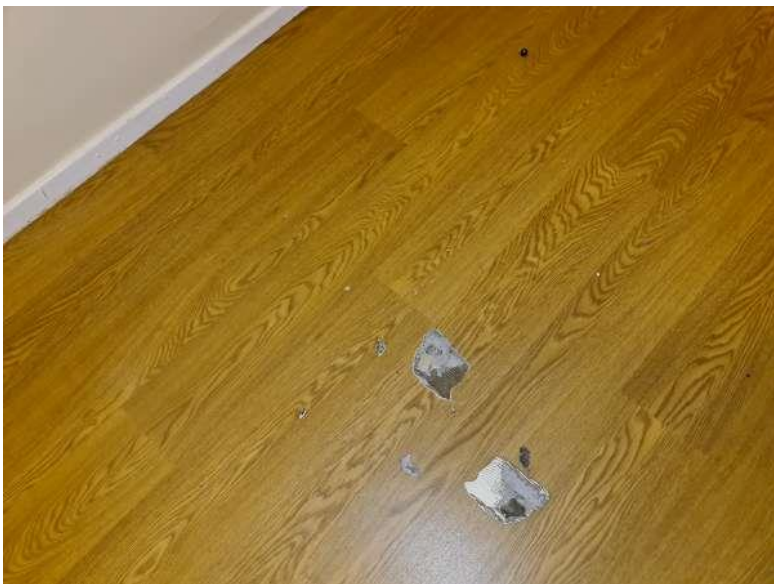
| Sample position | Cream tiles to floor throughout beneath vinyl covering | | |
| Extent / Quantity of material | 28m <sup>2</sup> total | | |

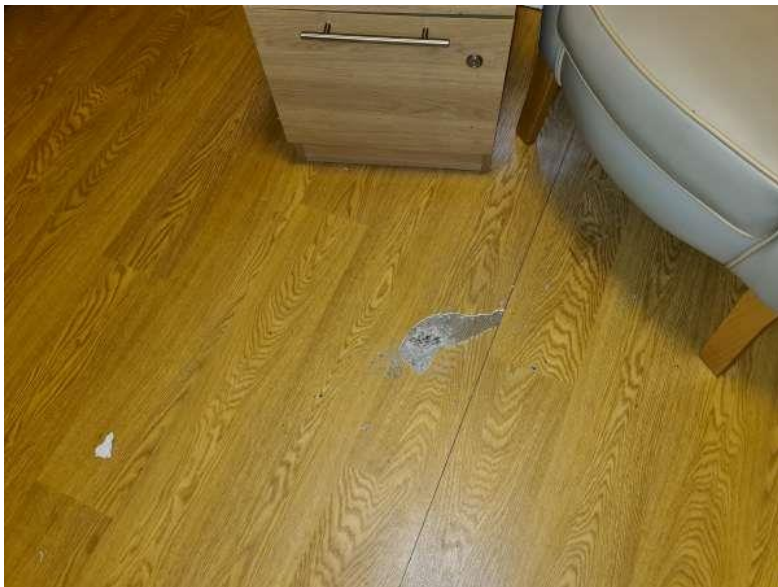
| Sample position | Adhesive to floor throughout beneath vinyl coverings and Carpet | | |
| Extent / Quantity of material | Up to 222m² total | | |

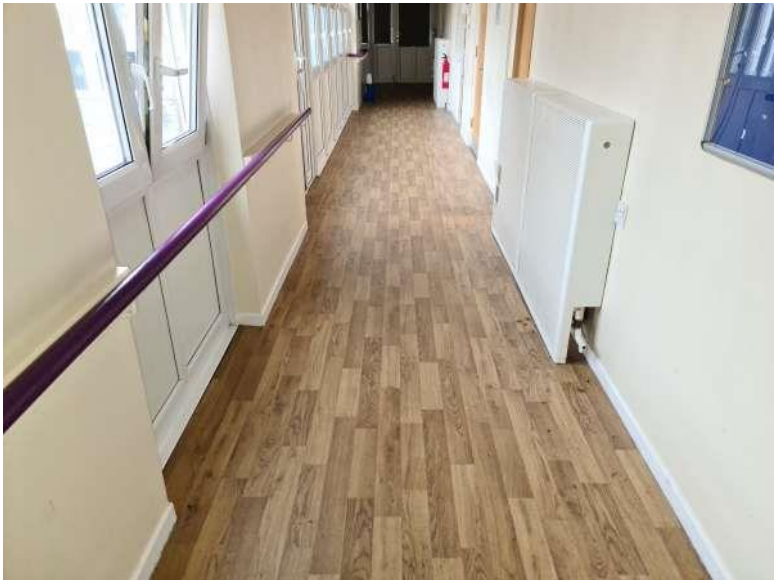
| Sample position | | Cream tiles to floor throughout beneath vinyl covering | |
| Extent / Quantity of material | | 76m <sup>2</sup> total | |

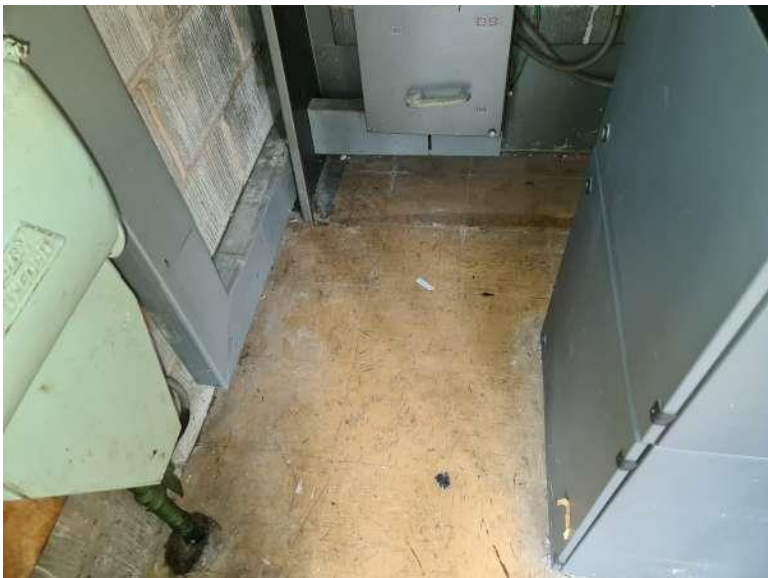
| Sample position | Cream tiles to floor throughout | | |
| Extent / Quantity of material | 4m <sup>2</sup> | | |

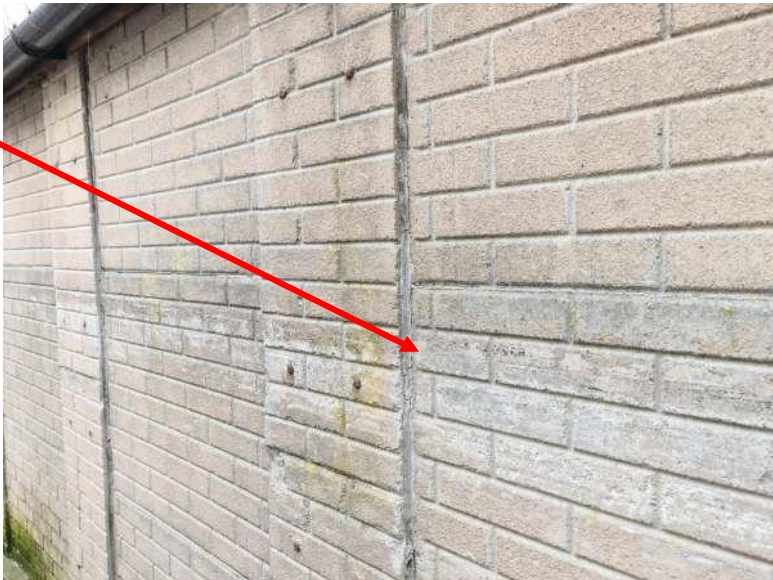
| Sample position | | Mastic to jointing of concrete walls | |
| Extent / Quantity of material | | 56 linear metres | |

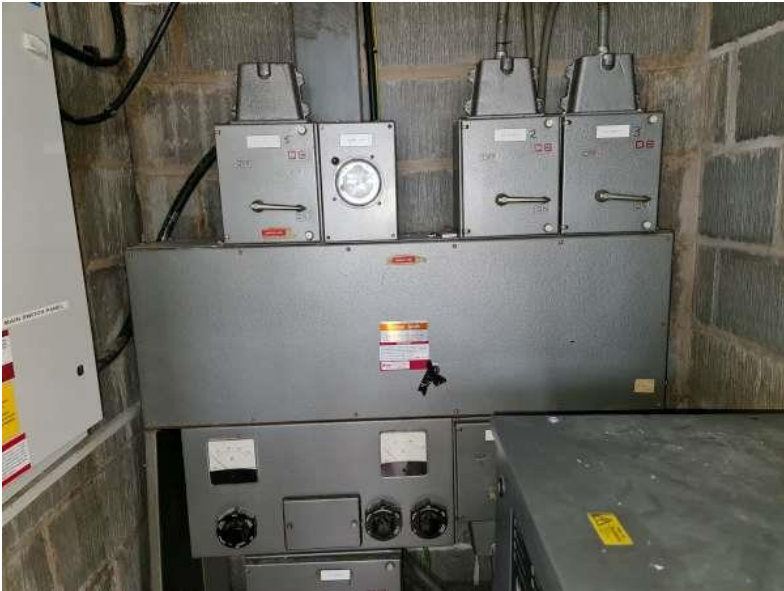
| Sample position | Flash guards and rope seals within electrical boxes | | |
| Extent / Quantity of material | 4 fuse boxes | | |

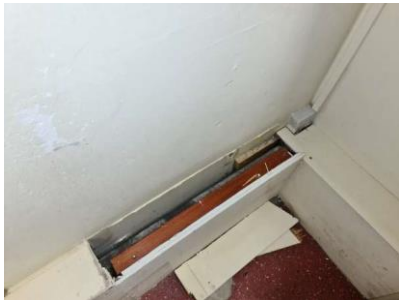
| General view of areas inspected during the survey | Example of vinyl floor coverings identified throughout | Example of plasterboard partition walls identified in various areas |

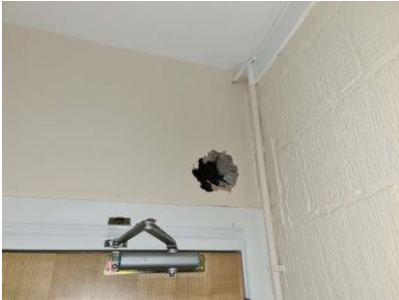
| General view of timber boxings inspected during the survey | General view of plasterboard boxings inspected during the survey | General view of areas inspected during the survey |

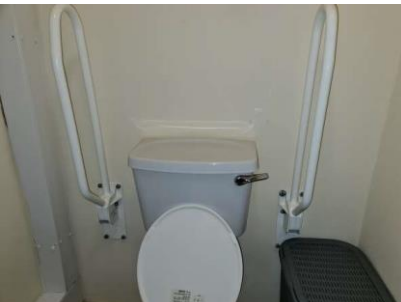
| General view of areas inspected during the survey | Example of carpet floor coverings identified throughout | Example of plasterboard partition walls identified in various areas |

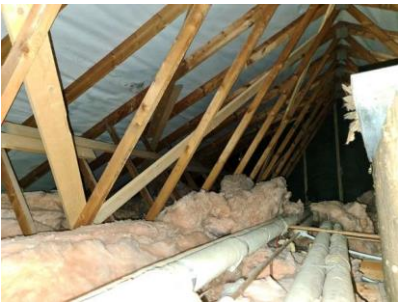
| General view of loft spaces inspected during the survey | | |

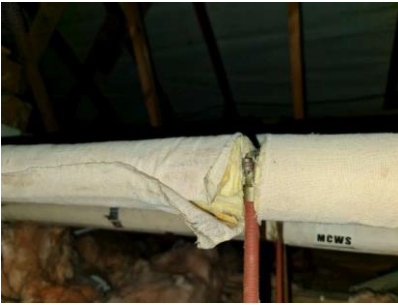
| General view of loft spaces inspected during the survey | | Example of MMMF insulation identified extensively to pipework throughout |

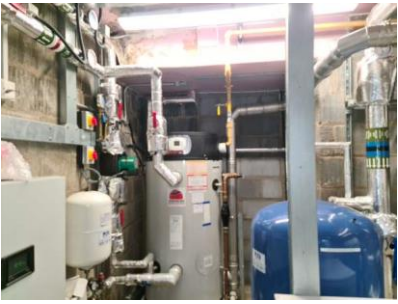
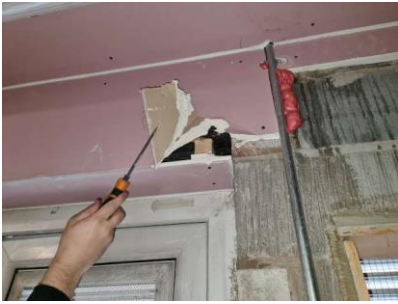
| General view of areas inspected during the survey | | General view of plasterboard boxings inspected during the survey |

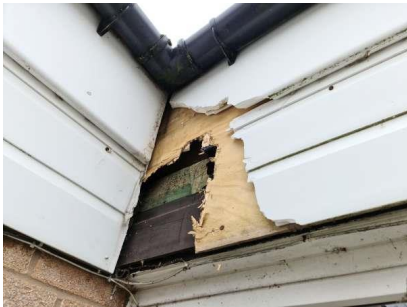
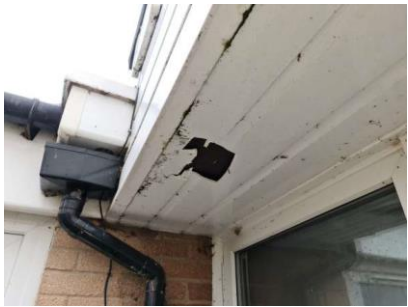
| General view of external Upvc cladded over timber and Felt identified to facias and soffits | General view of Upvc window panels | General view of external Upvc cladded over timber and Felt identified to facias and soffits |

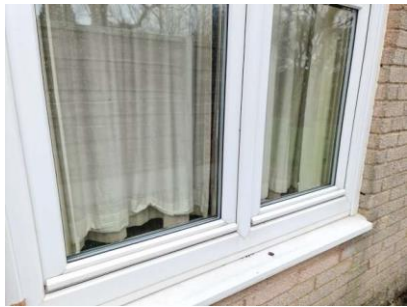
| General view of Upvc windows throughout | General view of external Upvc cladded over timber and Felt identified to facias and soffits | |

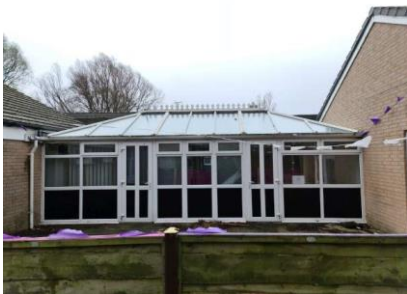
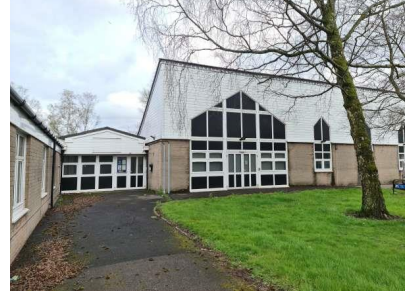
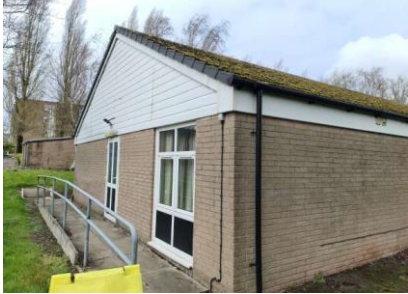
| External views of buildings | | |
