## ASBESTOS DEMOLITION SURVEY

Former Soap Works, Kenyon St Works, Kenyon St, Ramsbottom, BL0 0AB

PROJECT NO. 70064333 -- 70043831

DATE: September 2019

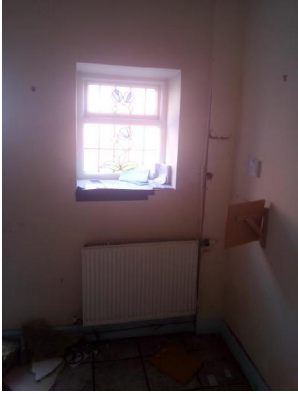
| Location | Item Description | Extent / Quantity | Product Type | Damage Extent | Surface Treatment | Asbestos Type | Material Assessment Total | Material Risk Rating | Accessibility | Sample Reference | Asbestos Identification | Recommendations / Comments | Photographs |
|---|---|---|---|---|---|---|---|---|---|---|---|---|---|
| Administration Building<br>Ground Floor<br>001 Entrance | Cement window sill | 1 m <sup>2</sup> | 1 | 2 | 1 | 1 | 5 | Low | High | 70043831/JM014 | Chrysotile | <b>Remove</b><br><br>Ceramic floor tiles over concrete, brick and plaster walls, plasterboard ceiling, mmmf insulation, modern stair nosing & vinyl to stairs. | |

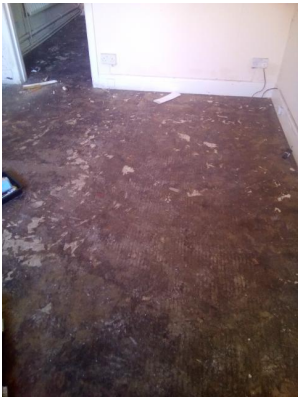
| Location | Item Description | Extent / Quantity | Product Type | Damage Extent | Surface Treatment | Asbestos Type | Material Assessment Total | Material Risk Rating | Accessibility | Sample Reference | Asbestos Identification | Recommendations / Comments | Photographs |
|---|---|---|---|---|---|---|---|---|---|---|---|---|---|
| Administration Building<br>Ground Floor<br>002 Office | Screed to floor | 12 m² | - | - | - | - | - | - | - | 70043831/JM015 | No asbestos detected | Concrete floor, brick and plaster walls, plasterboard ceiling. | |

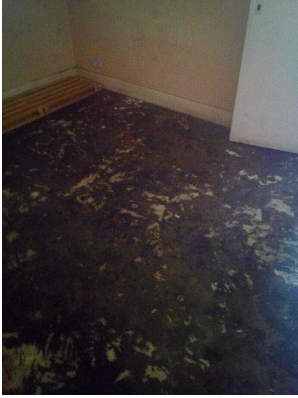
| Location | Item Description | Extent / Quantity | Product Type | Damage Extent | Surface Treatment | Asbestos Type | Material Assessment Total | Material Risk Rating | Accessibility | Sample Reference | Asbestos Identification | Recommendations / Comments | Photographs |
|---|---|---|---|---|---|---|---|---|---|---|---|---|---|
| Administration Building<br>Ground Floor<br>003 Office | Screed to floor | 14 m² | - | - | - | - | - | - | - | As 70043831/JM015 | No asbestos detected | Concrete floor, brick and plaster walls, fibreboard partition to room 0/009, plasterboard ceiling. | |

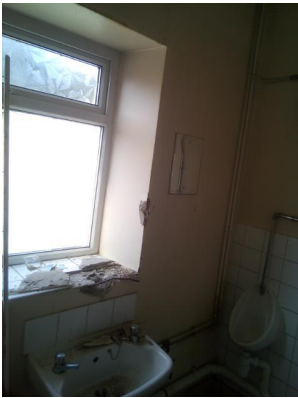
| Location | Item Description | Extent / Quantity | Product Type | Damage Extent | Surface Treatment | Asbestos Type | Material Assessment Total | Material Risk Rating | Accessibility | Sample Reference | Asbestos Identification | Recommendations / Comments | Photographs |
|---|---|---|---|---|---|---|---|---|---|---|---|---|---|
| Administration Building<br>Ground Floor<br>004 Male WC | No asbestos suspected | | - | - | - | - | - | - | - | - | - | Ceramic floor tiles, brick and plaster walls, plaster ceiling, ceramic toilet cistern. | |

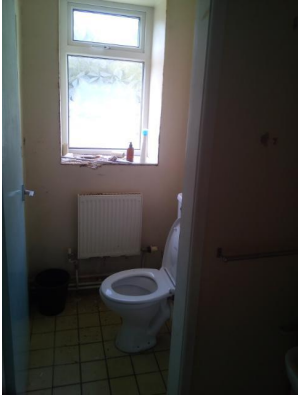
| Location | Item Description | Extent / Quantity | Product Type | Damage Extent | Surface Treatment | Asbestos Type | Material Assessment Total | Material Risk Rating | Accessibility | Sample Reference | Asbestos Identification | Recommendations / Comments | Photographs |
|---|---|---|---|---|---|---|---|---|---|---|---|---|---|
| Administration Building<br>Ground Floor<br>005 Female WC | No asbestos suspected | | - | - | - | - | - | - | - | - | - | Ceramic floor tiles, brick and plaster walls, plaster ceiling, ceramic toilet cistern. | |

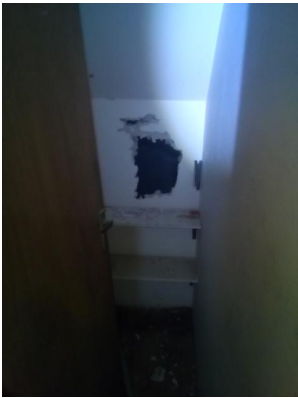
| Location | Item Description | Extent / Quantity | Product Type | Damage Extent | Surface Treatment | Asbestos Type | Material Assessment Total | Material Risk Rating | Accessibility | Sample Reference | Asbestos Identification | Recommendations / Comments | Photographs |
|---|---|---|---|---|---|---|---|---|---|---|---|---|---|
| Administration Building<br>Ground Floor<br>006 Under stairs store | Vinyl flooring & screed | 2 m <sup>2</sup> | - | - | - | - | - | - | - | 70043831/JM016 | No asbestos detected | Solid floor, plasterboard walls & ceiling, wooden stairs. | |

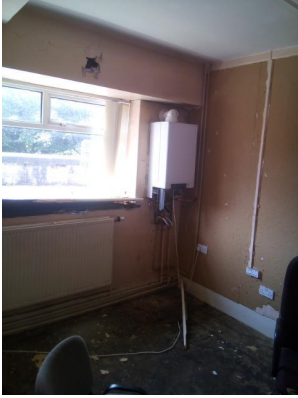
| Location | Item Description | Extent / Quantity | Product Type | Damage Extent | Surface Treatment | Asbestos Type | Material Assessment Total | Material Risk Rating | Accessibility | Sample Reference | Asbestos Identification | Recommendations / Comments | Photographs |
|---|---|---|---|---|---|---|---|---|---|---|---|---|---|
| Administration Building<br>Ground Floor<br>007 Office | Screed to floor | 9 m <sup>2</sup> | - | - | - | - | - | - | - | As 70043831/JM015 | No asbestos detected | Concrete floor, brick and plaster walls, plasterboard ceiling, modern boiler, concrete primary ceiling. | |

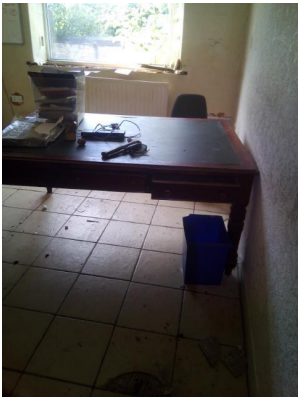
| Location | Item Description | Extent / Quantity | Product Type | Damage Extent | Surface Treatment | Asbestos Type | Material Assessment Total | Material Risk Rating | Accessibility | Sample Reference | Asbestos Identification | Recommendations / Comments | Photographs |
|---|---|---|---|---|---|---|---|---|---|---|---|---|---|
| Administration Building<br>Ground Floor<br>008 Office | Screed to floor | 10 m <sup>2</sup> | - | - | - | - | - | - | - | As 70043831/JM015 | No asbestos detected | Concrete floor, ceramic floor tiles, brick and plaster walls, plasterboard ceiling, concrete primary ceiling. | |

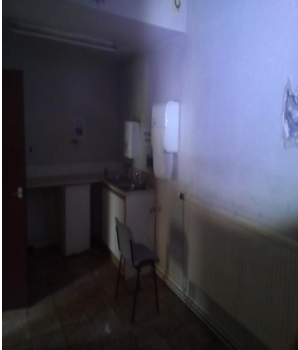
| Location | Item Description | Extent / Quantity | Product Type | Damage Extent | Surface Treatment | Asbestos Type | Material Assessment Total | Material Risk Rating | Accessibility | Sample Reference | Asbestos Identification | Recommendations / Comments | Photographs |
|---|---|---|---|---|---|---|---|---|---|---|---|---|---|
| Administration Building<br>Ground Floor<br>009 Canteen | No asbestos suspected | | - | - | - | - | - | - | - | - | - | Ceramic floor tiles (Red screed under) brick and plasterboard walls, plasterboard ceiling. | |

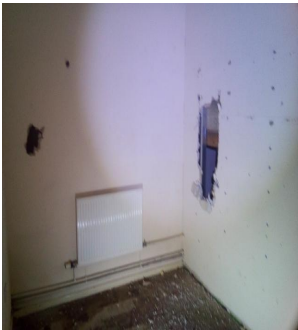
| Location | Item Description | Extent / Quantity | Product Type | Damage Extent | Surface Treatment | Asbestos Type | Material Assessment Total | Material Risk Rating | Accessibility | Sample Reference | Asbestos Identification | Recommendations / Comments | Photographs |
|---|---|---|---|---|---|---|---|---|---|---|---|---|---|
| Administration Building<br>Ground Floor<br>010 Store | No asbestos suspected | | - | - | - | - | - | - | - | - | - | Ceramic floor tiles (Red screed under) brick and plasterboard walls, plasterboard ceiling, wooden primary ceiling, wooden stairs. | |

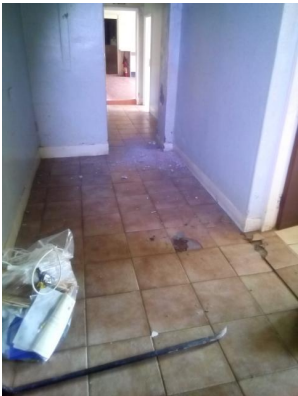
| Location | Item Description | Extent / Quantity | Product Type | Damage Extent | Surface Treatment | Asbestos Type | Material Assessment Total | Material Risk Rating | Accessibility | Sample Reference | Asbestos Identification | Recommendations / Comments | Photographs |
|---|---|---|---|---|---|---|---|---|---|---|---|---|---|
| Administration Building<br>Ground Floor<br>011 Corridor | No asbestos suspected | | - | - | - | - | - | - | - | - | - | Ceramic floor tiles (Red screed under) brick and plasterboard walls, plasterboard ceiling. | |

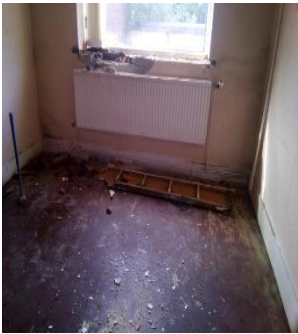
| Location | Item Description | Extent / Quantity | Product Type | Damage Extent | Surface Treatment | Asbestos Type | Material Assessment Total | Material Risk Rating | Accessibility | Sample Reference | Asbestos Identification | Recommendations / Comments | Photographs |
|---|---|---|---|---|---|---|---|---|---|---|---|---|---|
| Administration Building<br>Ground Floor<br>012 Office | Vinyl flooring & screed | 12 m <sup>2</sup> | - | - | - | - | - | - | - | As 70043831/JM016 | No asbestos detected | Solid floor, plasterboard walls & ceiling, wooden primary ceiling, wooden windowsill. | |

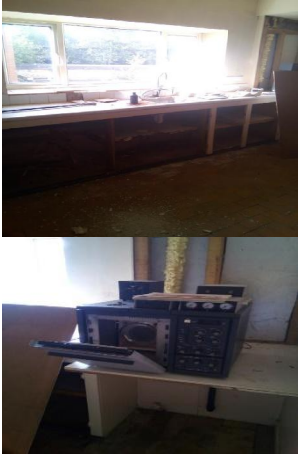
| Location | Item Description | Extent / Quantity | Product Type | Damage Extent | Surface Treatment | Asbestos Type | Material Assessment Total | Material Risk Rating | Accessibility | Sample Reference | Asbestos Identification | Recommendations / Comments | Photographs |
|---|---|---|---|---|---|---|---|---|---|---|---|---|---|
| Administration Building<br>Ground Floor<br>013 Lab and under stairs store | Sink pad | 1 No. | - | - | - | - | - | - | - | 70026829/MC004 | No asbestos detected | Concrete floor, ceramic floor tiles, brick and plaster walls, plasterboard ceiling, chipboard primary ceiling, foam insulation to Chromatography equipment. | |

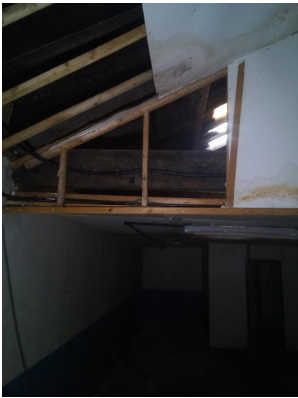
| Location | Item Description | Extent / Quantity | Product Type | Damage Extent | Surface Treatment | Asbestos Type | Material Assessment Total | Material Risk Rating | Accessibility | Sample Reference | Asbestos Identification | Recommendations / Comments | Photographs |
|---|---|---|---|---|---|---|---|---|---|---|---|---|---|
| Administration Building<br>Ground Floor<br>014 Old perfume Store | Insulation board panels to left and rear wall | 50 m <sup>2</sup> | - | - | - | - | - | - | - | 70026829/MC005 | No asbestos detected | Concrete floor, brick walls, fibreboard and plywood ceiling, metal tanks, modern electrics, sarking felt to underside of slate pitched roof. | |

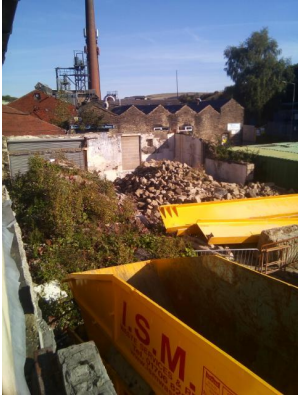
| Location | Item Description | Extent / Quantity | Product Type | Damage Extent | Surface Treatment | Asbestos Type | Material Assessment Total | Material Risk Rating | Accessibility | Sample Reference | Asbestos Identification | Recommendations / Comments | Photographs |
|---|---|---|---|---|---|---|---|---|---|---|---|---|---|
| Administration Building<br>Ground Floor<br>015 Warehouse | No asbestos suspected | | - | - | - | - | - | - | - | - | - | Warehouse has been demolished. | |

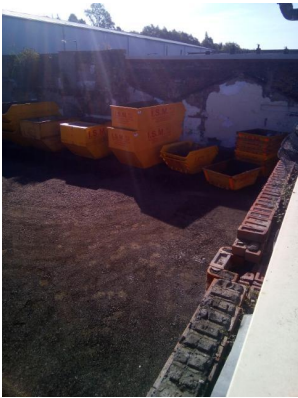
| Location | Item Description | Extent / Quantity | Product Type | Damage Extent | Surface Treatment | Asbestos Type | Material Assessment Total | Material Risk Rating | Accessibility | Sample Reference | Asbestos Identification | Recommendations / Comments | Photographs |
|---|---|---|---|---|---|---|---|---|---|---|---|---|---|
| Administration Building<br>Ground Floor<br>016 Small Warehouse | No asbestos suspected | | - | - | - | - | - | - | - | - | - | Warehouse has been demolished. | |

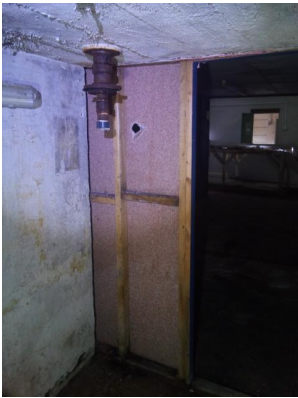
| Location | Item Description | Extent / Quantity | Product Type | Damage Extent | Surface Treatment | Asbestos Type | Material Assessment Total | Material Risk Rating | Accessibility | Sample Reference | Asbestos Identification | Recommendations / Comments | Photographs |
|---|---|---|---|---|---|---|---|---|---|---|---|---|---|
| Administration Building<br>Ground Floor<br>017 Store | Insulation board surround to entrance | 3 m <sup>2</sup> | - | - | - | - | - | - | - | As70026829/MC005 | No asbestos detected | Concrete floor, brick walls, concrete ceiling. | |

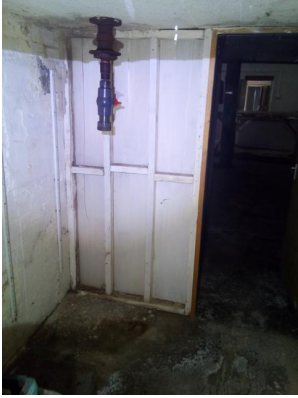
| Location | Item Description | Extent / Quantity | Product Type | Damage Extent | Surface Treatment | Asbestos Type | Material Assessment Total | Material Risk Rating | Accessibility | Sample Reference | Asbestos Identification | Recommendations / Comments | Photographs |
|---|---|---|---|---|---|---|---|---|---|---|---|---|---|
| Administration Building<br>Ground Floor<br>018 Store | Insulation board surround to entrance | 3 m <sup>2</sup> | - | - | - | - | - | - | - | As70026829/MC005 | No asbestos detected | Concrete floor, brick walls, concrete ceiling. | |

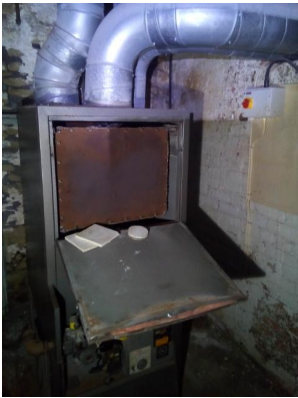
| Location | Item Description | Extent / Quantity | Product Type | Damage Extent | Surface Treatment | Asbestos Type | Material Assessment Total | Material Risk Rating | Accessibility | Sample Reference | Asbestos Identification | Recommendations / Comments | Photographs |
|---|---|---|---|---|---|---|---|---|---|---|---|---|---|
| Administration Building<br>Ground Floor<br>019 Plant room | Insulation board panels to boiler | 1 m <sup>2</sup> | - | - | - | - | - | - | - | 70043831/JM017 | No asbestos detected | - | |

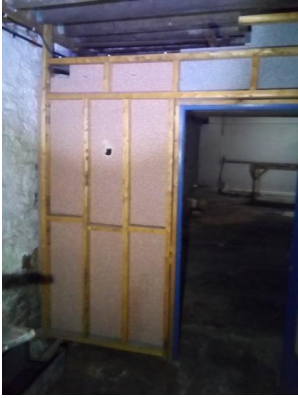
| Location | Item Description | Extent / Quantity | Product Type | Damage Extent | Surface Treatment | Asbestos Type | Material Assessment Total | Material Risk Rating | Accessibility | Sample Reference | Asbestos Identification | Recommendations / Comments | Photographs |
|---|---|---|---|---|---|---|---|---|---|---|---|---|---|
| Administration Building<br>Ground Floor<br>019 Plant room | Insulation board surround to entrance | 3 m <sup>2</sup> | - | - | - | - | - | - | - | As70026829/MC005 | No asbestos detected | Concrete floor, brick walls, concrete ceiling, modern textile seals to boiler. | |

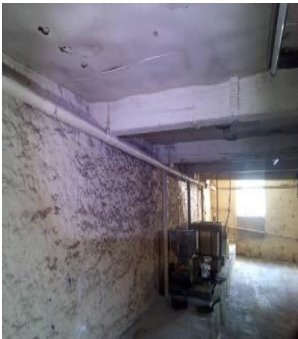
| Location | Item Description | Extent / Quantity | Product Type | Damage Extent | Surface Treatment | Asbestos Type | Material Assessment Total | Material Risk Rating | Accessibility | Sample Reference | Asbestos Identification | Recommendations / Comments | Photographs |
|---|---|---|---|---|---|---|---|---|---|---|---|---|---|
| Administration Building<br>Ground Floor<br>020 Warehouse | Gaskets to pipework | Througout | 2 | 1 | 1 | 1 | 5 | Low | High | As70026829/MC033 | Chrysotile | Remove | |

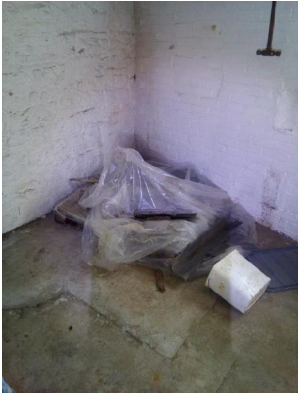
| Location | Item Description | Extent / Quantity | Product Type | Damage Extent | Surface Treatment | Asbestos Type | Material Assessment Total | Material Risk Rating | Accessibility | Sample Reference | Asbestos Identification | Recommendations / Comments | Photographs |
|---|---|---|---|---|---|---|---|---|---|---|---|---|---|
| Administration Building<br>Ground Floor<br>021 Garage | Cement debris to rear left corner of the room | 5 m² | 1 | 3 | 1 | 1 | 6 | Low | High | 70043831/JM019 | Chrysotile | <p><b>Remove<br/>Cement debris on a<br/>pallet wrapped in<br/>polythene.</b></p> <p>Concrete floor, brick walls, compressed card ceiling tiles, mmmf insulation, metal primary ceiling.</p> | |

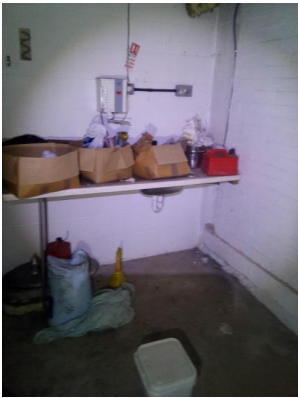
| Location | Item Description | Extent / Quantity | Product Type | Damage Extent | Surface Treatment | Asbestos Type | Material Assessment Total | Material Risk Rating | Accessibility | Sample Reference | Asbestos Identification | Recommendations / Comments | Photographs |
|---|---|---|---|---|---|---|---|---|---|---|---|---|---|
| Administration Building<br>Ground Floor<br>021 Garage | Sink pad | 1 No. | - | - | - | - | - | - | - | As70026829/MC004 | No asbestos detected | - | |

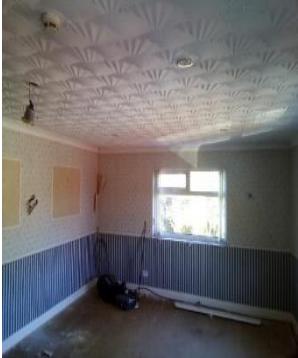
| Location | Item Description | Extent / Quantity | Product Type | Damage Extent | Surface Treatment | Asbestos Type | Material Assessment Total | Material Risk Rating | Accessibility | Sample Reference | Asbestos Identification | Recommendations / Comments | Photographs |
|---|---|---|---|---|---|---|---|---|---|---|---|---|---|
| Administration Building<br>1st Floor<br>001 Large office | Textured coating to plasterboard ceiling | 50 m² | - | - | - | - | - | - | - | 70026829/MC001 | No asbestos detected | Wooden floor, brick and plasterboard walls, plasterboard ceiling. | |

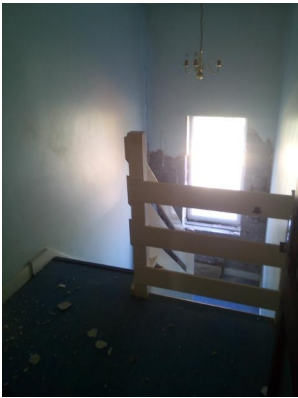
| Location | Item Description | Extent / Quantity | Product Type | Damage Extent | Surface Treatment | Asbestos Type | Material Assessment Total | Material Risk Rating | Accessibility | Sample Reference | Asbestos Identification | Recommendations / Comments | Photographs |
|---|---|---|---|---|---|---|---|---|---|---|---|---|---|
| Administration Building<br>1st Floor<br>002 Stairwell | Textured coating to plasterboard ceiling | 10 m <sup>2</sup> | - | - | - | - | - | - | - | 70026829/MC002 | No asbestos detected | Wooden floor, brick and plasterboard walls, plasterboard ceiling, wooden stairs. | |

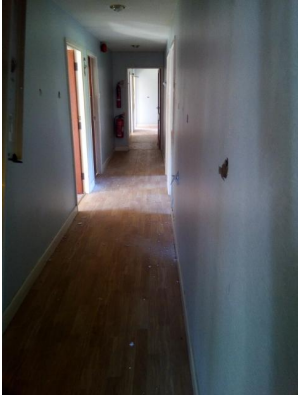
| Location | Item Description | Extent / Quantity | Product Type | Damage Extent | Surface Treatment | Asbestos Type | Material Assessment Total | Material Risk Rating | Accessibility | Sample Reference | Asbestos Identification | Recommendations / Comments | Photographs |
|---|---|---|---|---|---|---|---|---|---|---|---|---|---|
| Administration Building<br>1st Floor<br>003 Corridor | Textured coating to plasterboard ceiling | 14 m <sup>2</sup> | - | - | - | - | - | - | - | As70026829/MC002 | No asbestos detected | Wooden floor, brick and plasterboard walls, plasterboard ceiling. | |

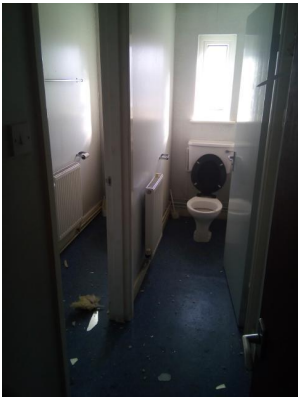
| Location | Item Description | Extent / Quantity | Product Type | Damage Extent | Surface Treatment | Asbestos Type | Material Assessment Total | Material Risk Rating | Accessibility | Sample Reference | Asbestos Identification | Recommendations / Comments | Photographs |
|---|---|---|---|---|---|---|---|---|---|---|---|---|---|
| Administration Building<br>1st Floor<br>004 WC | Textured coating to plasterboard ceiling | 16 m <sup>2</sup> | - | - | - | - | - | - | - | As70026829/MC002 | No asbestos detected | Wooden floor, brick and plasterboard walls, plasterboard ceiling, ceramic cistern. | |

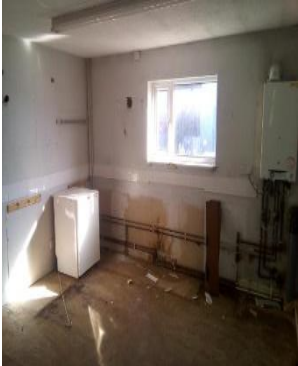
| Location | Item Description | Extent / Quantity | Product Type | Damage Extent | Surface Treatment | Asbestos Type | Material Assessment Total | Material Risk Rating | Accessibility | Sample Reference | Asbestos Identification | Recommendations / Comments | Photographs |
|---|---|---|---|---|---|---|---|---|---|---|---|---|---|
| Administration Building<br>1st Floor<br>005 Canteen | Textured coating to plasterboard ceiling | 10 m <sup>2</sup> | - | - | - | - | - | - | - | As70026829/MC002 | No asbestos detected | Wooden floor, brick and plasterboard walls, plasterboard ceiling, modern boiler, wooden boxing. | |

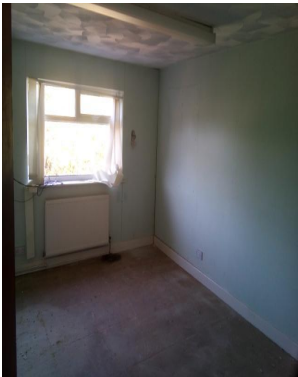
| Location | Item Description | Extent / Quantity | Product Type | Damage Extent | Surface Treatment | Asbestos Type | Material Assessment Total | Material Risk Rating | Accessibility | Sample Reference | Asbestos Identification | Recommendations / Comments | Photographs |
|---|---|---|---|---|---|---|---|---|---|---|---|---|---|
| Administration Building<br>1st Floor<br>006 Office | Textured coating to plasterboard ceiling | 16 m <sup>2</sup> | - | - | - | - | - | - | - | As70026829/MC001 | No asbestos detected | Wooden floor, brick and plasterboard walls, plasterboard ceiling. | |

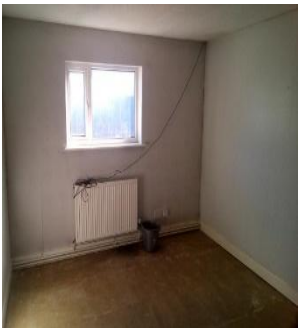
| Location | Item Description | Extent / Quantity | Product Type | Damage Extent | Surface Treatment | Asbestos Type | Material Assessment Total | Material Risk Rating | Accessibility | Sample Reference | Asbestos Identification | Recommendations / Comments | Photographs |
|---|---|---|---|---|---|---|---|---|---|---|---|---|---|
| Administration Building<br>1st Floor<br>007 Office | Textured coating to plasterboard ceiling | 10 m <sup>2</sup> | - | - | - | - | - | - | - | As70026829/MC002 | No asbestos detected | Wooden floor, brick and plasterboard walls, plasterboard ceiling. | |

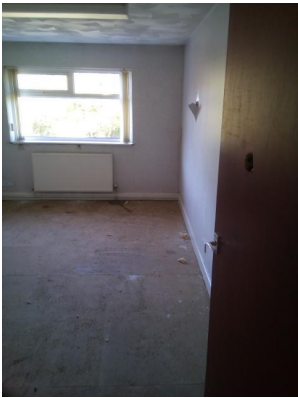
| Location | Item Description | Extent / Quantity | Product Type | Damage Extent | Surface Treatment | Asbestos Type | Material Assessment Total | Material Risk Rating | Accessibility | Sample Reference | Asbestos Identification | Recommendations / Comments | Photographs |
|---|---|---|---|---|---|---|---|---|---|---|---|---|---|
| Administration Building<br>1st Floor<br>008 Office | Textured coating to plasterboard ceiling | 12 m² | - | - | - | - | - | - | - | As70026829/MC001 | No asbestos detected | Wooden floor, brick and plasterboard walls, plasterboard ceiling. | |

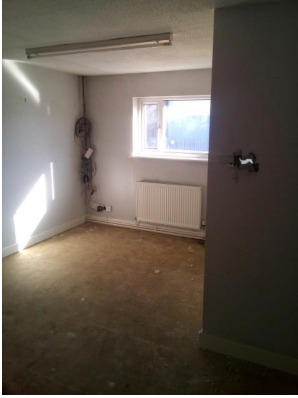
| Location | Item Description | Extent / Quantity | Product Type | Damage Extent | Surface Treatment | Asbestos Type | Material Assessment Total | Material Risk Rating | Accessibility | Sample Reference | Asbestos Identification | Recommendations / Comments | Photographs |
|---|---|---|---|---|---|---|---|---|---|---|---|---|---|
| Administration Building<br>1st Floor<br>009 Office | Textured coating to plasterboard ceiling | 10 m² | - | - | - | - | - | - | - | 70026829/MC003 | No asbestos detected | Wooden floor, brick and plasterboard walls, plasterboard ceiling. | |

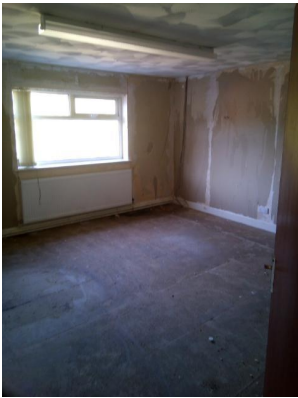
| Location | Item Description | Extent / Quantity | Product Type | Damage Extent | Surface Treatment | Asbestos Type | Material Assessment Total | Material Risk Rating | Accessibility | Sample Reference | Asbestos Identification | Recommendations / Comments | Photographs |
|---|---|---|---|---|---|---|---|---|---|---|---|---|---|
| Administration Building<br>1st Floor<br>010 Office | Textured coating to plasterboard ceiling | 20 m <sup>2</sup> | - | - | - | - | - | - | - | As70026829/MC001 | No asbestos detected | Wooden floor, brick and plasterboard walls, plasterboard ceiling. | |

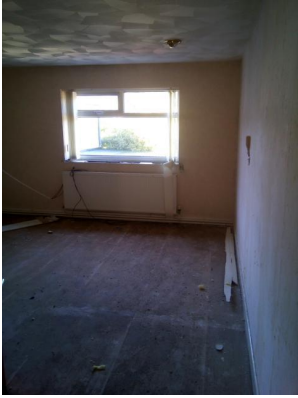
| Location | Item Description | Extent / Quantity | Product Type | Damage Extent | Surface Treatment | Asbestos Type | Material Assessment Total | Material Risk Rating | Accessibility | Sample Reference | Asbestos Identification | Recommendations / Comments | Photographs |
|---|---|---|---|---|---|---|---|---|---|---|---|---|---|
| Administration Building<br>1st Floor<br>011 Office | Textured coating to plasterboard ceiling | 18 m <sup>2</sup> | - | - | - | - | - | - | - | As70026829/MC001 | No asbestos detected | Wooden floor, brick and plasterboard walls, plasterboard ceiling. | |

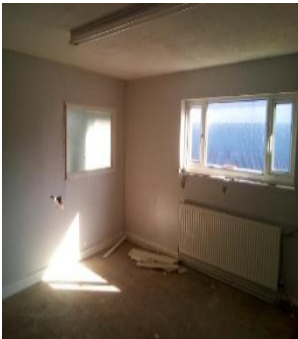
| Location | Item Description | Extent / Quantity | Product Type | Damage Extent | Surface Treatment | Asbestos Type | Material Assessment Total | Material Risk Rating | Accessibility | Sample Reference | Asbestos Identification | Recommendations / Comments | Photographs |
|---|---|---|---|---|---|---|---|---|---|---|---|---|---|
| Administration Building<br>1st Floor<br>012 Office | Textured coating to plasterboard ceiling | 18 m <sup>2</sup> | - | - | - | - | - | - | - | As70026829/MC003 | No asbestos detected | Wooden floor, brick and plasterboard walls, plasterboard ceiling. | |

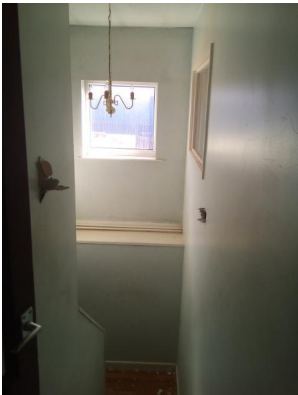
| Location | Item Description | Extent / Quantity | Product Type | Damage Extent | Surface Treatment | Asbestos Type | Material Assessment Total | Material Risk Rating | Accessibility | Sample Reference | Asbestos Identification | Recommendations / Comments | Photographs |
|---|---|---|---|---|---|---|---|---|---|---|---|---|---|
| Administration Building<br>1st Floor<br>013 Stairwell | Textured coating to plasterboard ceiling | 10 m <sup>2</sup> | - | - | - | - | - | - | - | As70026829/MC003 | No asbestos detected | Wooden floor, brick and plasterboard walls, plasterboard ceiling, wooden stairs, laminate flooring. | |

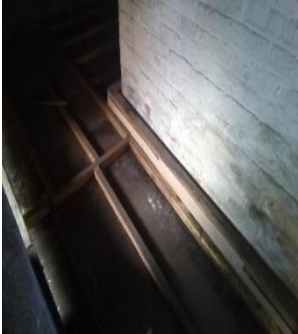
| Location | Item Description | Extent / Quantity | Product Type | Damage Extent | Surface Treatment | Asbestos Type | Material Assessment Total | Material Risk Rating | Accessibility | Sample Reference | Asbestos Identification | Recommendations / Comments | Photographs |
|---|---|---|---|---|---|---|---|---|---|---|---|---|---|
| Administration Building<br>1st Floor<br>014 Store | Insulation board exposed wall from rooms 017-019 directly below | 5 lm | - | - | - | - | - | - | - | As70026829/MC005 | No asbestos detected | - | |

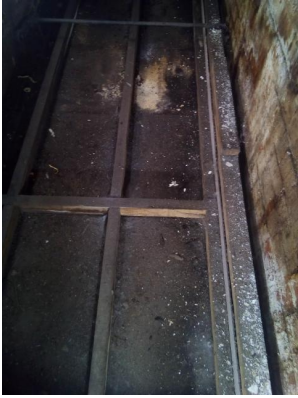
| Location | Item Description | Extent / Quantity | Product Type | Damage Extent | Surface Treatment | Asbestos Type | Material Assessment Total | Material Risk Rating | Accessibility | Sample Reference | Asbestos Identification | Recommendations / Comments | Photographs |
|---|---|---|---|---|---|---|---|---|---|---|---|---|---|
| Administration Building<br>1st Floor<br>014 Warehouse Store | Debris to top of ceiling to room below | 2 m <sup>2</sup> | - | - | - | - | - | - | - | 70043831/MCAs70026829/MC009 | No asbestos detected | - | |

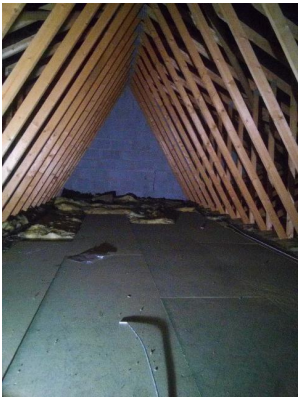
| Location | Item Description | Extent / Quantity | Product Type | Damage Extent | Surface Treatment | Asbestos Type | Material Assessment Total | Material Risk Rating | Accessibility | Sample Reference | Asbestos Identification | Recommendations / Comments | Photographs |
|---|---|---|---|---|---|---|---|---|---|---|---|---|---|
| Administration Building<br>2nd Floor<br>001 Loft Space 1 | No asbestos suspected | | - | - | - | - | - | - | - | - | - | Plasterboard base, part wooden flooring, brick walls, mmmf insulation, modern sarking felt, plastic flue. | |

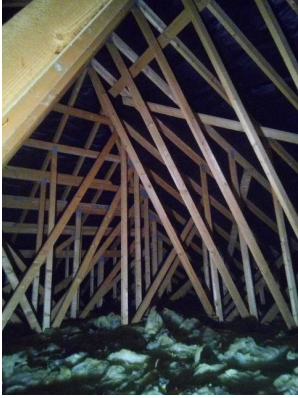
| Location | Item Description | Extent / Quantity | Product Type | Damage Extent | Surface Treatment | Asbestos Type | Material Assessment Total | Material Risk Rating | Accessibility | Sample Reference | Asbestos Identification | Recommendations / Comments | Photographs |
|---|---|---|---|---|---|---|---|---|---|---|---|---|---|
| Administration Building<br>2nd Floor<br>002 Loft Space 2 | No asbestos suspected | | - | - | - | - | - | - | - | - | - | Plasterboard base, brick walls, mmmf insulation, modern sarking felt, plastic flue. | |

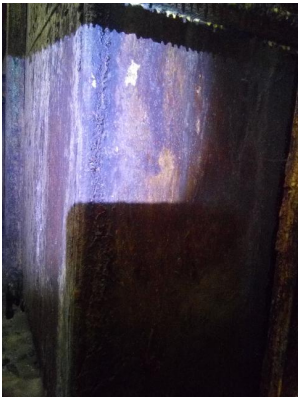
| Location | Item Description | Extent / Quantity | Product Type | Damage Extent | Surface Treatment | Asbestos Type | Material Assessment Total | Material Risk Rating | Accessibility | Sample Reference | Asbestos Identification | Recommendations / Comments | Photographs |
|---|---|---|---|---|---|---|---|---|---|---|---|---|---|
| Main Factory Basement<br>002 Caustic soda & bleachers | Bitumen coating to tanks | 100 m <sup>2</sup> | - | - | - | - | - | - | - | 70043831/JM009 | No asbestos detected | Concrete floor, brick walls, metal pipes, metal tanks with kingspan insulation.<br>Ceiling room 0/025 | |

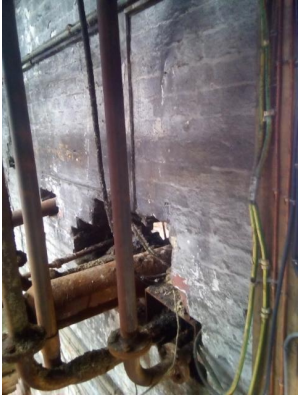
| Location | Item Description | Extent / Quantity | Product Type | Damage Extent | Surface Treatment | Asbestos Type | Material Assessment Total | Material Risk Rating | Accessibility | Sample Reference | Asbestos Identification | Recommendations / Comments | Photographs |
|---|---|---|---|---|---|---|---|---|---|---|---|---|---|
| Main Factory Ground Floor<br>001 Boiler House | Residual insulation to wall around pipe penetration to room 0/024 | 5 m <sup>2</sup> | - | - | - | - | - | - | - | 70043831/JM013 | No asbestos detected | Concrete floor, concrete ducts, brick and block walls. | |

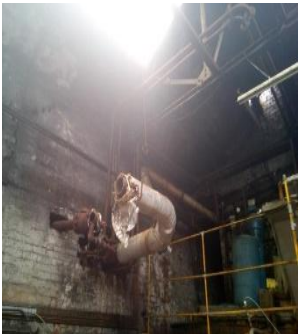
| Location | Item Description | Extent / Quantity | Product Type | Damage Extent | Surface Treatment | Asbestos Type | Material Assessment Total | Material Risk Rating | Accessibility | Sample Reference | Asbestos Identification | Recommendations / Comments | Photographs |
|---|---|---|---|---|---|---|---|---|---|---|---|---|---|
| Main Factory Ground Floor<br>001 Boiler House | Composite sample of gaskets | Througout No. | 2 | 1 | 1 | 1 | 5 | Low | High | 70026829/MC014 | Chrysotile | Remove | |

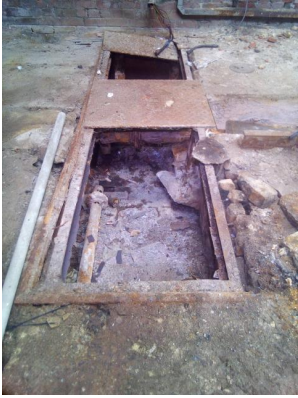
| Location | Item Description | Extent / Quantity | Product Type | Damage Extent | Surface Treatment | Asbestos Type | Material Assessment Total | Material Risk Rating | Accessibility | Sample Reference | Asbestos Identification | Recommendations / Comments | Photographs |
|---|---|---|---|---|---|---|---|---|---|---|---|---|---|
| Main Factory Ground Floor<br>001 Boiler House | Composite sample to pipe in floor duct | 4 m <sup>2</sup> | - | - | - | - | - | - | - | 70026829/MC017 | No asbestos detected | - | |

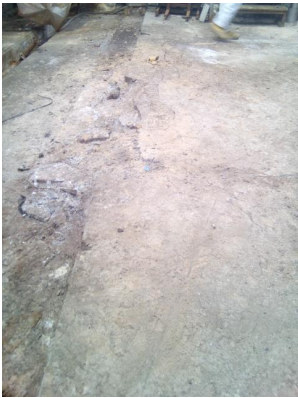
| Location | Item Description | Extent / Quantity | Product Type | Damage Extent | Surface Treatment | Asbestos Type | Material Assessment Total | Material Risk Rating | Accessibility | Sample Reference | Asbestos Identification | Recommendations / Comments | Photographs |
|---|---|---|---|---|---|---|---|---|---|---|---|---|---|
| Main Factory<br>Ground Floor<br>001 Boiler House | Composite sample to floor | 60 m <sup>2</sup> | - | - | - | - | - | - | - | 70026829/MC018 | No asbestos detected | - | |

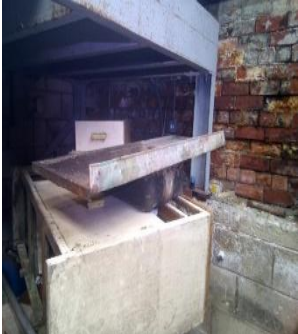
| Location | Item Description | Extent / Quantity | Product Type | Damage Extent | Surface Treatment | Asbestos Type | Material Assessment Total | Material Risk Rating | Accessibility | Sample Reference | Asbestos Identification | Recommendations / Comments | Photographs |
|---|---|---|---|---|---|---|---|---|---|---|---|---|---|
| Main Factory<br>Ground Floor<br>001 Boiler House | Sink pad | 1 No. | - | - | - | - | - | - | - | 70026829/MC019 | No asbestos detected | - | |

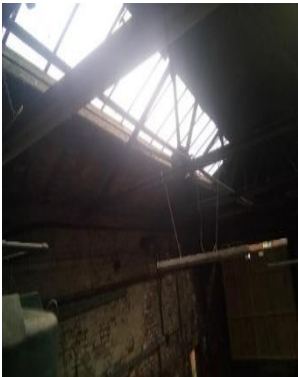
| Location | Item Description | Extent / Quantity | Product Type | Damage Extent | Surface Treatment | Asbestos Type | Material Assessment Total | Material Risk Rating | Accessibility | Sample Reference | Asbestos Identification | Recommendations / Comments | Photographs |
|---|---|---|---|---|---|---|---|---|---|---|---|---|---|
| Main Factory Ground Floor<br>001 Boiler House | Rope seal to skylights | 15 windows No. | 2 | 1 | 1 | 1 | 5 | Low | High | As70026829/MC006 | Chrysotile | Remove | |

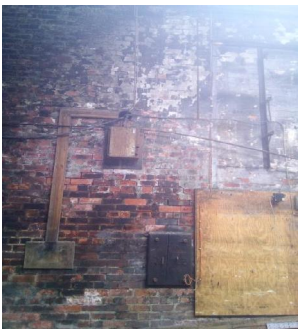
| Location | Item Description | Extent / Quantity | Product Type | Damage Extent | Surface Treatment | Asbestos Type | Material Assessment Total | Material Risk Rating | Accessibility | Sample Reference | Asbestos Identification | Recommendations / Comments | Photographs |
|---|---|---|---|---|---|---|---|---|---|---|---|---|---|
| Main Factory Ground Floor<br>001 Boiler House | Flashguards to electrics | 1 No. | 2 | 1 | 1 | 1 | 5 | Low | High | As70026829/MC007 | Chrysotile | Remove | |

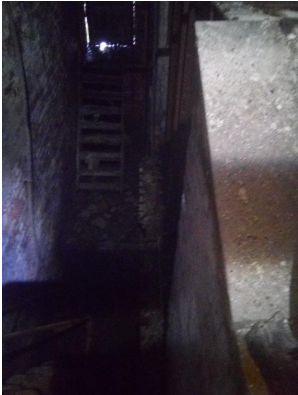
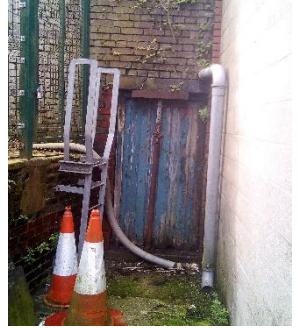
| Location | Item Description | Extent / Quantity | Product Type | Damage Extent | Surface Treatment | Asbestos Type | Material Assessment Total | Material Risk Rating | Accessibility | Sample Reference | Asbestos Identification | Recommendations / Comments | Photographs |
|---|---|---|---|---|---|---|---|---|---|---|---|---|---|
| Main Factory Ground Floor<br>002 Area to rear of boiler house | No access | - | - | - | - | - | - | - | - | Presumed 02 | Presumed Asbestos | <p>No safe access. Wooden platform supporting metal stairs in poor state. No access through external door behind chimney due to the concrete lintel being cracked and supported with an acrow</p> <p>Care should be taken during demolition and work stopped if suspect material is discovered whilst removing the boiler work should be stopped</p> <p>Viewed from above only.</p> <p>Brick walls, metal burner unit and associated pipework, mmmf pipe insulation, high-level.</p> | |

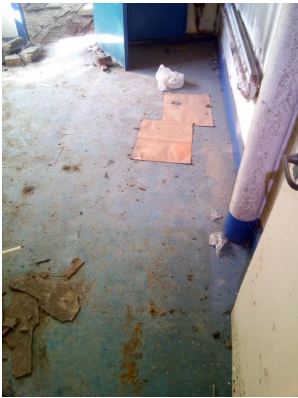
| Location | Item Description | Extent / Quantity | Product Type | Damage Extent | Surface Treatment | Asbestos Type | Material Assessment Total | Material Risk Rating | Accessibility | Sample Reference | Asbestos Identification | Recommendations / Comments | Photographs |
|---|---|---|---|---|---|---|---|---|---|---|---|---|---|
| Main Factory Ground Floor 003 Office | Flooring | 12 m <sup>2</sup> | - | - | - | - | - | - | - | 70026829/MC020 | No asbestos detected | Wooden floor, plaster and brick walls, wooden boxing & ceiling, mmmf pipe insulation. | |

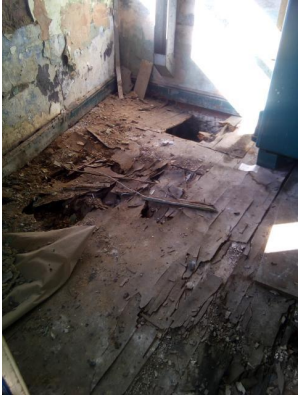
| Location | Item Description | Extent / Quantity | Product Type | Damage Extent | Surface Treatment | Asbestos Type | Material Assessment Total | Material Risk Rating | Accessibility | Sample Reference | Asbestos Identification | Recommendations / Comments | Photographs |
|---|---|---|---|---|---|---|---|---|---|---|---|---|---|
| Main Factory Ground Floor 004 Office | Flooring | 12 m <sup>2</sup> | - | - | - | - | - | - | - | 70026829/MC021 | No asbestos detected | Wooden floor, plaster and brick walls, wooden boxing & ceiling, mmmf pipe insulation, metal down pipe, metal wall heater, large safe. | |

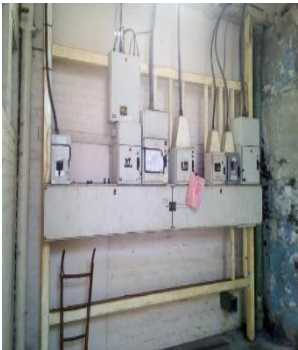
| Location | Item Description | Extent / Quantity | Product Type | Damage Extent | Surface Treatment | Asbestos Type | Material Assessment Total | Material Risk Rating | Accessibility | Sample Reference | Asbestos Identification | Recommendations / Comments | Photographs |
|---|---|---|---|---|---|---|---|---|---|---|---|---|---|
| Main Factory Ground Floor 005 Loading Bay | Flashguards to electrics | 10 No. | 2 | 1 | 1 | 1 | 5 | Low | Low | As 70026829/MC007 | Chrysotile | Remove | |

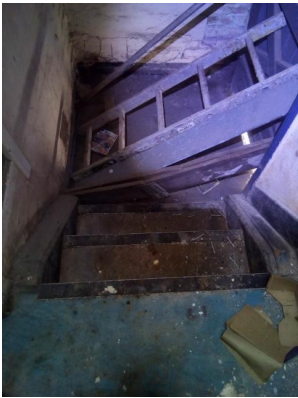
| Location | Item Description | Extent / Quantity | Product Type | Damage Extent | Surface Treatment | Asbestos Type | Material Assessment Total | Material Risk Rating | Accessibility | Sample Reference | Asbestos Identification | Recommendations / Comments | Photographs |
|---|---|---|---|---|---|---|---|---|---|---|---|---|---|
| Main Factory Ground Floor 006 Entrance | Stair nosing | 3 lm | - | - | - | - | - | - | - | 70026829/MC022 | No asbestos detected | Wooden floor, plaster and brick walls, wooden ceiling, metal down pipes. | |

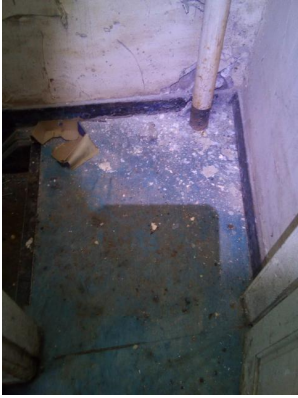
| Location | Item Description | Extent / Quantity | Product Type | Damage Extent | Surface Treatment | Asbestos Type | Material Assessment Total | Material Risk Rating | Accessibility | Sample Reference | Asbestos Identification | Recommendations / Comments | Photographs |
|---|---|---|---|---|---|---|---|---|---|---|---|---|---|
| Main Factory Ground Floor 006 Entrance | Flooring | 3 m² | - | - | - | - | - | - | - | As70026829/MC020 | No asbestos detected | - | |

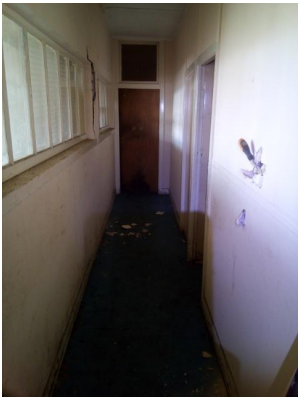
| Location | Item Description | Extent / Quantity | Product Type | Damage Extent | Surface Treatment | Asbestos Type | Material Assessment Total | Material Risk Rating | Accessibility | Sample Reference | Asbestos Identification | Recommendations / Comments | Photographs |
|---|---|---|---|---|---|---|---|---|---|---|---|---|---|
| Main Factory Ground Floor 007 Corridor | Flooring | 14 m <sup>2</sup> | - | - | - | - | - | - | - | As70026829/MC020 | No asbestos detected | - | |

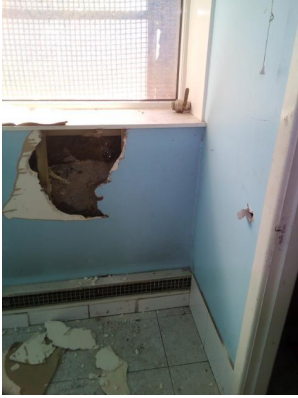
| Location | Item Description | Extent / Quantity | Product Type | Damage Extent | Surface Treatment | Asbestos Type | Material Assessment Total | Material Risk Rating | Accessibility | Sample Reference | Asbestos Identification | Recommendations / Comments | Photographs |
|---|---|---|---|---|---|---|---|---|---|---|---|---|---|
| Main Factory Ground Floor 008 Shower room | No asbestos suspected | - | - | - | - | - | - | - | - | - | - | Ceramic floor tiles, plaster walls wooden window will, wooden doors, plastic water pipe. | |

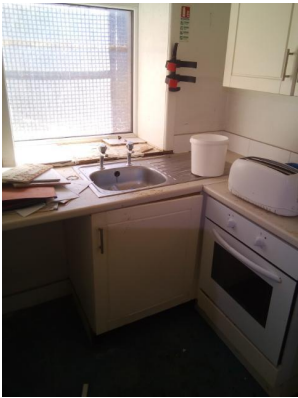
| Location | Item Description | Extent / Quantity | Product Type | Damage Extent | Surface Treatment | Asbestos Type | Material Assessment Total | Material Risk Rating | Accessibility | Sample Reference | Asbestos Identification | Recommendations / Comments | Photographs |
|---|---|---|---|---|---|---|---|---|---|---|---|---|---|
| Main Factory Ground Floor 009 Kitchen | Sink pad | 1 No. | - | - | - | - | - | - | - | 70026829/MC023 | No asbestos detected | Brick and plaster walls, wooden windowsill, plasterboard ceiling. | |

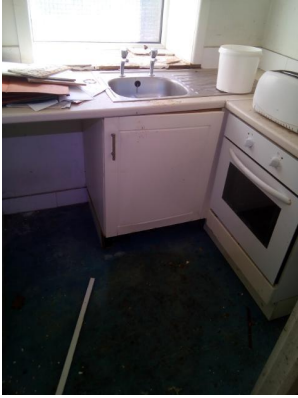
| Location | Item Description | Extent / Quantity | Product Type | Damage Extent | Surface Treatment | Asbestos Type | Material Assessment Total | Material Risk Rating | Accessibility | Sample Reference | Asbestos Identification | Recommendations / Comments | Photographs |
|---|---|---|---|---|---|---|---|---|---|---|---|---|---|
| Main Factory Ground Floor 009 Kitchen | Flooring | 3 m² | - | - | - | - | - | - | - | As70026829/MC020 | No asbestos detected | - | |

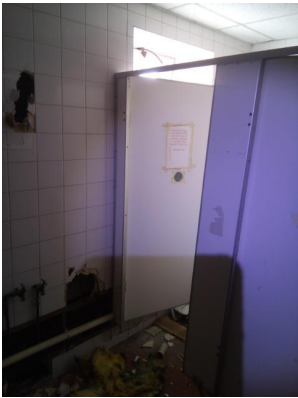
| Location | Item Description | Extent / Quantity | Product Type | Damage Extent | Surface Treatment | Asbestos Type | Material Assessment Total | Material Risk Rating | Accessibility | Sample Reference | Asbestos Identification | Recommendations / Comments | Photographs |
|---|---|---|---|---|---|---|---|---|---|---|---|---|---|
| Main Factory Ground Floor 010 Male WC | No asbestos suspected | | - | - | - | - | - | - | - | - | - | Ceramic floor tiles, brick and plaster walls, exposed metal pipes, compressed card ceiling tiles, plasterboard under ceramic tiled window will. | |

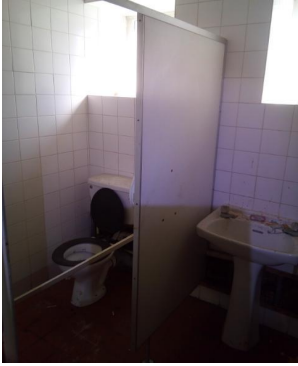
| Location | Item Description | Extent / Quantity | Product Type | Damage Extent | Surface Treatment | Asbestos Type | Material Assessment Total | Material Risk Rating | Accessibility | Sample Reference | Asbestos Identification | Recommendations / Comments | Photographs |
|---|---|---|---|---|---|---|---|---|---|---|---|---|---|
| Main Factory Ground Floor 011 Female WC | No asbestos suspected | | - | - | - | - | - | - | - | - | - | Ceramic floor tiles, brick and plaster walls, exposed metal pipes, compressed card ceiling tiles, plasterboard under ceramic tiled window will. | |

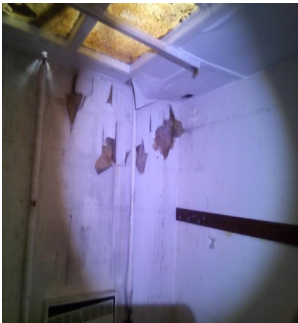
| Location | Item Description | Extent / Quantity | Product Type | Damage Extent | Surface Treatment | Asbestos Type | Material Assessment Total | Material Risk Rating | Accessibility | Sample Reference | Asbestos Identification | Recommendations / Comments | Photographs |
|---|---|---|---|---|---|---|---|---|---|---|---|---|---|
| Main Factory Ground Floor 012 Old locker room | Flooring | 14 m <sup>2</sup> | - | - | - | - | - | - | - | As70026829/MC020 | No asbestos detected | Vinyl flooring, solid walls, 1 partition, fibreboard and glass ceiling. | |

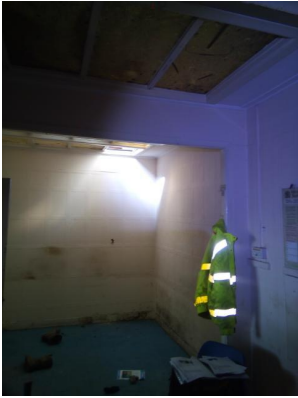
| Location | Item Description | Extent / Quantity | Product Type | Damage Extent | Surface Treatment | Asbestos Type | Material Assessment Total | Material Risk Rating | Accessibility | Sample Reference | Asbestos Identification | Recommendations / Comments | Photographs |
|---|---|---|---|---|---|---|---|---|---|---|---|---|---|
| Main Factory Ground Floor 013 Old Canteen | Flooring | 22 m <sup>2</sup> | - | - | - | - | - | - | - | As70026829/MC020 | No asbestos detected | Vinyl flooring, solid walls, 1 partition, fibreboard and glass ceiling. | |

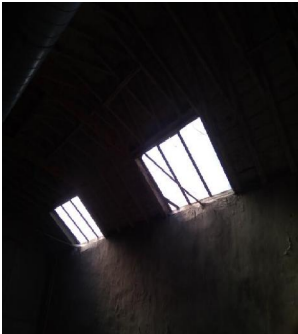
| Location | Item Description | Extent / Quantity | Product Type | Damage Extent | Surface Treatment | Asbestos Type | Material Assessment Total | Material Risk Rating | Accessibility | Sample Reference | Asbestos Identification | Recommendations / Comments | Photographs |
|---|---|---|---|---|---|---|---|---|---|---|---|---|---|
| Main Factory Ground Floor 014 Warehouse | Rope seal to skylights | 6 m <sup>2</sup> | 2 | 1 | 2 | 1 | 6 | Low | High | As70028629/MC006 | Chrysotile | Remove | |

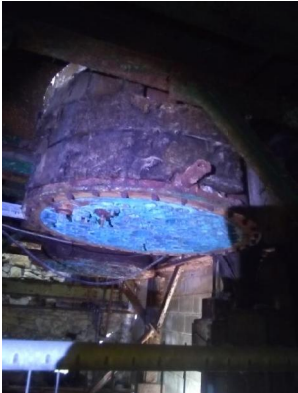
| Location | Item Description | Extent / Quantity | Product Type | Damage Extent | Surface Treatment | Asbestos Type | Material Assessment Total | Material Risk Rating | Accessibility | Sample Reference | Asbestos Identification | Recommendations / Comments | Photographs |
|---|---|---|---|---|---|---|---|---|---|---|---|---|---|
| Main Factory Ground Floor 016 Underside of Tanks | Residual insulation to 2 mmmf covered vessels | 2 x 6 m <sup>2</sup> | 3 | 3 | 3 | 2 | 11 | High | High | 70043831/JM003 | Amosite, Chrysotile | <b>Remove</b><br>Vessels have been re-lagged in mmmf insulation. | |

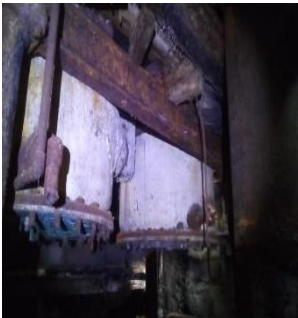
| Location | Item Description | Extent / Quantity | Product Type | Damage Extent | Surface Treatment | Asbestos Type | Material Assessment Total | Material Risk Rating | Accessibility | Sample Reference | Asbestos Identification | Recommendations / Comments | Photographs |
|---|---|---|---|---|---|---|---|---|---|---|---|---|---|
| Main Factory Ground Floor<br>016 Underside of Tanks | Insulation to 2 vessels | 2 X 5 m <sup>2</sup> | 3 | 3 | 3 | 2 | 11 | High | High | MC70026829/MC024 | Amosite, Chrysotile | <b>Remove</b><br><br>Concrete floor, brick walls, wooden ceiling, metal pipework, mmmf insulation to 2 vessels. | |

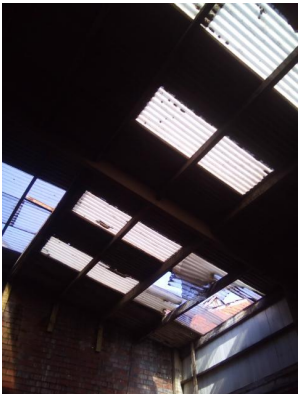
| Location | Item Description | Extent / Quantity | Product Type | Damage Extent | Surface Treatment | Asbestos Type | Material Assessment Total | Material Risk Rating | Accessibility | Sample Reference | Asbestos Identification | Recommendations / Comments | Photographs |
|---|---|---|---|---|---|---|---|---|---|---|---|---|---|
| Main Factory Ground Floor<br>017 Loading Bay | Cement roof | 55 m² | 1 | 2 | 1 | 1 | 5 | Low | Low | As 70026829/MC008 | Chrysotile | Concrete floor, brick metal & wooden walls, plastic skylights. | |

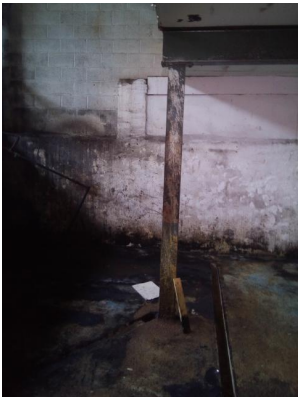
| Location | Item Description | Extent / Quantity | Product Type | Damage Extent | Surface Treatment | Asbestos Type | Material Assessment Total | Material Risk Rating | Accessibility | Sample Reference | Asbestos Identification | Recommendations / Comments | Photographs |
|---|---|---|---|---|---|---|---|---|---|---|---|---|---|
| Main Factory Ground Floor<br>022 Under Former P16 soap kettle | No asbestos suspected | | - | - | - | - | - | - | - | - | - | Concrete floor, brick & wooden walls, wooden ceiling. | |

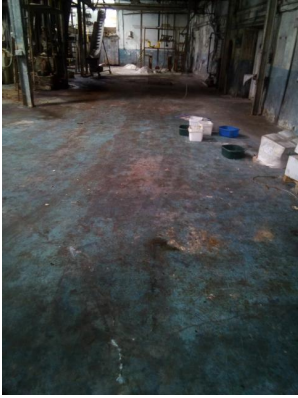
| Location | Item Description | Extent / Quantity | Product Type | Damage Extent | Surface Treatment | Asbestos Type | Material Assessment Total | Material Risk Rating | Accessibility | Sample Reference | Asbestos Identification | Recommendations / Comments | Photographs |
|---|---|---|---|---|---|---|---|---|---|---|---|---|---|
| Main Factory Ground Floor<br>023 Former Tank room 3 | Floor screed | 300 m <sup>2</sup> | - | - | - | - | - | - | - | 70043831/JM007 | No asbestos detected | Concrete floor, brick and plaster walls, plasterboard ceiling, exposed metal pipes, velux skylights, mmmf pipe insulation to small diameter pipework. | |

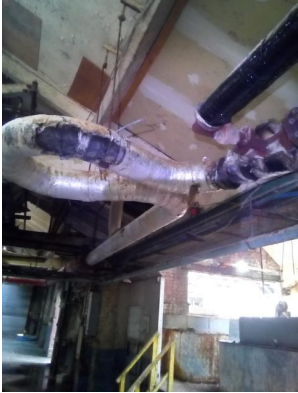
| Location | Item Description | Extent / Quantity | Product Type | Damage Extent | Surface Treatment | Asbestos Type | Material Assessment Total | Material Risk Rating | Accessibility | Sample Reference | Asbestos Identification | Recommendations / Comments | Photographs |
|---|---|---|---|---|---|---|---|---|---|---|---|---|---|
| Main Factory Ground Floor<br>023 Former Tank room 3 | Residual insulation to smaller diameter mmmf lagged pipe attached to large diameter hard set insulation pipe | 12 lm | 3 | 3 | 3 | 2 | 11 | High | High | 70043831/JM006 | Amosite, Chrysotile | Remove | |

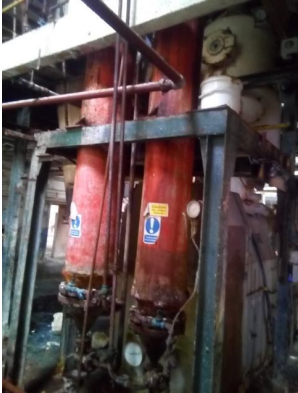
| Location | Item Description | Extent / Quantity | Product Type | Damage Extent | Surface Treatment | Asbestos Type | Material Assessment Total | Material Risk Rating | Accessibility | Sample Reference | Asbestos Identification | Recommendations / Comments | Photographs |
|---|---|---|---|---|---|---|---|---|---|---|---|---|---|
| Main Factory Ground Floor<br>023 Former Tank room 3 | Large diameter pipe insulation to vertical vessels | 2 X 4 lm | 3 | 2 | 2 | 2 | 9 | Med | High | 70026829/MC025 | Amosite, Chrysotile | Remove | |

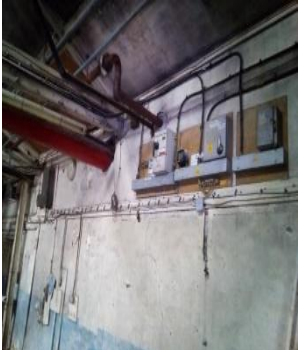
| Location | Item Description | Extent / Quantity | Product Type | Damage Extent | Surface Treatment | Asbestos Type | Material Assessment Total | Material Risk Rating | Accessibility | Sample Reference | Asbestos Identification | Recommendations / Comments | Photographs |
|---|---|---|---|---|---|---|---|---|---|---|---|---|---|
| Main Factory Ground Floor<br>023 Former Tank room 3 | Flashguards to electrics | 5 Boxes No. | 2 | 1 | 1 | 1 | 5 | Low | High | As70026829/MC007 | Chrysotile | Remove | |

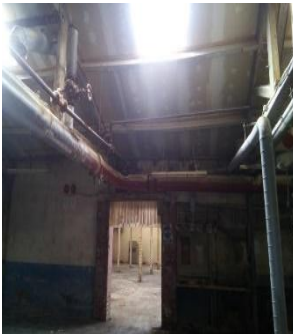
| Location | Item Description | Extent / Quantity | Product Type | Damage Extent | Surface Treatment | Asbestos Type | Material Assessment Total | Material Risk Rating | Accessibility | Sample Reference | Asbestos Identification | Recommendations / Comments | Photographs |
|---|---|---|---|---|---|---|---|---|---|---|---|---|---|
| Main Factory Ground Floor<br>023 Former Tank room 3 | Large diameter hard set pipe insulation up to joining smaller diameter mmmf lagged pipe | 15 lm | 3 | 2 | 2 | 2 | 9 | Med | Med | As70026829/MC025 | Amosite, Chrysotile | Remove | |

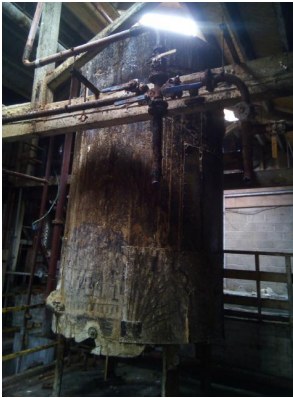
| Location | Item Description | Extent / Quantity | Product Type | Damage Extent | Surface Treatment | Asbestos Type | Material Assessment Total | Material Risk Rating | Accessibility | Sample Reference | Asbestos Identification | Recommendations / Comments | Photographs |
|---|---|---|---|---|---|---|---|---|---|---|---|---|---|
| Main Factory Ground Floor<br>024 Former Tank room 4 | Insulation to vessel / tank | 20 m² | - | - | - | - | - | - | - | 700206829/MC027 | No asbestos detected | Concrete floor, brick and plaster walls, plasterboard ceiling, exposed metal pipes, mmmf pipe insulation to small diameter pipes, metal ducting. Wooden office to corner of room | |

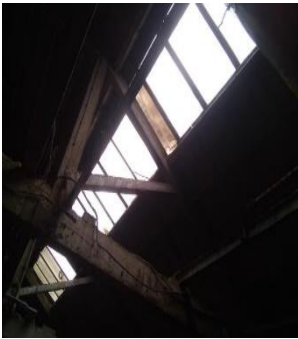
| Location | Item Description | Extent / Quantity | Product Type | Damage Extent | Surface Treatment | Asbestos Type | Material Assessment Total | Material Risk Rating | Accessibility | Sample Reference | Asbestos Identification | Recommendations / Comments | Photographs |
|---|---|---|---|---|---|---|---|---|---|---|---|---|---|
| Main Factory Ground Floor<br>024 Former Tank room 4 | Rope seal to skylights | 44 Windows No. | 2 | 1 | 1 | 1 | 5 | Low | Med | 70026829/MC006 | Chrysotile | Remove | |

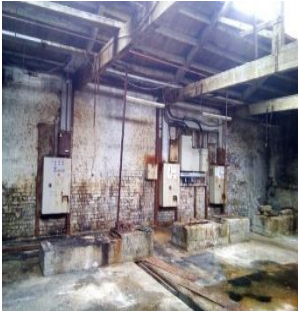
| Location | Item Description | Extent / Quantity | Product Type | Damage Extent | Surface Treatment | Asbestos Type | Material Assessment Total | Material Risk Rating | Accessibility | Sample Reference | Asbestos Identification | Recommendations / Comments | Photographs |
|---|---|---|---|---|---|---|---|---|---|---|---|---|---|
| Main Factory Ground Floor<br>024 Former Tank room 4 | Flashguards to electrics | 5 boxes No. | 2 | 1 | 2 | 1 | 6 | Low | Med | As70026829/MC007 | Chrysotile | Remove | |

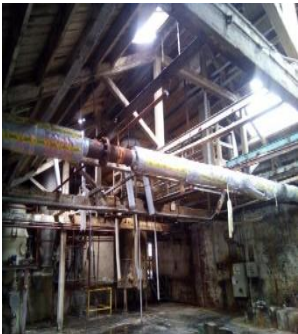
| Location | Item Description | Extent / Quantity | Product Type | Damage Extent | Surface Treatment | Asbestos Type | Material Assessment Total | Material Risk Rating | Accessibility | Sample Reference | Asbestos Identification | Recommendations / Comments | Photographs |
|---|---|---|---|---|---|---|---|---|---|---|---|---|---|
| Main Factory Ground Floor<br>024 Former Tank room 4 | Large diameter pipe insulation | 12 lm | 3 | 2 | 2 | 2 | 9 | Med | Med | 70026829/MC025 | Amosite, Chrysotile | <b>Remove</b><br><br><b>Includes wall penetration to room 0/023</b> | |

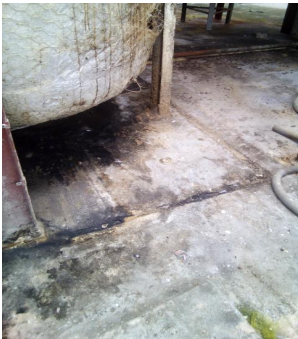
| Location | Item Description | Extent / Quantity | Product Type | Damage Extent | Surface Treatment | Asbestos Type | Material Assessment Total | Material Risk Rating | Accessibility | Sample Reference | Asbestos Identification | Recommendations / Comments | Photographs |
|---|---|---|---|---|---|---|---|---|---|---|---|---|---|
| Main Factory Ground Floor<br>025 Caustic soda & bleachers room | Loose gaskets to the floor | Througout No. | 2 | 1 | 1 | 1 | 5 | Low | High | 70043831/MCJM008 | Chrysotile | <b>Remove</b><br><br>Loose gaskets throughout. | |

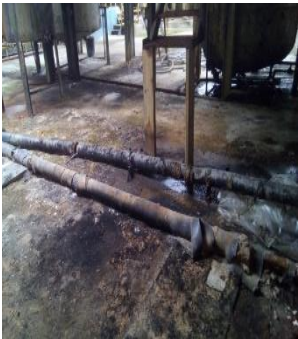
| Location | Item Description | Extent / Quantity | Product Type | Damage Extent | Surface Treatment | Asbestos Type | Material Assessment Total | Material Risk Rating | Accessibility | Sample Reference | Asbestos Identification | Recommendations / Comments | Photographs |
|---|---|---|---|---|---|---|---|---|---|---|---|---|---|
| Main Factory Ground Floor<br>025 Caustic soda & bleachers room | Hard set pipe insulation | 11 lm | 3 | 3 | 3 | 3 | 12 | High | High | As70026829/MC029 | Crocidolite, Amosite & Chrysotile | Remove, Restrict access until made safe<br><br>The 2 pipes have been cut down and are laid on the floor. | |

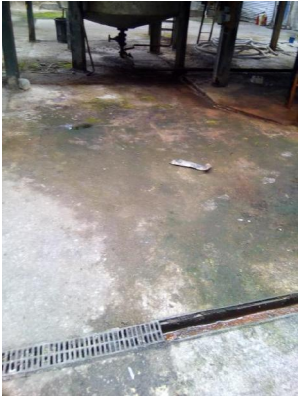
| Location | Item Description | Extent / Quantity | Product Type | Damage Extent | Surface Treatment | Asbestos Type | Material Assessment Total | Material Risk Rating | Accessibility | Sample Reference | Asbestos Identification | Recommendations / Comments | Photographs |
|---|---|---|---|---|---|---|---|---|---|---|---|---|---|
| Main Factory Ground Floor<br>025 Caustic soda & bleachers room | Insulation debris to floor | 1 m² | - | - | - | - | - | - | - | 70026829/MC30 | No asbestos detected | - | |

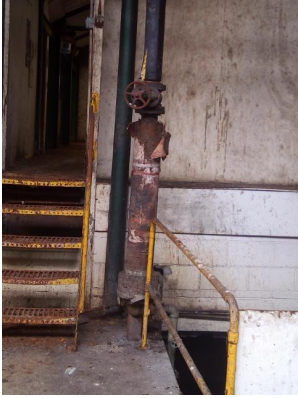
| Location | Item Description | Extent / Quantity | Product Type | Damage Extent | Surface Treatment | Asbestos Type | Material Assessment Total | Material Risk Rating | Accessibility | Sample Reference | Asbestos Identification | Recommendations / Comments | Photographs |
|---|---|---|---|---|---|---|---|---|---|---|---|---|---|
| Main Factory Ground Floor<br>025 Caustic soda & bleachers room | Vertical pipe insulation next to room 0/022 | 2 lm | - | - | - | - | - | - | - | As70026829/MC027 | No asbestos detected | Cork pipe insulation. | |
