## ASBESTOS DEMOLITION SURVEY

Former Soap Works, Kenyon St Works, Kenyon St, Ramsbottom, BL0 0AB

PROJECT NO. 70064333 -- 70043831

DATE: September 2019

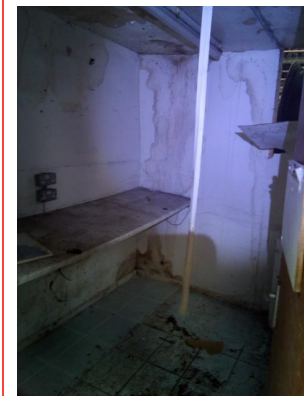
| Location | Item Description | Extent / Quantity | Product Type | Damage Extent | Surface Treatment | Asbestos Type | Material Assessment Total | Material Risk Rating | Accessibility | Sample Reference | Asbestos Identification | Recommendations / Comments | Photographs |
|---|---|---|---|---|---|---|---|---|---|---|---|---|---|
| Main Factory Ground Floor<br>026 Caustic soda & bleachers Office | No asbestos suspected | | - | - | - | - | - | - | - | - | - | Ceramic floor tiles, wooden walls and ceiling. | |

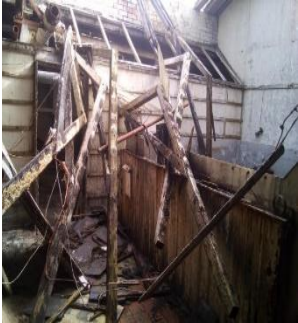
| Location | Item Description | Extent / Quantity | Product Type | Damage Extent | Surface Treatment | Asbestos Type | Material Assessment Total | Material Risk Rating | Accessibility | Sample Reference | Asbestos Identification | Recommendations / Comments | Photographs |
|---|---|---|---|---|---|---|---|---|---|---|---|---|---|
| Main Factory<br>Ground Floor<br>Mezzanine<br>001 Soap kettle P1 & P2 | No access | - | - | - | - | - | - | Very Low | - | Presumed 03 | Presumed Asbestos | <b>Roof has collapsed - Not safe to inspect.</b><br><br>Tanks wooden cladding over insulation onto metal.<br><br><b>Care should be taken during demolition and work stopped if suspect material are discovered</b> | |

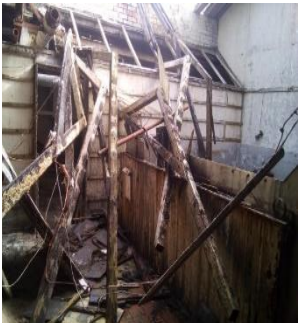
| Location | Item Description | Extent / Quantity | Product Type | Damage Extent | Surface Treatment | Asbestos Type | Material Assessment Total | Material Risk Rating | Accessibility | Sample Reference | Asbestos Identification | Recommendations / Comments | Photographs |
|---|---|---|---|---|---|---|---|---|---|---|---|---|---|
| Main Factory<br>Ground Floor<br>Mezzanine<br>001 Soap kettle P1 & P2 | Soap kettle P1 & P2 tank insulation | 2 x 20 m <sup>2</sup> | - | - | - | - | - | - | - | 70043831/JM010 | No asbestos detected | <b>Samples taken from tanks P1 &amp; P2</b> | |

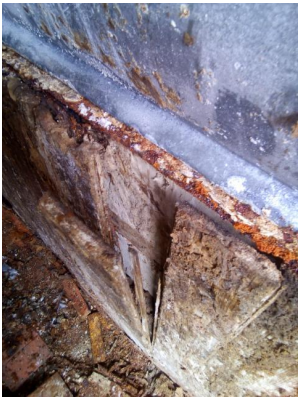
| Location | Item Description | Extent / Quantity | Product Type | Damage Extent | Surface Treatment | Asbestos Type | Material Assessment Total | Material Risk Rating | Accessibility | Sample Reference | Asbestos Identification | Recommendations / Comments | Photographs |
|---|---|---|---|---|---|---|---|---|---|---|---|---|---|
| Main Factory Ground Floor Mezzanine<br>002 Soap kettle P3-P6 | Insulation to kettle P3, under metal and wooden cladding | 30 m <sup>2</sup> | 3 | 2 | 3 | 3 | 11 | High | High | As 70043831/JM011 | Crocidolite, Amosite & Chrysotile | Wooden floor, ceramic floor tile covered, brick walls, metal tanks. | |

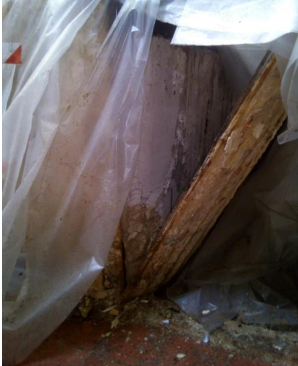
| Location | Item Description | Extent / Quantity | Product Type | Damage Extent | Surface Treatment | Asbestos Type | Material Assessment Total | Material Risk Rating | Accessibility | Sample Reference | Asbestos Identification | Recommendations / Comments | Photographs |
|---|---|---|---|---|---|---|---|---|---|---|---|---|---|
| Main Factory Ground Floor Mezzanine<br>002 Soap kettle P3-P6 | Insulation to kettle P5, under metal and wooden cladding | 64 m <sup>2</sup> | 3 | 2 | 3 | 3 | 11 | High | High | 70043831/JM011 | Crocidolite, Amosite & Chrysotile | <b>Remove</b> | |

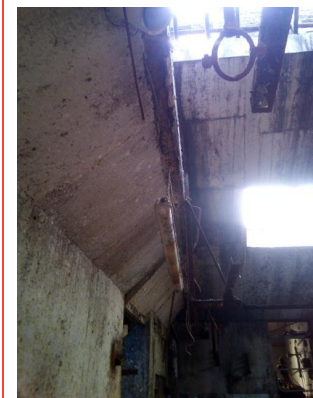
| Location | Item Description | Extent / Quantity | Product Type | Damage Extent | Surface Treatment | Asbestos Type | Material Assessment Total | Material Risk Rating | Accessibility | Sample Reference | Asbestos Identification | Recommendations / Comments | Photographs |
|---|---|---|---|---|---|---|---|---|---|---|---|---|---|
| Main Factory<br>Ground Floor<br>Mezzanine<br>002 Soap kettle P3- | Insulation board walls & ceiling | 150 m <sup>2</sup> | - | - | - | - | - | - | - | As70026829/MC005 | No asbestos detected | - | |

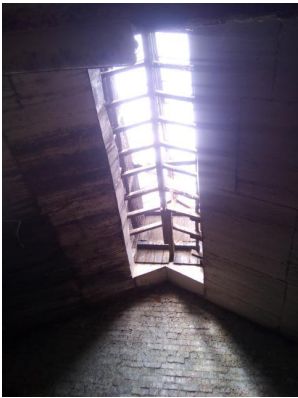
| Location | Item Description | Extent / Quantity | Product Type | Damage Extent | Surface Treatment | Asbestos Type | Material Assessment Total | Material Risk Rating | Accessibility | Sample Reference | Asbestos Identification | Recommendations / Comments | Photographs |
|---|---|---|---|---|---|---|---|---|---|---|---|---|---|
| Main Factory<br>Ground Floor<br>Mezzanine<br>002 Soap kettle P3- | Rope to skylights | 7<br>Windows<br>No. | 2 | 1 | 1 | 1 | 5 | Low | Low | As70026829/MC006 | Chrysotile | Remove | |

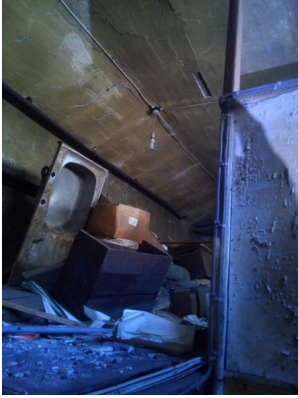
| Location | Item Description | Extent / Quantity | Product Type | Damage Extent | Surface Treatment | Asbestos Type | Material Assessment Total | Material Risk Rating | Accessibility | Sample Reference | Asbestos Identification | Recommendations / Comments | Photographs |
|---|---|---|---|---|---|---|---|---|---|---|---|---|---|
| Main Factory<br>1st Floor<br>001 Loft Space<br>above rooms 0/003<br>- 0/013 | Limited access | | - | - | - | - | - | - | - | - | - | Visually no asbestos suspected.<br>Inspected from ladders only. No safe access | |

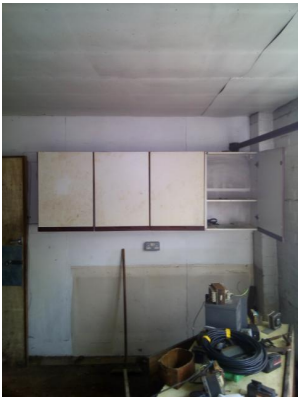
| Location | Item Description | Extent / Quantity | Product Type | Damage Extent | Surface Treatment | Asbestos Type | Material Assessment Total | Material Risk Rating | Accessibility | Sample Reference | Asbestos Identification | Recommendations / Comments | Photographs |
|---|---|---|---|---|---|---|---|---|---|---|---|---|---|
| Main Factory<br>1st Floor<br>004 Office | Insulation board<br>partition wall | 5 m <sup>2</sup> | - | - | - | - | - | - | - | 70026829/MC031 | No asbestos<br>detected | Wooden floor, brick<br>external walls,<br>hardboard partition to<br>corridor and ceiling. | |

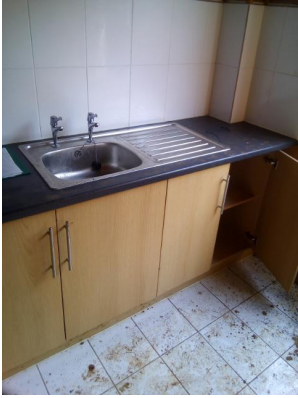
| Location | Item Description | Extent / Quantity | Product Type | Damage Extent | Surface Treatment | Asbestos Type | Material Assessment Total | Material Risk Rating | Accessibility | Sample Reference | Asbestos Identification | Recommendations / Comments | Photographs |
|---|---|---|---|---|---|---|---|---|---|---|---|---|---|
| Main Factory<br>1st Floor<br>005 Lab | Sink pad | 1 No. | - | - | - | - | - | - | - | 70026829/MC032 | No asbestos<br>detected | Ceramic floor tiles,<br>wooden floor, brick<br>external walls,<br>hardboard partition to<br>corridor and ceiling. | |

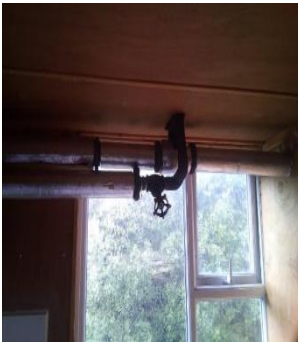
| Location | Item Description | Extent / Quantity | Product Type | Damage Extent | Surface Treatment | Asbestos Type | Material Assessment Total | Material Risk Rating | Accessibility | Sample Reference | Asbestos Identification | Recommendations / Comments | Photographs |
|---|---|---|---|---|---|---|---|---|---|---|---|---|---|
| Main Factory<br>1st Floor<br>005 Lab | Gasket | 4 No. | 2 | 1 | 1 | 1 | 5 | Low | High | 70026829/MC033 | Chrysotile | Remove | |

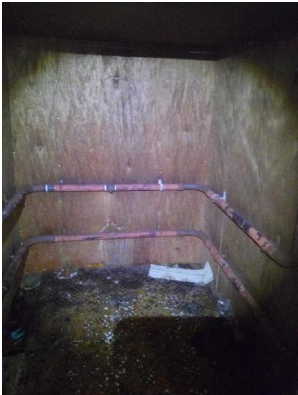
| Location | Item Description | Extent / Quantity | Product Type | Damage Extent | Surface Treatment | Asbestos Type | Material Assessment Total | Material Risk Rating | Accessibility | Sample Reference | Asbestos Identification | Recommendations / Comments | Photographs |
|---|---|---|---|---|---|---|---|---|---|---|---|---|---|
| Main Factory<br>1st Floor<br>006 Former hot room | No asbestos suspected | | - | - | - | - | - | - | - | - | - | Metal floor, wooden walls & ceiling, metal pipes. | |

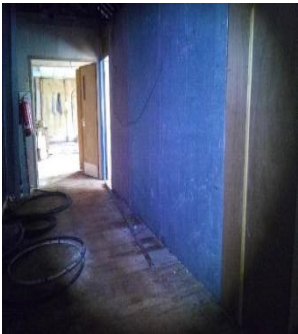
| Location | Item Description | Extent / Quantity | Product Type | Damage Extent | Surface Treatment | Asbestos Type | Material Assessment Total | Material Risk Rating | Accessibility | Sample Reference | Asbestos Identification | Recommendations / Comments | Photographs |
|---|---|---|---|---|---|---|---|---|---|---|---|---|---|
| Main Factory<br>1st Floor<br>007 Store 1 | Insulation board<br>partition to rooms<br>1/004 & 1/005 | 8 m <sup>2</sup> | - | - | - | - | - | - | - | As70026829/MC031 | No asbestos<br>detected | Metal and wooden<br>floors, brick walls,<br>modern sarking felt,<br>plastic water tank and<br>skylights | |

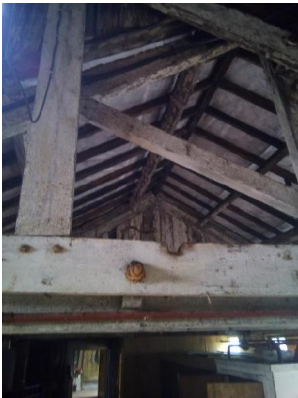
| Location | Item Description | Extent / Quantity | Product Type | Damage Extent | Surface Treatment | Asbestos Type | Material Assessment Total | Material Risk Rating | Accessibility | Sample Reference | Asbestos Identification | Recommendations / Comments | Photographs |
|---|---|---|---|---|---|---|---|---|---|---|---|---|---|
| Main Factory<br>1st Floor<br>007 Store 1 | Residual insulation to<br>old pipe bracket and<br>wooden roof support | 1 lm | 3 | 3 | 3 | 1 | 10 | High | High | 70026829/MC034 | Chrysotile | <b>Remove</b> | |

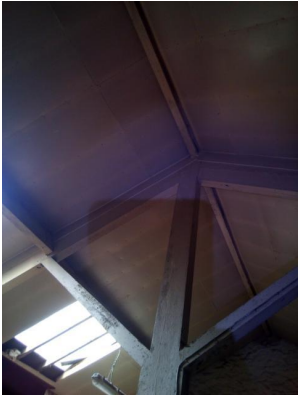
| Location | Item Description | Extent / Quantity | Product Type | Damage Extent | Surface Treatment | Asbestos Type | Material Assessment Total | Material Risk Rating | Accessibility | Sample Reference | Asbestos Identification | Recommendations / Comments | Photographs |
|---|---|---|---|---|---|---|---|---|---|---|---|---|---|
| Main Factory<br>1st Floor<br>008 Soap kettle<br>P16 | Underdrawing to ceiling | 100 m <sup>2</sup> | - | - | - | - | - | - | - | As70026829/MC031 | No asbestos detected | Metal and wooden floor, brick and plaster walls, metal tanks, plastic water tanks, plastic skylights. | |

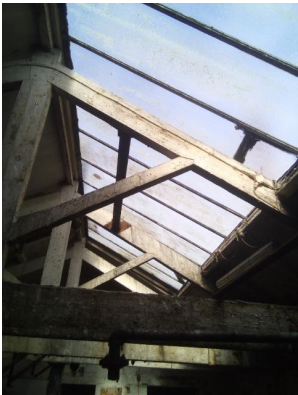
| Location | Item Description | Extent / Quantity | Product Type | Damage Extent | Surface Treatment | Asbestos Type | Material Assessment Total | Material Risk Rating | Accessibility | Sample Reference | Asbestos Identification | Recommendations / Comments | Photographs |
|---|---|---|---|---|---|---|---|---|---|---|---|---|---|
| Main Factory<br>1st Floor<br>009 Soap kettle P7-P9 | Skylights | 11 windows No. | 2 | 1 | 1 | 1 | 5 | Low | High | As70026829/MC006 | Chrysotile | Remove | |

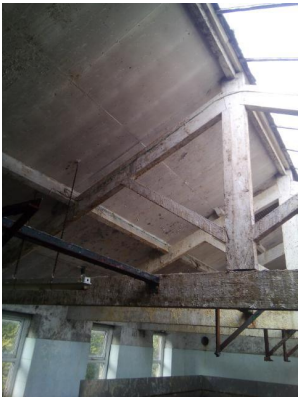
| Location | Item Description | Extent / Quantity | Product Type | Damage Extent | Surface Treatment | Asbestos Type | Material Assessment Total | Material Risk Rating | Accessibility | Sample Reference | Asbestos Identification | Recommendations / Comments | Photographs |
|---|---|---|---|---|---|---|---|---|---|---|---|---|---|
| Main Factory<br>1st Floor<br>009 Soap kettle P7-P9 | Underdrawing to ceiling | 120 m <sup>2</sup> | - | - | - | - | - | - | - | As70026829/MC031 | No asbestos detected | Metal and wooden floor, brick and plaster walls, metal tanks, plastic water tanks, plastic skylights. | |

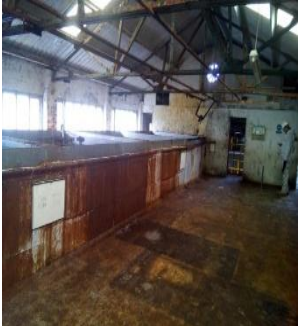
| Location | Item Description | Extent / Quantity | Product Type | Damage Extent | Surface Treatment | Asbestos Type | Material Assessment Total | Material Risk Rating | Accessibility | Sample Reference | Asbestos Identification | Recommendations / Comments | Photographs |
|---|---|---|---|---|---|---|---|---|---|---|---|---|---|
| Main Factory<br>1st Floor<br>010 Soap kettle P10 - P15 | Insulation board panel to wall | 4 m <sup>2</sup> | - | - | - | - | - | - | - | As70026829/MC031 | No asbestos detected | Wooden floor, brick and wooden walls, metal cladding to tanks over polystyrene insulation, metal roof, modern electrics. | |

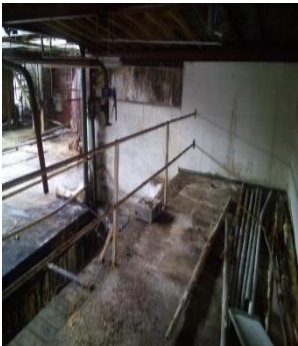
| Location | Item Description | Extent / Quantity | Product Type | Damage Extent | Surface Treatment | Asbestos Type | Material Assessment Total | Material Risk Rating | Accessibility | Sample Reference | Asbestos Identification | Recommendations / Comments | Photographs |
|---|---|---|---|---|---|---|---|---|---|---|---|---|---|
| Main Factory<br>1st Floor<br>011 Soap kettle<br>P16 | No asbestos suspected | | - | - | - | - | - | - | - | - | - | Wooden floor, brick walls, wooden ceiling. | |

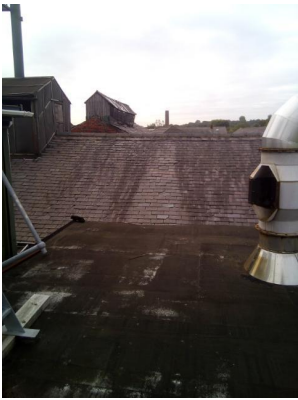
| Location | Item Description | Extent / Quantity | Product Type | Damage Extent | Surface Treatment | Asbestos Type | Material Assessment Total | Material Risk Rating | Accessibility | Sample Reference | Asbestos Identification | Recommendations / Comments | Photographs |
|---|---|---|---|---|---|---|---|---|---|---|---|---|---|
| Main Factory<br>External<br>Roof accessed from<br>0/024 | Flat roof | 150 m <sup>2</sup> | - | - | - | - | - | - | - | 70043831/JM012 | No asbestos detected | Composite sample of accessible flat roof. All other roofs are pitched slate covered.<br><br>Brick and stone walls, slate pitched roof, metal vessels to roof, brick chimney, upvc windows | |

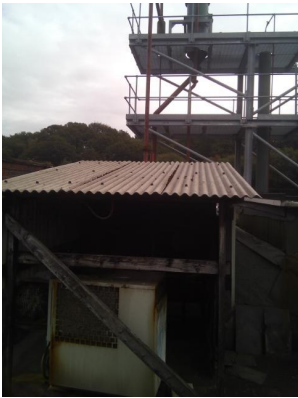
| Location | Item Description | Extent / Quantity | Product Type | Damage Extent | Surface Treatment | Asbestos Type | Material Assessment Total | Material Risk Rating | Accessibility | Sample Reference | Asbestos Identification | Recommendations / Comments | Photographs |
|---|---|---|---|---|---|---|---|---|---|---|---|---|---|
| Main Factory External<br>Roof accessed from 0/024 | Cement roof to canopy | 2 m <sup>2</sup> | 1 | 1 | 1 | 1 | 4 | Very Low | High | As70026829/MC028 | Chrysotile | <b>Remove.</b> | |

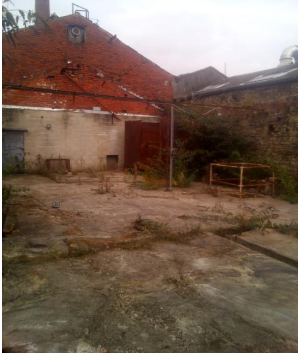
| Location | Item Description | Extent / Quantity | Product Type | Damage Extent | Surface Treatment | Asbestos Type | Material Assessment Total | Material Risk Rating | Accessibility | Sample Reference | Asbestos Identification | Recommendations / Comments | Photographs |
|---|---|---|---|---|---|---|---|---|---|---|---|---|---|
| Main Factory External<br>005 Courtyard 1 | No asbestos suspected | | - | - | - | - | - | - | - | - | - | Concrete floor, brick walls, metal tank. | |

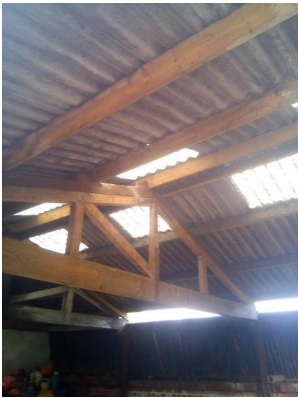
| Location | Item Description | Extent / Quantity | Product Type | Damage Extent | Surface Treatment | Asbestos Type | Material Assessment Total | Material Risk Rating | Accessibility | Sample Reference | Asbestos Identification | Recommendations / Comments | Photographs |
|---|---|---|---|---|---|---|---|---|---|---|---|---|---|
| Old Forklift Shed<br>Ground Floor<br>001 Shed | Cement roof | 60 m <sup>2</sup> | 1 | 1 | 1 | 1 | 4 | Very Low | High | As70026829/MC028 | Chrysotile | Remove<br><br>Concrete floor, brick low level walls, metal supports, metal clad external wall. | |

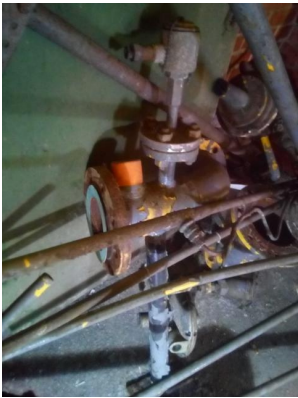
| Location | Item Description | Extent / Quantity | Product Type | Damage Extent | Surface Treatment | Asbestos Type | Material Assessment Total | Material Risk Rating | Accessibility | Sample Reference | Asbestos Identification | Recommendations / Comments | Photographs |
|---|---|---|---|---|---|---|---|---|---|---|---|---|---|
| Gas Meter House<br>Ground Floor<br>001 Gas Meter | Gaskets to pipes | 15 No. | 2 | 1 | 1 | 1 | 5 | Low | | 70026829/MC033 | Chrysotile | Remove | |

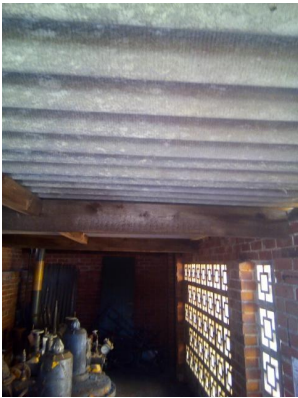
| Location | Item Description | Extent / Quantity | Product Type | Damage Extent | Surface Treatment | Asbestos Type | Material Assessment Total | Material Risk Rating | Accessibility | Sample Reference | Asbestos Identification | Recommendations / Comments | Photographs |
|---|---|---|---|---|---|---|---|---|---|---|---|---|---|
| Gas Meter House<br>Ground Floor<br>001 Gas Meter | Cement roof | 21 m <sup>2</sup> | 1 | 1 | 1 | 1 | 4 | Very Low | High | As70026829/MC028 | Chrysotile | <b>Remove</b><br>Concrete floor, brick walls, metal pipe. | |

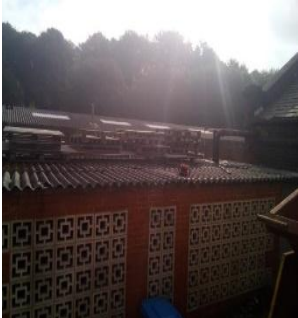
| Location | Item Description | Extent / Quantity | Product Type | Damage Extent | Surface Treatment | Asbestos Type | Material Assessment Total | Material Risk Rating | Accessibility | Sample Reference | Asbestos Identification | Recommendations / Comments | Photographs |
|---|---|---|---|---|---|---|---|---|---|---|---|---|---|
| Gas Meter House<br>External<br>001 External | Cement roof | Quantified internally | 1 | 1 | 1 | 1 | 4 | Very Low | | As70026829/MC028 | Chrysotile | <b>Remove</b><br>Brick walls, wooden door. | |
