| <b>BAY 23. EXISTING CONDITION AND REMEDIAL WORKS.</b> | | | |

### **3.2 Condition of the External Fabric and Methodology of Survey**

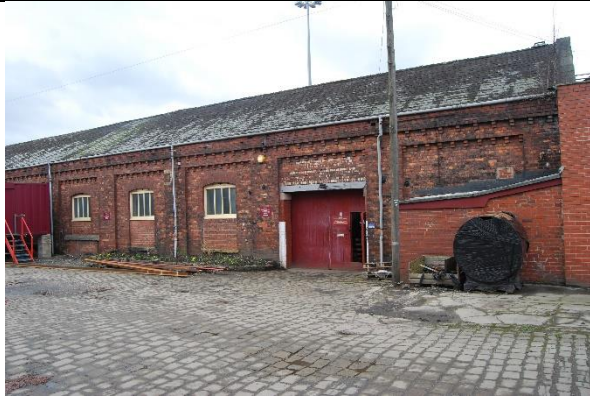
SE.01 (Bay 1a to 5a)

Primary defects noted as follows:

- i. Isolated bricks are falling away from the underside of the gutter where these have been cut to accommodate the timber rafters, repairs required.
- ii. There are a number of perished bricks requiring replacement, estimate 18m<sup>2</sup>.
- iii. The elevation is in need of re-pointing as follows:
  - Re-point the upper 6 courses of brickwork, elsewhere 68m<sup>2</sup> repoint
- iv. Overhaul all timber windows
- v. Rainwater goods comprise of PVC, replace with aluminium ogee and new downpipes. Include for new timber fascia.
- vi. Allow for removing a number of corroding iron brackets across the elevation and making good.

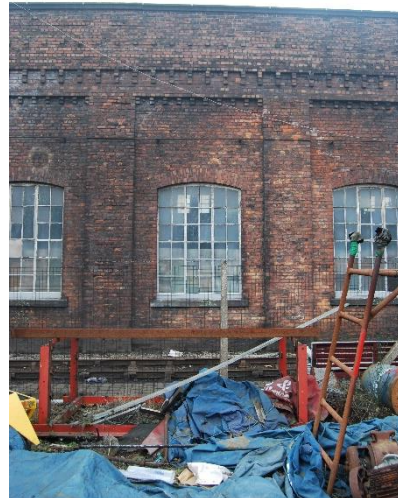
SE.06 (Typical bay – Bay 27a)

Note that Bay 29 is of a newer brickwork construction and was formed when the southerly extension was built. It appears in a serviceable condition.

Primary defects noted as follows:

- i. There are a number of perished bricks requiring replacement, estimate circa 30m<sup>2</sup>.
- ii. The elevation is in need of re-pointing as follows:
  - The upper section of the brickwork requires repointing from the lower corbel level to coping level.
  - A number of pilasters require partial repointing circa 35m<sup>2</sup>.
  - Repoint all copings.
- iii. Overhaul all timber windows
- iv. Allow for removing a number of corroding iron brackets across the elevation and making good.

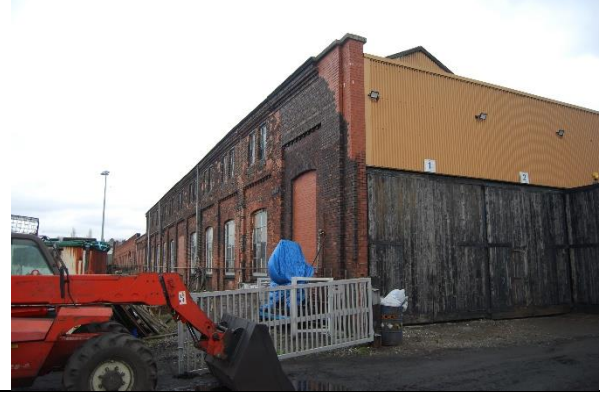
W.02 (Bays 19 to 29)

Primary defects noted as follows:

- i. There are a number of perished bricks requiring replacement, estimate circa 30m<sup>2</sup>.
- ii. The elevation is in need of 50% re-pointing and the following:
  - The upper section of the brickwork requires repointing from the lower corbel level to coping level.
- iii. Overhaul all timber windows
- iv. Allow for removing a number of corroding iron brackets across the elevation and making good.
- v. Replace up to 20m<sup>2</sup> perished bricks.
- vi. Replace existing rainwater goods with powder coated aluminium.

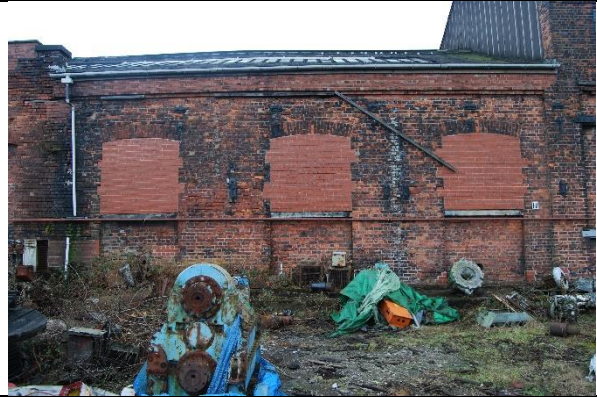
W.04 (Bays 16, 17 & 18)

Primary defects noted as follows:

- i. There are a number of perished bricks requiring replacement, estimate 30-40m<sup>2</sup>.
- ii. The elevation is in need of re-pointing as follows:
  - Re-point the upper 33 courses of brickwork, elsewhere 50% repoint
- iii. Rainwater goods comprise of PVC to Bays 16, 17 & 18, replace with aluminium ogee and new downpipes. Include for new timber fascia.
- iv. Take off a re-bed all existing copings to Bays 3 to 15.
- v. Allow for removing a number of corroding iron brackets across the elevation and making good.

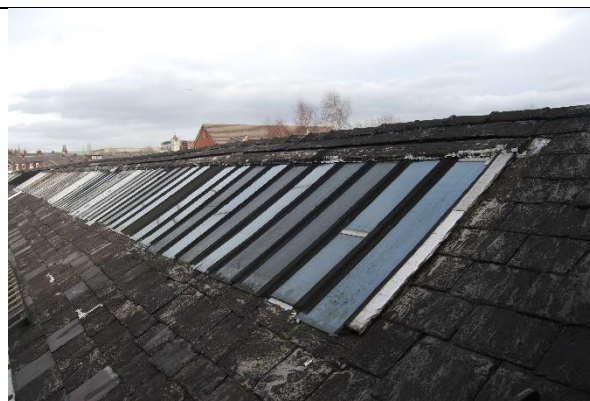
R.02

Condition: The roof and skylights are in a failing condition all evidenced by:

- Areas of fractured, missing, broken and slipped slates
- Majority of slates bitumen covered
- Defective flashings at north and south abutments
- Fractured glazing
- Perished timber glazing bars
- Significant repairs to flashings with various materials
- Interconnecting valley gutter has been extensively repaired and known to leak
- The parging to the underside of the slates is failing and falling into the workspace below. Daylight is evident in different locations.
- Damaged and failing rainwater goods

Remedial work recommended:

- Strip the entire roof
- Allow for timber repairs to existing rafters (provisional item)
- Recover and allow for reusing 50% of the existing slates on new breathable felt and battens
- Strip the entire rooflight and plane down existing rafters to take a new Rafterline aluminium patent glazing bar system with new glazing as supplied by the Standard Patent Glazing Company. Include for new aluminium flashings at the head and base of the glazing and appropriate trims. Allow for 16m of automated glazed lights in 2 banks of 8m.
- Include for new flashings at the north and south ends.
- Include for new ridge tiles.
- Include for new valley gutter.
- Include for new rainwater goods.

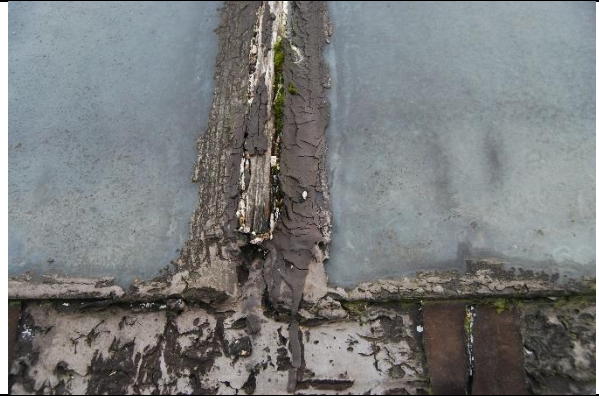
R.04

Condition: The roof and skylights are in a failing condition all evidenced by:

- Areas of fractured, missing, broken and slipped slates
- Majority of slates bitumen covered
- Defective flashings at north and south abutments
- Fractured glazing
- Perished timber glazing bars
- Significant repairs to flashings with various materials
- Abutment gutter to the west parapet has been extensively repaired and known to leak
- The parging to the underside of the slates is failing and falling into the workspace below. Daylight is evident in different locations.
- Damaged and failing rainwater goods

Remedial work recommended:

- Strip the entire roof
- Allow for timber repairs to existing rafters (provisional item)
- Recover and allow for reusing 50% of the existing slates on new breathable felt and battens
- Strip the entire rooflights and plane down existing rafters to take a new Rafterline aluminium patent glazing bar system with new glazing as supplied by the Standard Patent Glazing Company. Include for new aluminium flashings at the head and base of the glazing and appropriate trims. Allow for 16m of automated glazed lights in 2 banks of 8m, to both the upper and lower roof lights.
- Include for new flashings at the north and south ends.
- Include for new ridge tiles.
- Include for new valley gutter.
- Include for new rainwater goods.
- Allow for re-pointing the inner face of the parapet wall and new flashings.

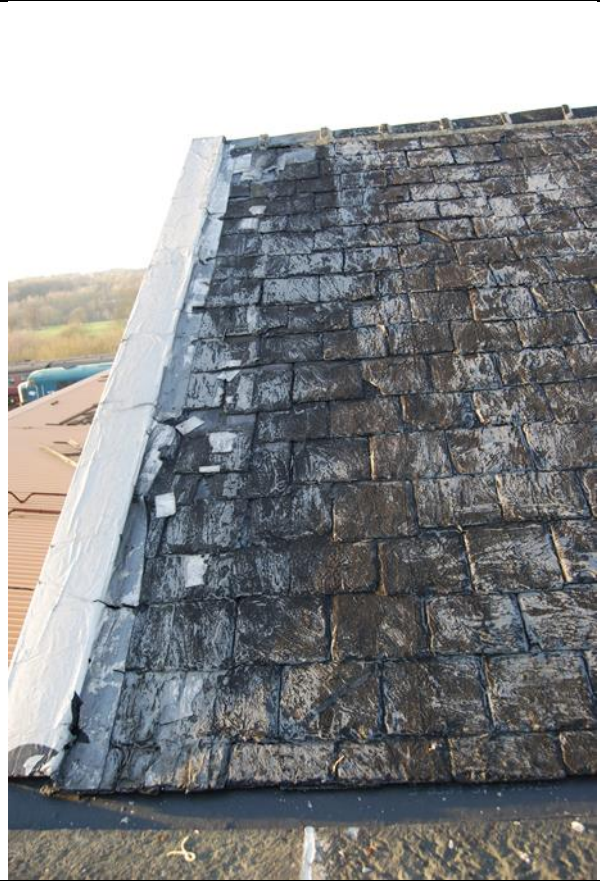
R.06

Condition: The roof and skylights are in a failing condition all evidenced by:

- Areas of fractured, missing, broken and slipped slates
- Majority of slates bitumen covered
- Defective flashings at south parapet
- Fractured glazing
- Perished timber glazing bars
- Significant repairs to flashings with various materials
- Abutment asbestos gutter to the east parapet has been relined with a single ply membrane
- The parging to the underside of the slates is failing and falling into the workspace below. Daylight is evident in different locations.
- Damaged and failing rainwater goods

Remedial work recommended:

- Strip the entire roof
- Allow for timber repairs to existing rafters (provisional item)
- Recover and allow for reusing 50% of the existing slates on new breathable felt and battens
- Strip the entire rooflights and plane down existing rafters to take a new Rafterline aluminium patent glazing bar system with new glazing as supplied by the Standard Patent Glazing Company. Include for new aluminium flashings at the head and base of the glazing and appropriate trims. Allow for 16m of automated glazed lights in 2 banks of 8m, to both the upper and lower roof lights.
- Include for new flashings at the south end.
- Include for new ridge tiles.
- Include for new abutment gutter replacing the existing asbestos
- Include for new rainwater goods.
- Allow for re-pointing the inner face of the parapet wall and new flashings.

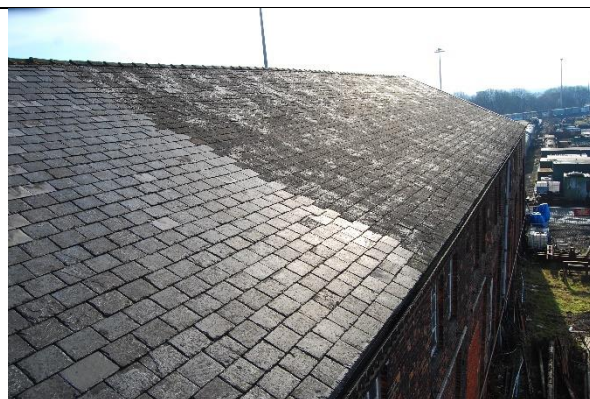
R.10

Condition: The roof and skylights are in a failing condition all evidenced by:

- Areas of fractured, missing, broken and slipped slates
- Majority of slates bitumen covered
- Defective flashings at south parapet
- Fractured glazing
- Perished timber glazing bars
- Significant repairs to flashings with various materials
- The parging to the underside of the slates is failing and falling into the workspace below. Daylight is evident in different locations.
- Damaged and failing rainwater goods

Remedial work recommended:

- Strip the entire roof
- Allow for timber repairs to existing rafters (provisional item)
- Recover and allow for reusing 50% of the existing slates on new breathable felt and battens
- Strip the entire rooflights and plane down existing rafters to take a new Rafterline aluminium patent glazing bar system with new glazing as supplied by the Standard Patent Glazing Company. Include for new aluminium flashings at the head and base of the glazing and appropriate trims. Allow for 16m of automated glazed lights in 2 banks of 8m, to both the upper and lower roof lights.
- Include for new flashings at the south end.
- Include for new ridge tiles.
- Include for new rainwater goods.
- Include for renewing the interconnecting valley gutter

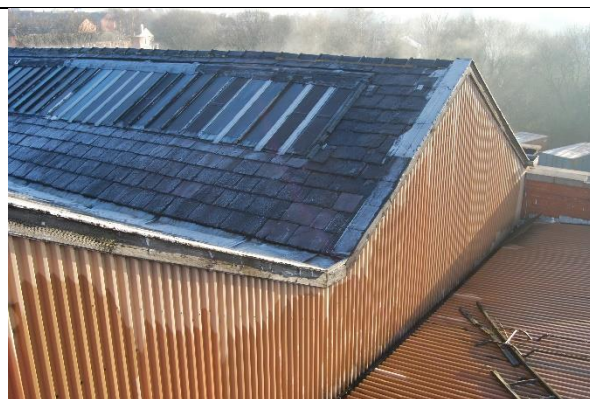
R.14

Condition: The roof is in a failing condition all evidenced by:

- Defective flashings to perimeter
- Perished barge boards
- Failing insulation boards internally

Remedial work recommended:
