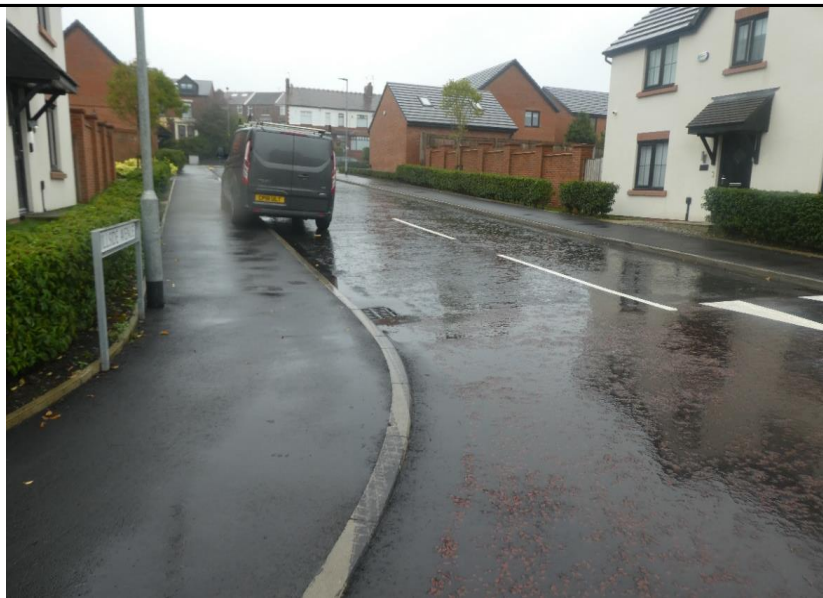
Photograph 2. Recently formed roadway and footpath surfacing

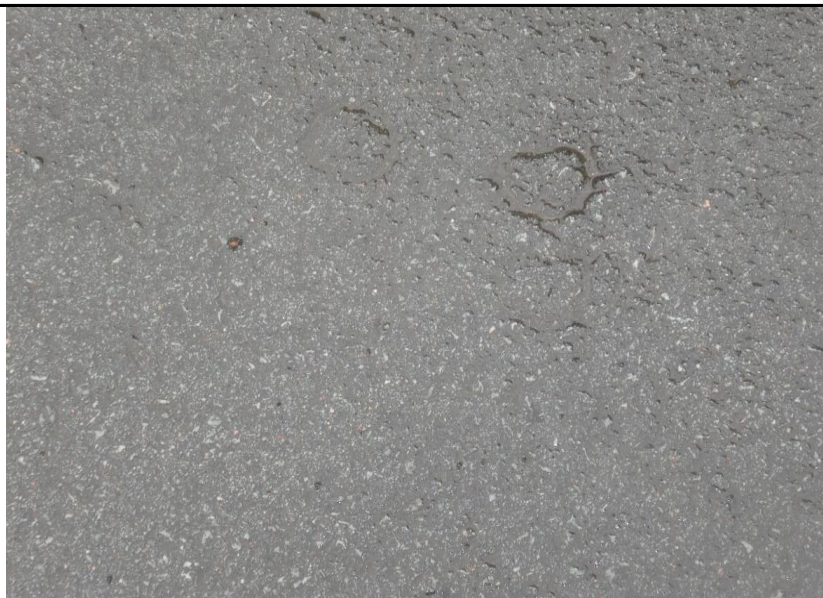
Photograph 10. Localised indentations to footpath areas

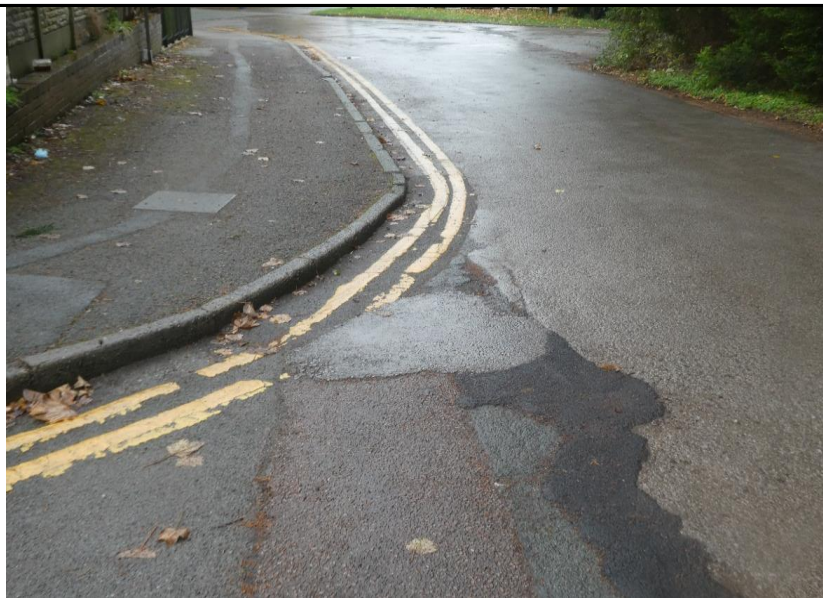
Photograph 18. Localised reinstatement of road surfacing to Norwood junction slightly eroded

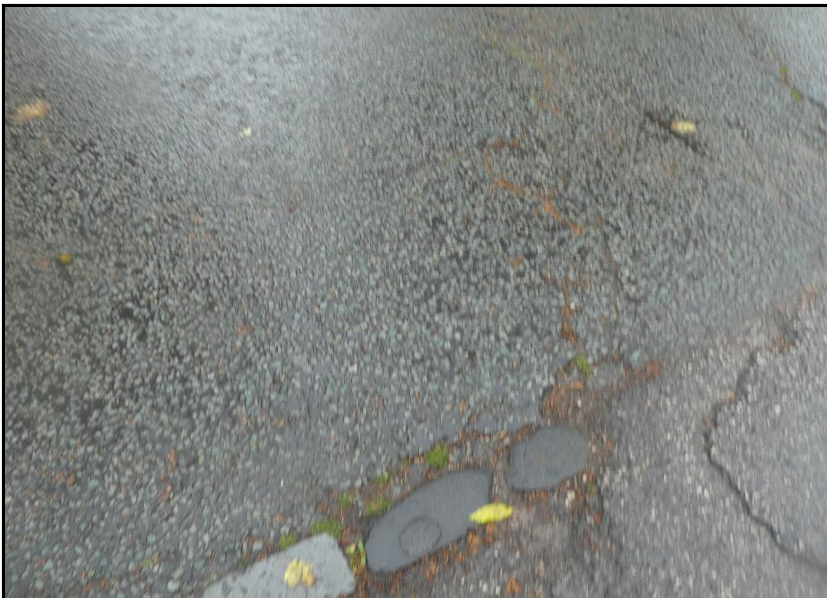
Photograph 33. Localised erosion to surfacing

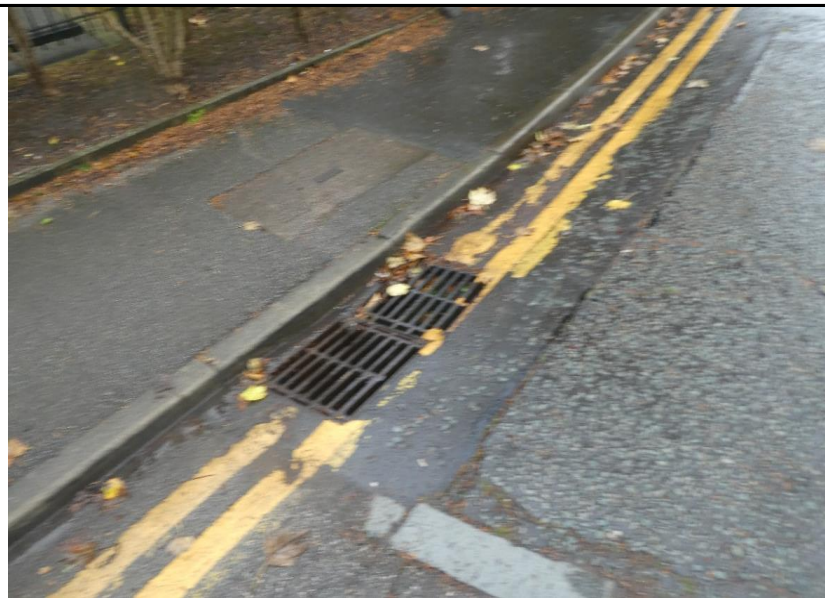
Photograph 34. Localised erosion to surfacing

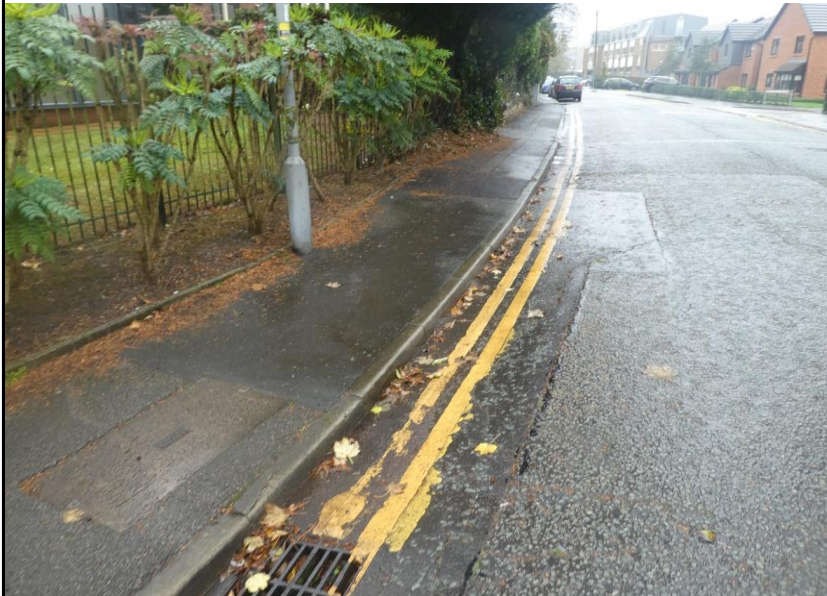
Photograph 35. Line marking eroding

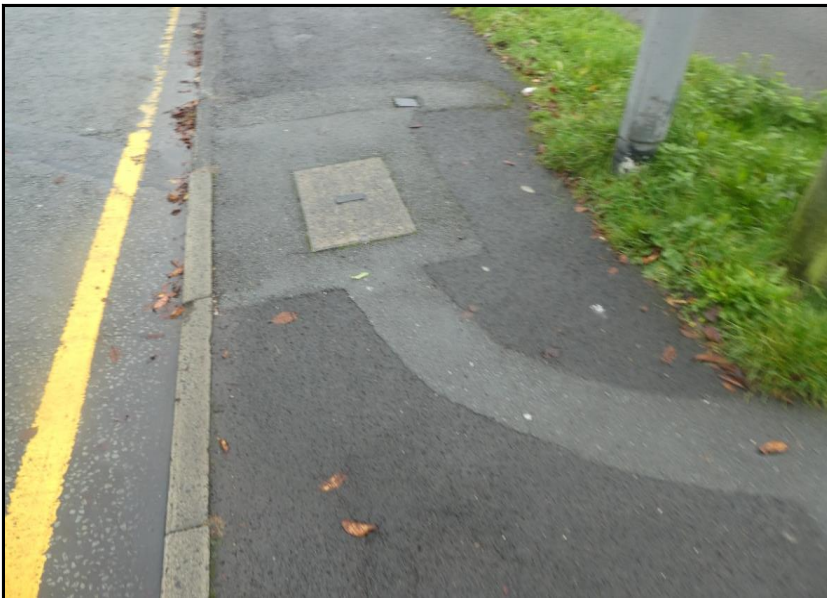
Photograph 65. Localised reinstament to footpath

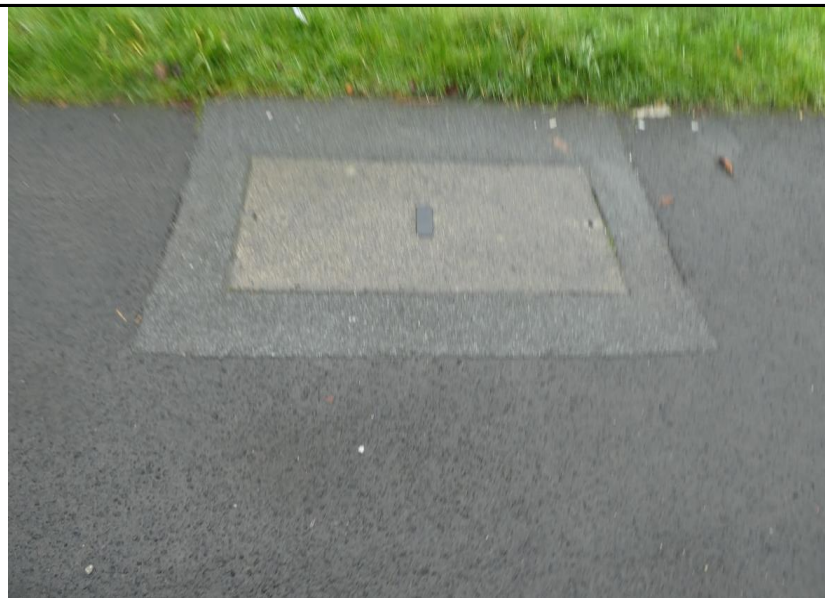
Photograph 66. Localised reinstament to footpath

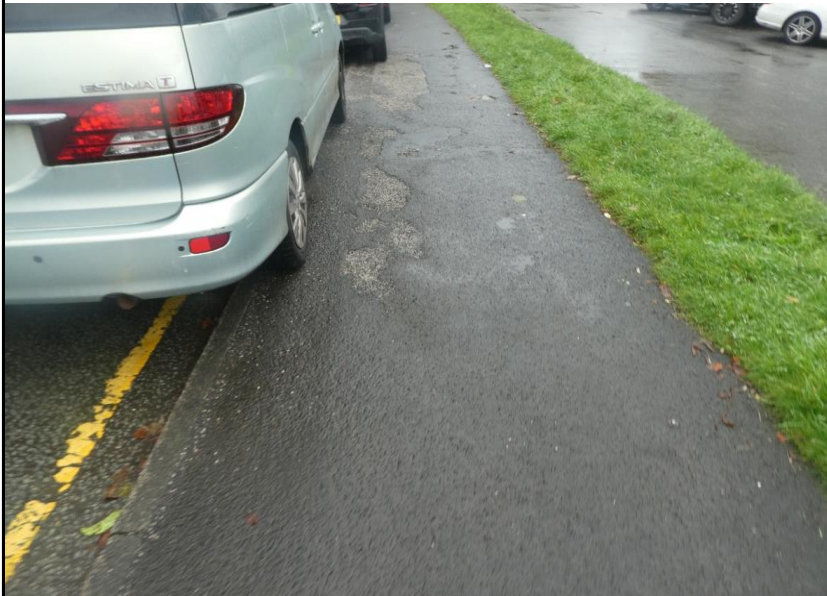
Photograph 67. Erosion to footpath

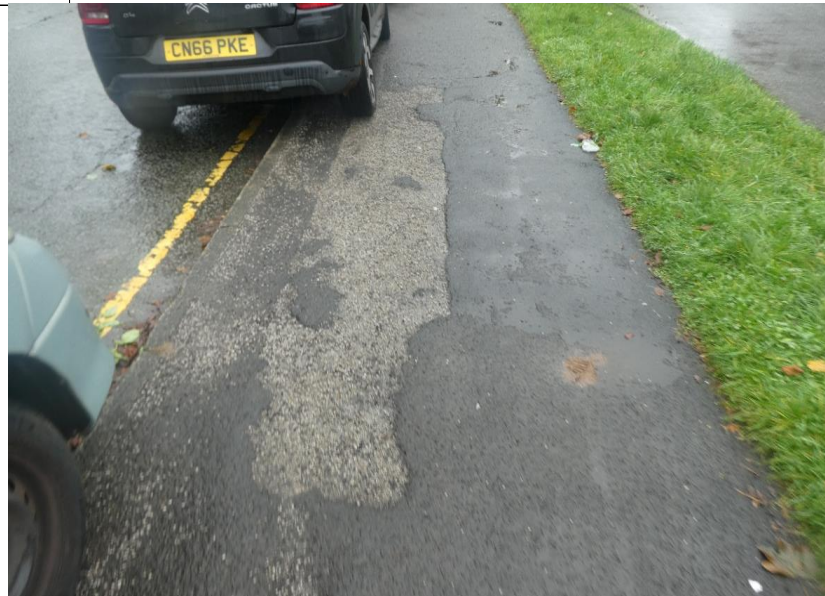
Photograph 68. Erosion to footpath

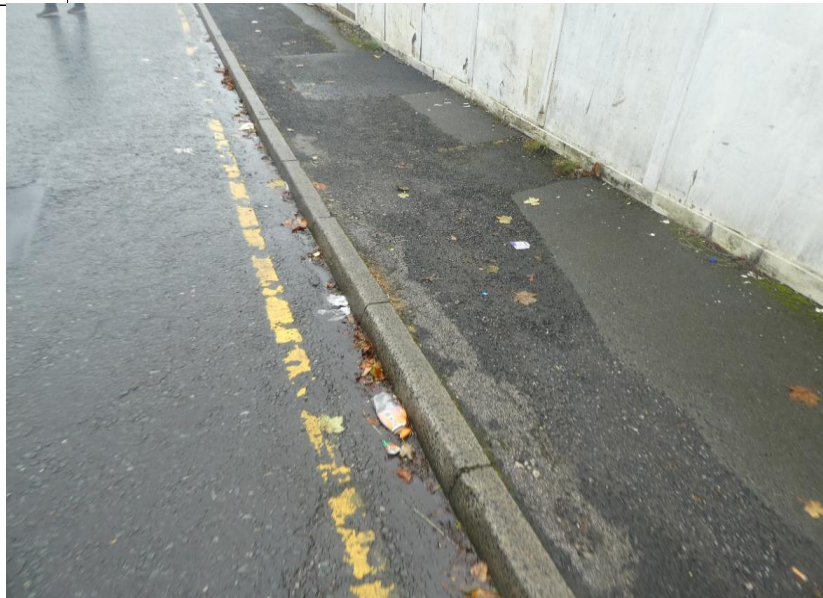
Photograph 84. Localised erosion to footpath.

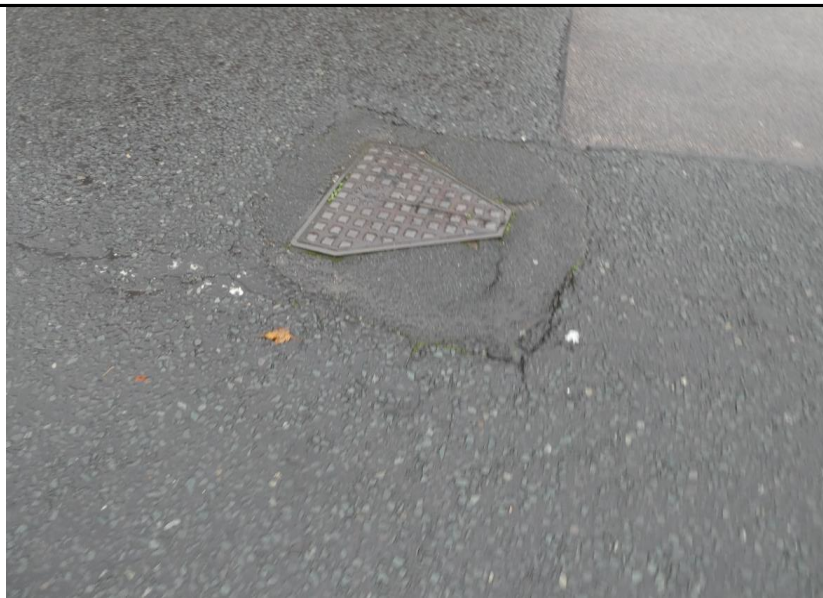
Photograph 86. Erosion to surfacing around inspection chamber.

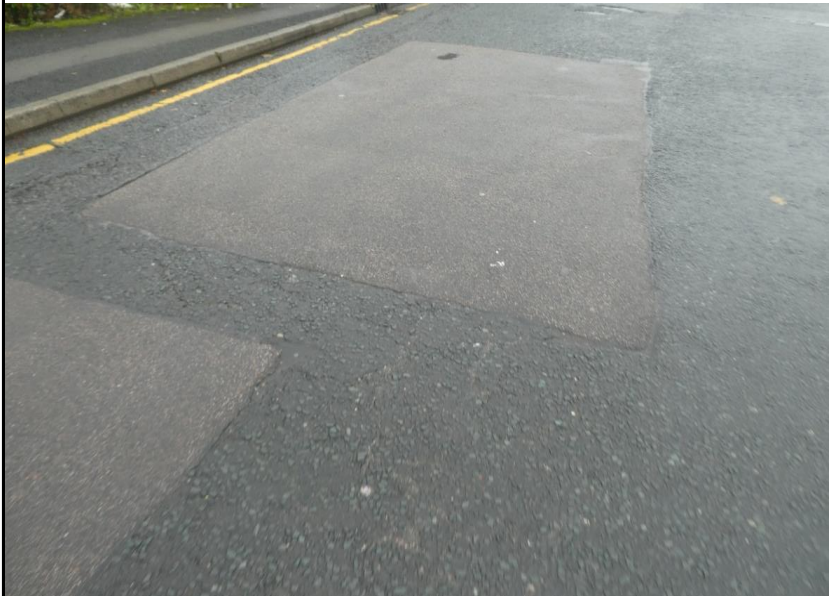
Photograph 87. Reinstatement of road surfacing.

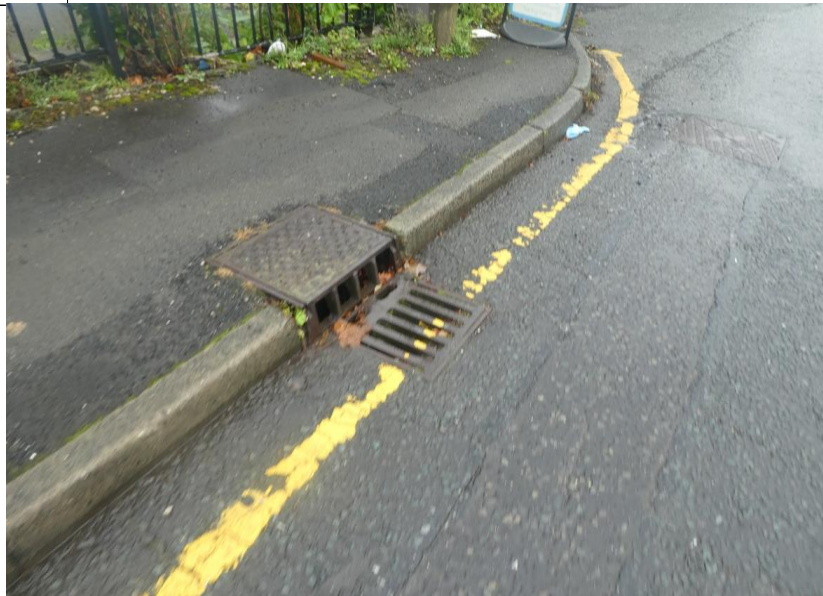
Photograph 88. Erosion to line marking.

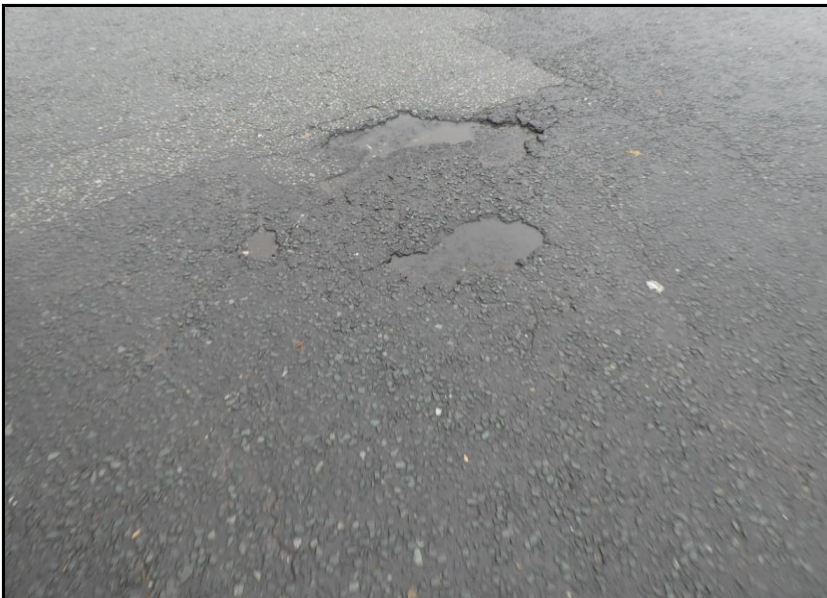
Photograph 89. Localised erosion to surfacing

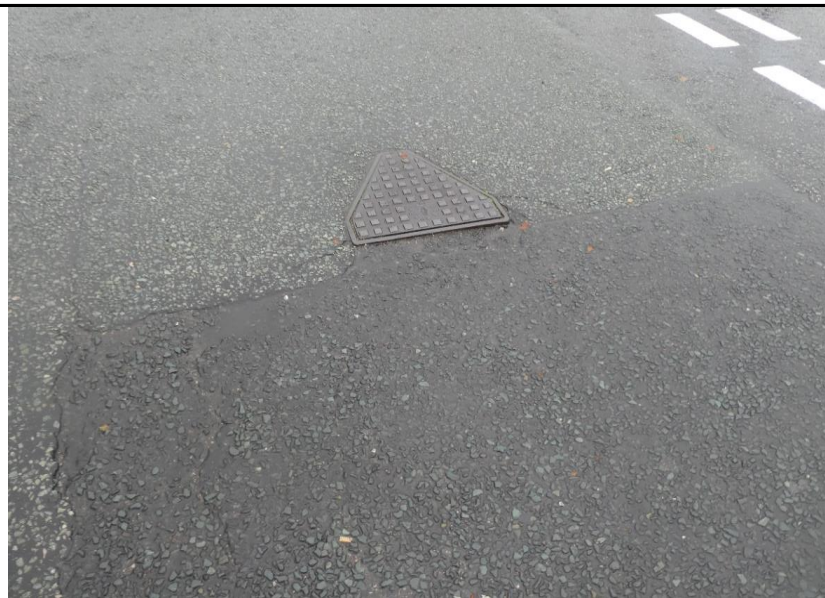
Photograph 90. Localised erosion to surfacing.
