# Mondi Mill Chimney Inspection Report

Mondi Mill  
Chimney Inspection  
Ramsbottom,  
BL0 0BS

B23519/R001

08 August 2019

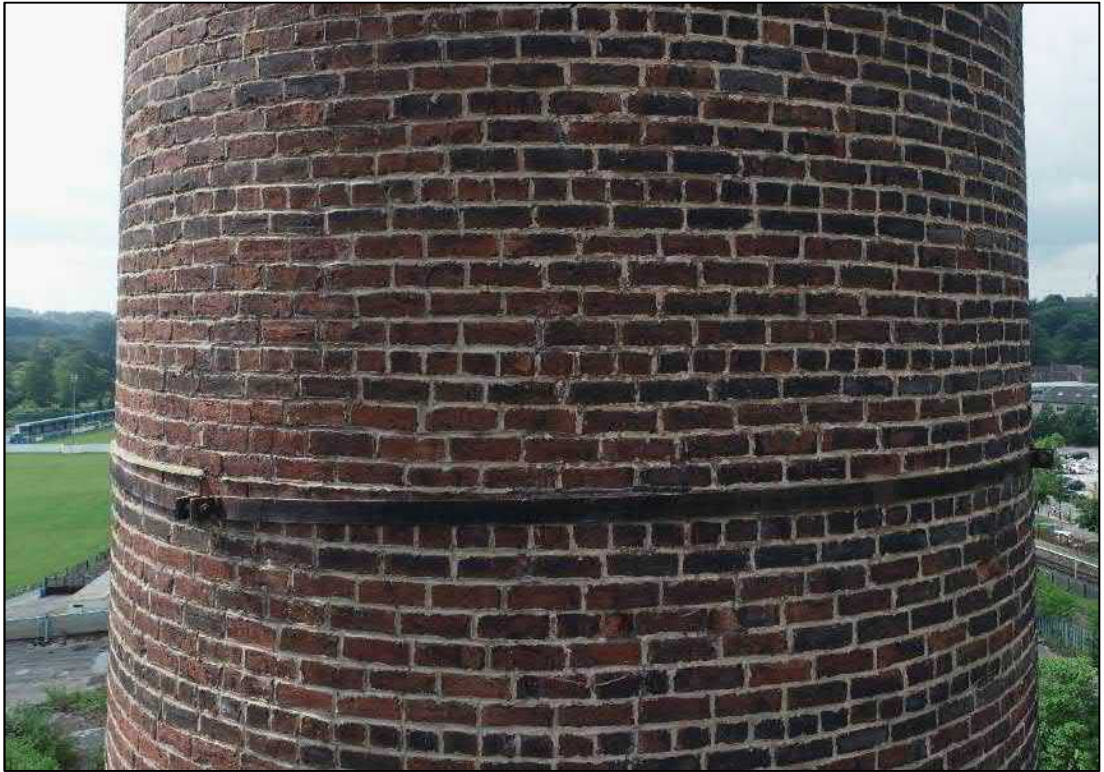
Photograph 1

- 3.2.4 Restraint band Nr.11 appears to have dropped at the northeast face (Photograph 1). This is local to the band connections and appears in the order of 60mm maximum.

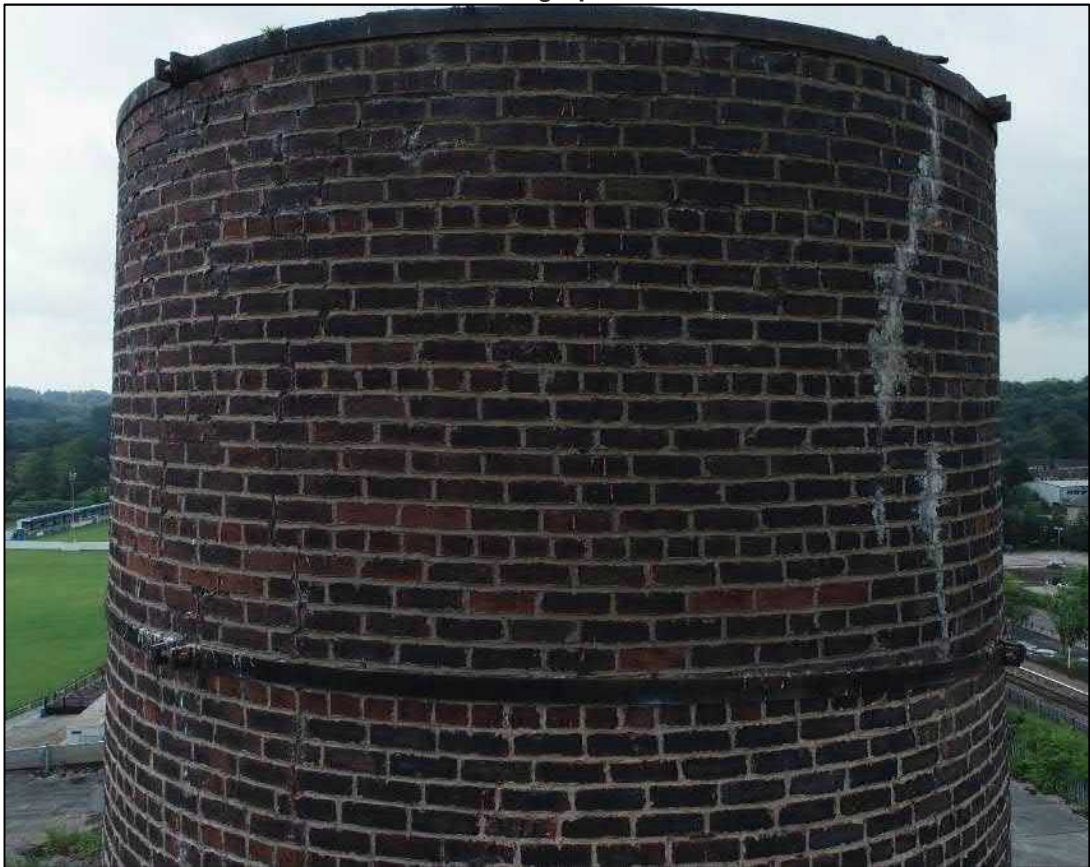
Photograph 2

- 3.2.5 A long, almost vertical, crack was evident from approx. five courses below band Nr.13 up to approx. 5 courses below band Nr.14. This occurred typically through the joints, however, some fractured masonry is present (Photograph 2).

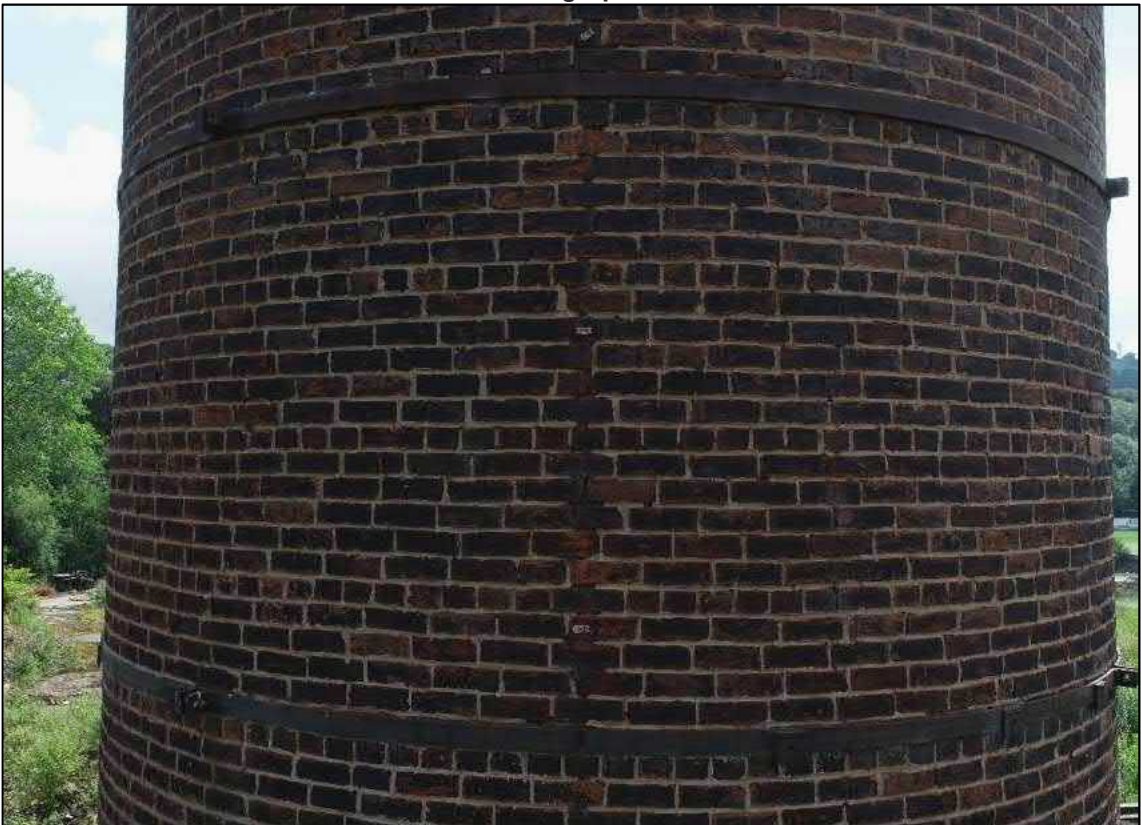
Photograph 4

- 3.3.1 The west elevation appears typically in a reasonable condition throughout. Recent repointing is present with minimal loss observed. One continuous line of missing/lost mortar was noted from bottom to top, however, this appears to have been on a potential lightning conductor rod route, as small clips (now redundant) were present affixed to the wall through the full height.
- 3.3.2 A vertical fracture in the masonry was noted between bands Nr.4 & 5, approximately seven courses in height (Photograph 4).

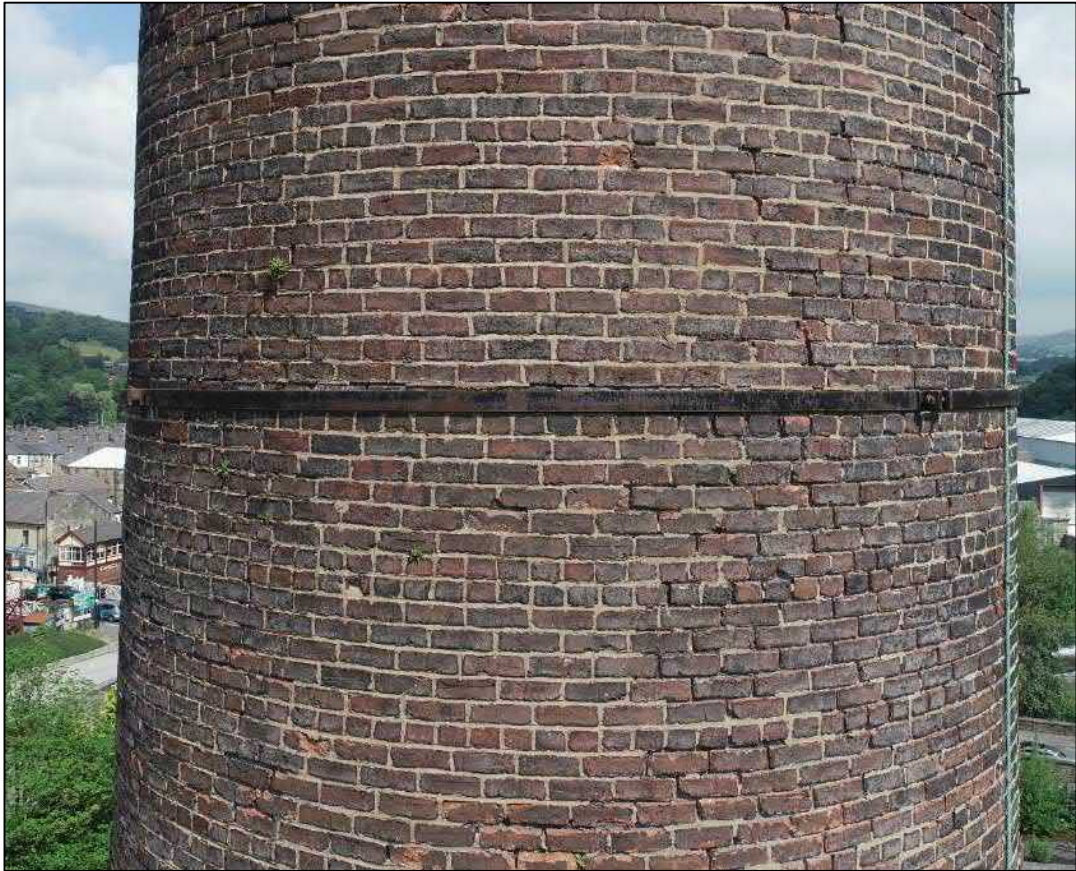
Photograph 7

- 3.4.2 Small areas of vegetation were evident growing from weathered joints on the southwest face. This is a repeated observation on this face with several areas noted from band Nr.6 upwards (Photograph 7).

- 3.4.3 Restraint band Nr.12 appears to have dropped at the southwest face (Photograph 7). This is local to the band connections and appears in the order of 30-40mm.

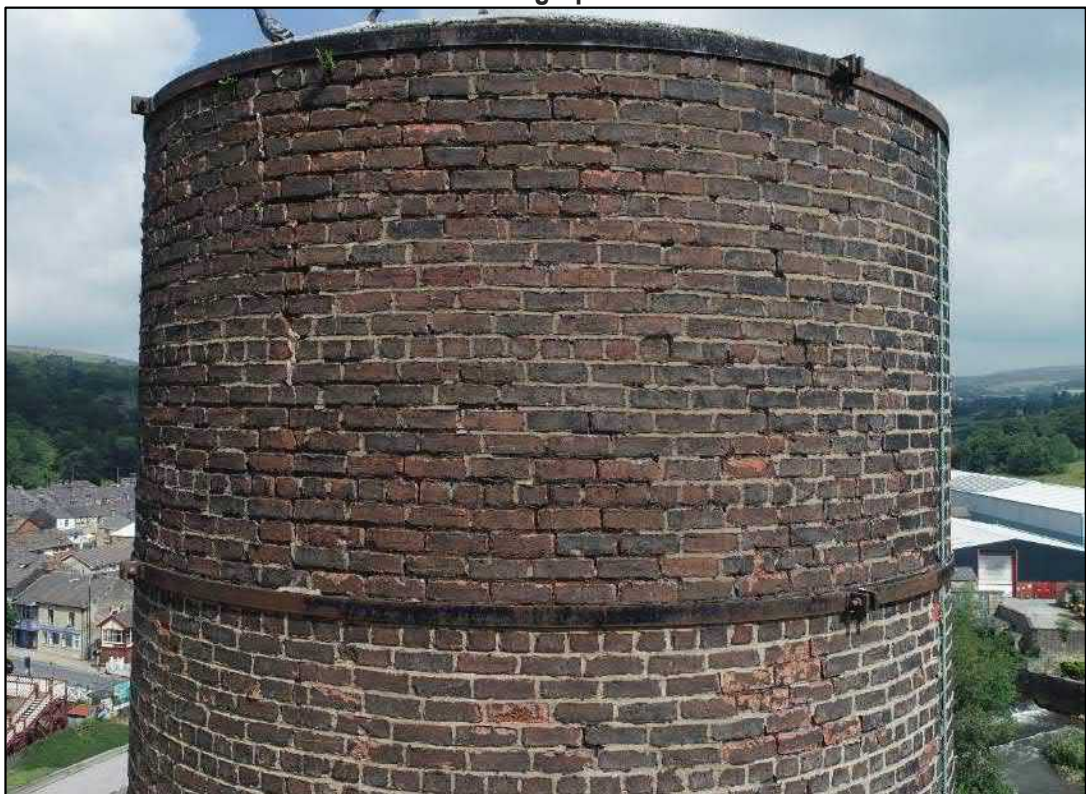
Photograph 8

- 3.4.5 A previously repointed crack was noted between bands Nr.13 & 14. This appears to have deteriorated with loss of mortar observed across the full height of the crack (Photograph 8).

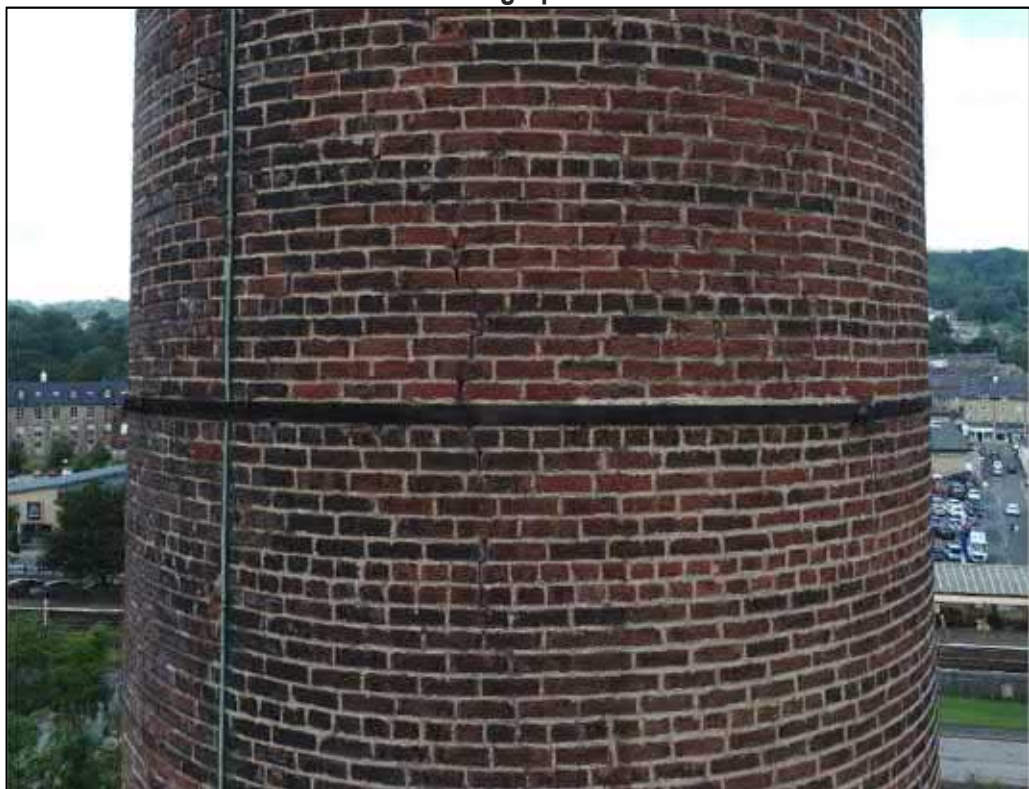
Photograph 12

- 3.5.6 A long vertical crack was observed between bands Nr.9 & 11. This has been noted on previous inspection in 2016 and appears to have deteriorated (Photograph 12).

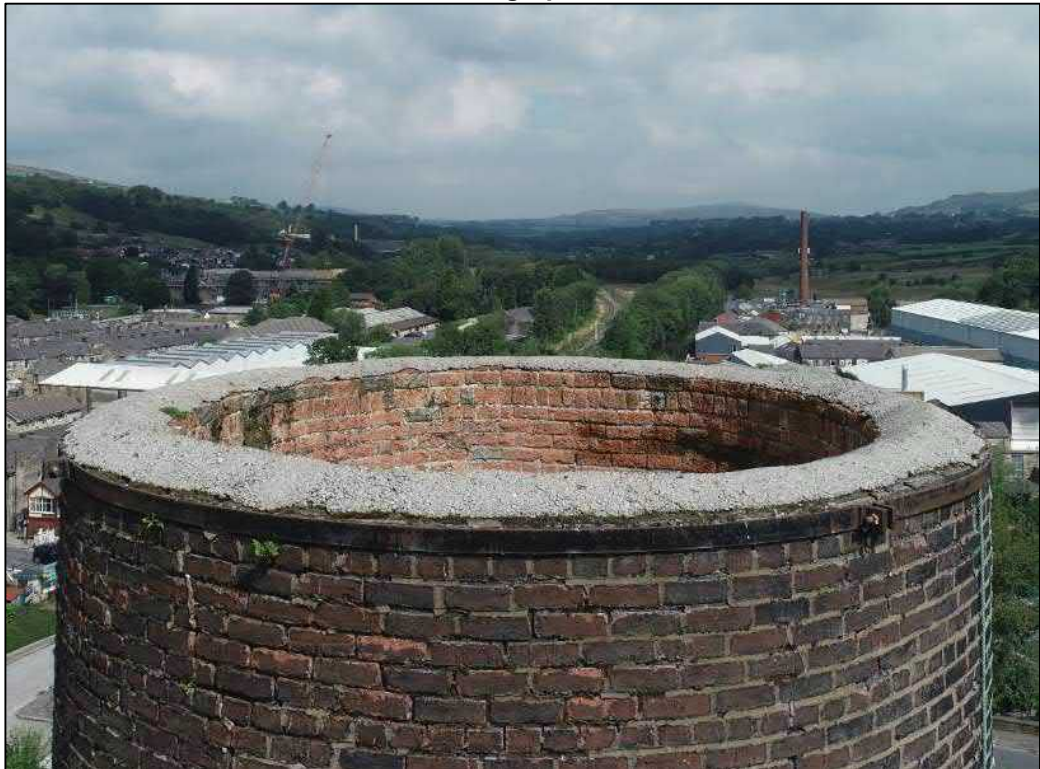
Photograph 14

- 3.6.1 The concrete haunching appears in reasonable condition, however, gaps were noted between the concrete and masonry below around the perimeter (Photograph 14).
- 3.6.2 Staining was observed to the inside faces of the chimney towards the top.
- 3.6.3 Vegetation was evident around the chimney at the base and it does not appear that the site is regularly maintained.

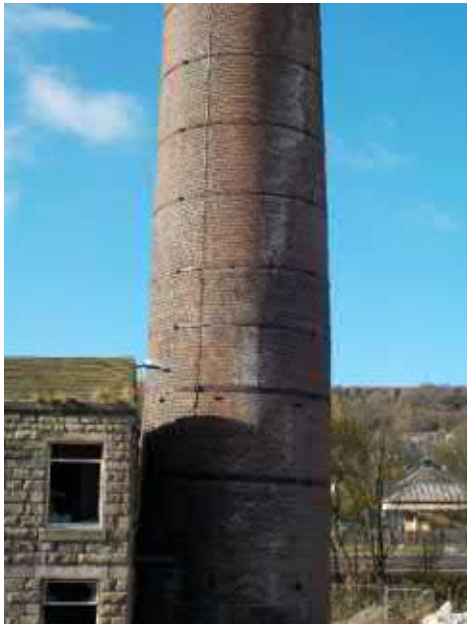
**Efflorescence to East Elevation**

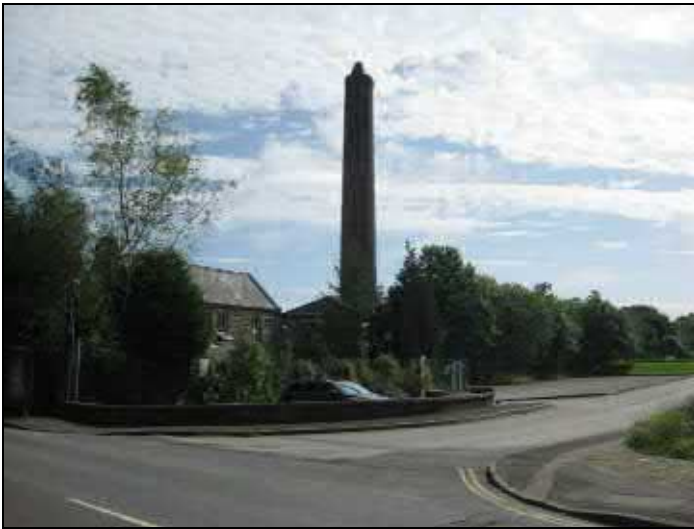
Elevation from NW showing lean to South West

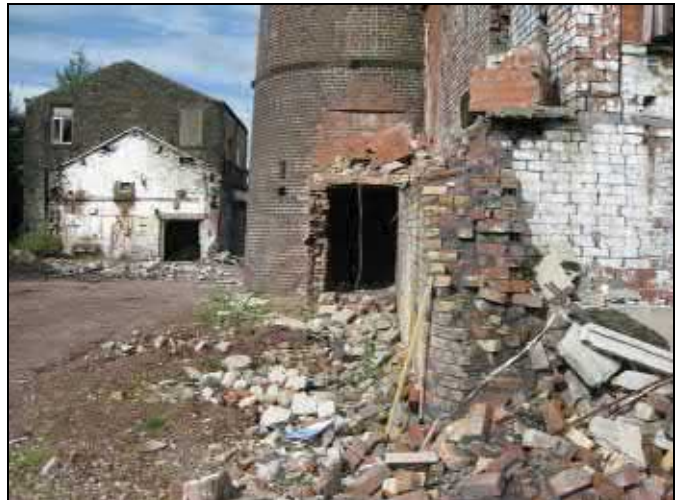
South elevation showing extremely unstable building  
connected to bottom of chimney

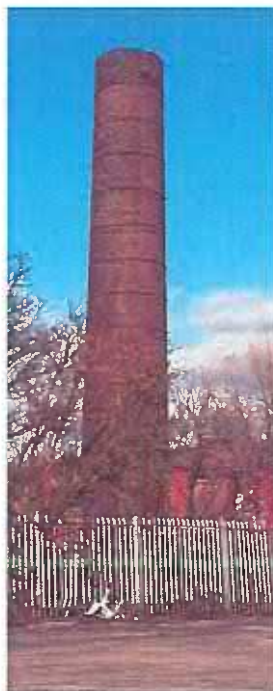
**Picture 1 – General view of chimney**

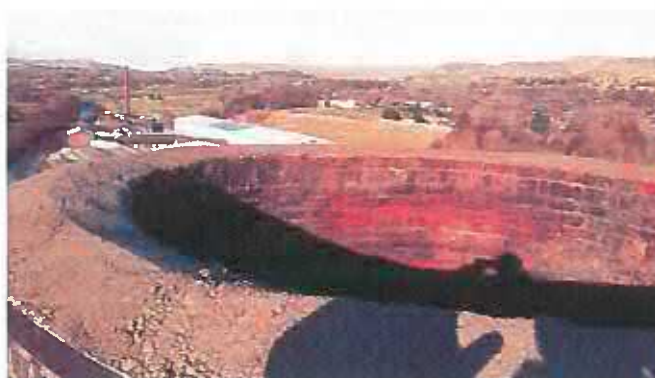
The chimney has been reduced in height which now significantly reduces the risk of failure. It has a temporary concrete haunch applied to the top of the brickwork to help deflect the potential for water/ice build up within the joints. At the present time the top of the chimney is open to the elements and there is no guard to prevent bird or water ingress.

**Picture 2 – Vie of concrete Haunch**
