S1/ECH/10/CB/HO/7.0/R1

### **FORMER MONDI SITE BRIDGE STREET RAMSBOTTOM**

Further to your instruction Betts Associates visited the above site in July 2019 to review the condition of existing buildings as shown on the aerial photograph.

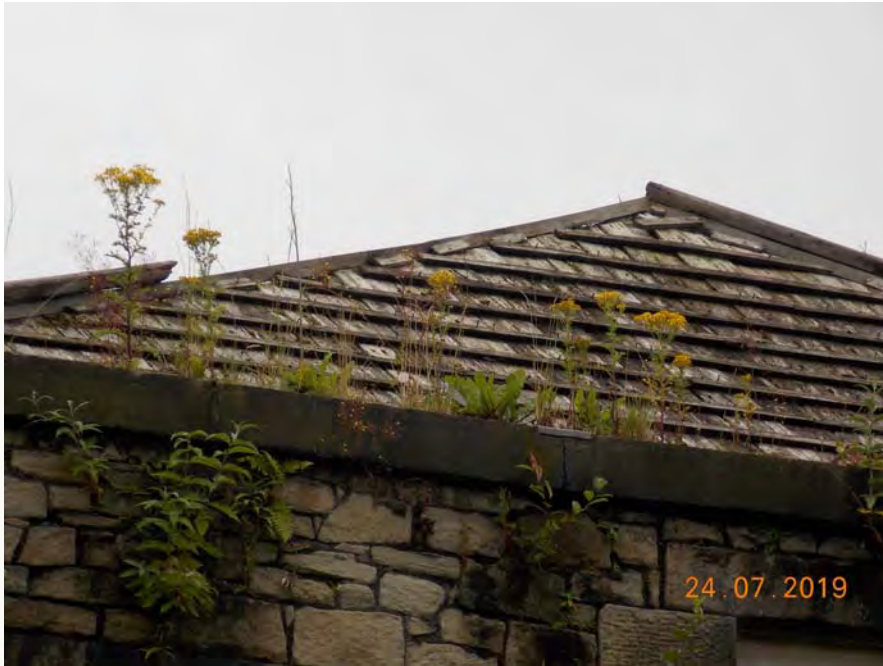
The roof has a hipped end on the north whilst the remainder is a standard pitch roof. Tiles have been removed showing sarking boards below. The removal of tiles would lead to weather ingress and damage to timbers.
