## Phase 1 GeoEnvironmental Desk Study

Land Adjacent to 11 Walter Street  
Prestwich

May 2023

**Report No. A5417-23**

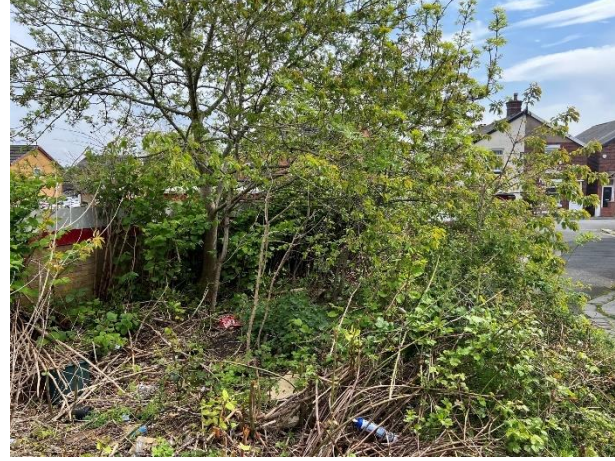
| <p style="text-align: center;"><b>Plate 7: Looking east to “crescent” area</b></p> | <p style="text-align: center;"><b>Plate 8 Evidence of drop to adjacent properties</b></p> |

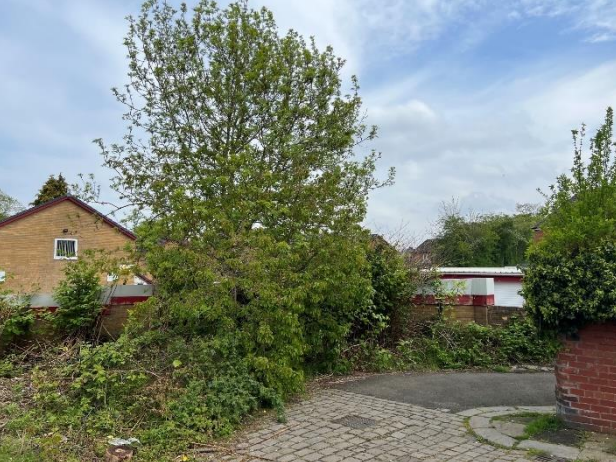
| <p style="text-align: center;"><b>Plate 9 General rubbish and tree chippings</b></p> | <p style="text-align: center;"><b>Plate 10 Looking north to “crescent” area</b></p> |
