# CCTV Survey Report

110 whatley street  
bolton

## 110 whatley street - CCTV Survey Report : 17/01/24

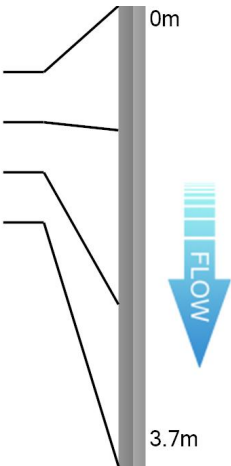
Section 1

| <b>Section: 1</b><br><b>From: MH1</b><br><b>To: outside MH</b> | | Purpose of Inspection: Routine inspection of condition<br><br>pipe is brocken at 1m and has a hole in at 2.4m line needs digging and repairing to resolve the issues | <b>DRB Grade: C</b><br><b>Pipe Size: 150</b><br><b>Material: Vitrified Clay (i.e. all clayware)</b><br><b>Use: Combined</b> |

00.00m MH Start node type, manhole  
01.00m BJ Broken pipe 12-12 at joint  
02.40m H Hole in drain/sewer 06-06  
03.70m MHF Finish node type, manhole

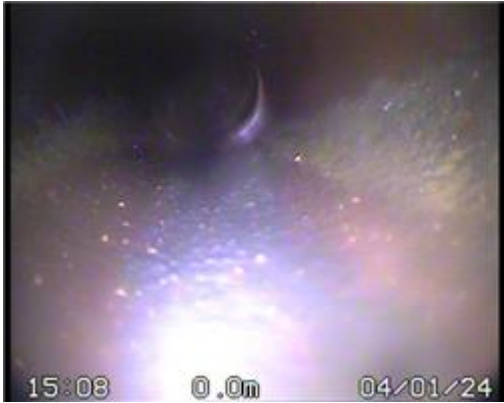
| Pos | Video Ref | Code | Description | Image |
|---|---|---|---|---|
| 00.00m | 0:00:00 | MH | Start node type, manhole | <p>Image Provided - Ref: 0_0</p> |

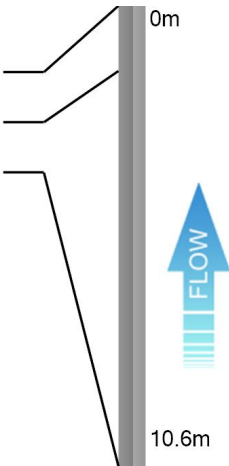
Section 2

| <b>Section: 2</b><br><b>From: MH1</b><br><b>To: old road gulley</b> | | Purpose of Inspection: Routine inspection of condition<br><br>line is no longer in use | <b>DRB Grade: B</b><br><b>Pipe Size: 150</b><br><b>Material: Vitrified Clay (i.e. all clayware)</b><br><b>Use: Combined</b> |

00.00m MH Start node type, manhole  
01.50m DERJ Settled deposits coarse 40% at joint  
10.60m GYF Finish node type Gully

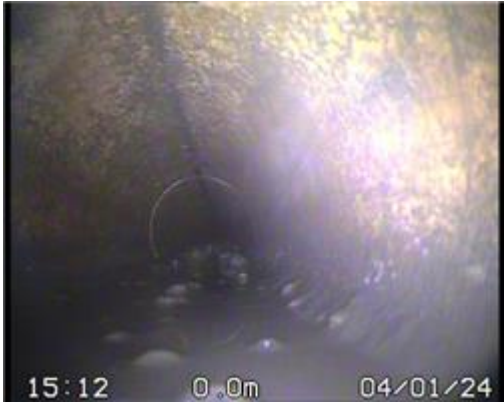
| Pos | Video Ref | Code | Description | Image |
|---|---|---|---|---|
| 00.00m | 0:00:00 | MH | Start node type, manhole | <p>Image Provided - Ref: 1_0</p> |

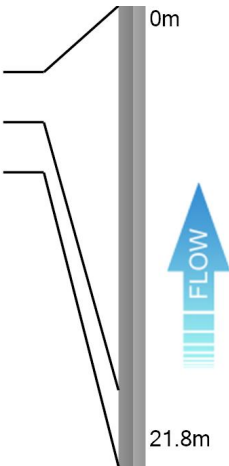
Section 3

| <b>Section: 3</b><br><b>From: MH2</b><br><b>To: house</b> | | Purpose of Inspection: Routine inspection of condition<br><br>line has a medium displaced joint that is causing the line to hold foul waste and water line needs digging and repairing to sort the issues | <b>DRB Grade: B</b><br><b>Pipe Size: 150</b><br><b>Material: Vitrified Clay (i.e. all clayware)</b><br><b>Use: Combined</b> |

00.00m MH Start node type, manhole  
18.20m JDM Joint displaced medium  
21.80m SA Survey abandoned

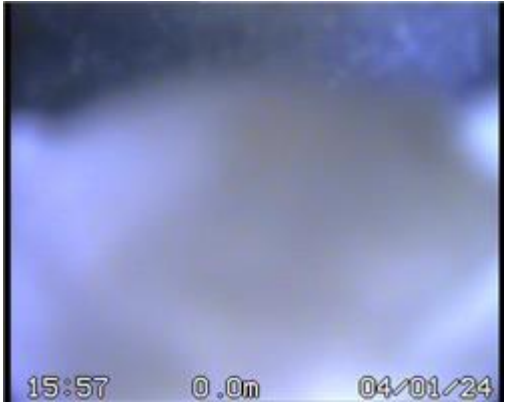
| Pos | Video Ref | Code | Description | Image |
|---|---|---|---|---|
| 00.00m | 0:00:00 | MH | Start node type, manhole | <p>Image Provided - Ref: 2_0</p> |

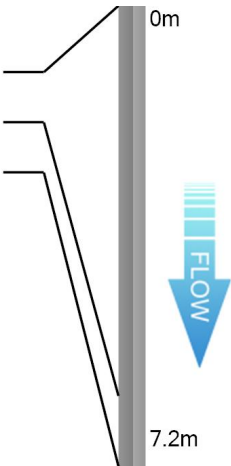
Section 4

| <b>Section: 4</b><br><b>From: MH2</b><br><b>To: MH3</b> | | Purpose of Inspection: Routine inspection of condition<br><br>line has a large crack in line needs patch liner or digging and repairing | <b>DRB Grade: A</b><br><b>Pipe Size: 150</b><br><b>Material: Vitrified Clay (i.e. all clayware)</b><br><b>Use: Combined</b> |

00.00m MH Start node type, manhole  
06.10m CLJ Crack, longitudinal 12 at joint  
07.20m MHF Finish node type, manhole

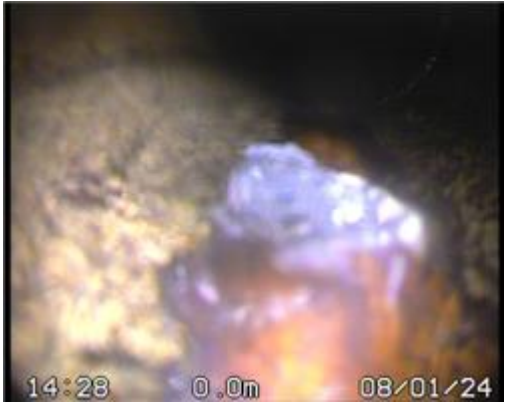
| Pos | Video Ref | Code | Description | Image |
|---|---|---|---|---|
| 00.00m | 0:00:00 | MH | Start node type, manhole | <p>Image Provided - Ref: 3_0</p> |
