# Drainage Report

**Bury Council  
1 - 5 The Elms, Elms Close  
Whitefield  
Greater Manchester  
M45 8XS**

## The Elms - CCTV Survey Report : 31/08/22

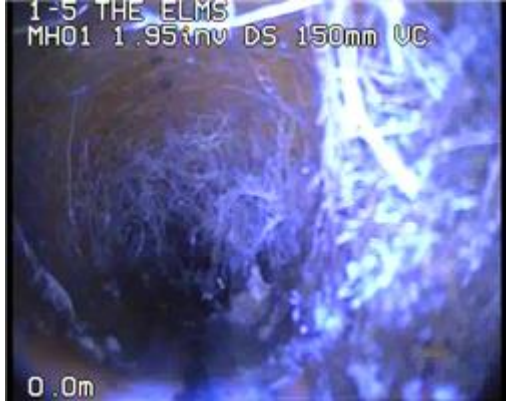
| Pos | Video Ref | Code | Description | Image |
|---|---|---|---|---|
| 00.00m | 0:00:00 | WL | Water level: 5% Height/Diameter | <p>Image Provided - Ref: 0_1</p> |

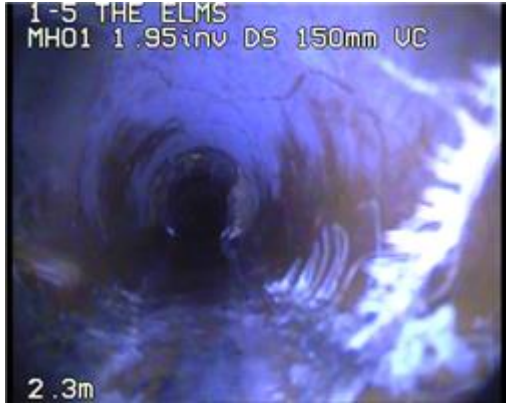
| Pos | Video Ref | Code | Description | Image |
|---|---|---|---|---|
| 02.30m | 0:00:10 | JN | Junction at 09 o'clock: 100mm Diameter | Image Provided - Ref: 0_5<br> |

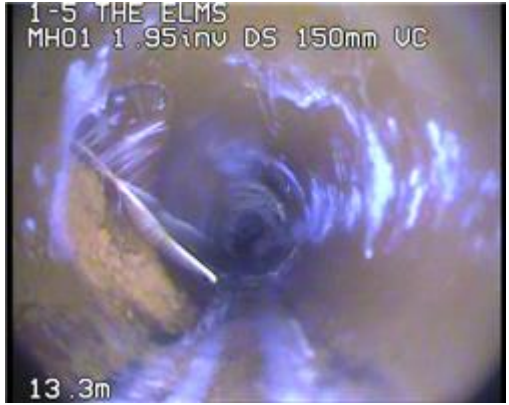
| Pos | Video Ref | Code | Description | Image |
|---|---|---|---|---|
| 13.30m | 0:00:56 | JN | Junction at 09 o'clock: 100mm Diameter | Image Provided - Ref: 0_6<br> |

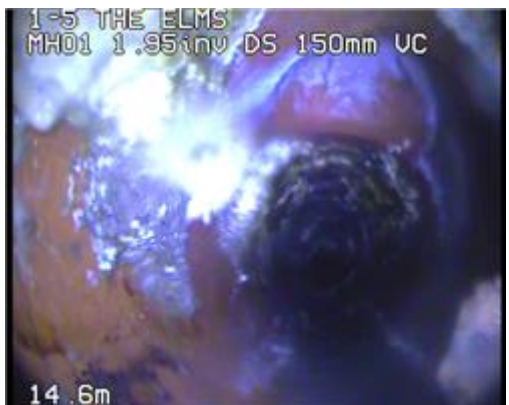
| Pos | Video Ref | Code | Description | Image |
|---|---|---|---|---|
| 14.50m | 0:01:24 | JN | Junction at 12 o'clock: 100mm Diameter | <p>Image Provided - Ref: 0_11</p> |

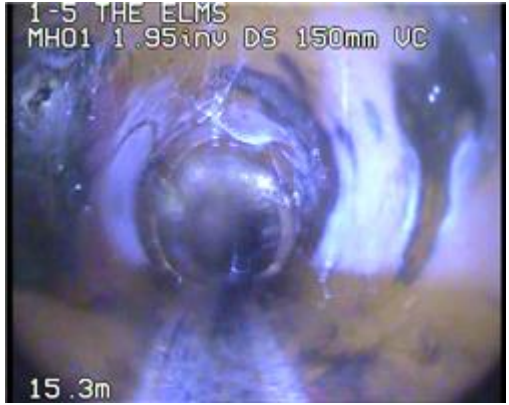
| Pos | Video Ref | Code | Description | Image |
|---|---|---|---|---|
| 15.30m | 0:01:33 | JN | Junction at 09 o'clock: 100mm Diameter | <p>Image Provided - Ref: 0_13</p> |

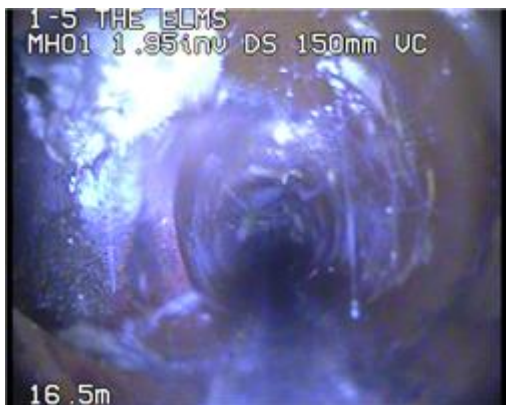
| Pos | Video Ref | Code | Description | Image |
|---|---|---|---|---|
| 16.50m | 0:01:40 | JN | Junction at 09 o'clock: 150mm Diameter | <p>Image Provided - Ref: 0_15</p> |

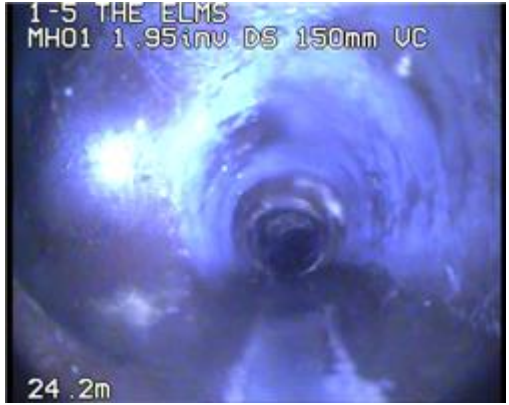
| Pos | Video Ref | Code | Description | Image |
|---|---|---|---|---|
| 24.20m | 0:02:12 | JN | Junction at 09 o'clock: 150mm Diameter | <p>Image Provided - Ref: 0_19</p> |

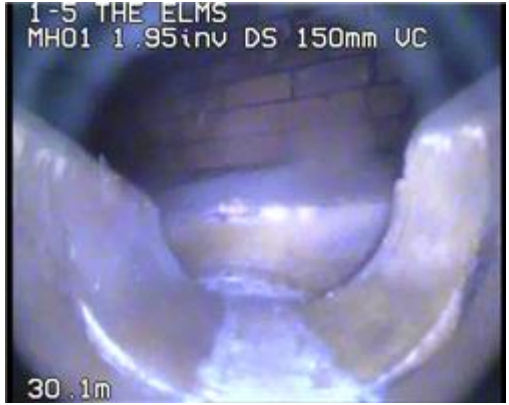
| Pos | Video Ref | Code | Description | Image |
|---|---|---|---|---|
| 30.10m | | MHF | Finish node type, manhole MH02 | <p>Image Provided - Ref: 0_9999</p> <p>1-5 THE ELMS<br/>MH01 1.95inv DS 150mm UC<br/>30.1m</p> |

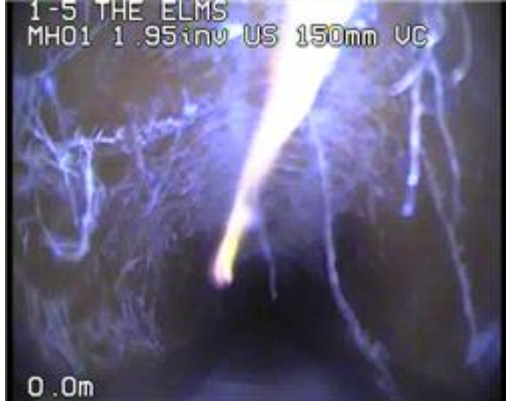
| Pos | Video Ref | Code | Description | Image |
|---|---|---|---|---|
| 00.00m | 0:00:00 | WL | Water level: 10% Height/Diameter | <p>Image Provided - Ref: 1_1</p> |

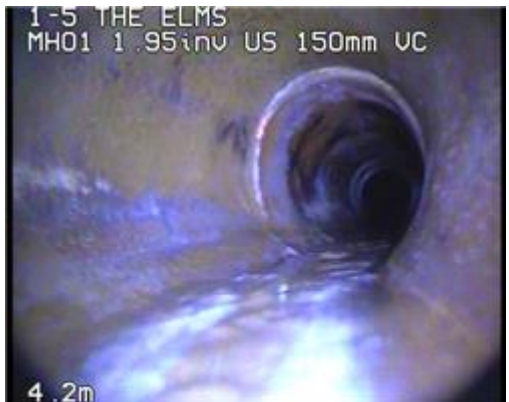
| Pos | Video Ref | Code | Description | Image |
|---|---|---|---|---|
| 04.20m | 0:00:21 | LRH | Line of drain/sewer deviates right [half] | <p>Image Provided - Ref: 1_3</p> |

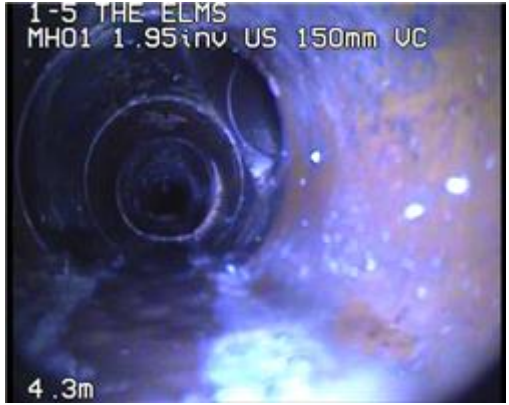
| Pos | Video Ref | Code | Description | Image |
|---|---|---|---|---|
| 04.30m | 0:00:26 | MCPVC | Material of pipe changes to Polyvinyl Chloride | <p>Image Provided - Ref: 1_4</p> |

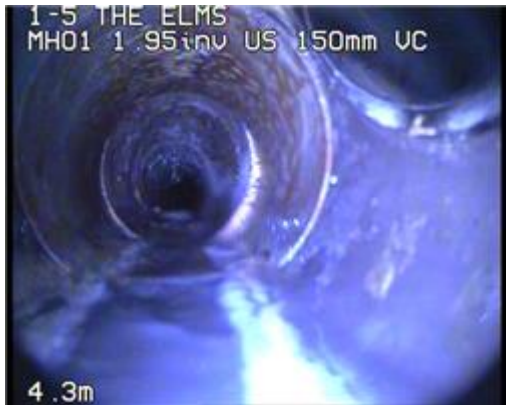
| Pos | Video Ref | Code | Description | Image |
|---|---|---|---|---|
| 04.40m | 0:00:28 | JN | Junction at 03 o'clock: 100mm Diameter | <p>Image Provided - Ref: 1_5</p> |

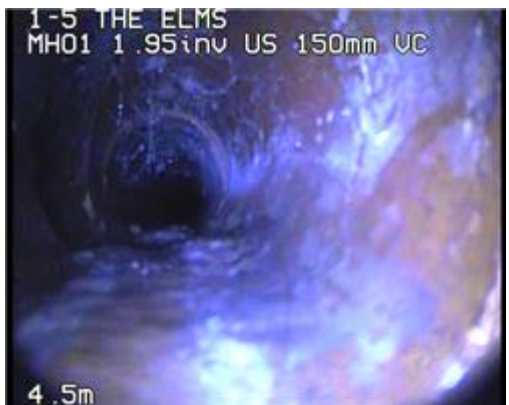
| Pos | Video Ref | Code | Description | Image |
|---|---|---|---|---|
| 04.60m | 0:00:30 | MCVC | Material of pipe changes to Vitrified Clay (i.e. all clayware) | <p>Image Provided - Ref: 1_6</p> |

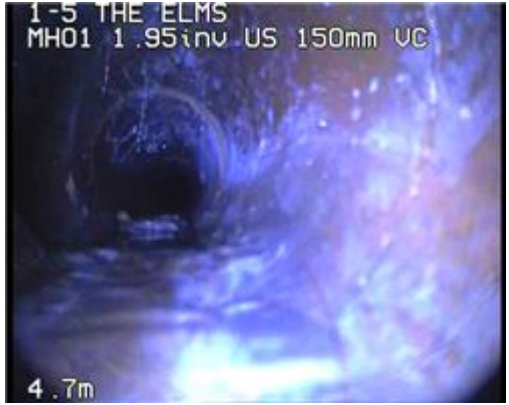
| Pos | Video Ref | Code | Description | Image |
|---|---|---|---|---|
| 04.80m | 0:00:35 | JN | Junction at 09 o'clock: 150mm Diameter<br>Junction coming in from neighbouring bungalow | Image Provided - Ref: 1_7<br> |

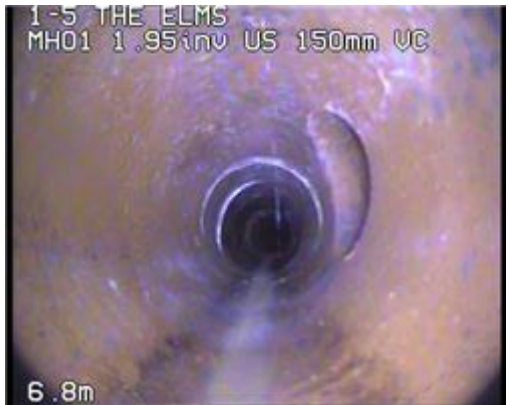
| Pos | Video Ref | Code | Description | Image |
|---|---|---|---|---|
| 07.00m | 0:00:54 | JN | Junction at 03 o'clock: 100mm Diameter | Image Provided - Ref: 1_8<br> |

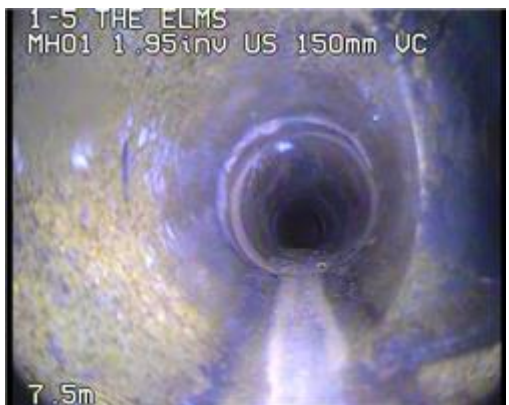
| Pos | Video Ref | Code | Description | Image |
|---|---|---|---|---|
| 07.50m | 0:00:58 | JN | Junction at 03 o'clock: 150mm Diameter | Image Provided - Ref: 1_9<br> |

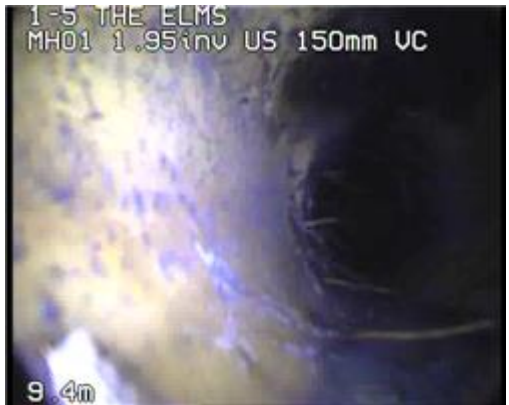
| Pos | Video Ref | Code | Description | Image |
|---|---|---|---|---|
| 09.50m | 0:01:13 | JN | Junction at 09 o'clock: 100mm<br>Diameter<br>Junction coming in from<br>neighbouring bungalow | Image Provided - Ref: 1_11<br> |

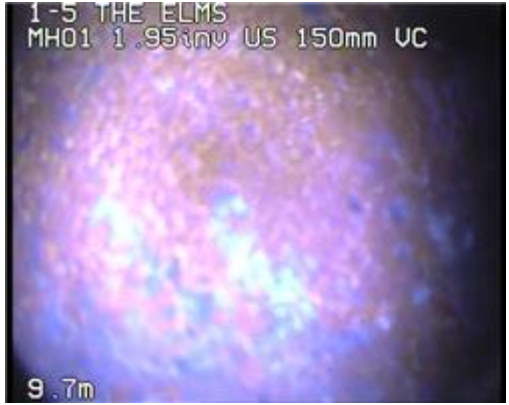
| Pos | Video Ref | Code | Description | Image |
|---|---|---|---|---|
| 09.70m | 0:01:14 | LRF | Line of drain/sewer deviates right [full] | <p>Image Provided - Ref: 1_13</p> |

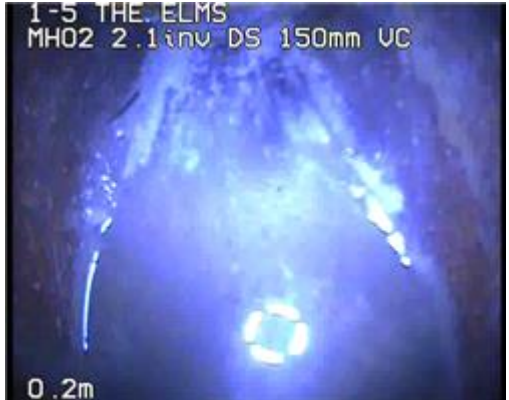
| Pos | Video Ref | Code | Description | Image |
|---|---|---|---|---|
| 00.00m | 0:00:00 | WL | Water level: 0% Height/Diameter | <p>Image Provided - Ref: 3_1</p> |

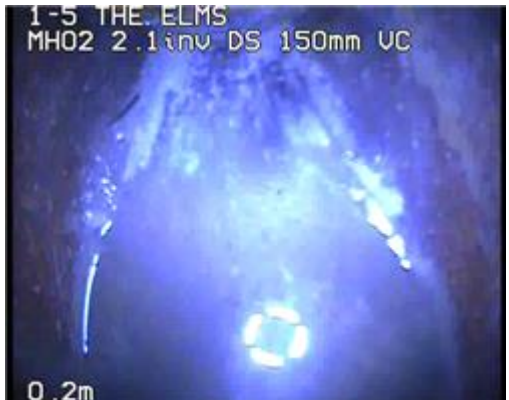
| Pos | Video Ref | Code | Description | Image |
|---|---|---|---|---|
| 00.20m | 0:00:00 | REM | General remark Rear of interceptor outlet | <p>Image Provided - Ref: 3_2</p> |

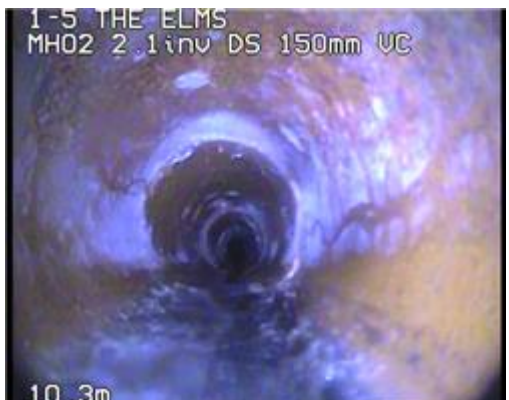
| Pos | Video Ref | Code | Description | Image |
|---|---|---|---|---|
| 10.30m | | BRF | Finish node type, major connection without manhole Off boundary in Elms Close | <p>Image Provided - Ref: 3_9999</p> |

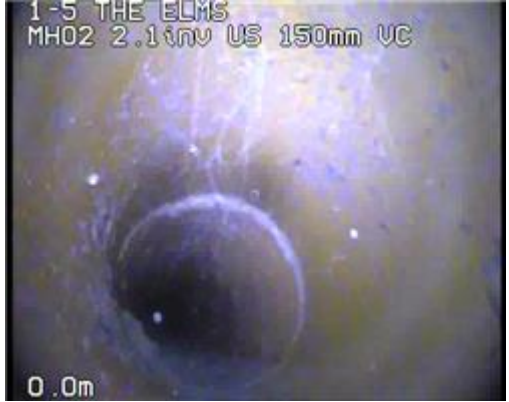
| Pos | Video Ref | Code | Description | Image |
|---|---|---|---|---|
| 00.00m | 0:00:00 | WL | Water level: 0% Height/Diameter | <p>Image Provided - Ref: 4_1</p> |

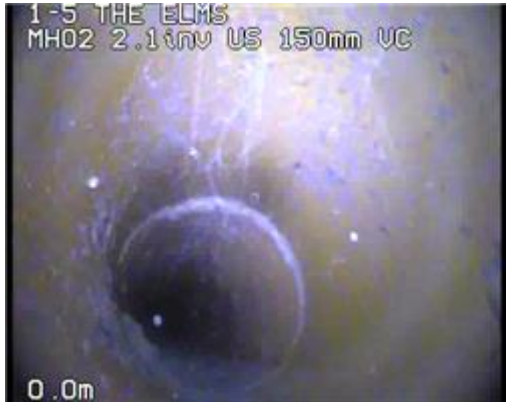
| Pos | Video Ref | Code | Description | Image |
|---|---|---|---|---|
| 00.20m | 0:00:00 | LLQ | Line of drain/sewer deviates left [quarter] | <p>Image Provided - Ref: 4_2</p> |

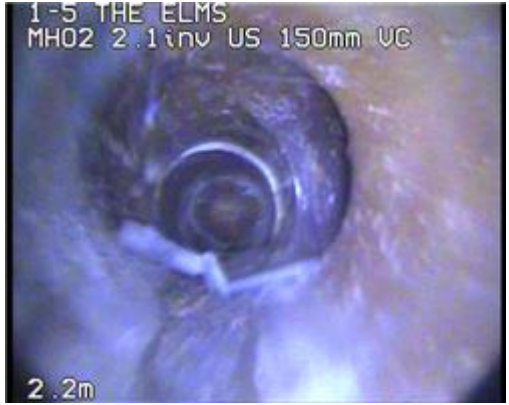
| Pos | Video Ref | Code | Description | Image |
|---|---|---|---|---|
| 02.40m | 0:00:12 | JN | Junction at 03 o'clock: 150mm Diameter | <p>Image Provided - Ref: 4_4</p> |

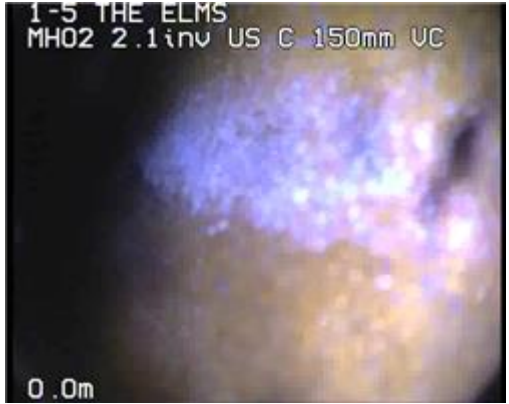
| Pos | Video Ref | Code | Description | Image |
|---|---|---|---|---|
| 00.00m | 0:00:00 | WL | Water level: 0% Height/Diameter | <p>Image Provided - Ref: 5_1</p> |

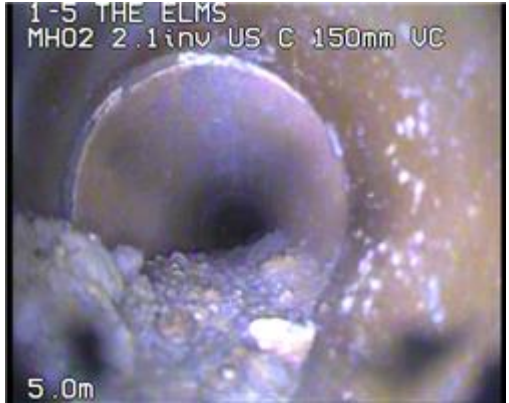
| Pos | Video Ref | Code | Description | Image |
|---|---|---|---|---|
| 05.00m | | BRF | Finish node type, major connection without manhole<br>Off boundary | <p>Image Provided - Ref: 5_9999</p> |
