| <b>Project Title</b> | New Church Street, Radcliffe |
| <b>Document Title</b> | Validation Completion Report |

# **GAS MITIGATION VALIDATION COMPLETION REPORT**

| Date of Certificate: | 11 <sup>th</sup> December 2017 |

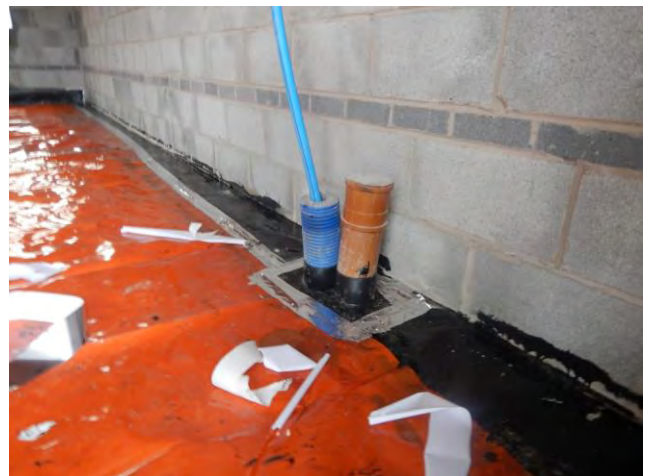
*Photograph 18: Showing the typical installation of a preformed tophat using butyl and silver joining tape on Plot 15-17 during inspection on 29<sup>th</sup> June 2017.*

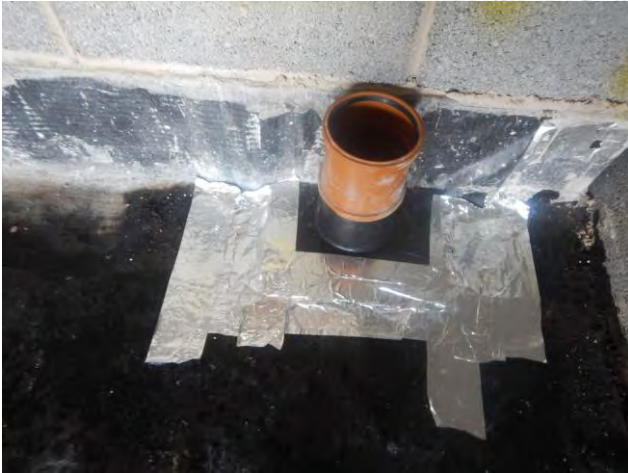
*Photograph 19: Showing the typical installation of a preformed tophat using butyl and silver joining tape on Plot 9 during inspection on 27<sup>th</sup> July 2017.*

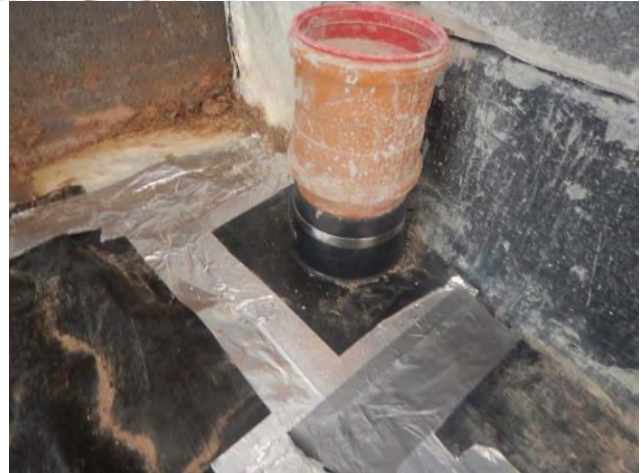
*Photograph 20: Showing the typical installation of a preformed tophat using a jubilee clip, butyl and silver joining tape on Plot 4 during inspection on 14<sup>th</sup> August 2017.*

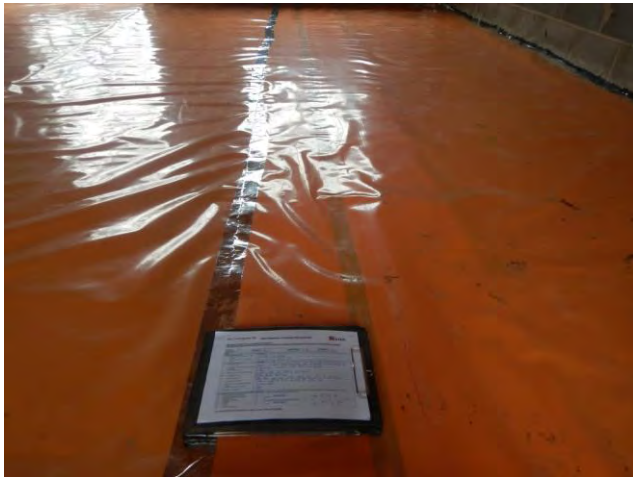
*Photograph 21: Showing the jointing of two sections of membrane with greater than 150mm of overlap, sealed with butyl and silver joining tape on Plot 13 during inspection on 11<sup>th</sup> July 2017.*

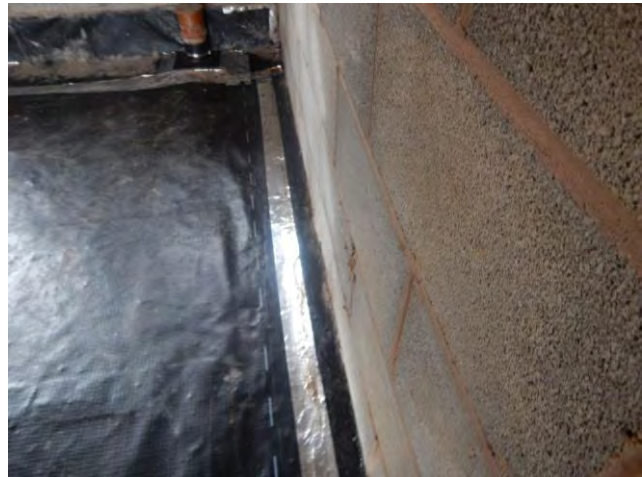
*Photograph 22: Showing the membrane jointed to the perimeter stage one membrane underneath the blockwork with >150mm overlap on Plot 33 during inspection on 31<sup>st</sup> July 2017.*
