## Gas Protection - Validation Record Sheet

**This Record sheet is only applicable to block and beam floor slabs for Characteristic Situation 2 gas protection systems**

Plot 29, Block 10

**For Residential Development at New Church Street, Radcliffe.**

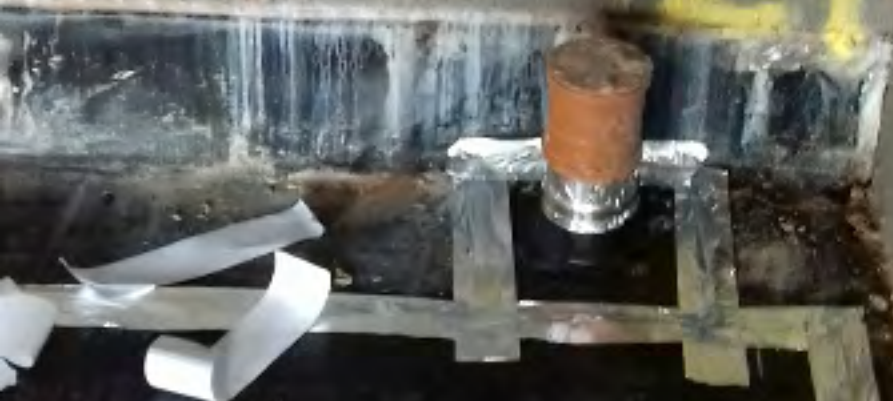
PLOT  
29

| 2.2 | Condition of sub-grade & underside of gas membrane | FLOOR BRUSHED, ALL TAPES APPLIED WELL AND SEALED TO A GOOD QUALITY | | | | | |
| 2.4 | Gas membrane condition and coverage | GOOD, SEALED ON ALL FOUR SIDES | | | | | |
| 2.7 | Condition of joints/seals | ALL GOOD, VISIBLE OVERLAPS | | | | | |
| 2.8 | Number and condition of service entry seals | 3 NO TOPHATS WITH SUBILEE CLIPS - ALL TAPES CHECKED AND OK | | | | | |

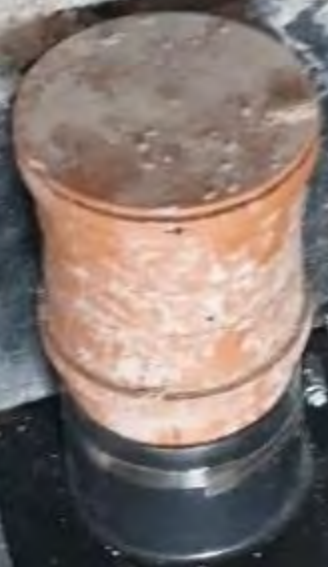
Plot 32

| 2.2 | Condition of sub-grade & underside of gas membrane | GOOD, FLOOR BRUSHED AND TAPES APPLIED WELL AND SEALED | | | | | |
| 2.4 | Gas membrane condition and coverage | GOOD, SEALED ON ALL SIDES | | | | | |
| 2.7 | Condition of joints/seals | GOOD, OVERLAPS VISIBLE | | | | | |
| 2.8 | Number and condition of service entry seals | ALL GOOD, 3 NO TOP HATS WITH SUBILEE CLIPS. TAPES CHECKED. | | | | | |

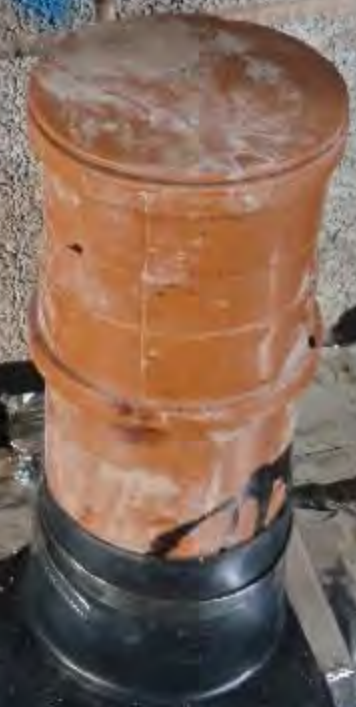
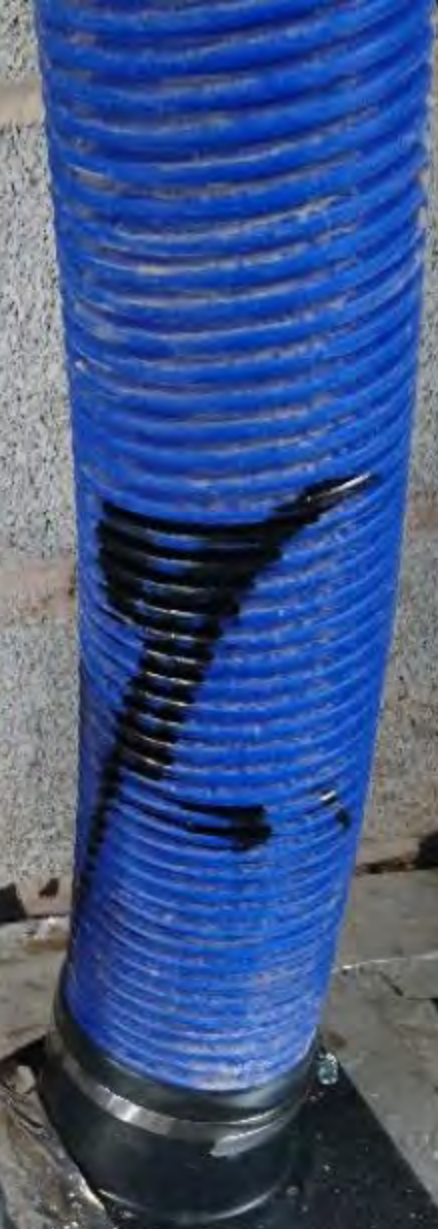
Plot 34

| 2.2 | Condition of sub-grade & underside of gas membrane | GOOD QUALITY, BRUSHED FLOOR, TAPE APPLIED WELL AND SEALED. | | | | | |
| 2.4 | Gas membrane condition and coverage | GOOD, SEALED ON ALL FOUR SIDES. | | | | | |
| 2.7 | Condition of joints/seals | GOOD, OVERLAPS VISIBLE | | | | | |
| 2.8 | Number and condition of service entry seals | ALL GOOD, 3 NO. TOP HATS WITH SUBILES CLIPS, TAPES CHECKED. | | | | | |

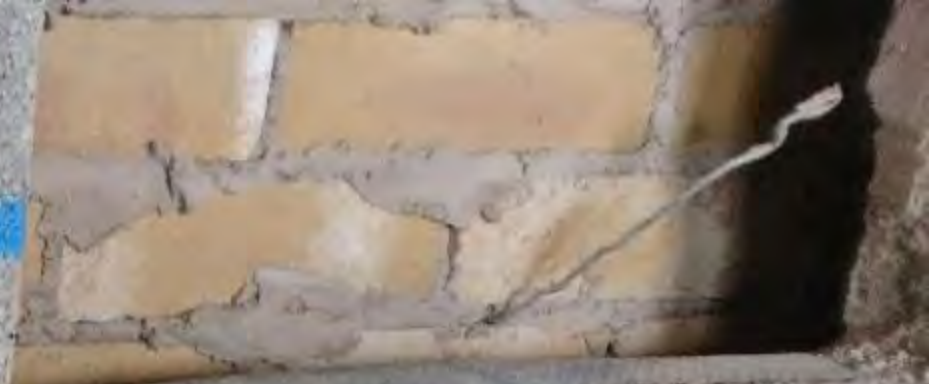
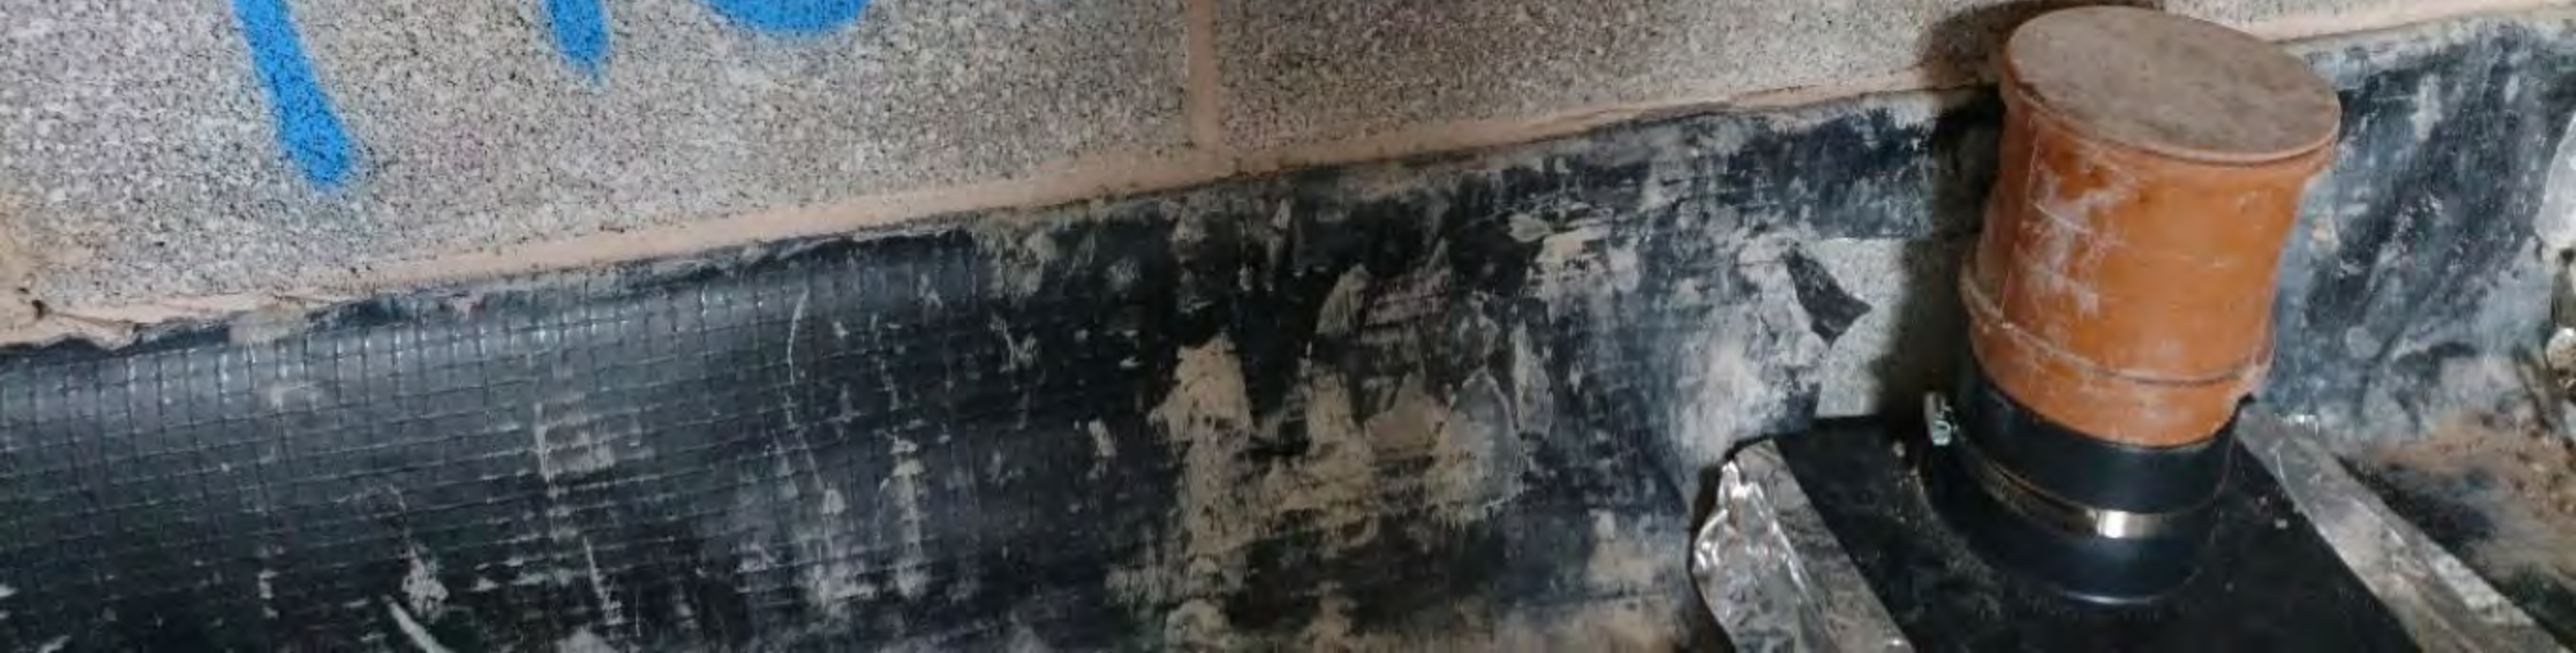
P10t33

| 2.2 | Condition of sub-grade & underside of gas membrane | FLOOR BRUSHED AND ALL TAPES APPLIED WELL SEALED TO A GOOD QUALITY | | | | | |
| 2.4 | Gas membrane condition and coverage | SEALED ON ALL FOUR SIDES – ALL GOOD | | | | | |
| 2.7 | Condition of joints/seals | VISIBLE OVERLAPS, ALL GOOD | | | | | |
| 2.8 | Number and condition of service entry seals | 3 NO TOPHATS FITTED WITH JUBILEE CLIPS, TAPES CHECKED, ALL OK | | | | | |
| 2.10 | Repairs or Corrections: | 1 NO REPAIR BY FRONT DOOR. USED 300mm WIDE RADBAR SIA DETAIL STRIP x 20m | | | | | |

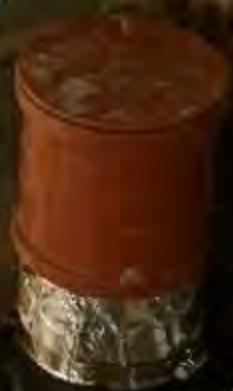
PLOT  
37

| 2.2 | Condition of sub-grade & underside of gas membrane | SEALED TO A GOOD QUALITY, TAPES APPLIED WELL. FLOOR SWEEP CLEAN | | | | | |
| 2.7 | Condition of joints/seals | ALL GOOD, VISIBLE OVERLAPS | | | | | |
