**This Record sheet is only applicable to block and beam floor slabs for Characteristic Situation 2 gas protection systems**

**For Residential Development at New Church Street, Radcliffe.**

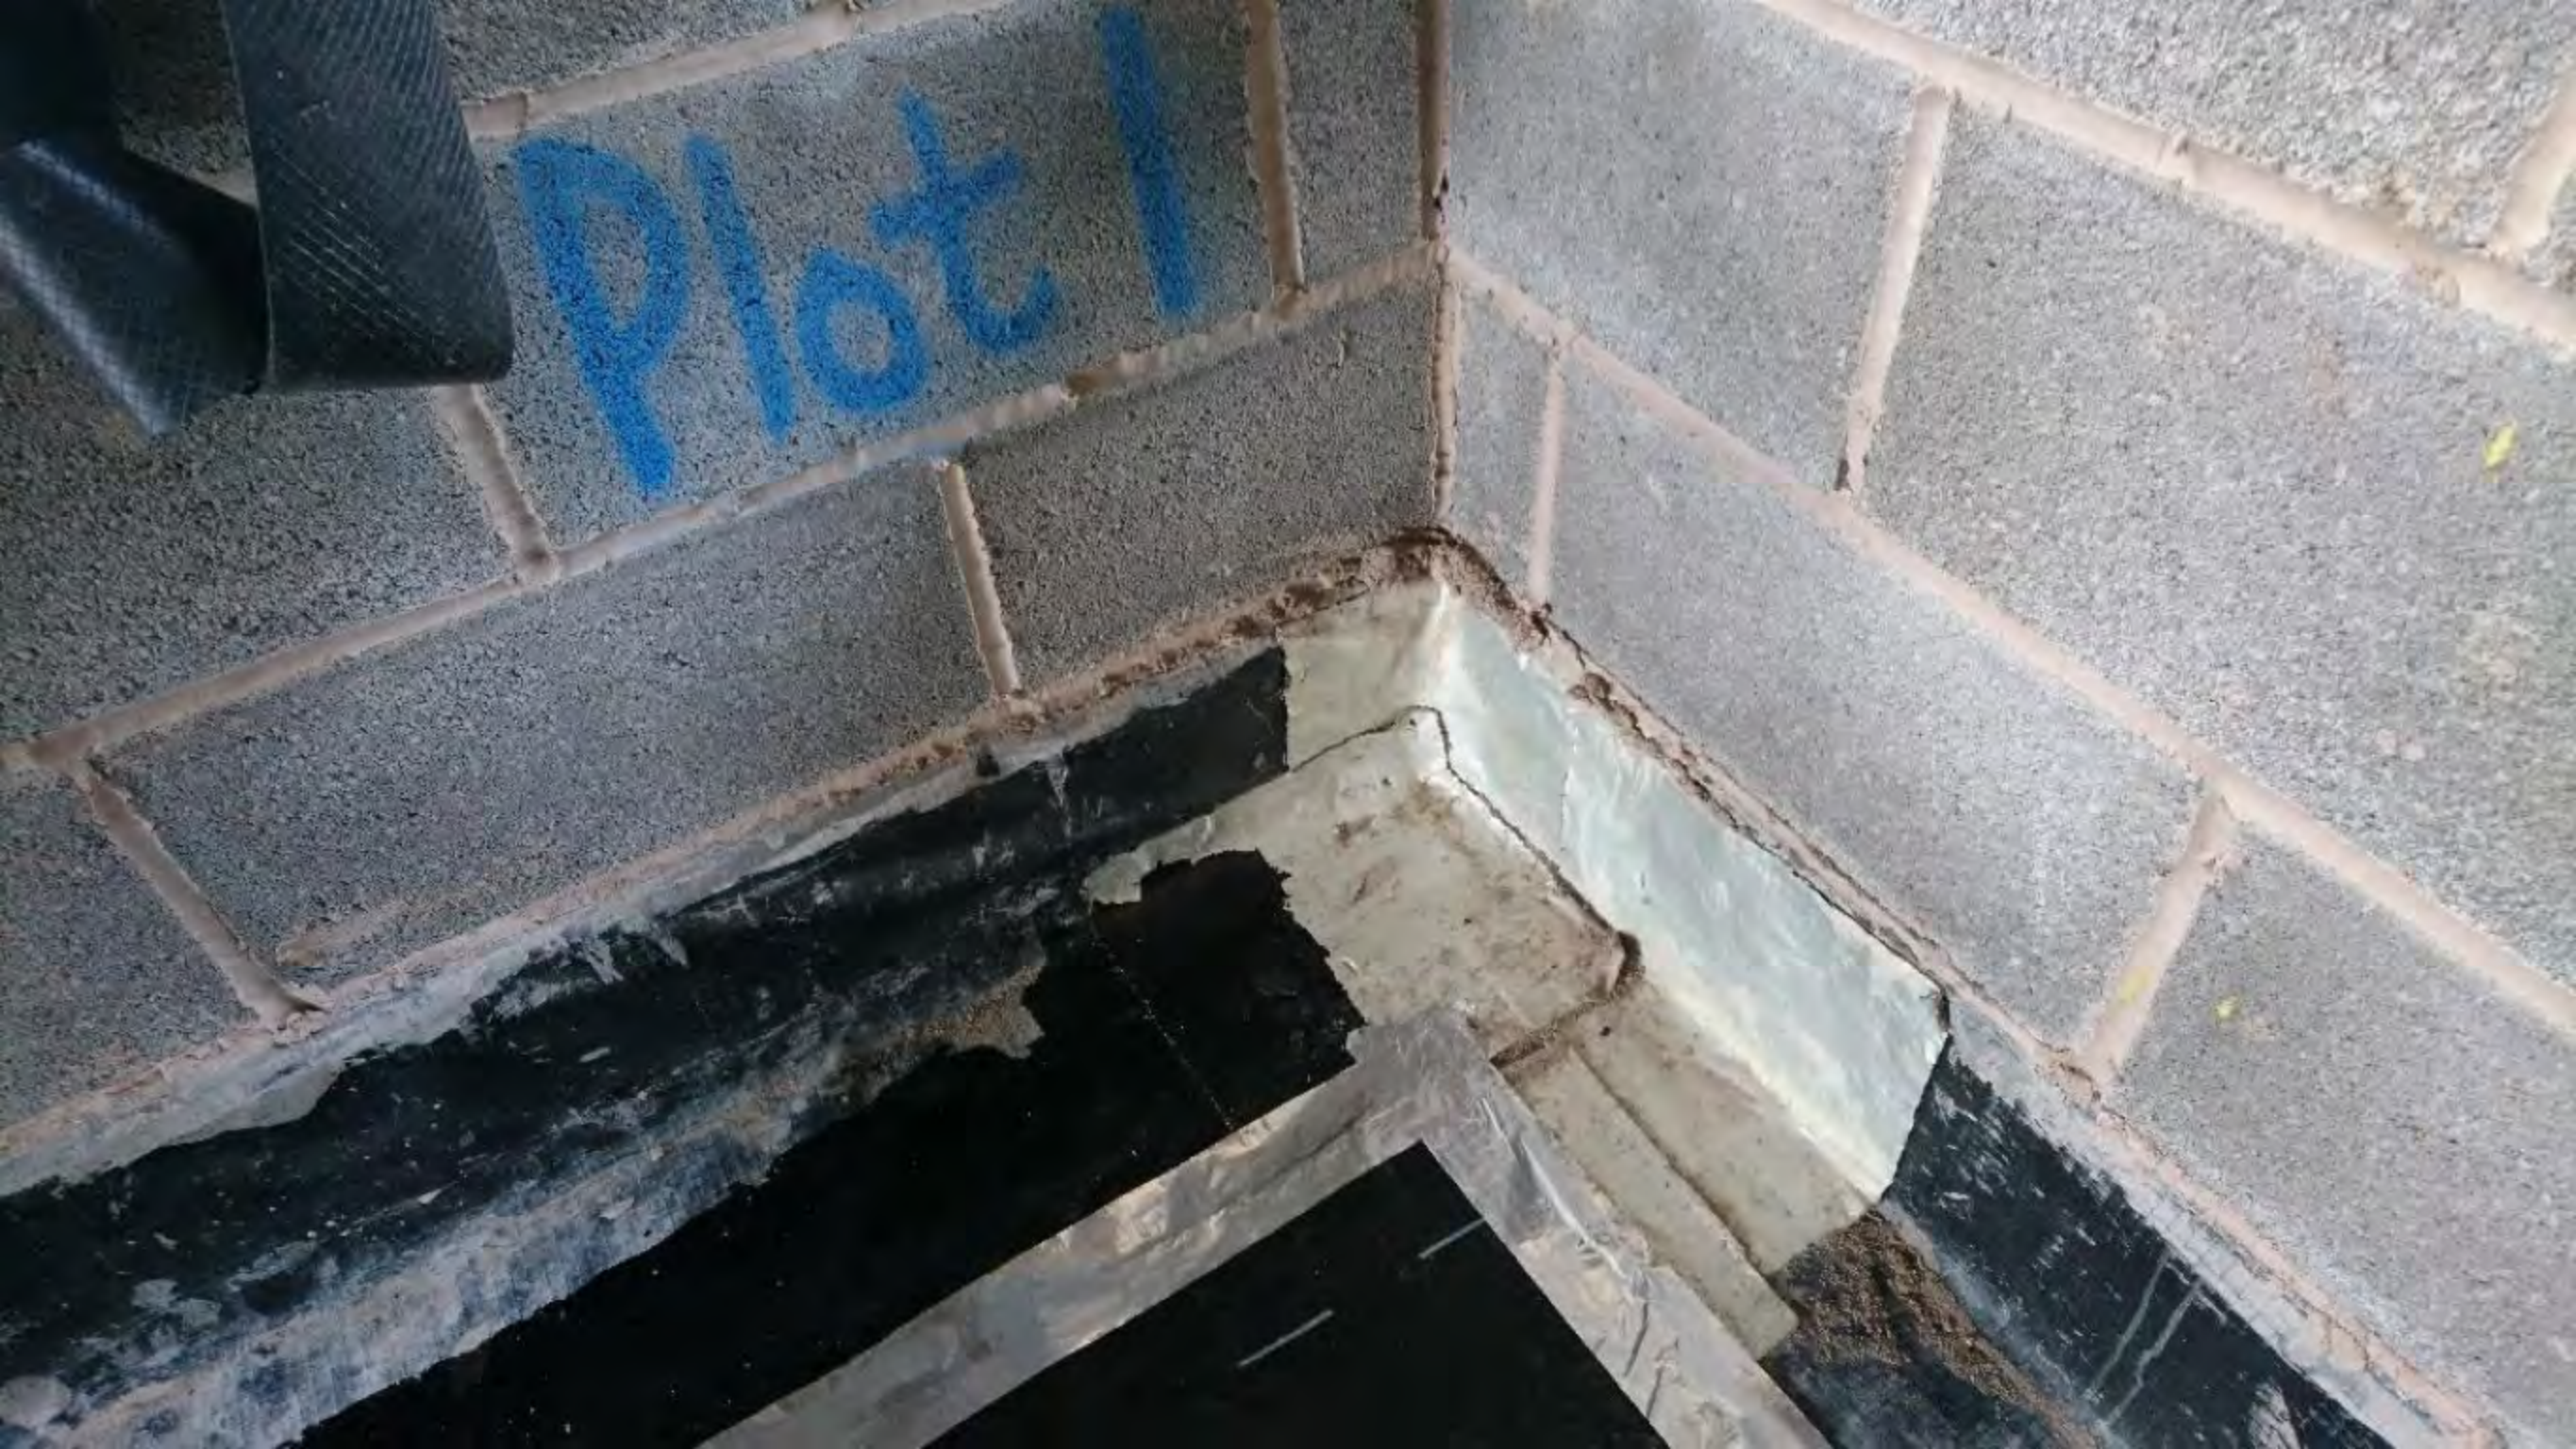
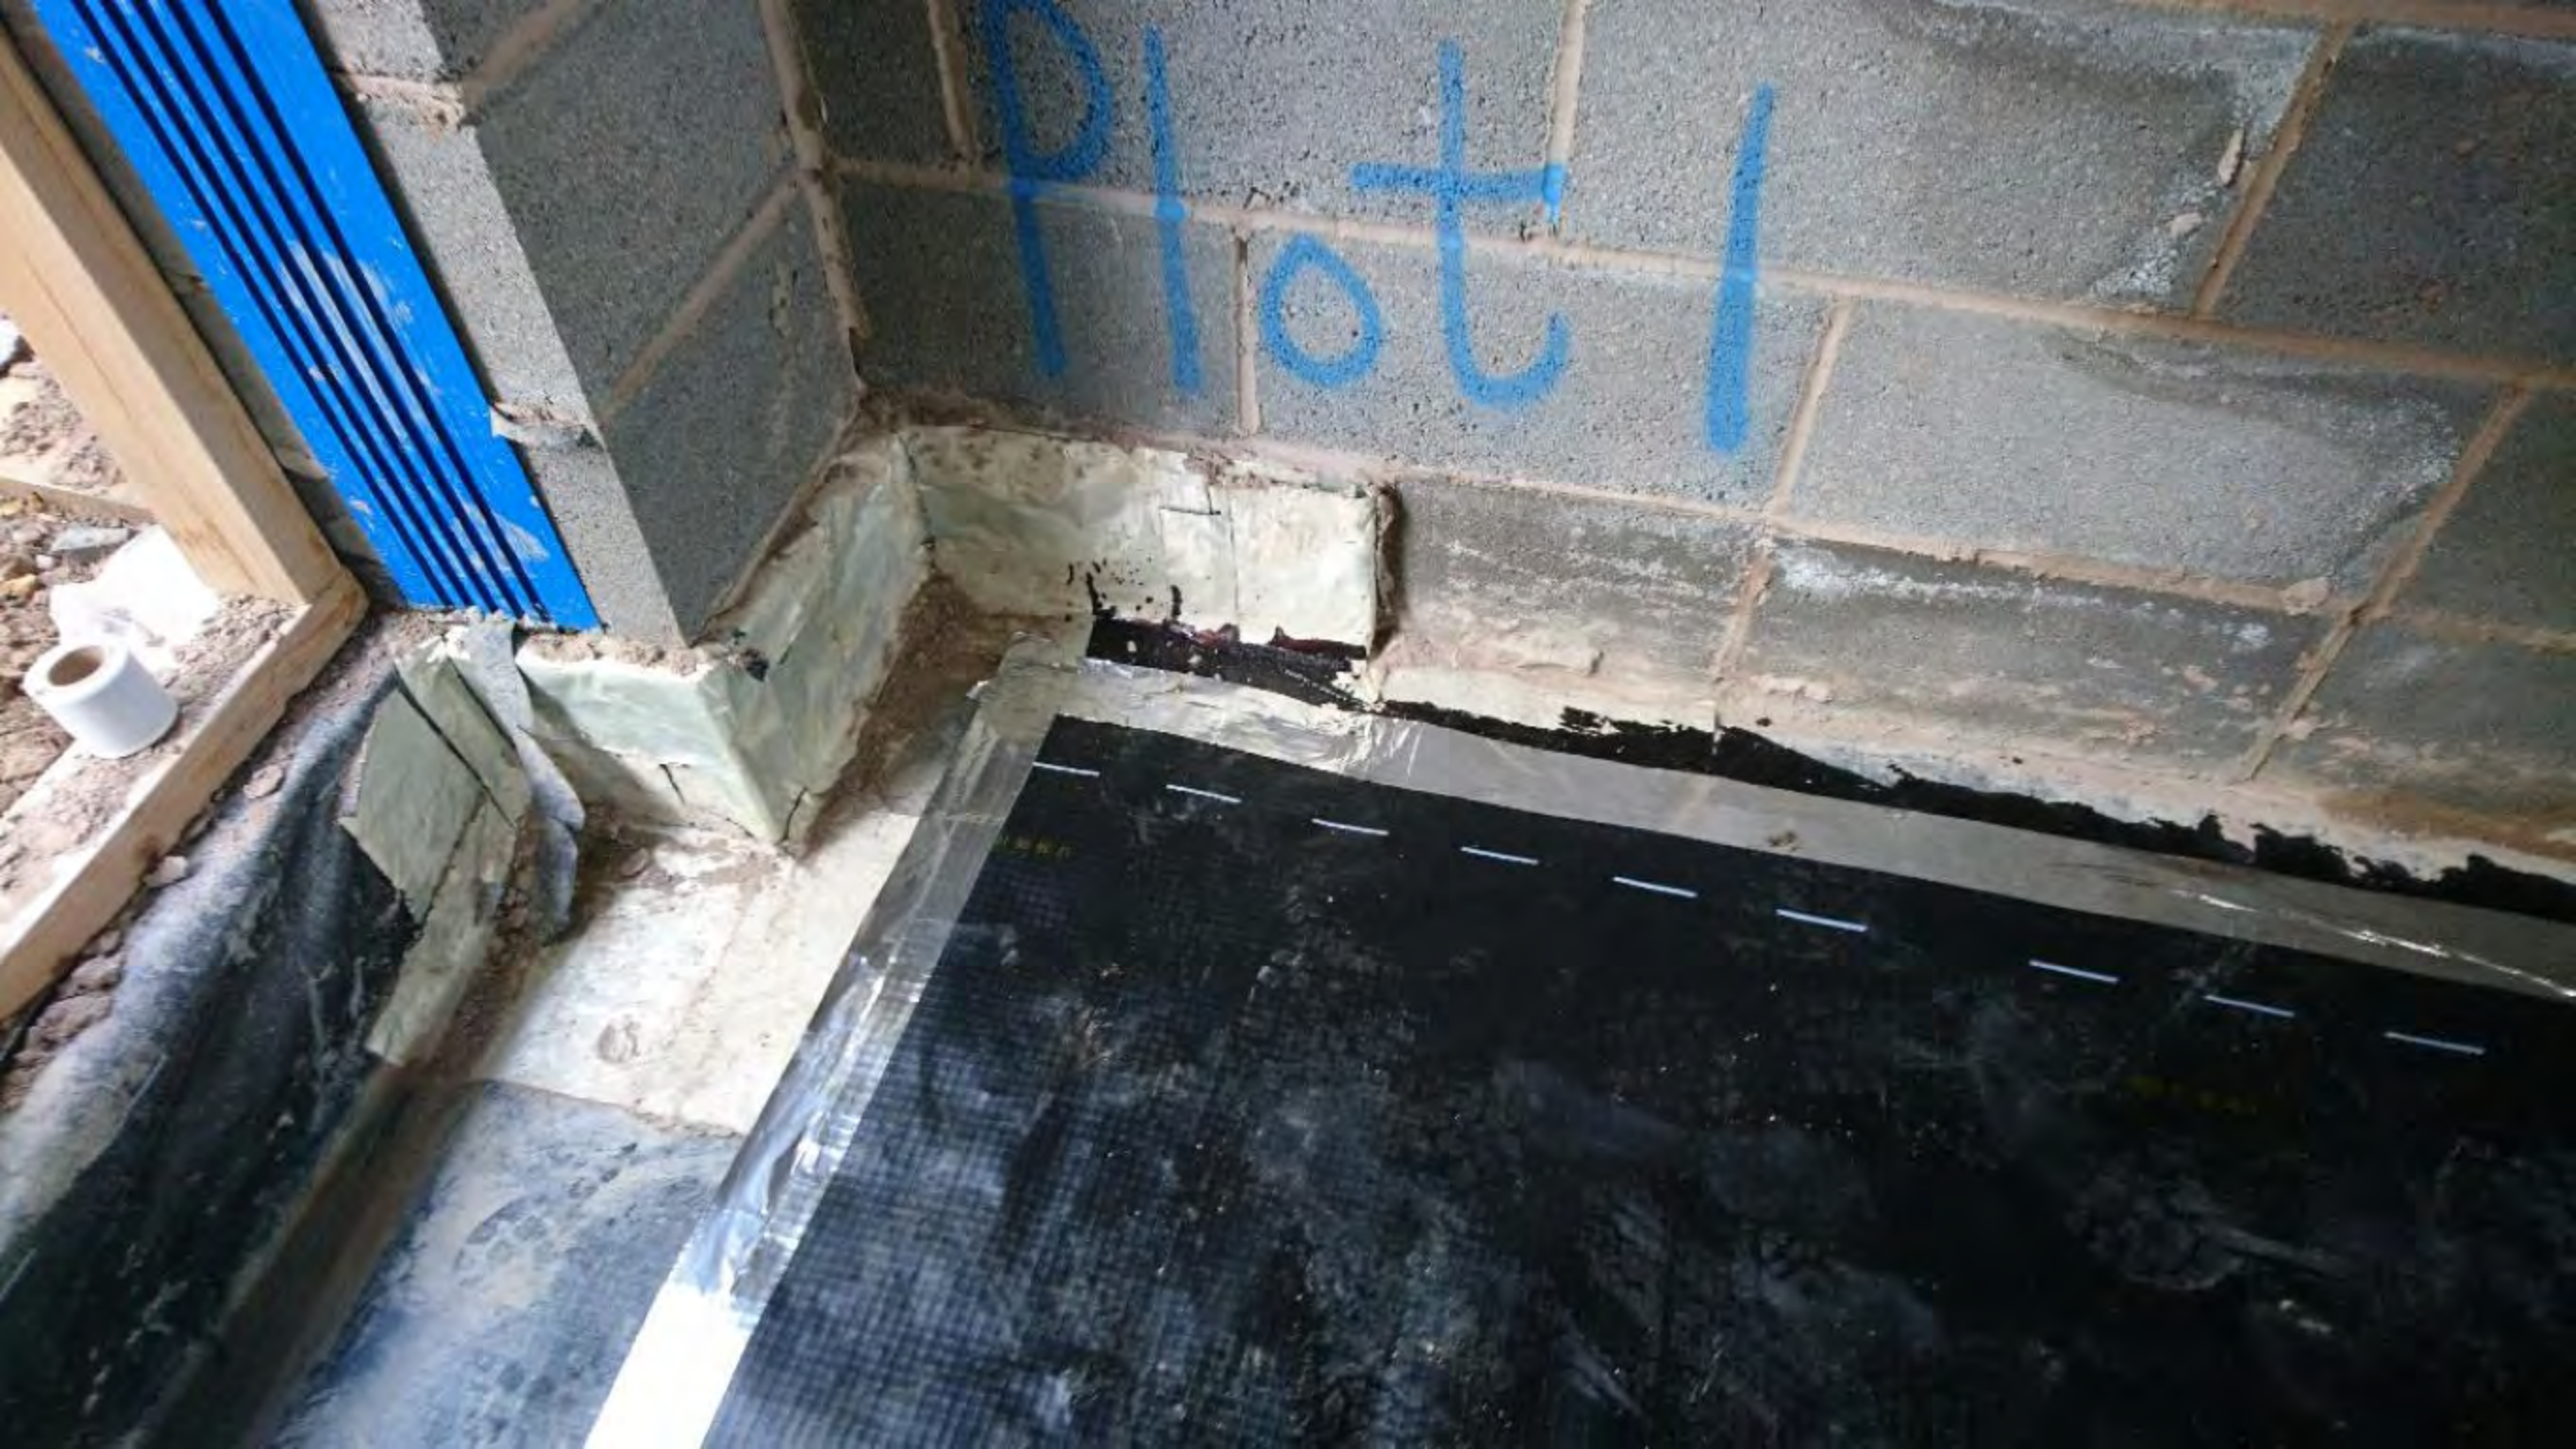
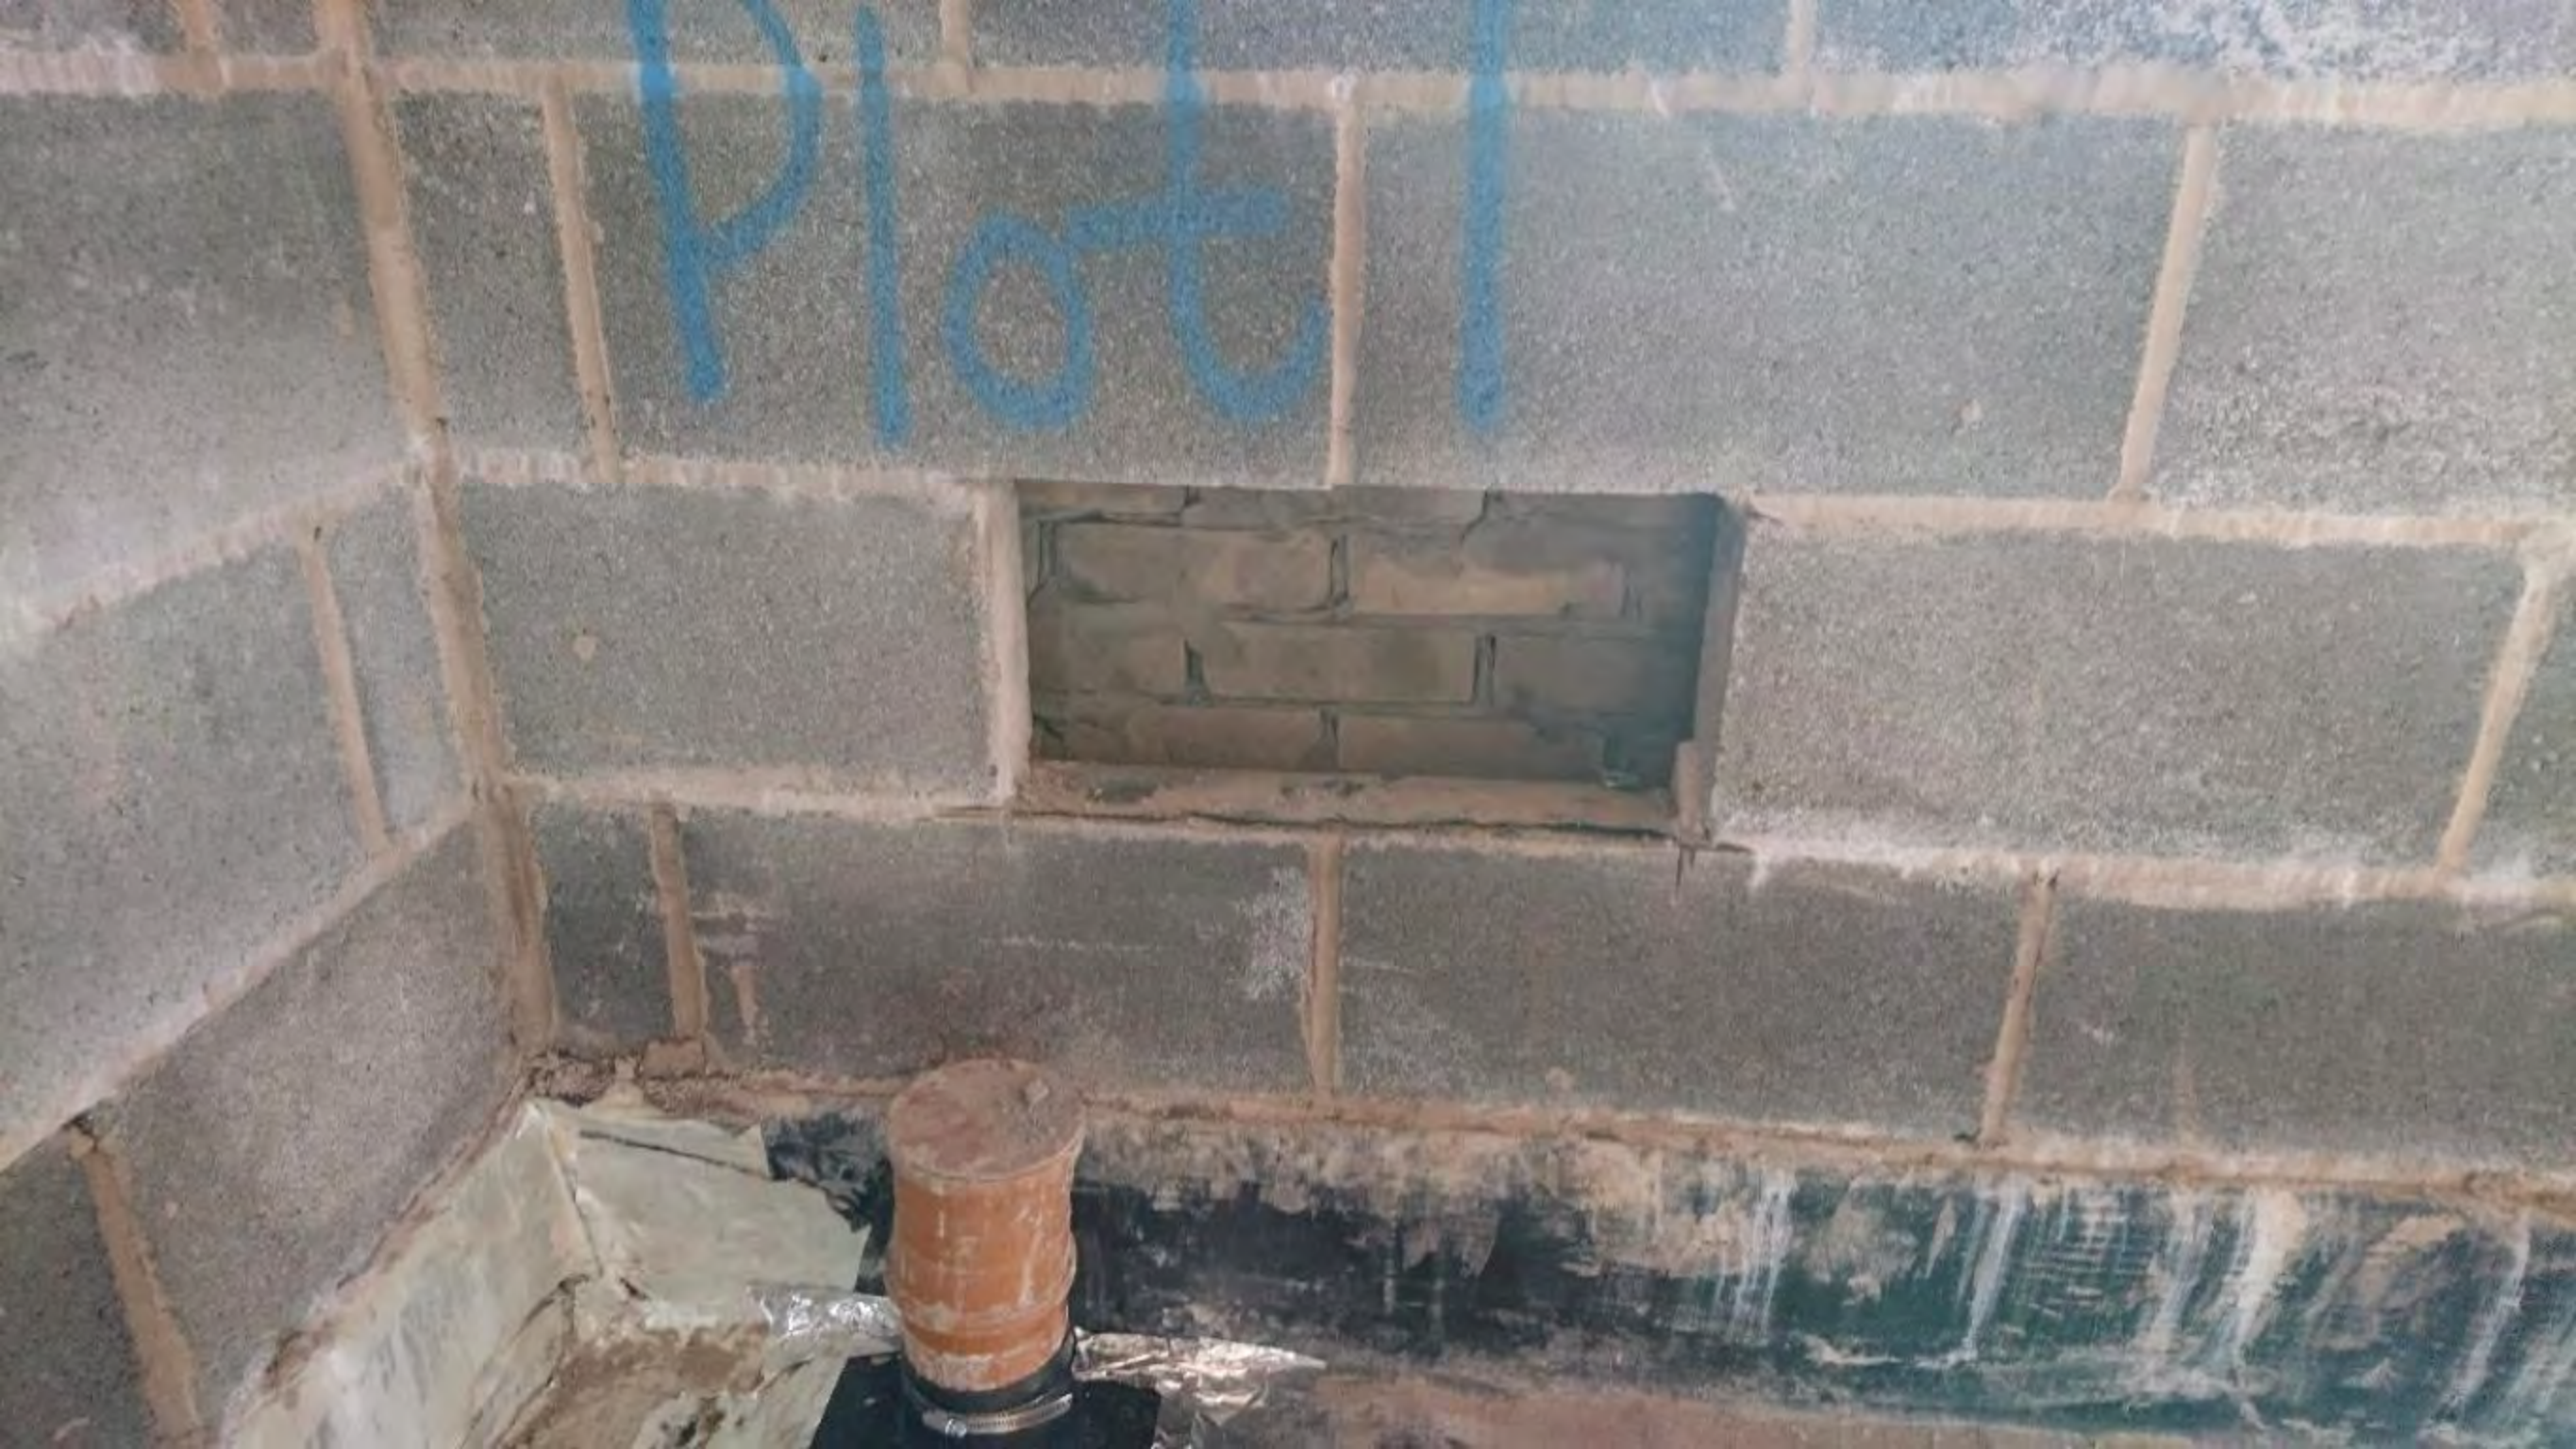
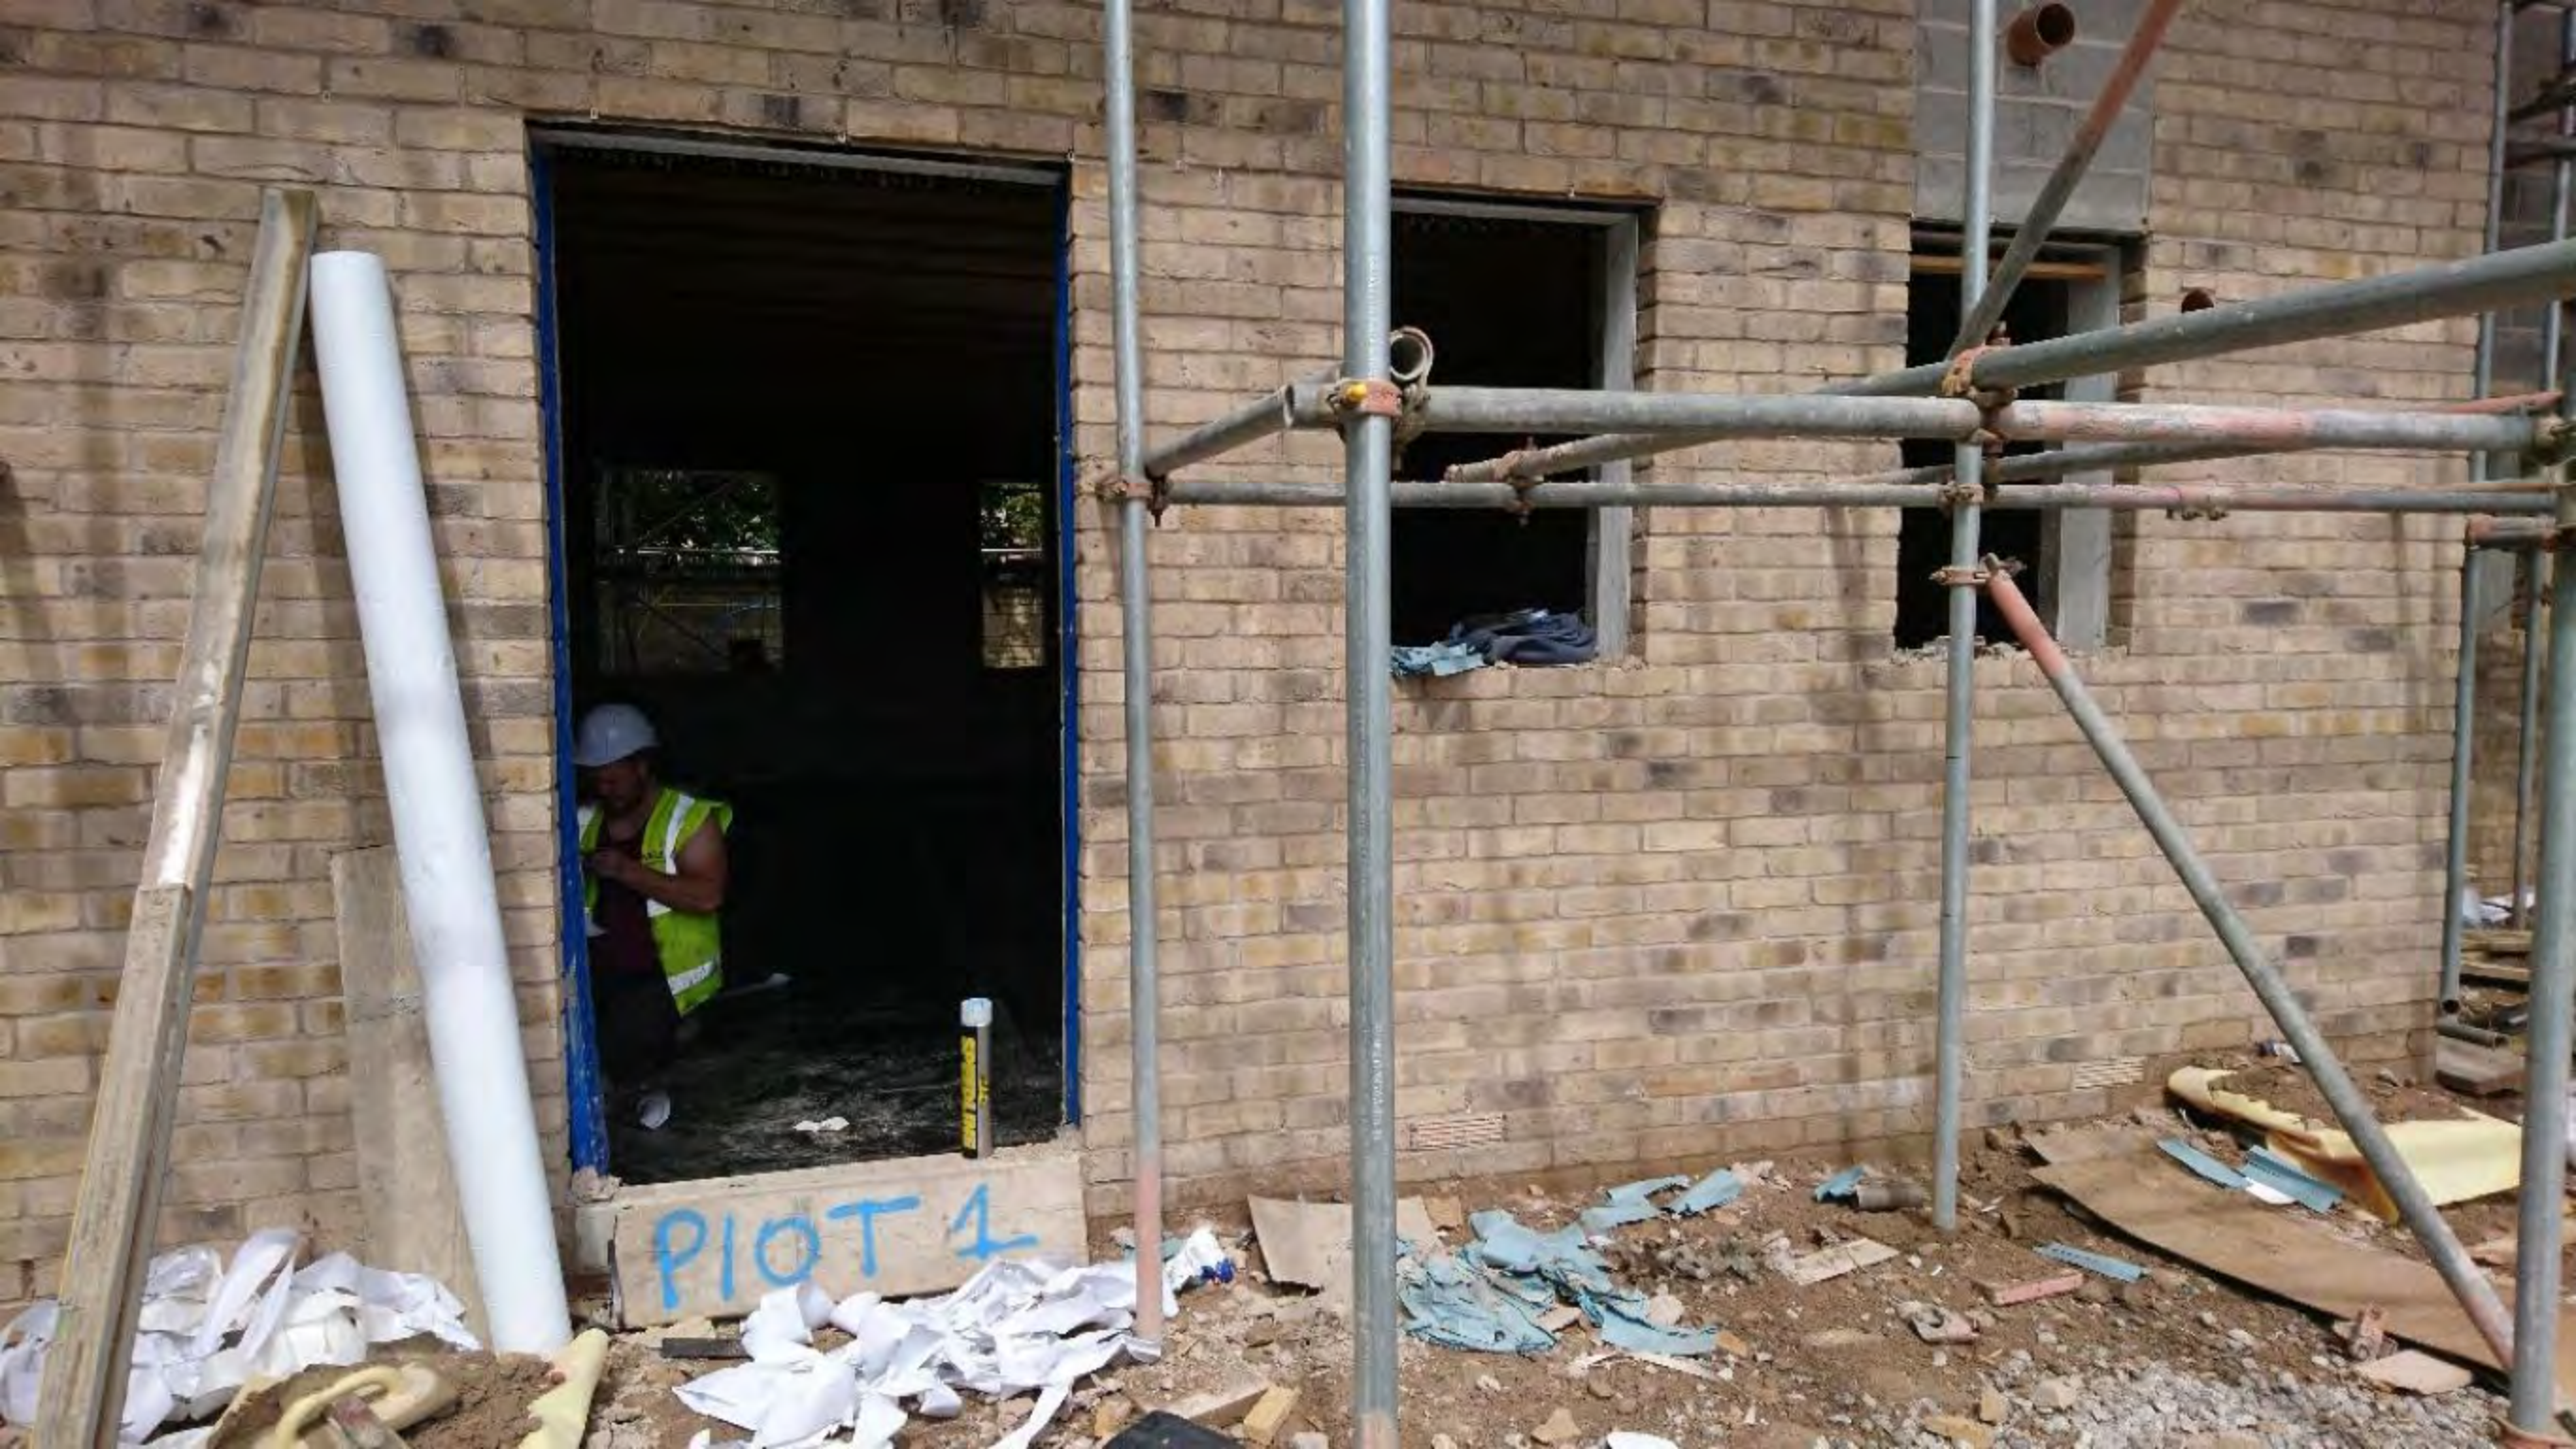
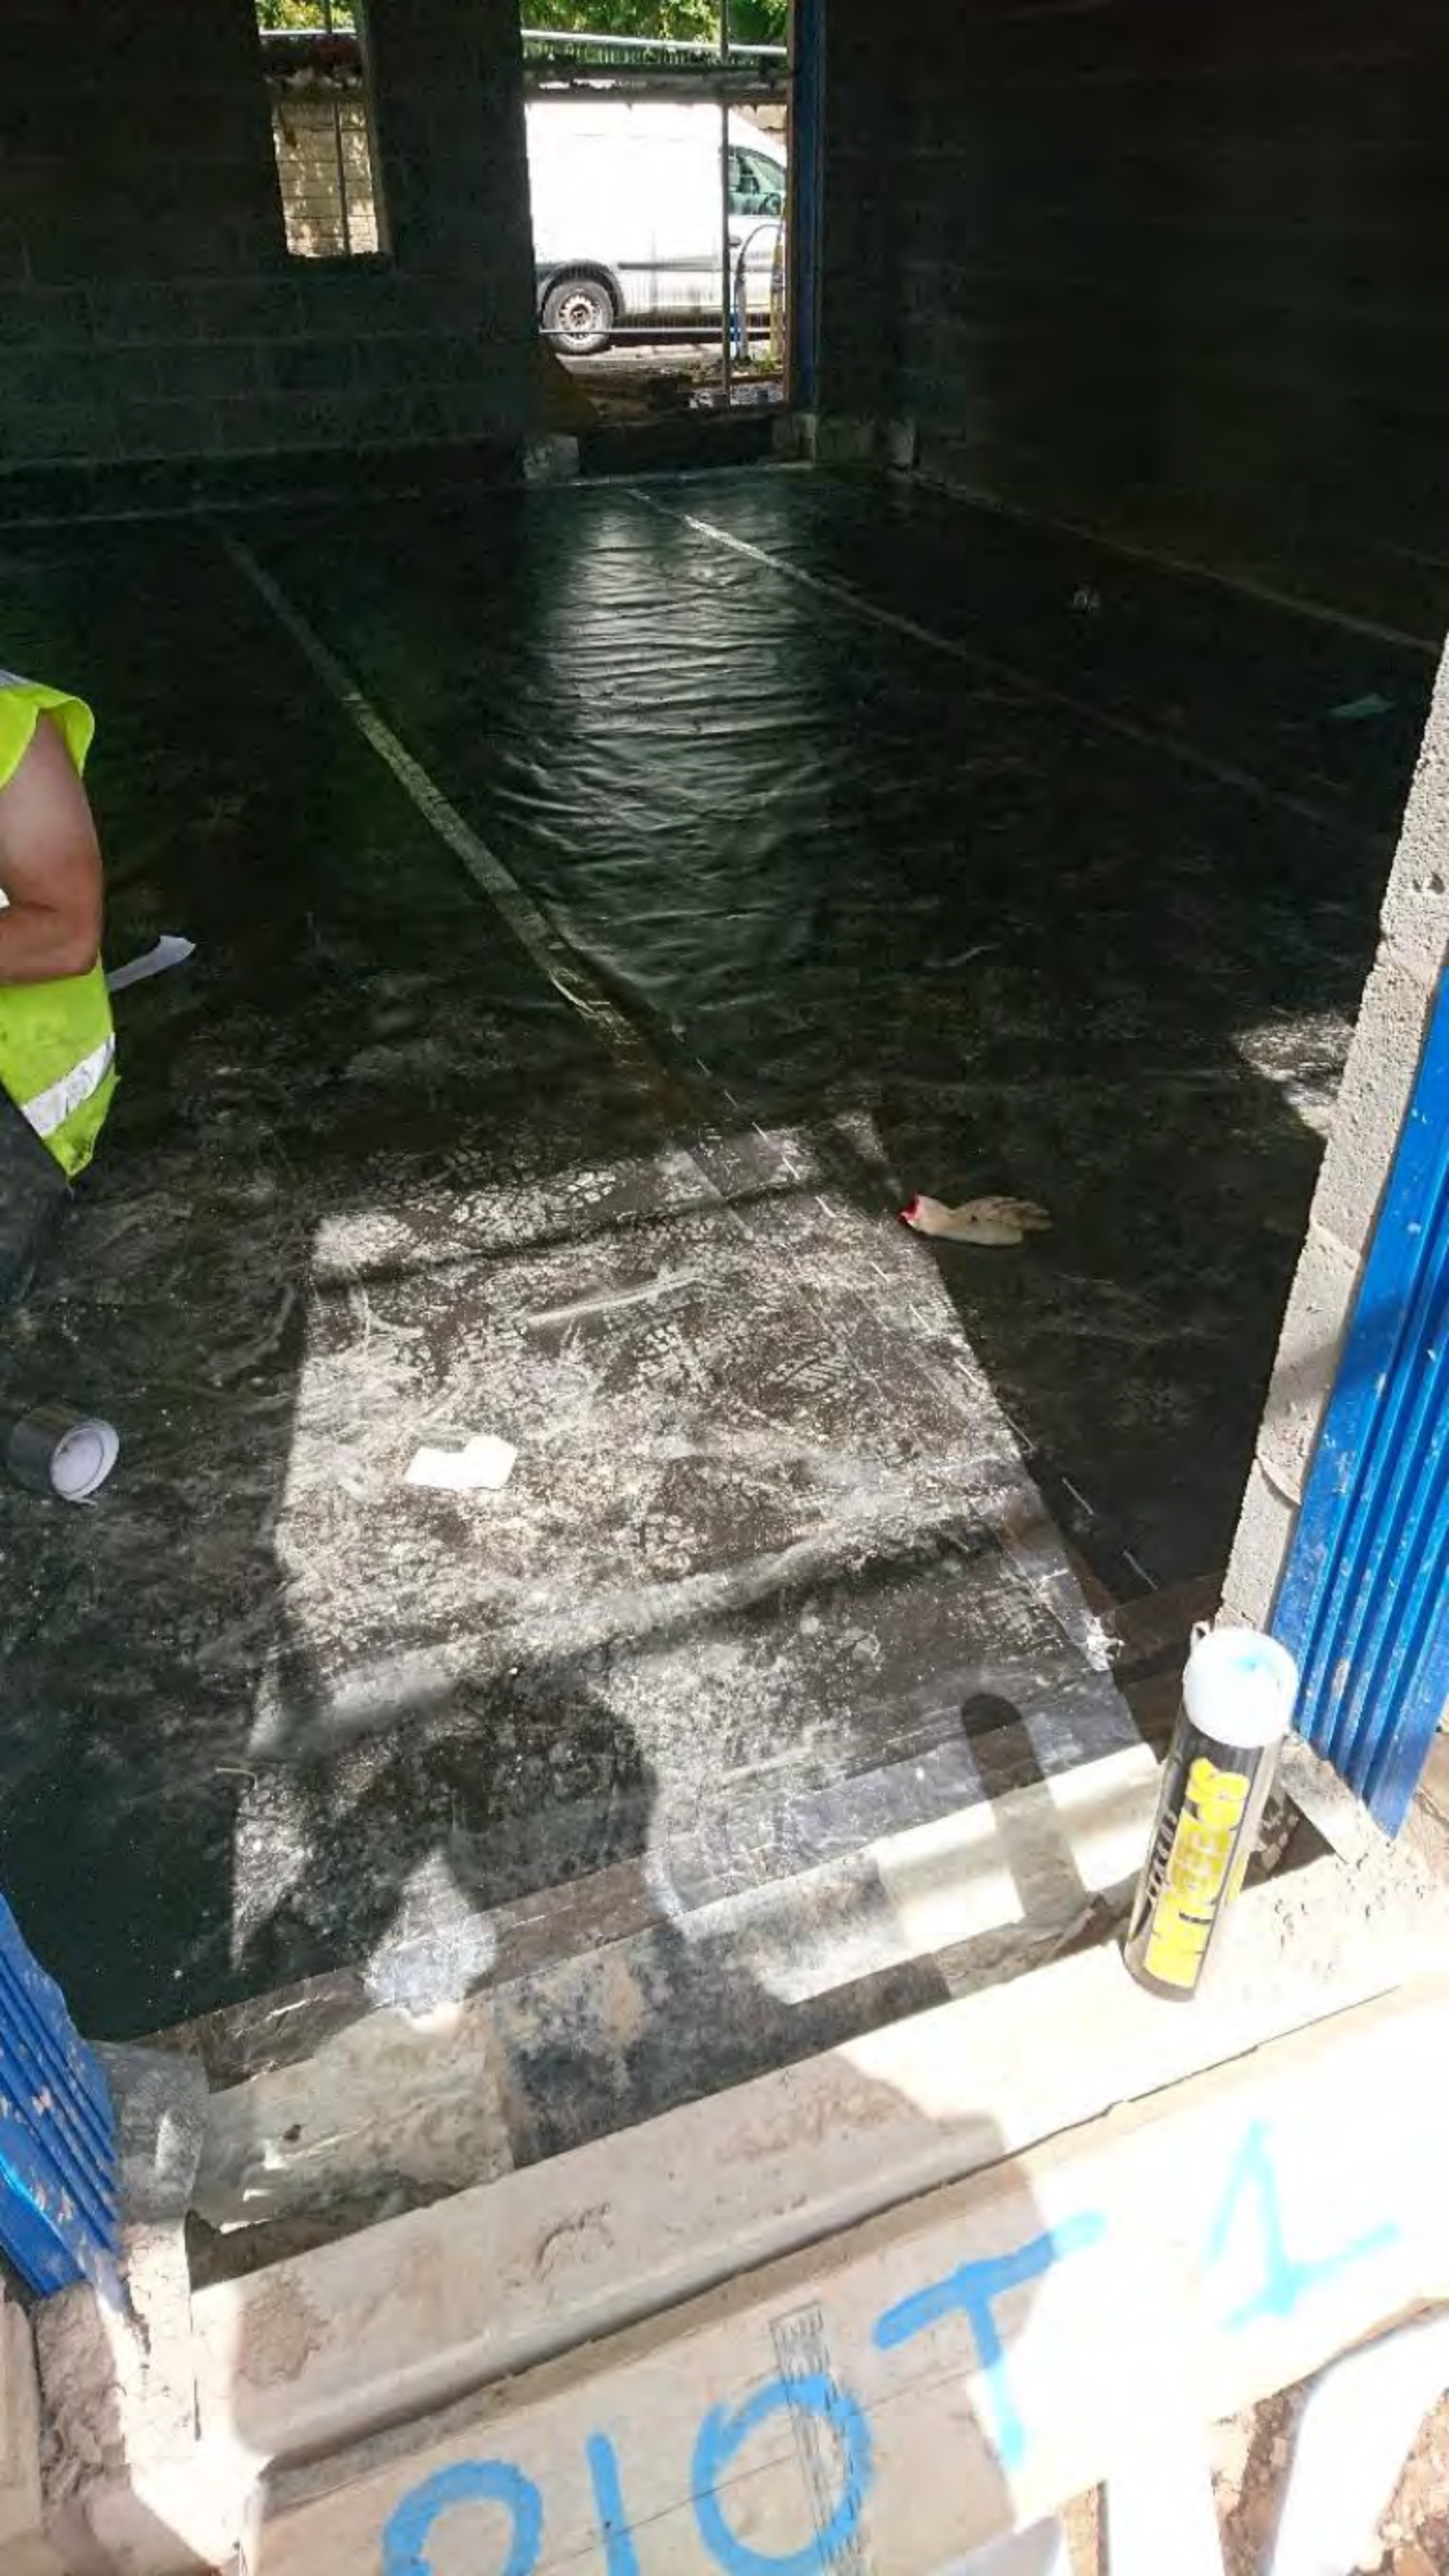
PIOT 1

| 2.2 | Condition of sub-grade & underside of gas membrane | GOOD QUALITY, FLOOR BRUSHED, TAPES APPLIED WELL AND SEALED | | | | | |
| 2.4 | Gas membrane condition and coverage | GOOD, SEALED ON ALL FOUR SIDES | | | | | |
| 2.7 | Condition of joints/seals | ALL GOOD, OVERLAPS VISIBLE | | | | | |
| 2.8 | Number and condition of service entry seals | ALL OK, 3 NO. TO PLUMS WITH JUBILEE CLIPS - TAPES CHECKED | | | | | |
| 2.10 | Repairs or Corrections: | NONE VISIBLE | | | | | |
