**This Record sheet is only applicable to block and beam floor slabs for Characteristic Situation 2 gas protection systems**

**For Residential Development at New Church Street, Radcliffe.**

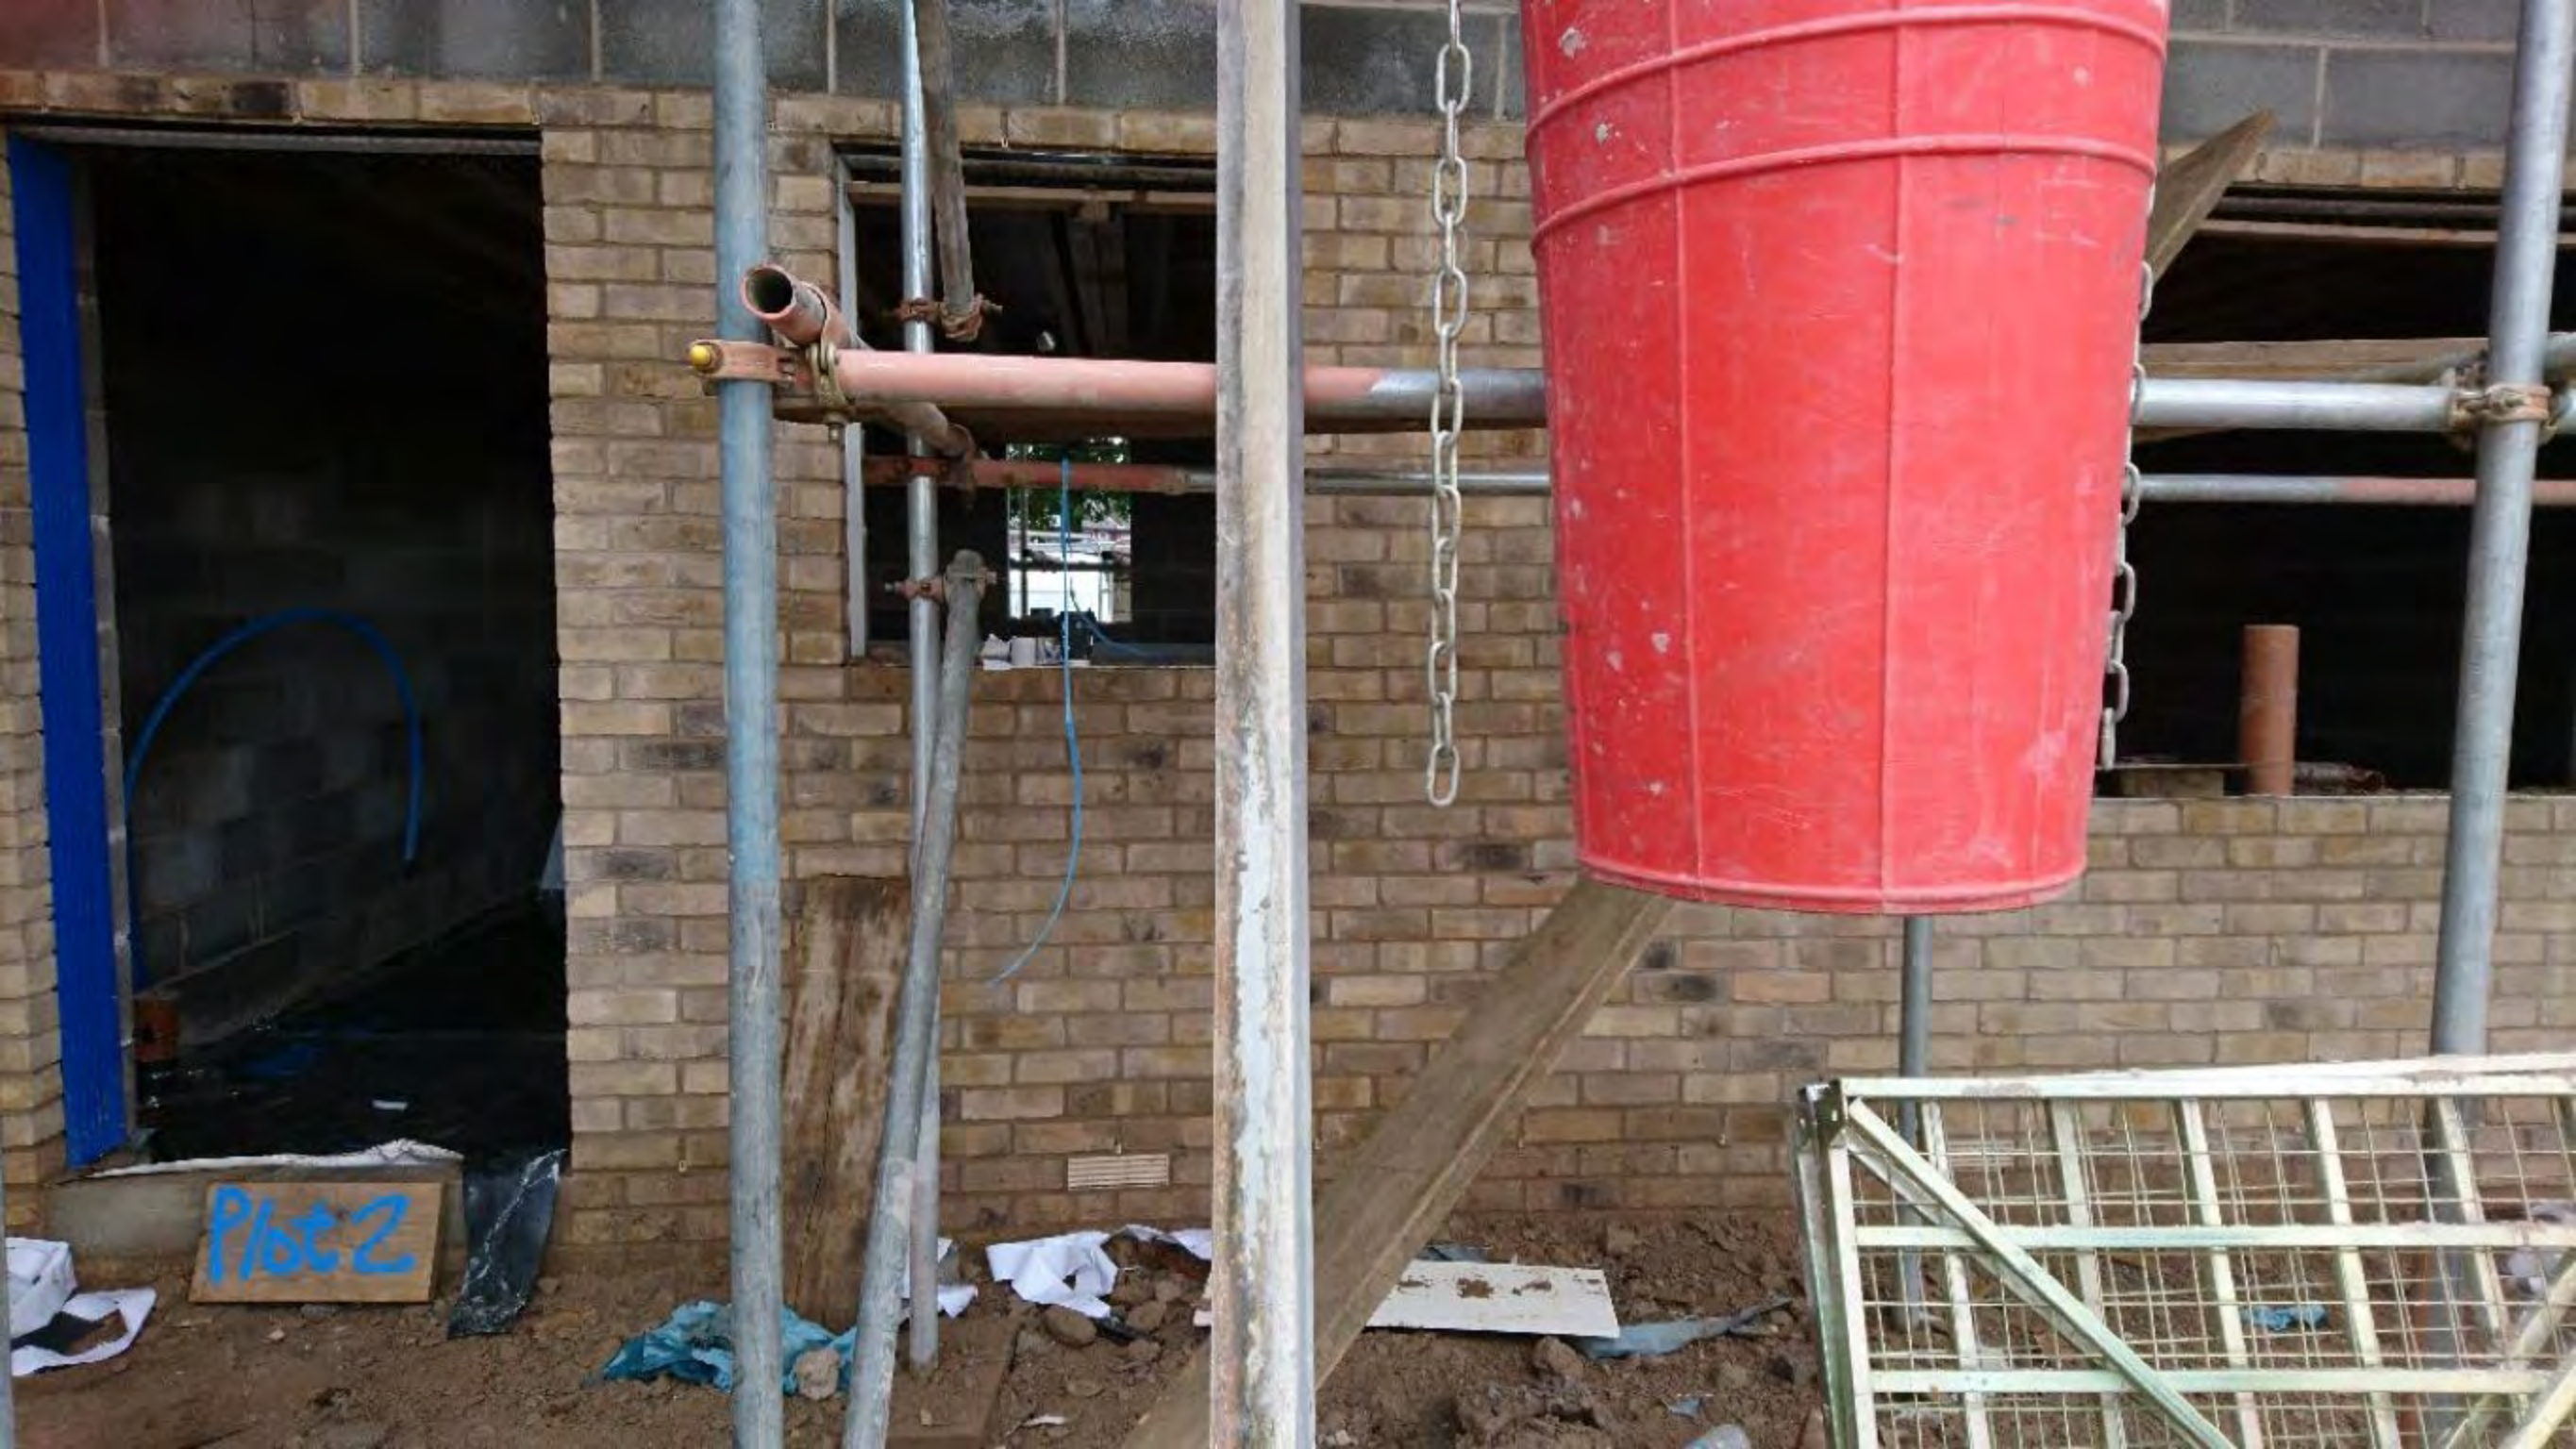
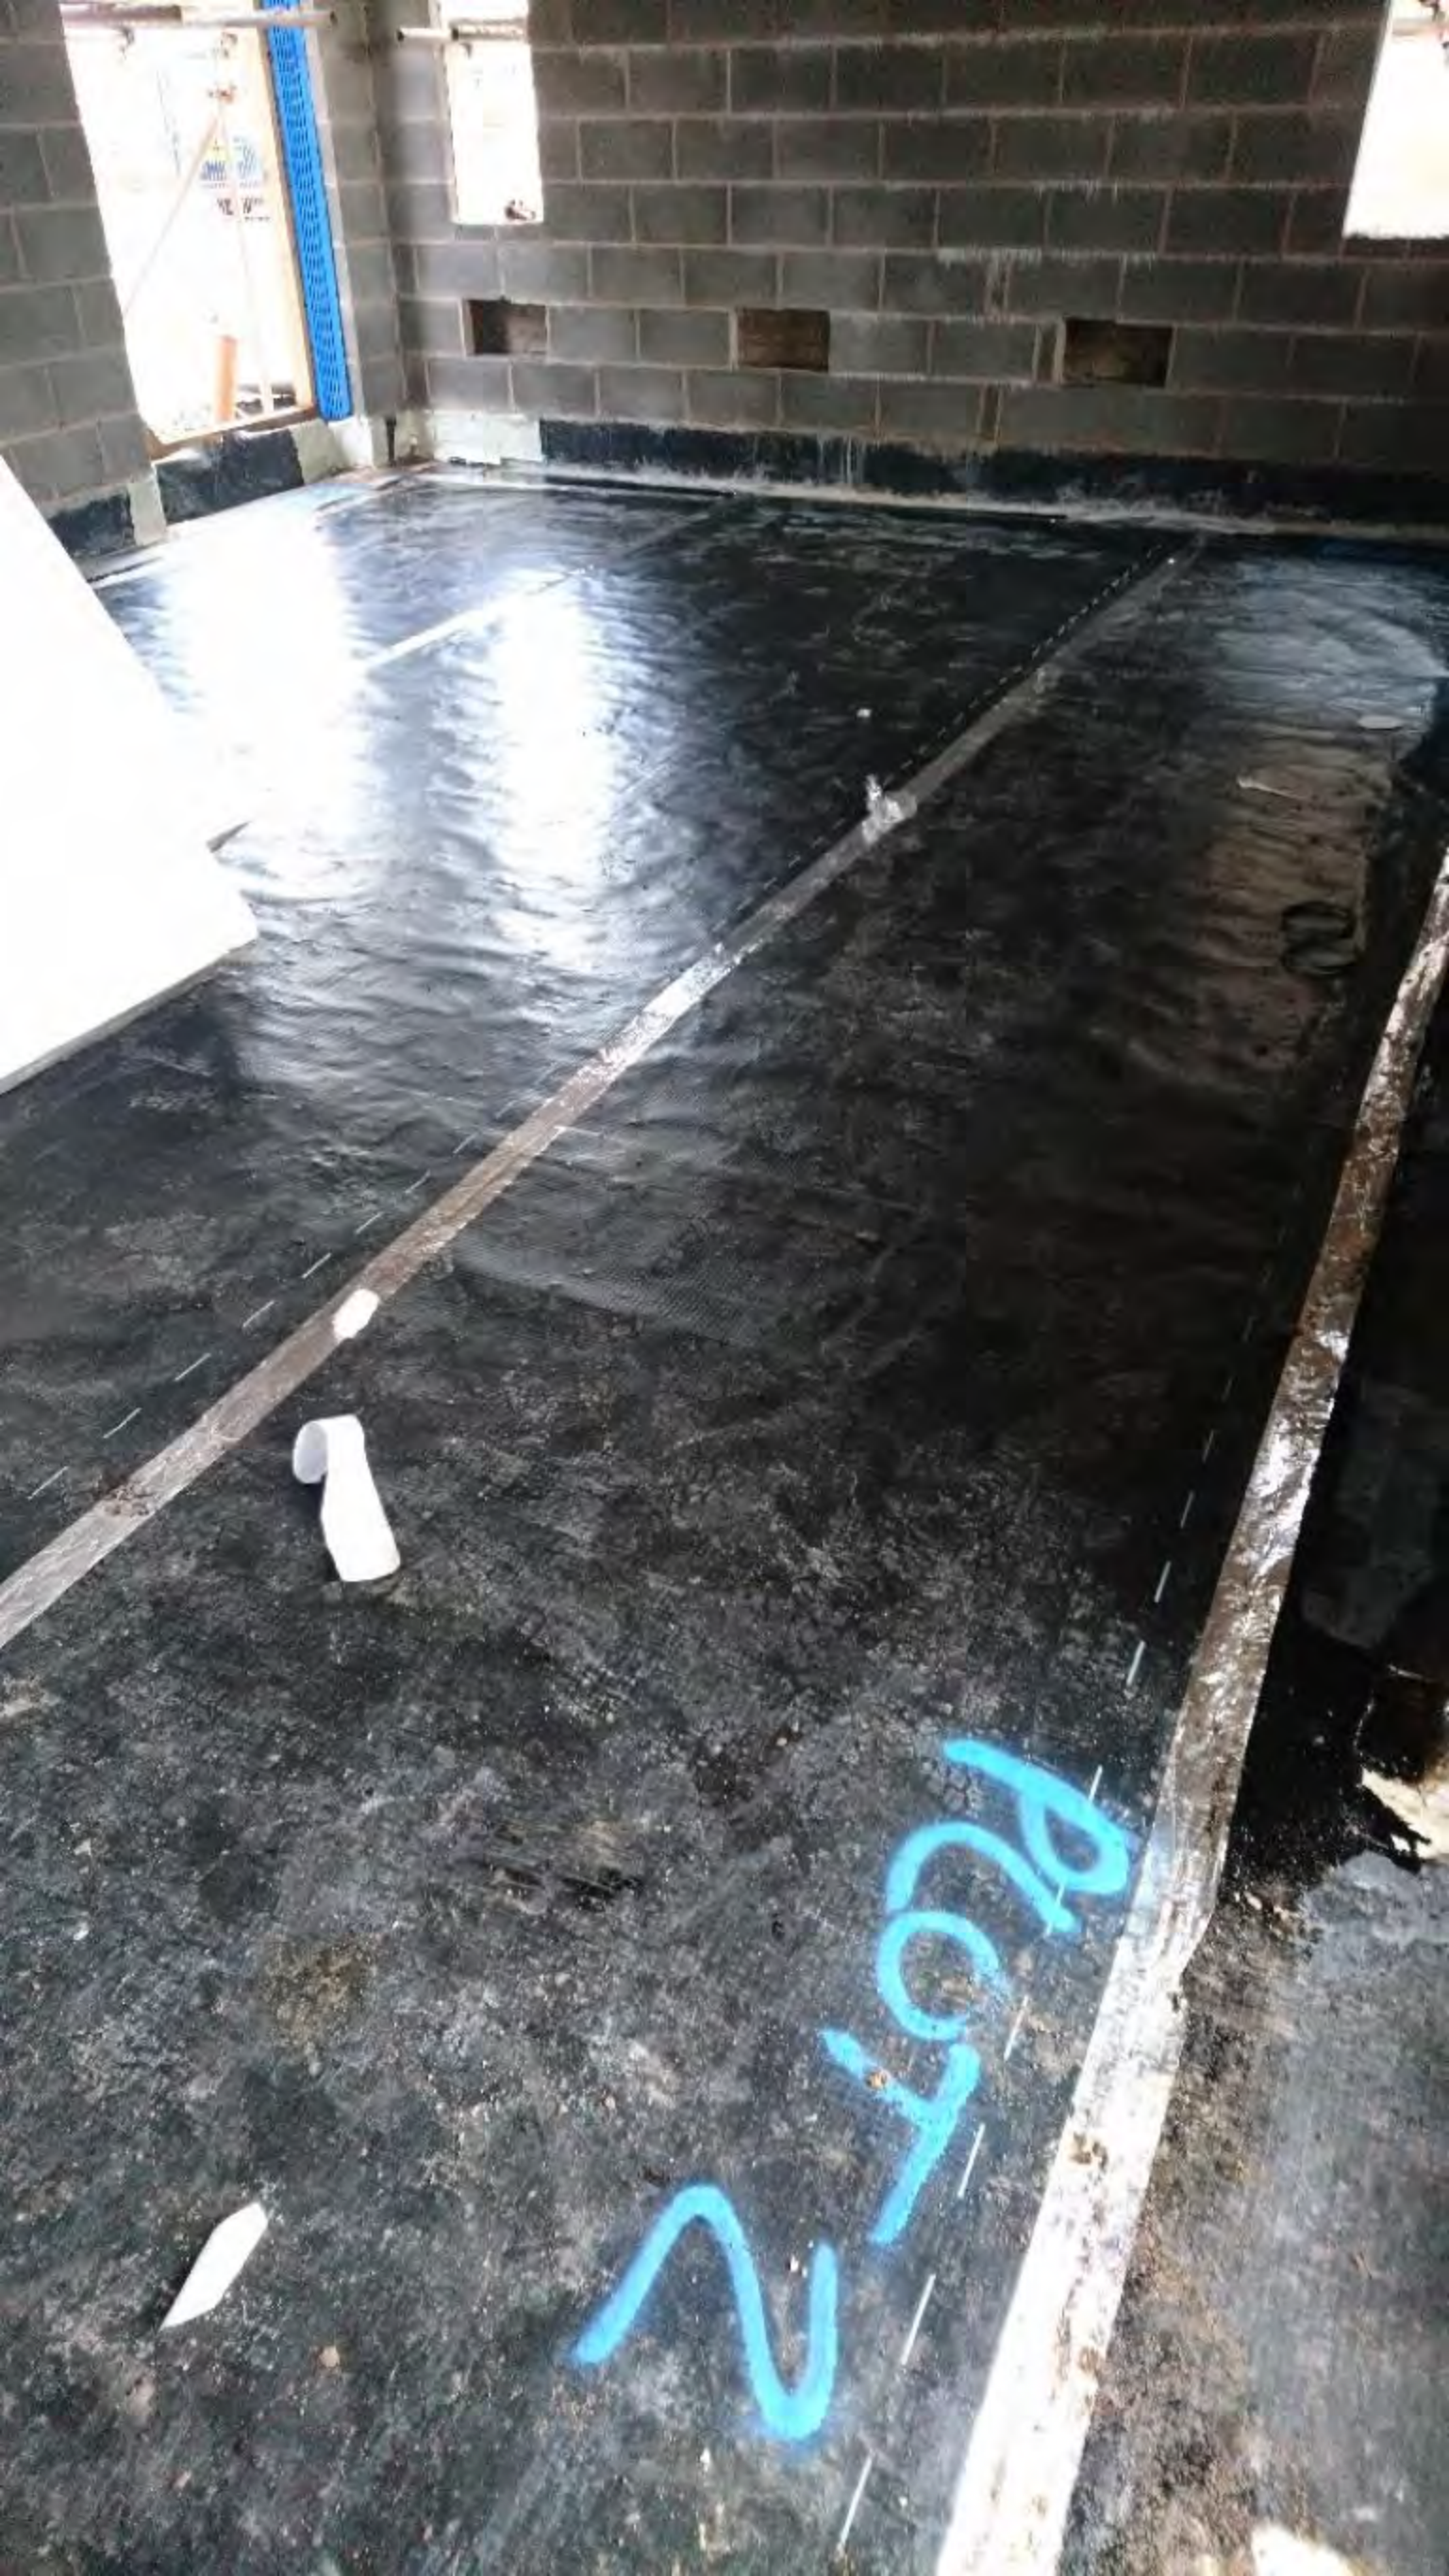
PLOT 2

| 2.2 | Condition of sub-grade & underside of gas membrane | GOOD QUALITY, BRUSHED FLOOR, ALL SEALED AND TAPES APPLIED WELL |
| 2.4 | Gas membrane condition and coverage | GOOD, ALL FOUR SIDES SEALED |
| 2.7 | Condition of joints/seals | ALL GOOD, OVERLAPS VISIBLE |
| 2.8 | Number and condition of service entry seals | TWO NUMBER TOP-HATS WITH JUBILEE CLIPS – TAPES CHECKED, ALL OK |
| 2.10 | Repairs or Corrections: | NONE VISIBLE |
