**This Record sheet is only applicable to block and beam floor slabs for Characteristic Situation 2 gas protection systems**

**For Residential Development at New Church Street, Radcliffe.**

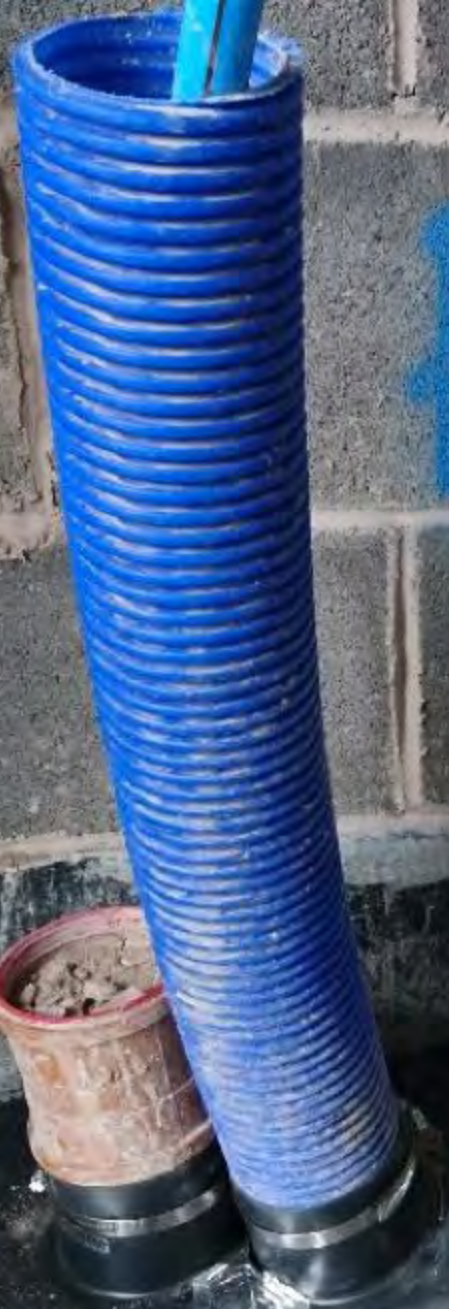
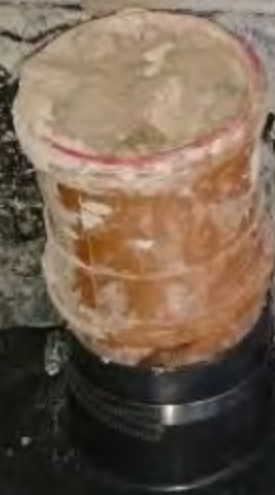
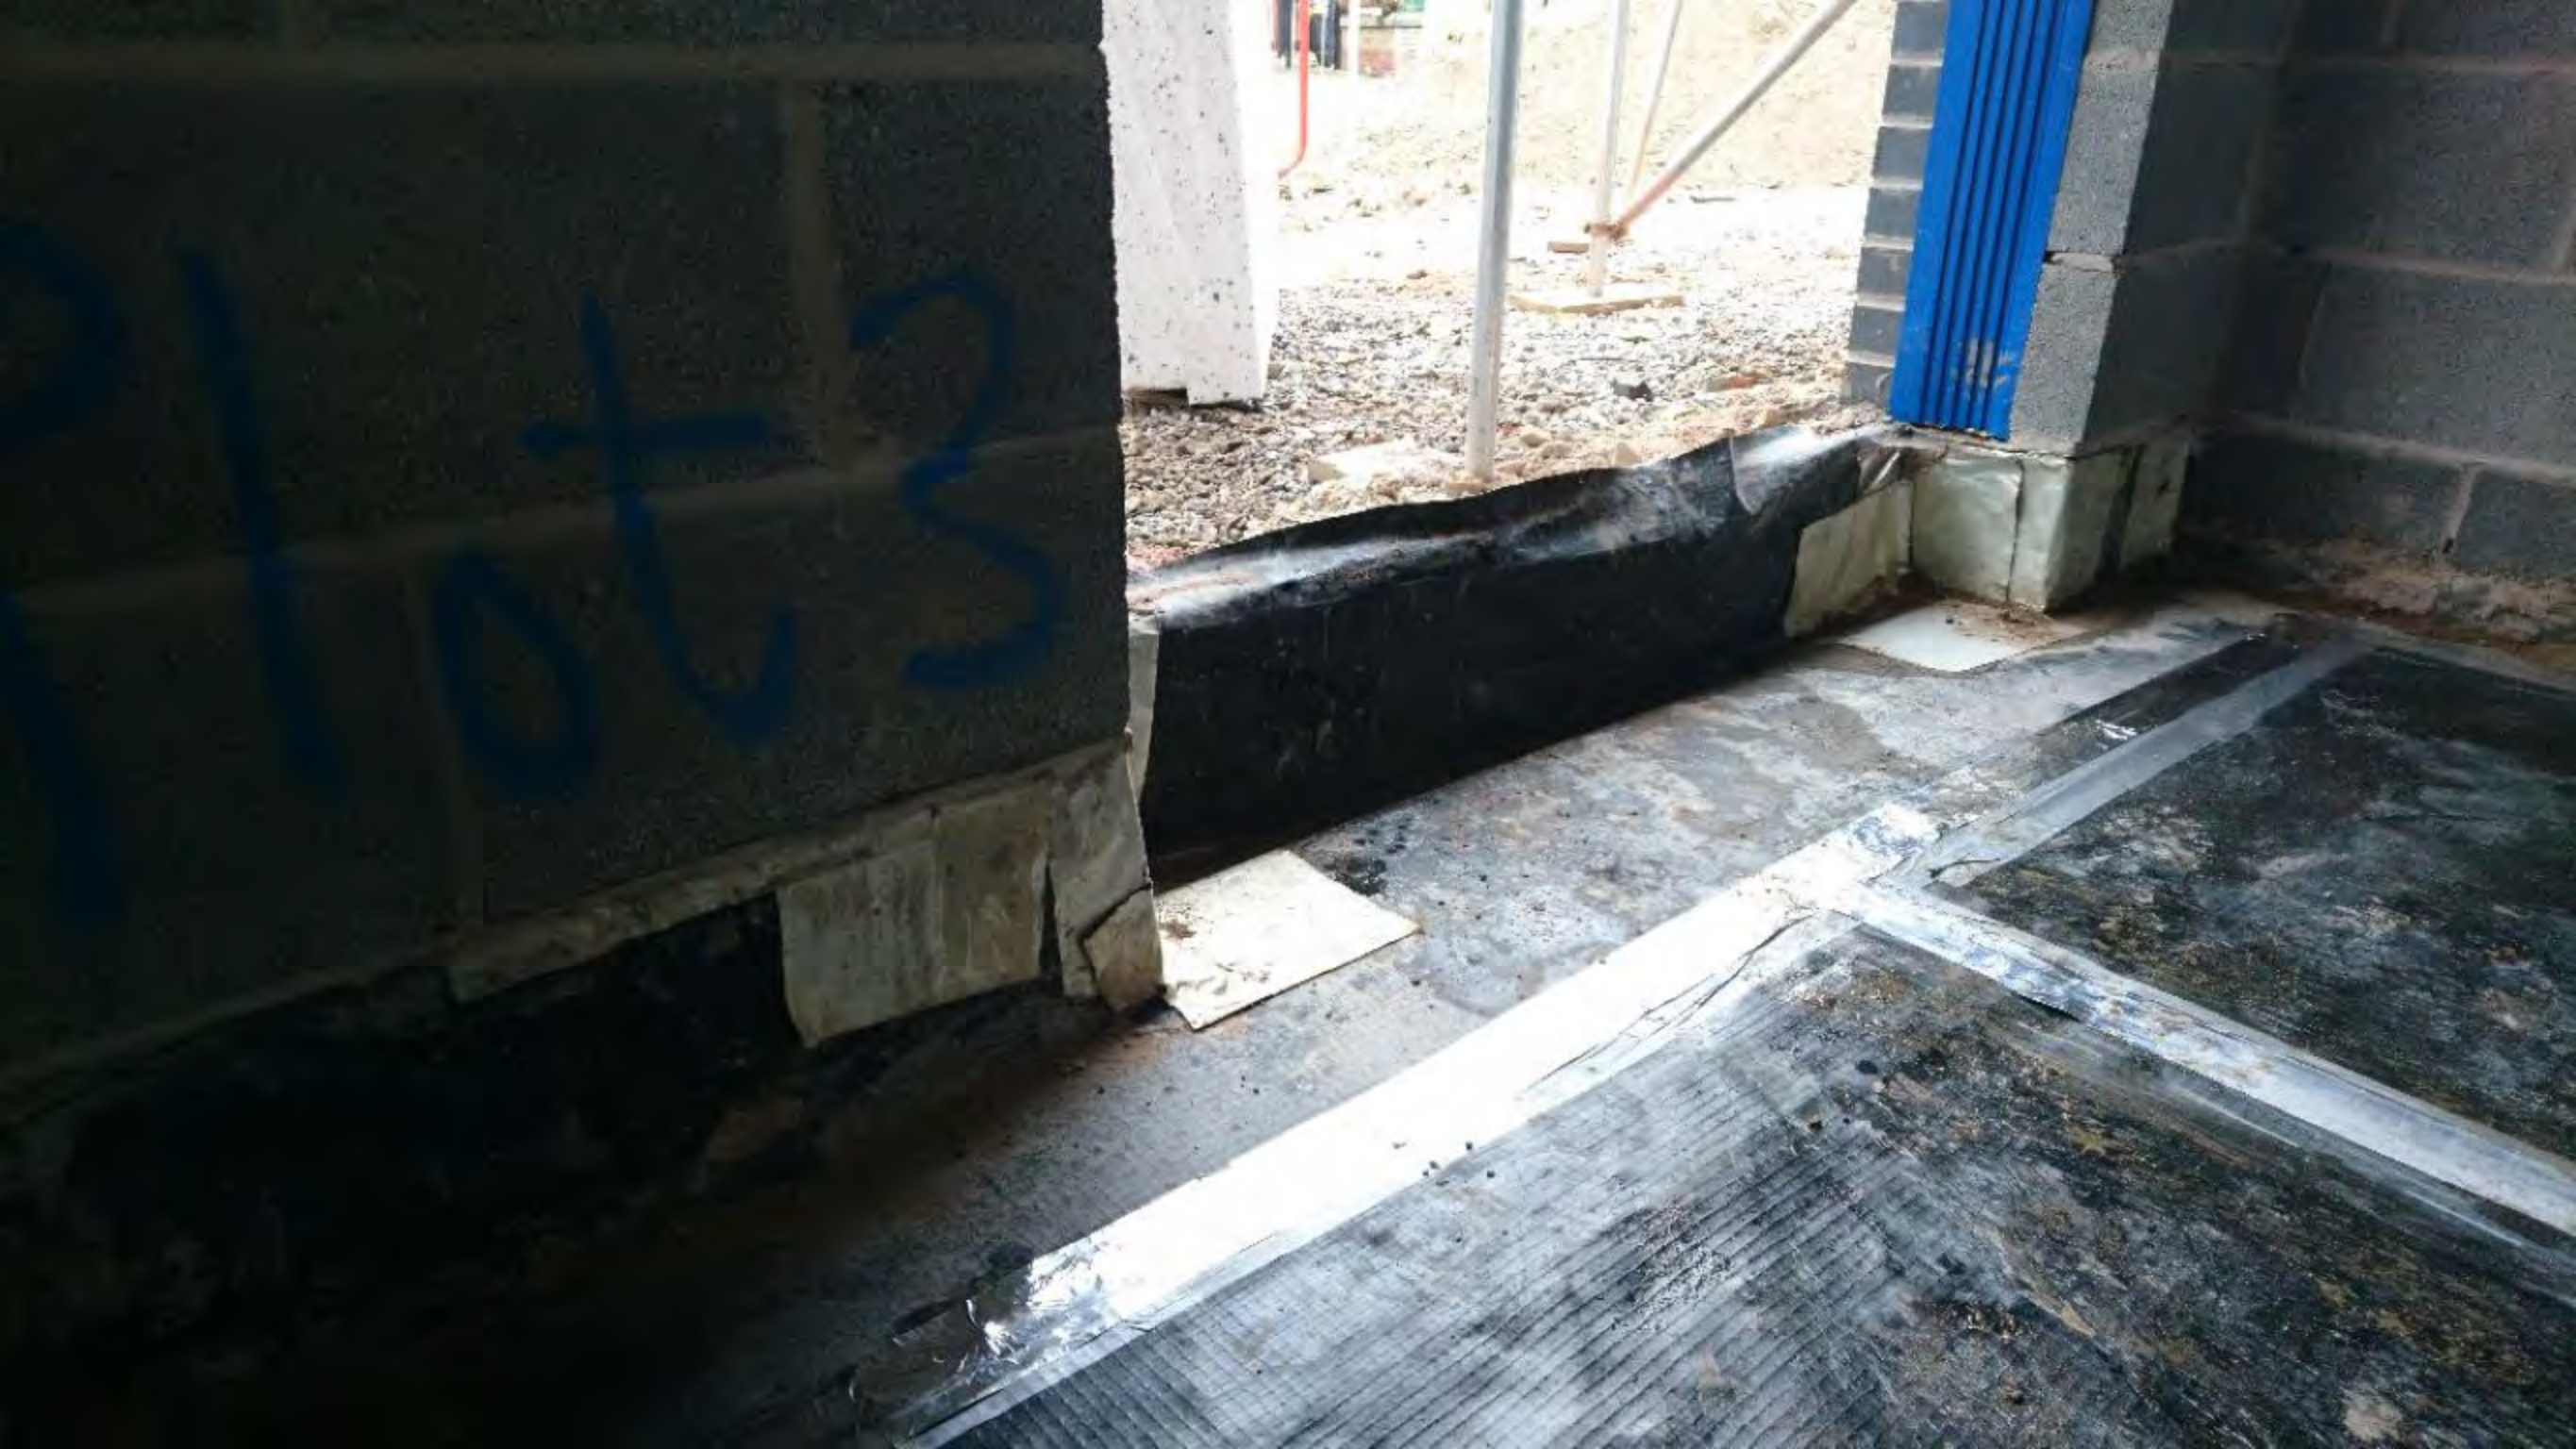
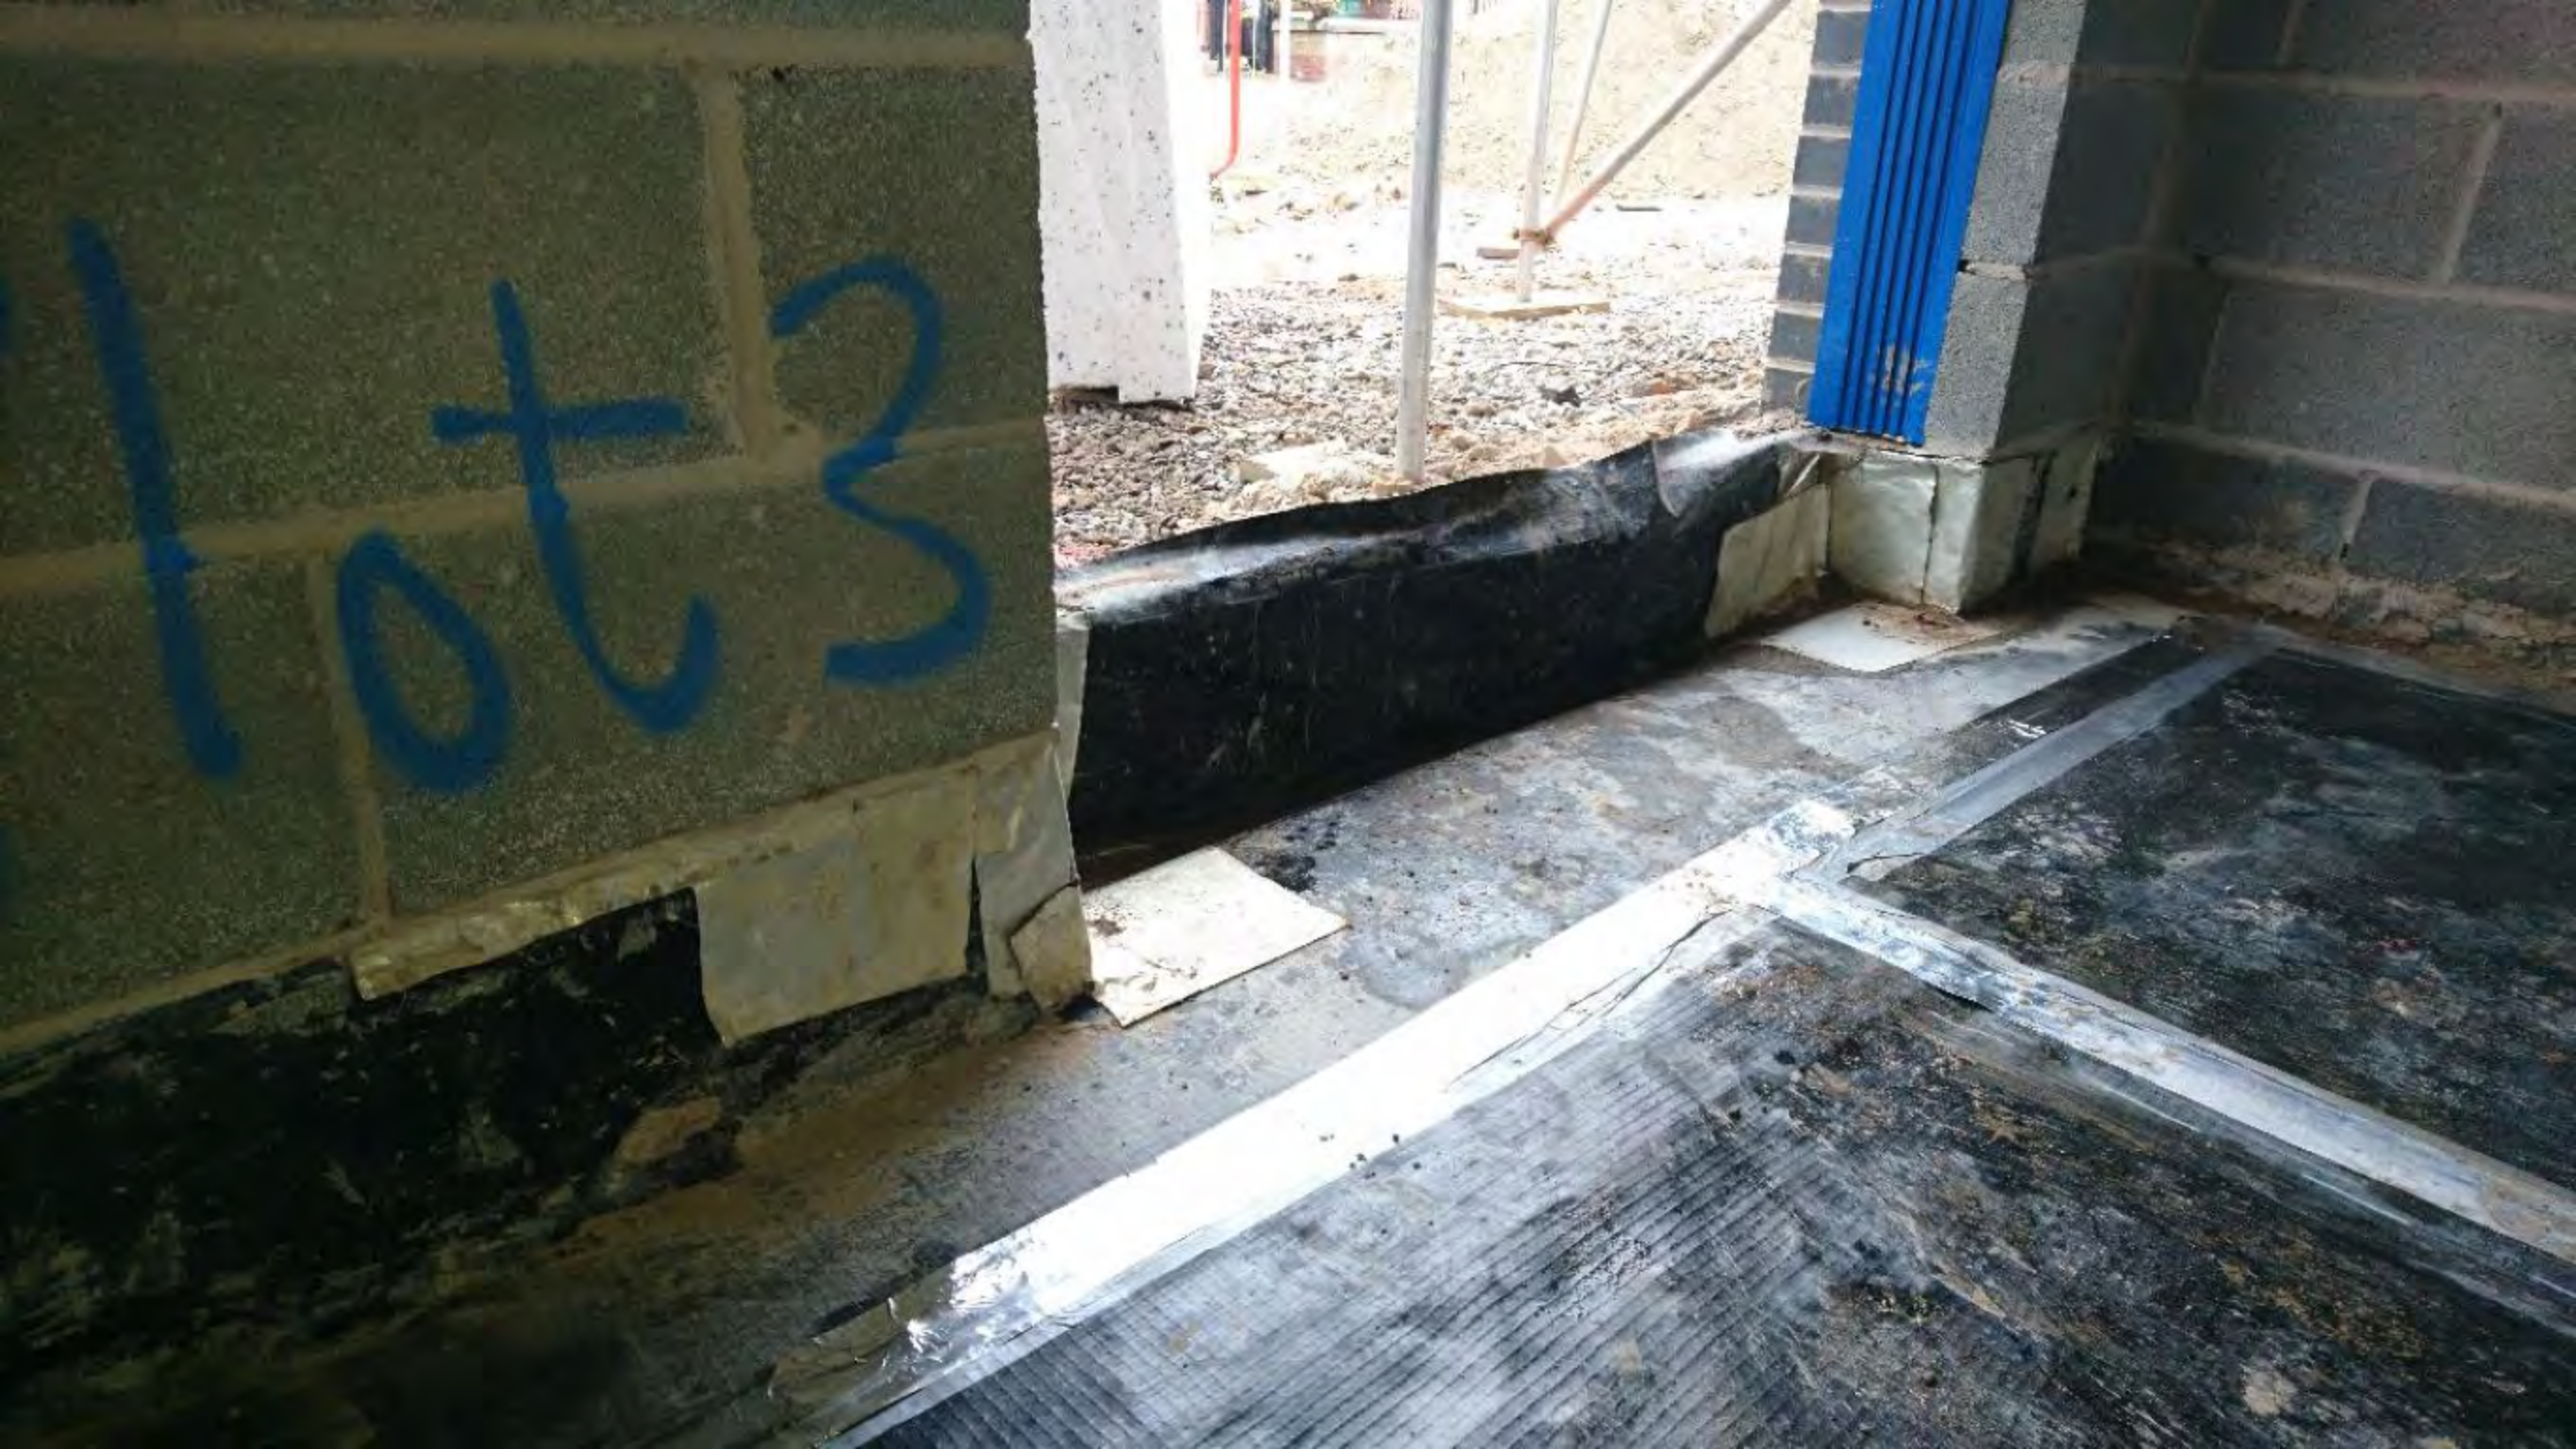
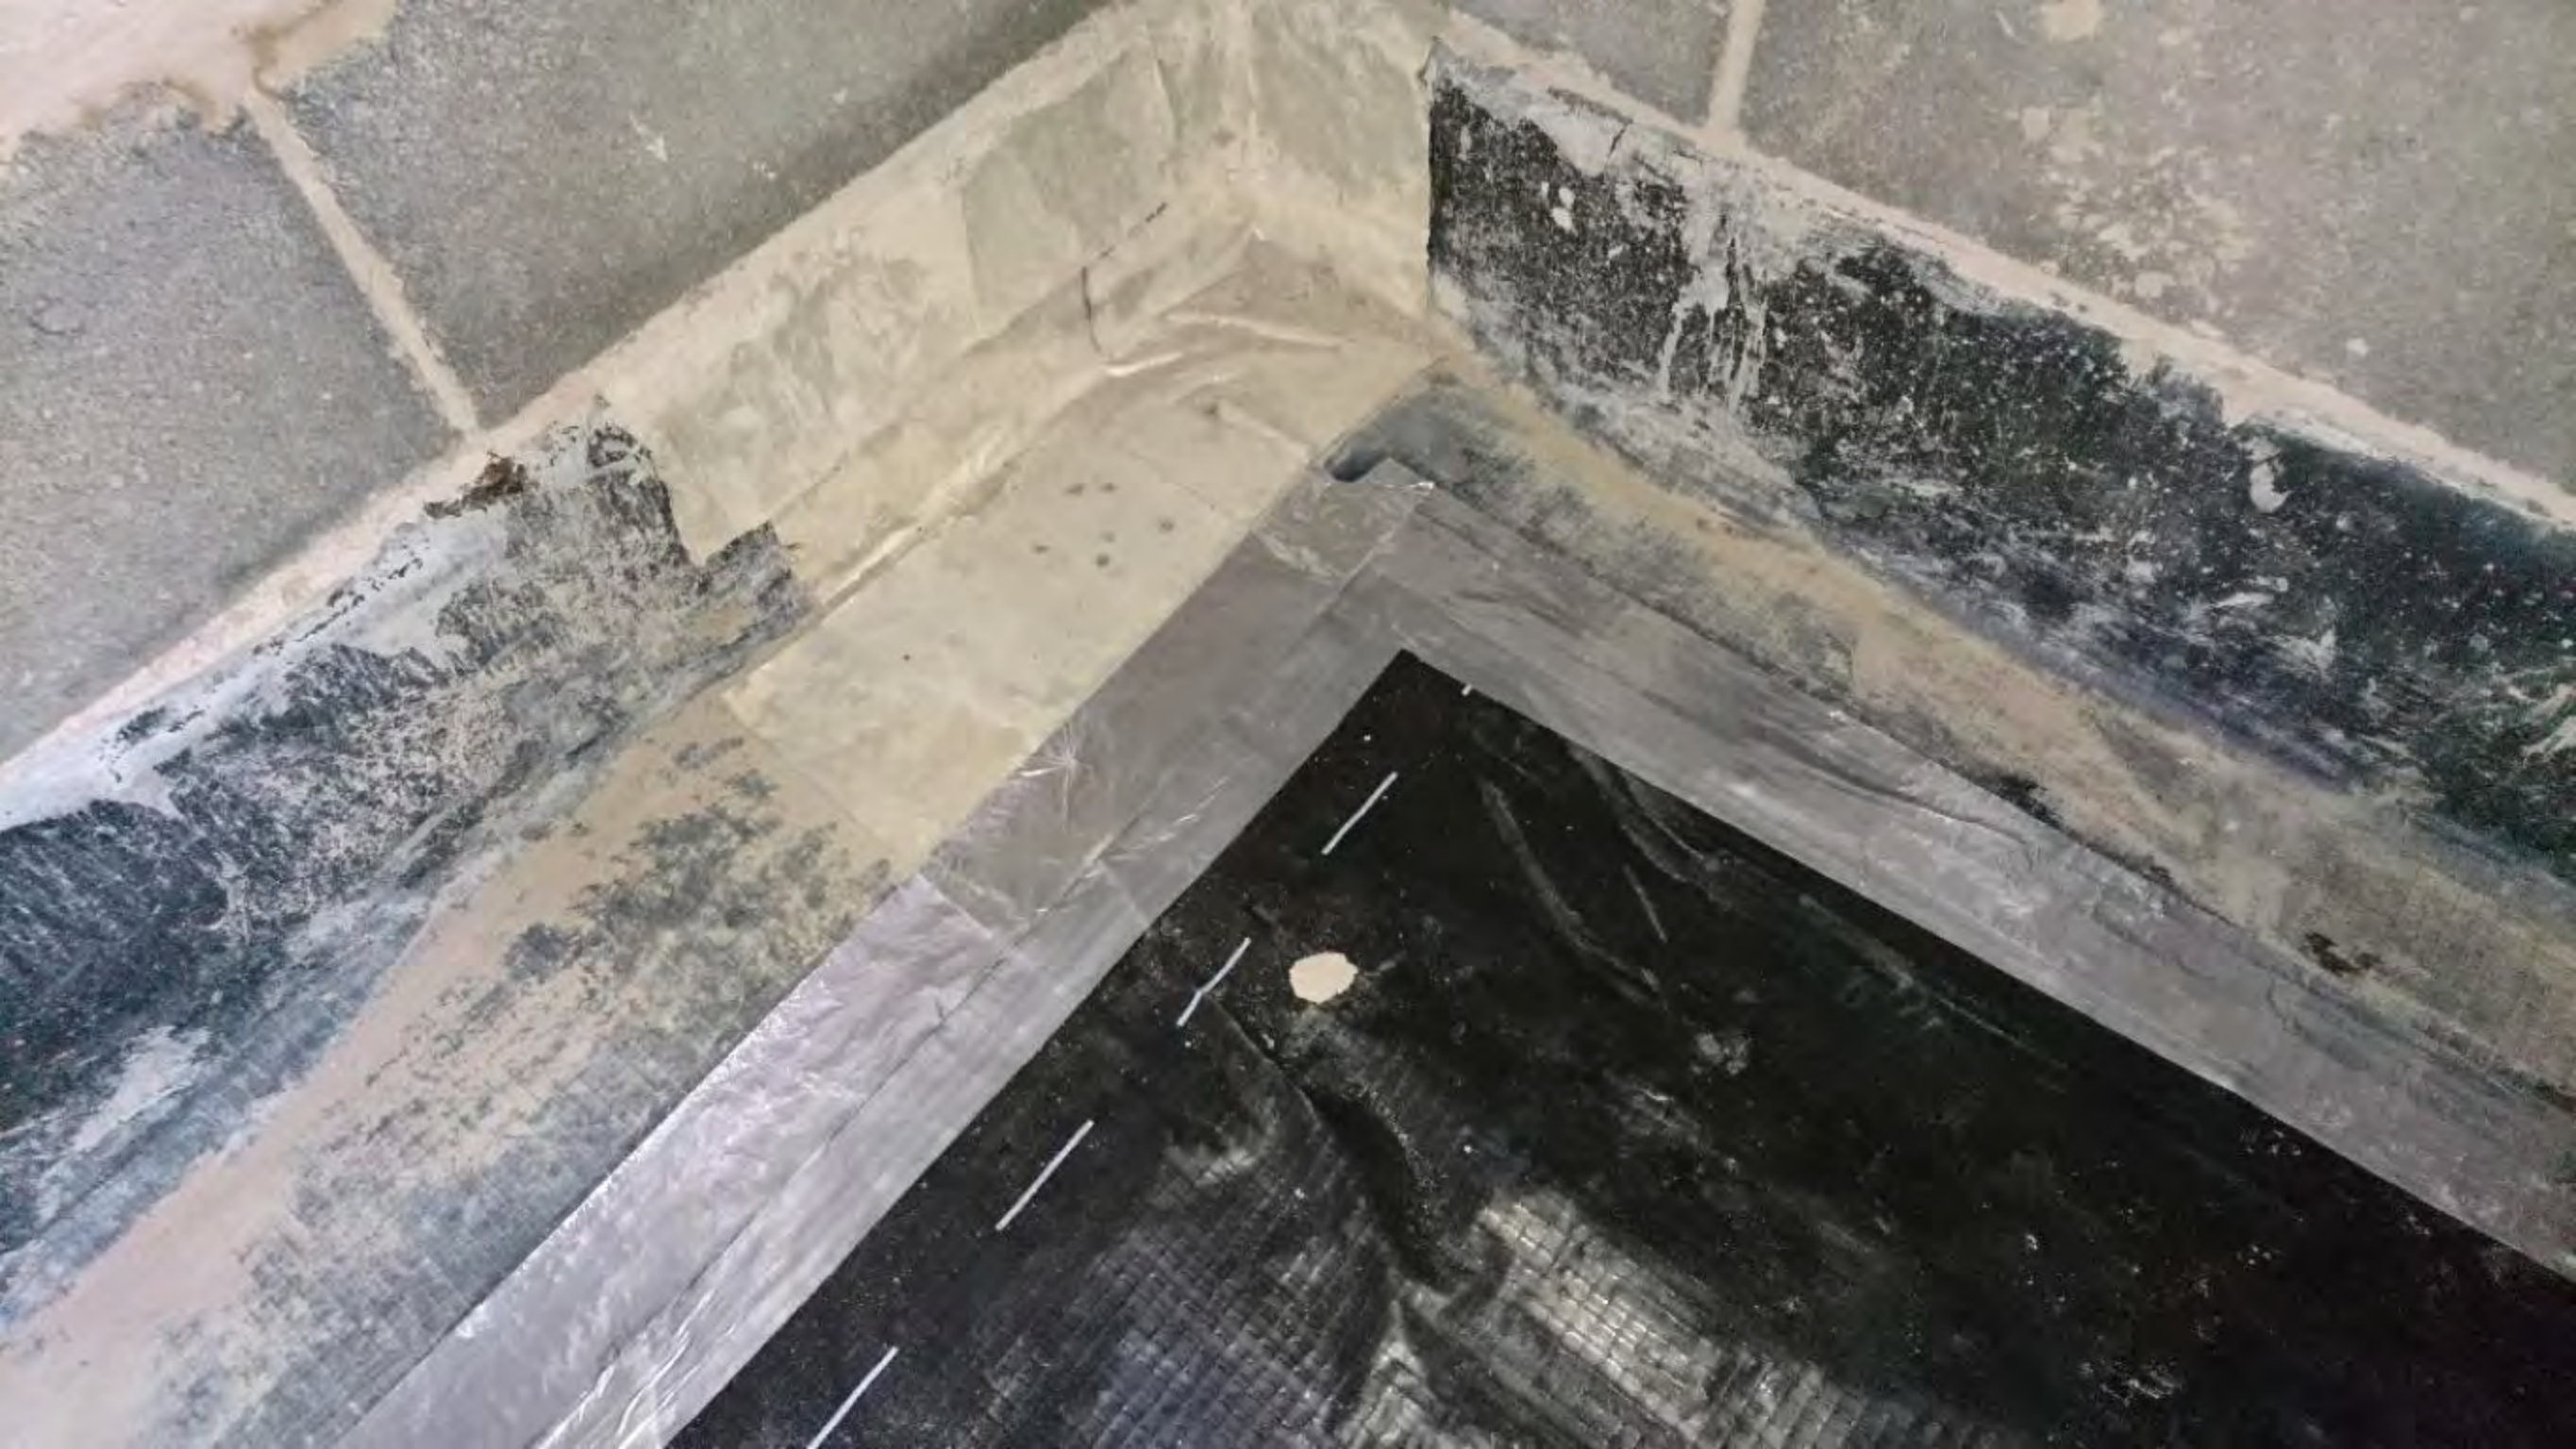
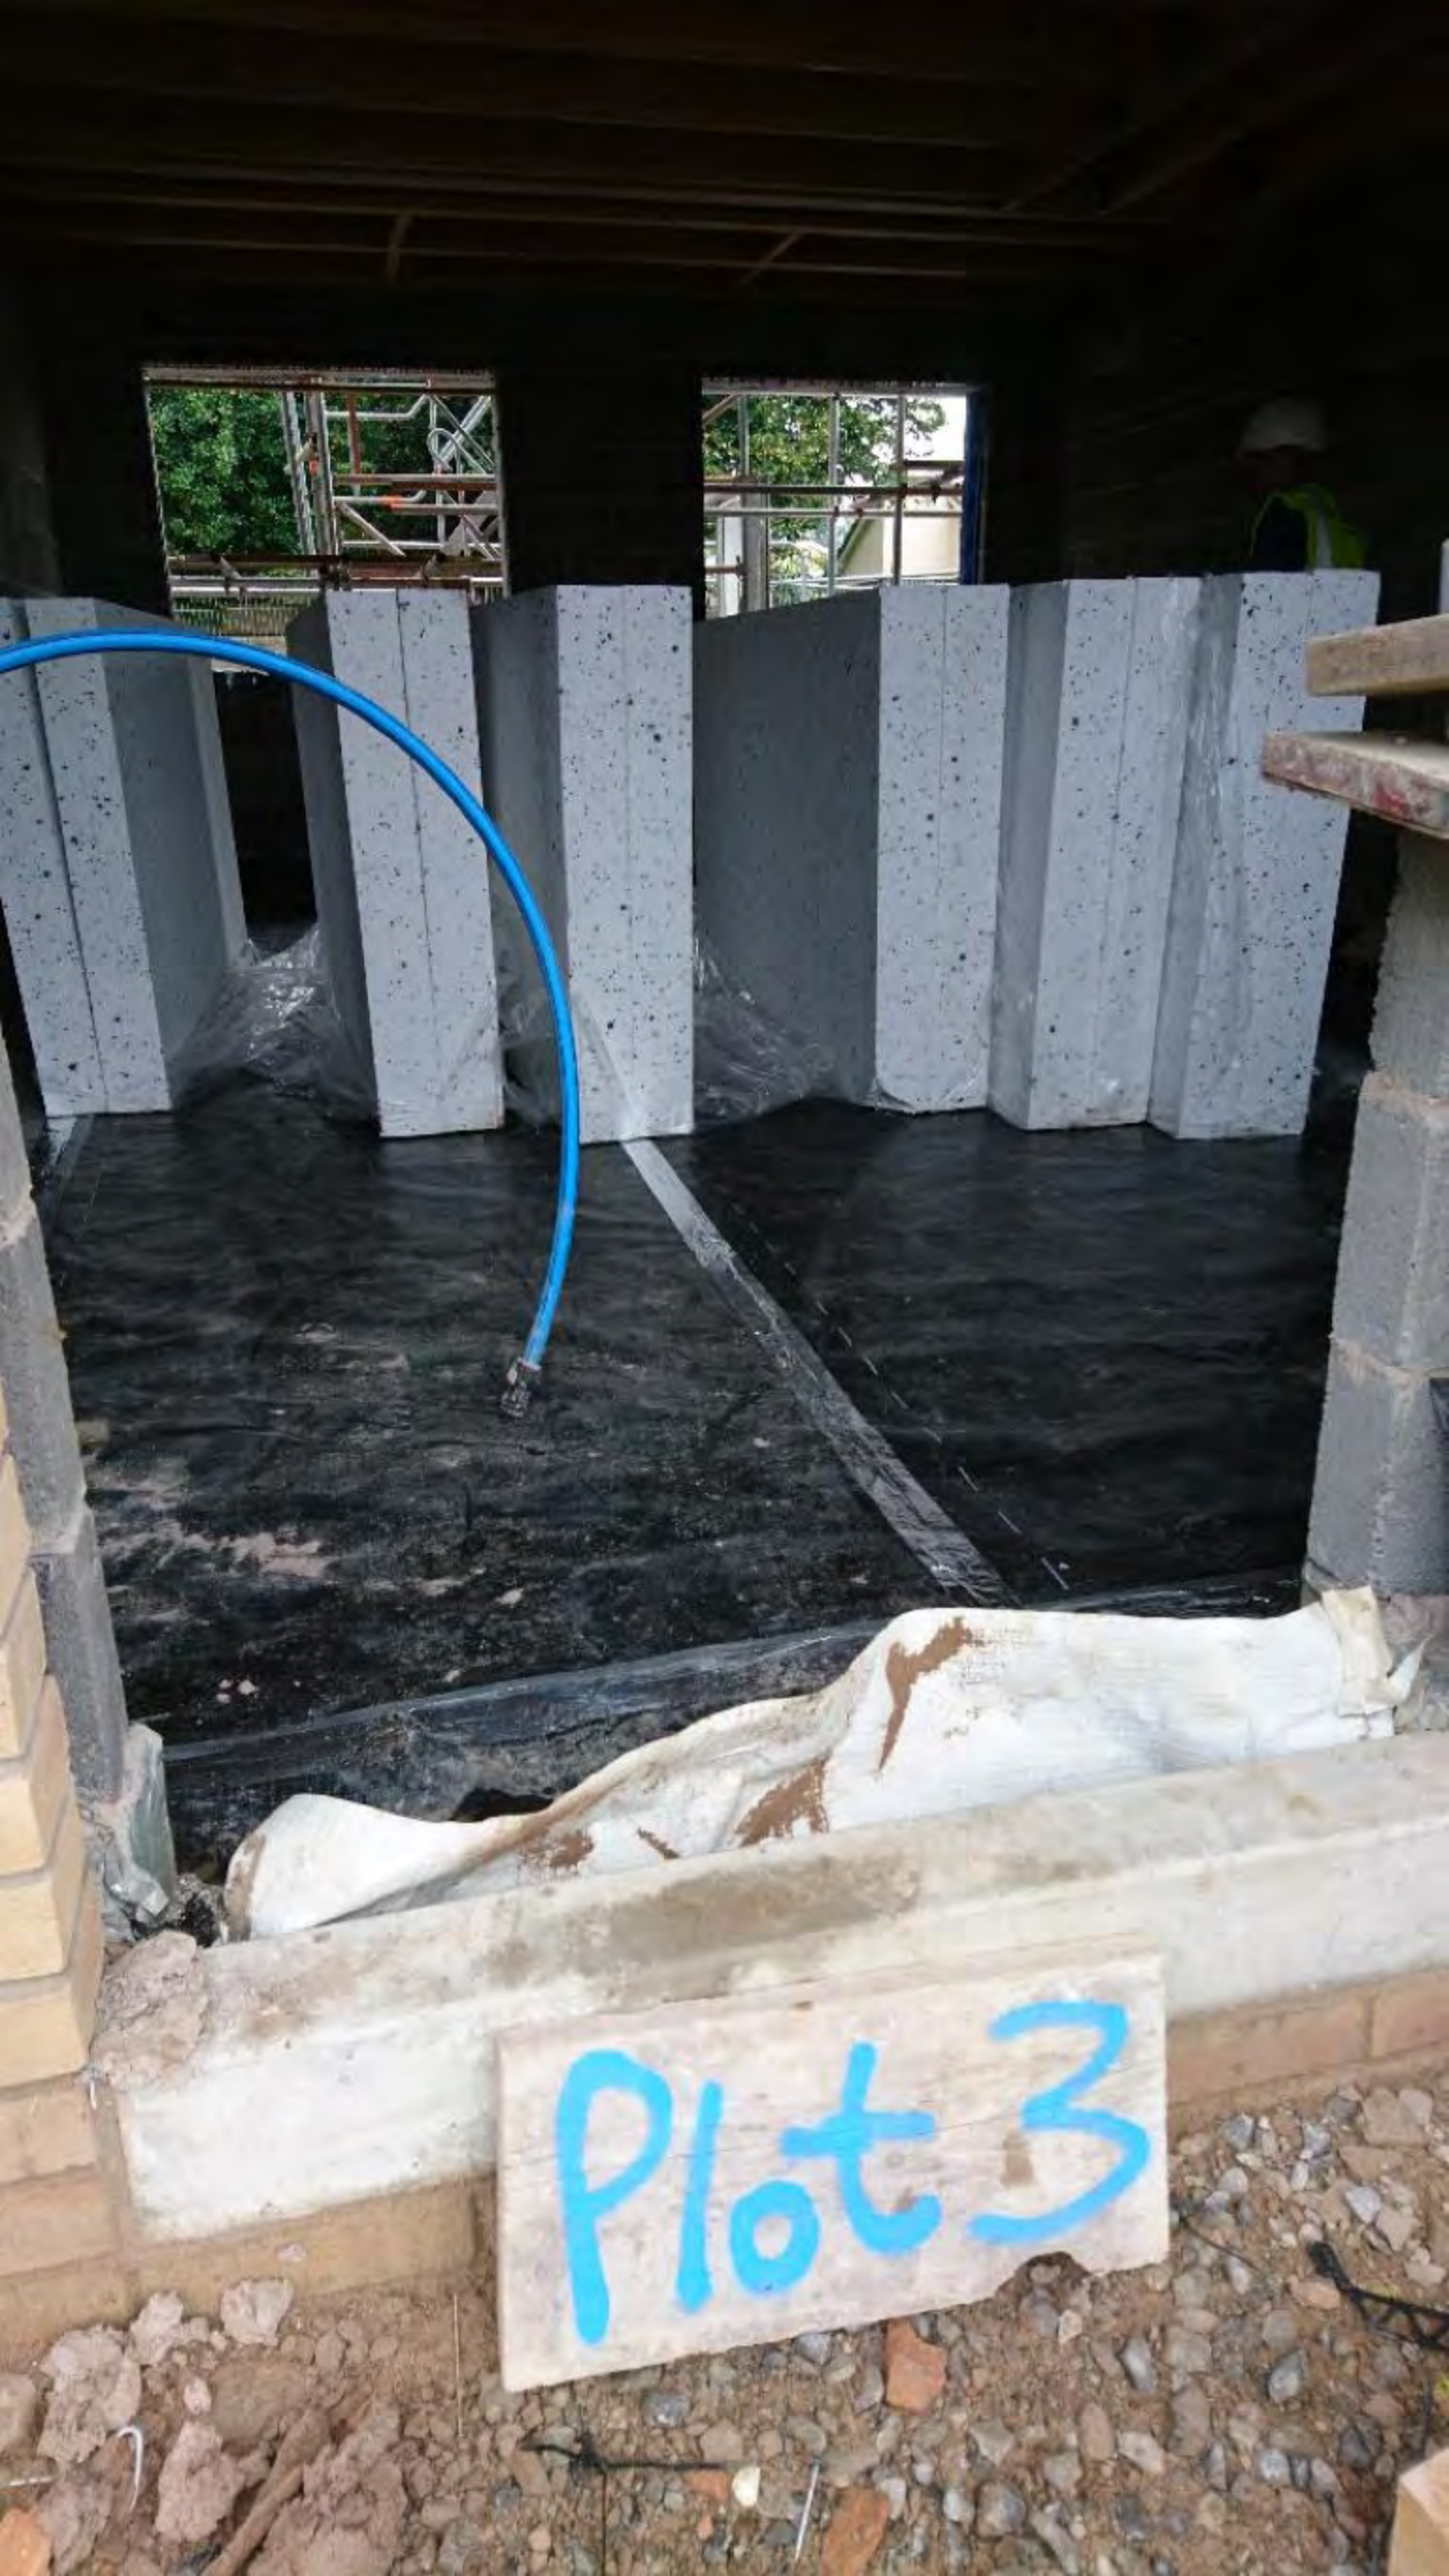
Plot 3

| 2.2 | Condition of sub-grade & underside of gas membrane | QUALITY GOOD, FLOOR BRUSHED, ALL TAPES APPLIED WELL AND SEALED | | | | | |
| 2.4 | Gas membrane condition and coverage | GOOD, SEALED ON ALL FOUR SIDES | | | | | |
| 2.7 | Condition of joints/seals | ALL GOOD, VISIBLE OVERLAPS | | | | | |
| 2.8 | Number and condition of service entry seals | OK, THREE NO. TOP-HATS WITH JUBILEE CLIPS - CHECKED ALL TAPES | | | | | |
| 2.10 | Repairs or Corrections: | NONE VISIBLE | | | | | |
