**This Record sheet is only applicable to block and beam floor slabs for Characteristic Situation 2 gas protection systems**

**For Residential Development at New Church Street, Radcliffe.**

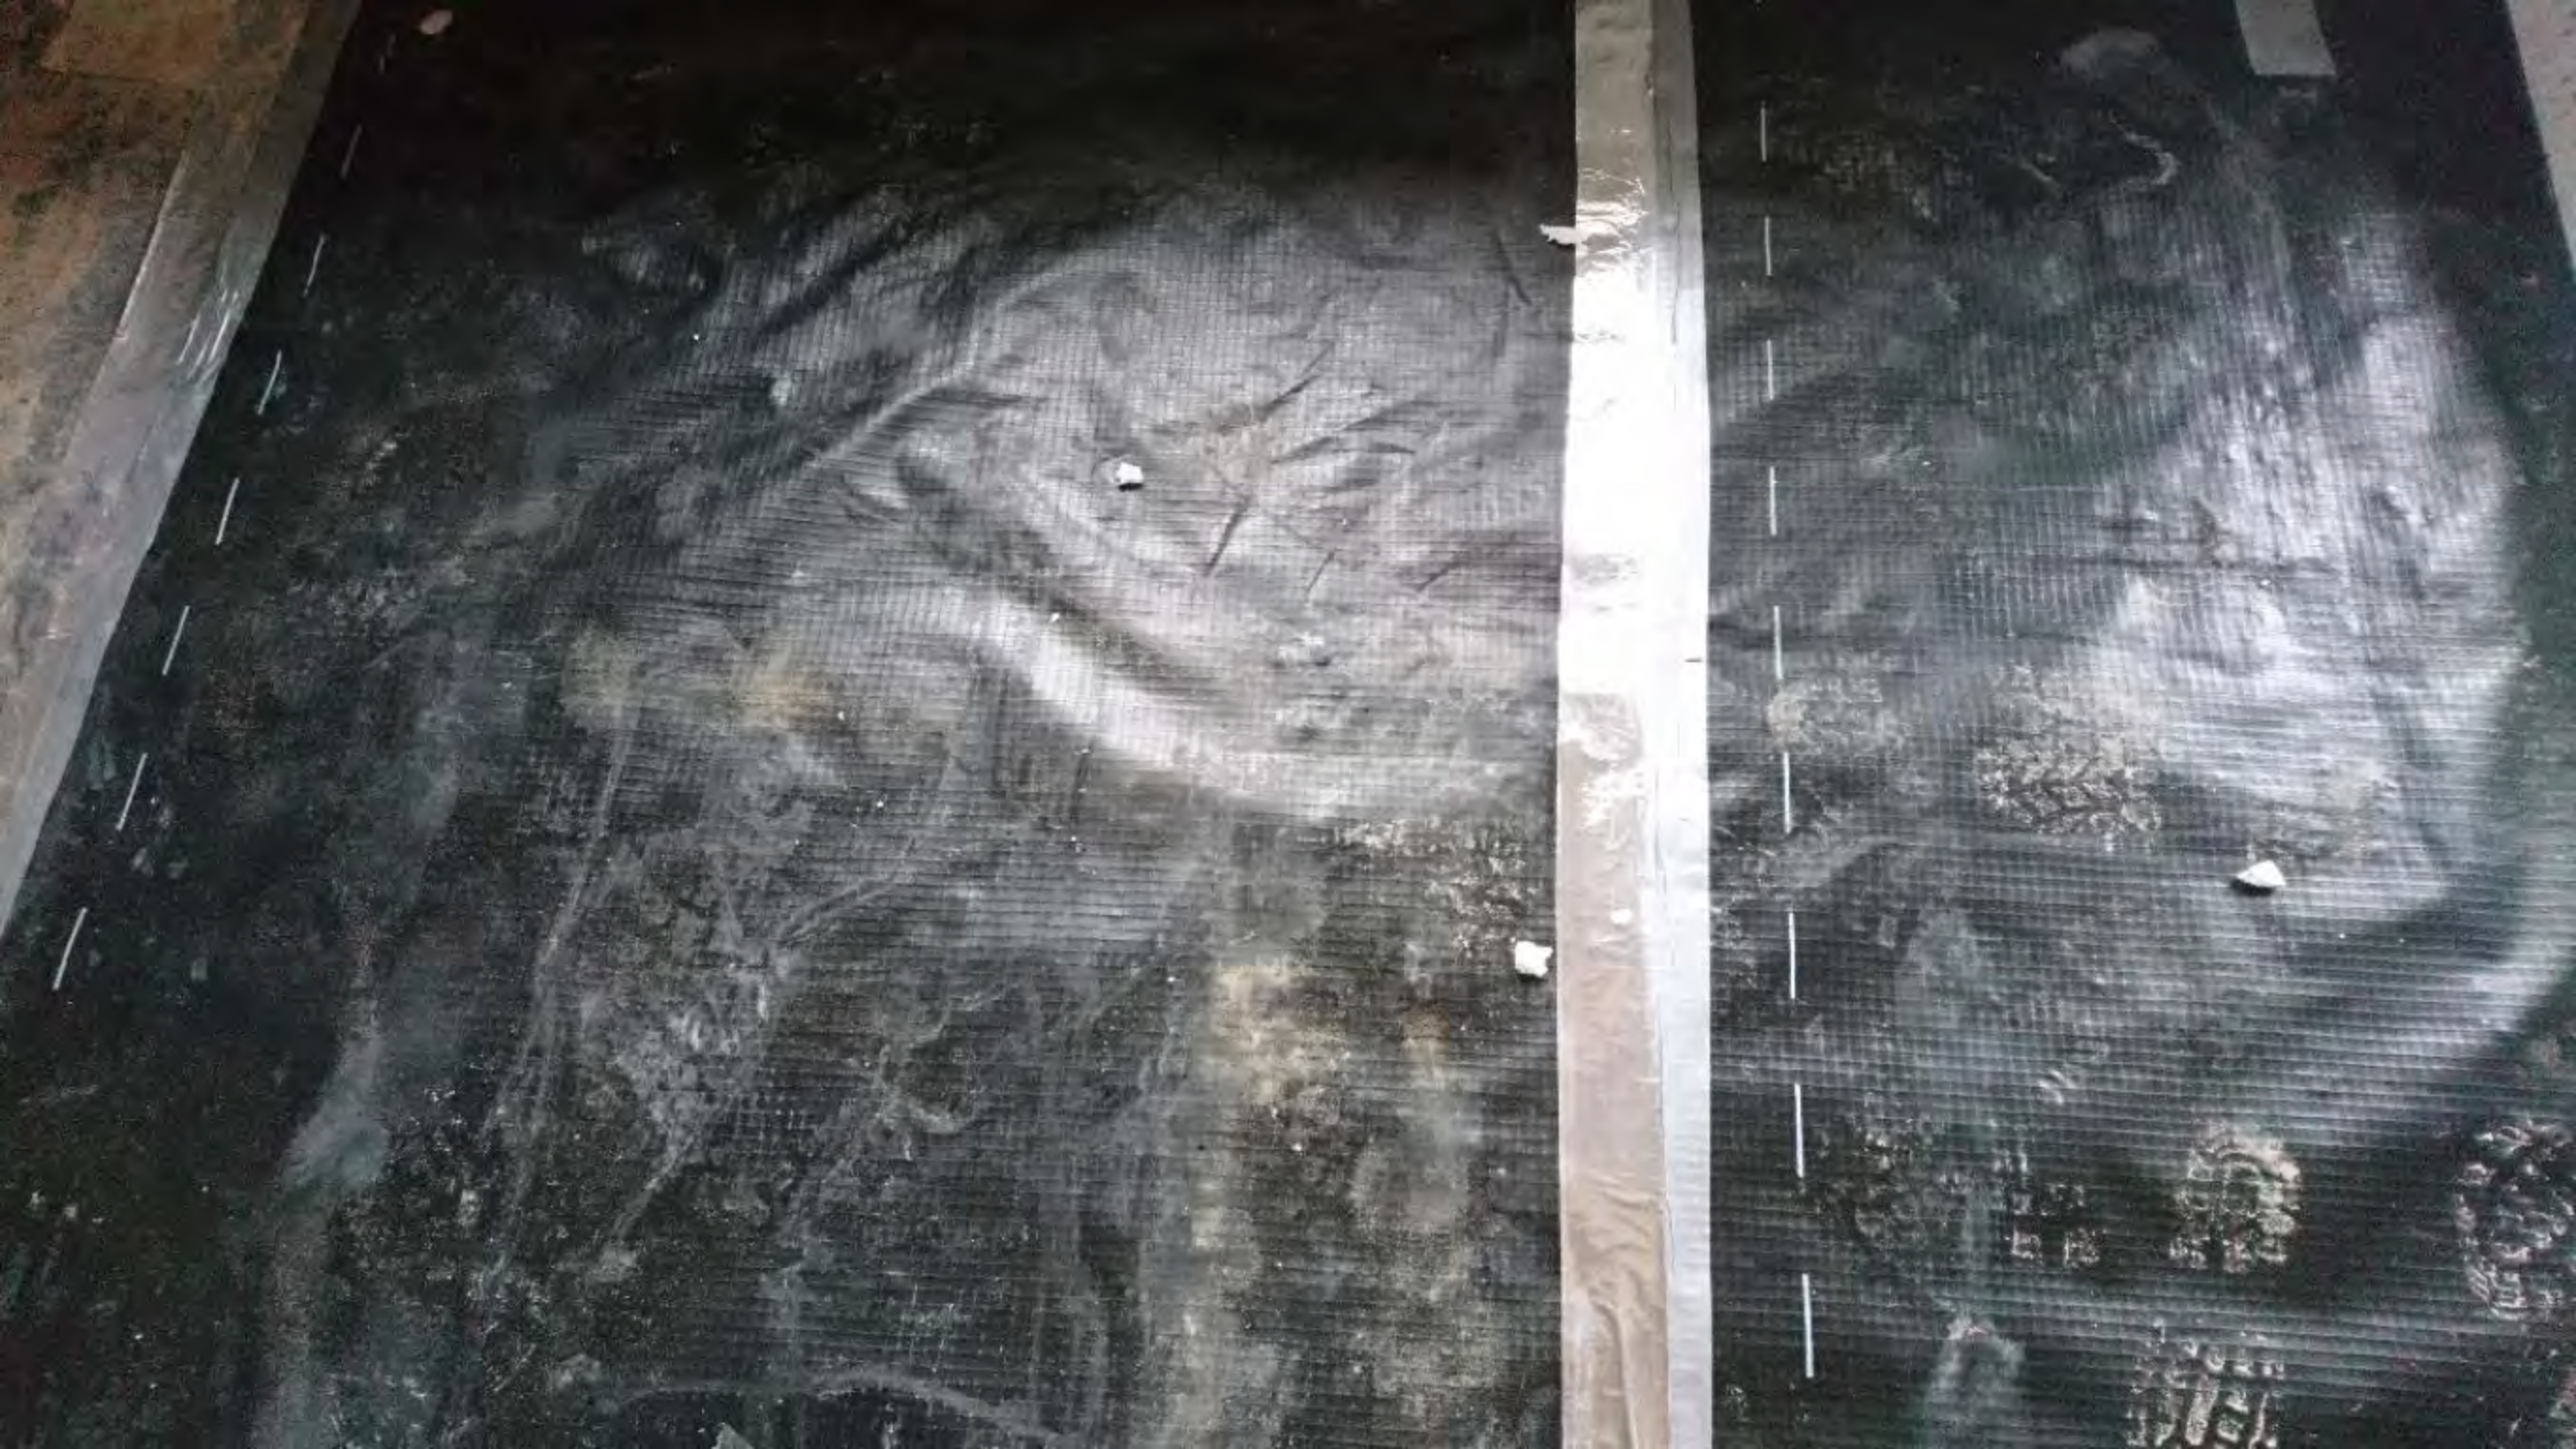
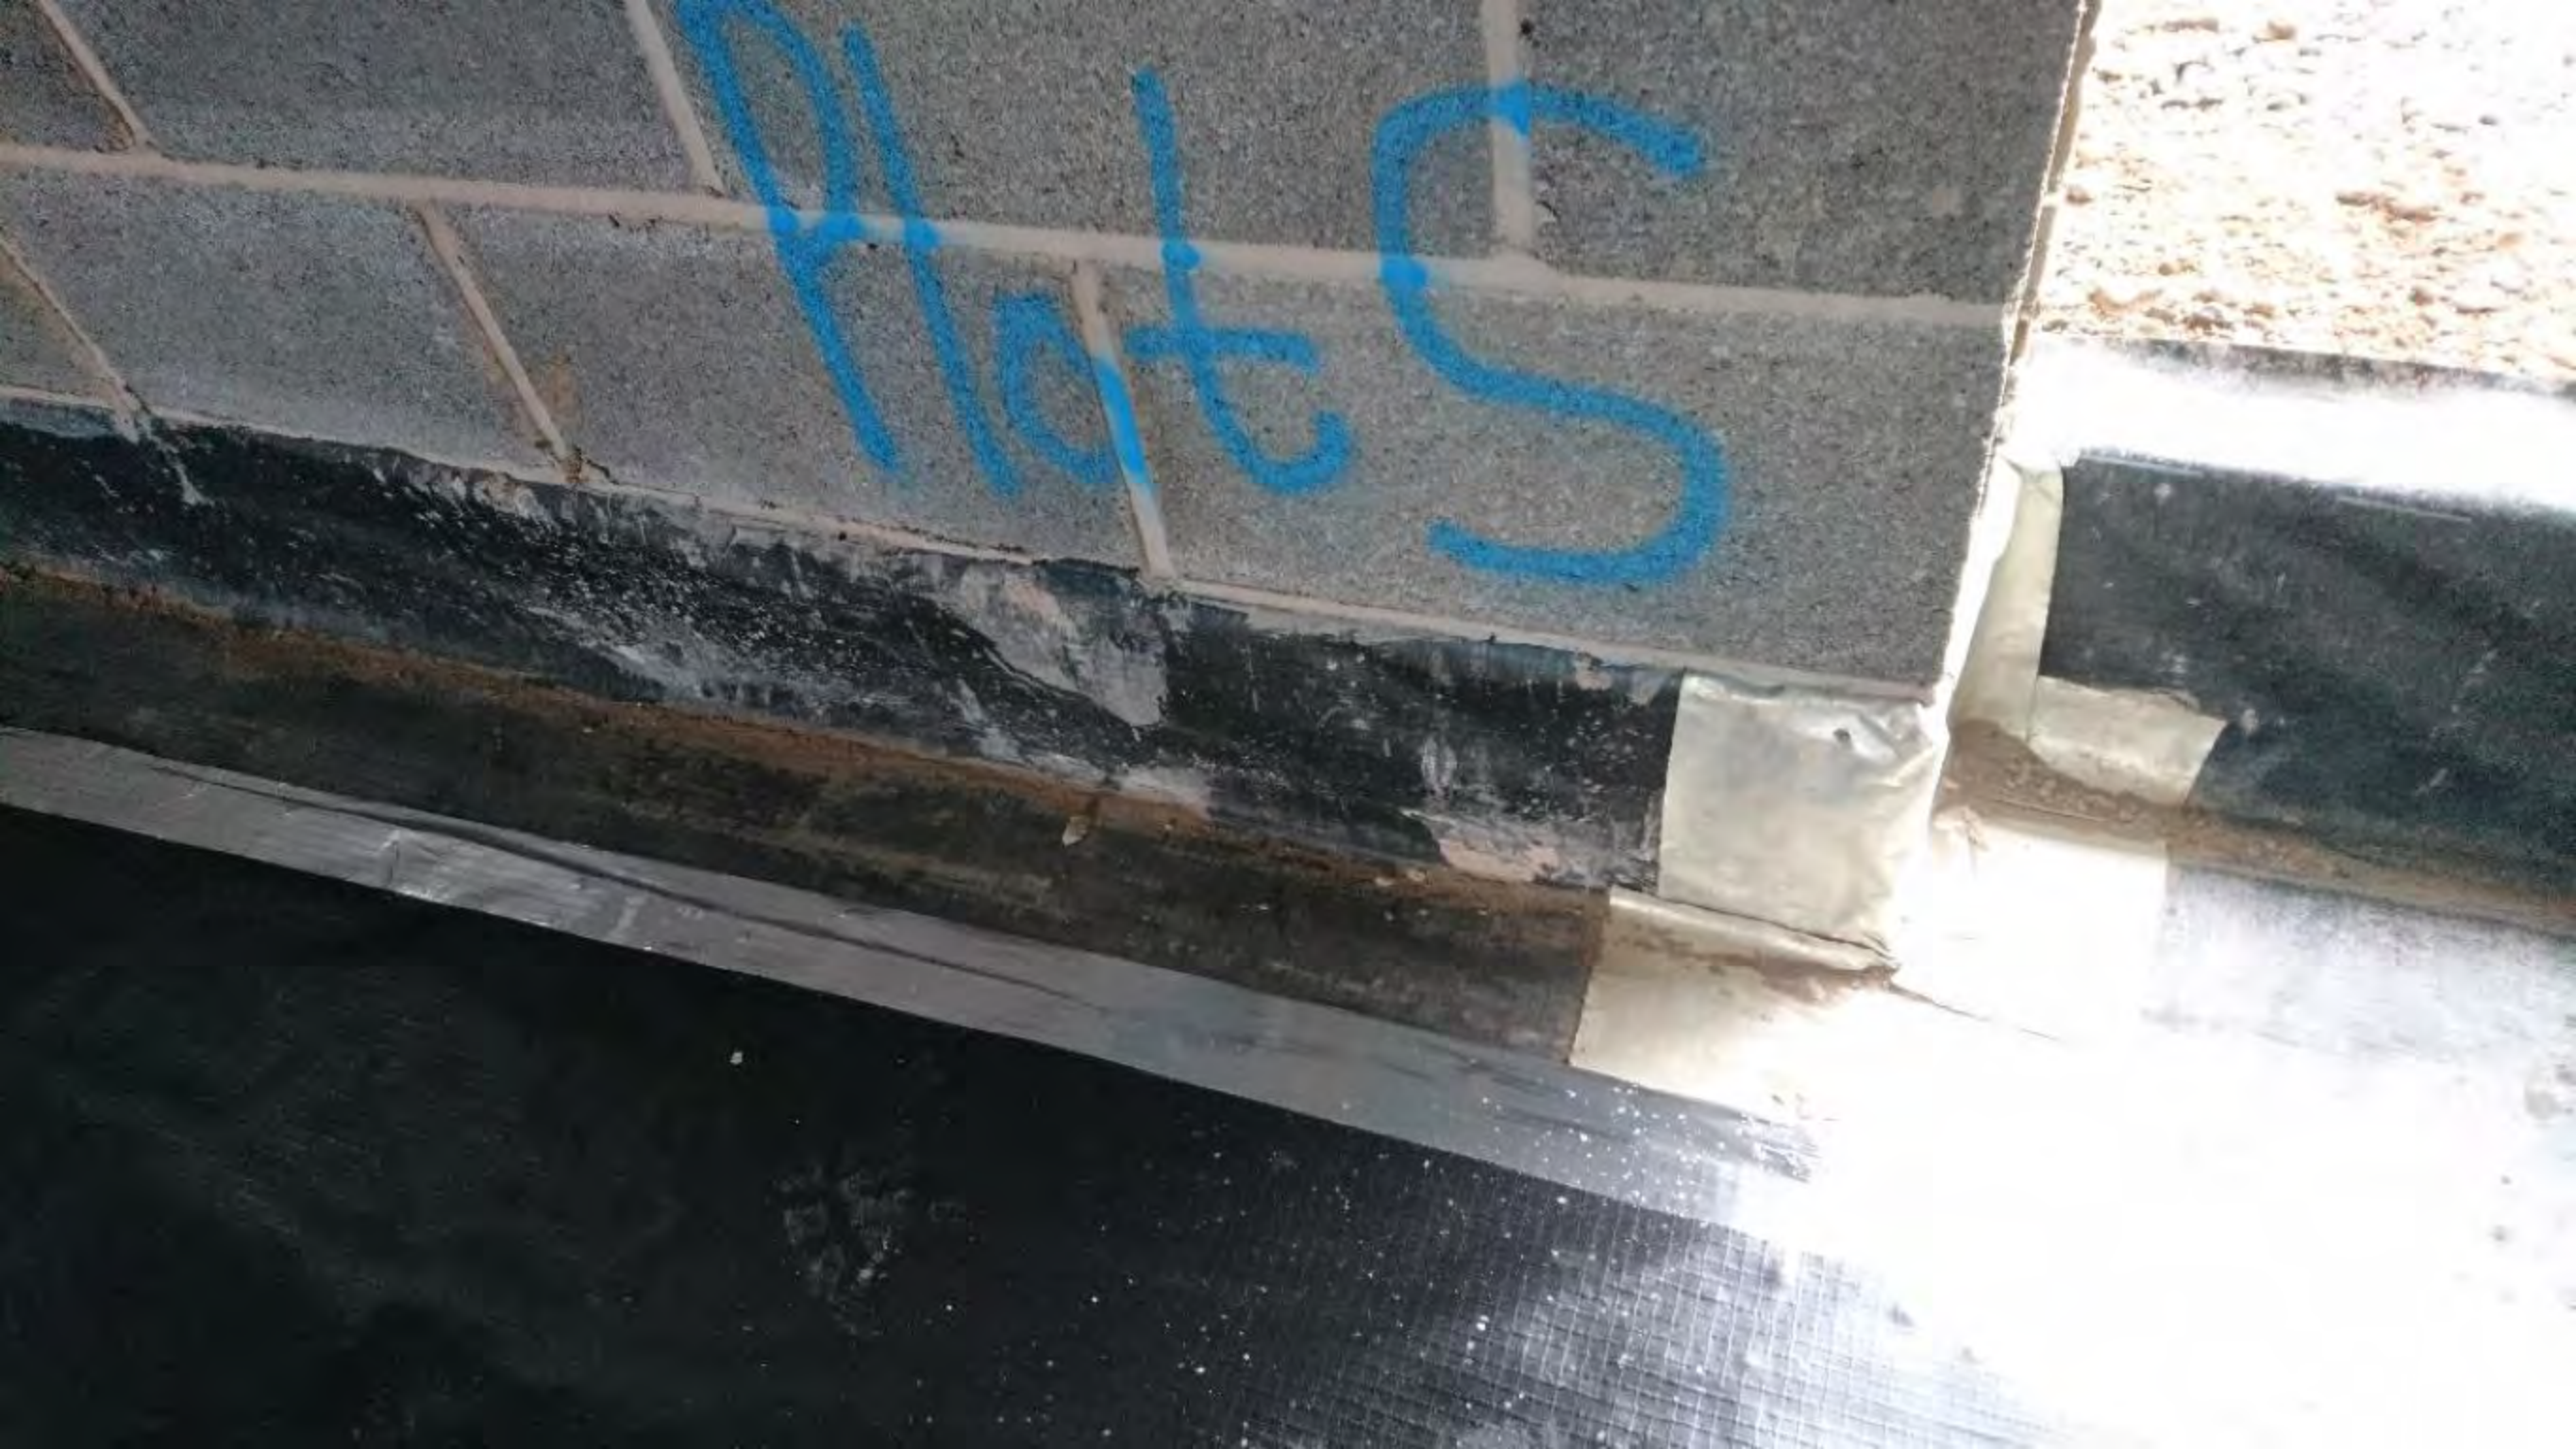
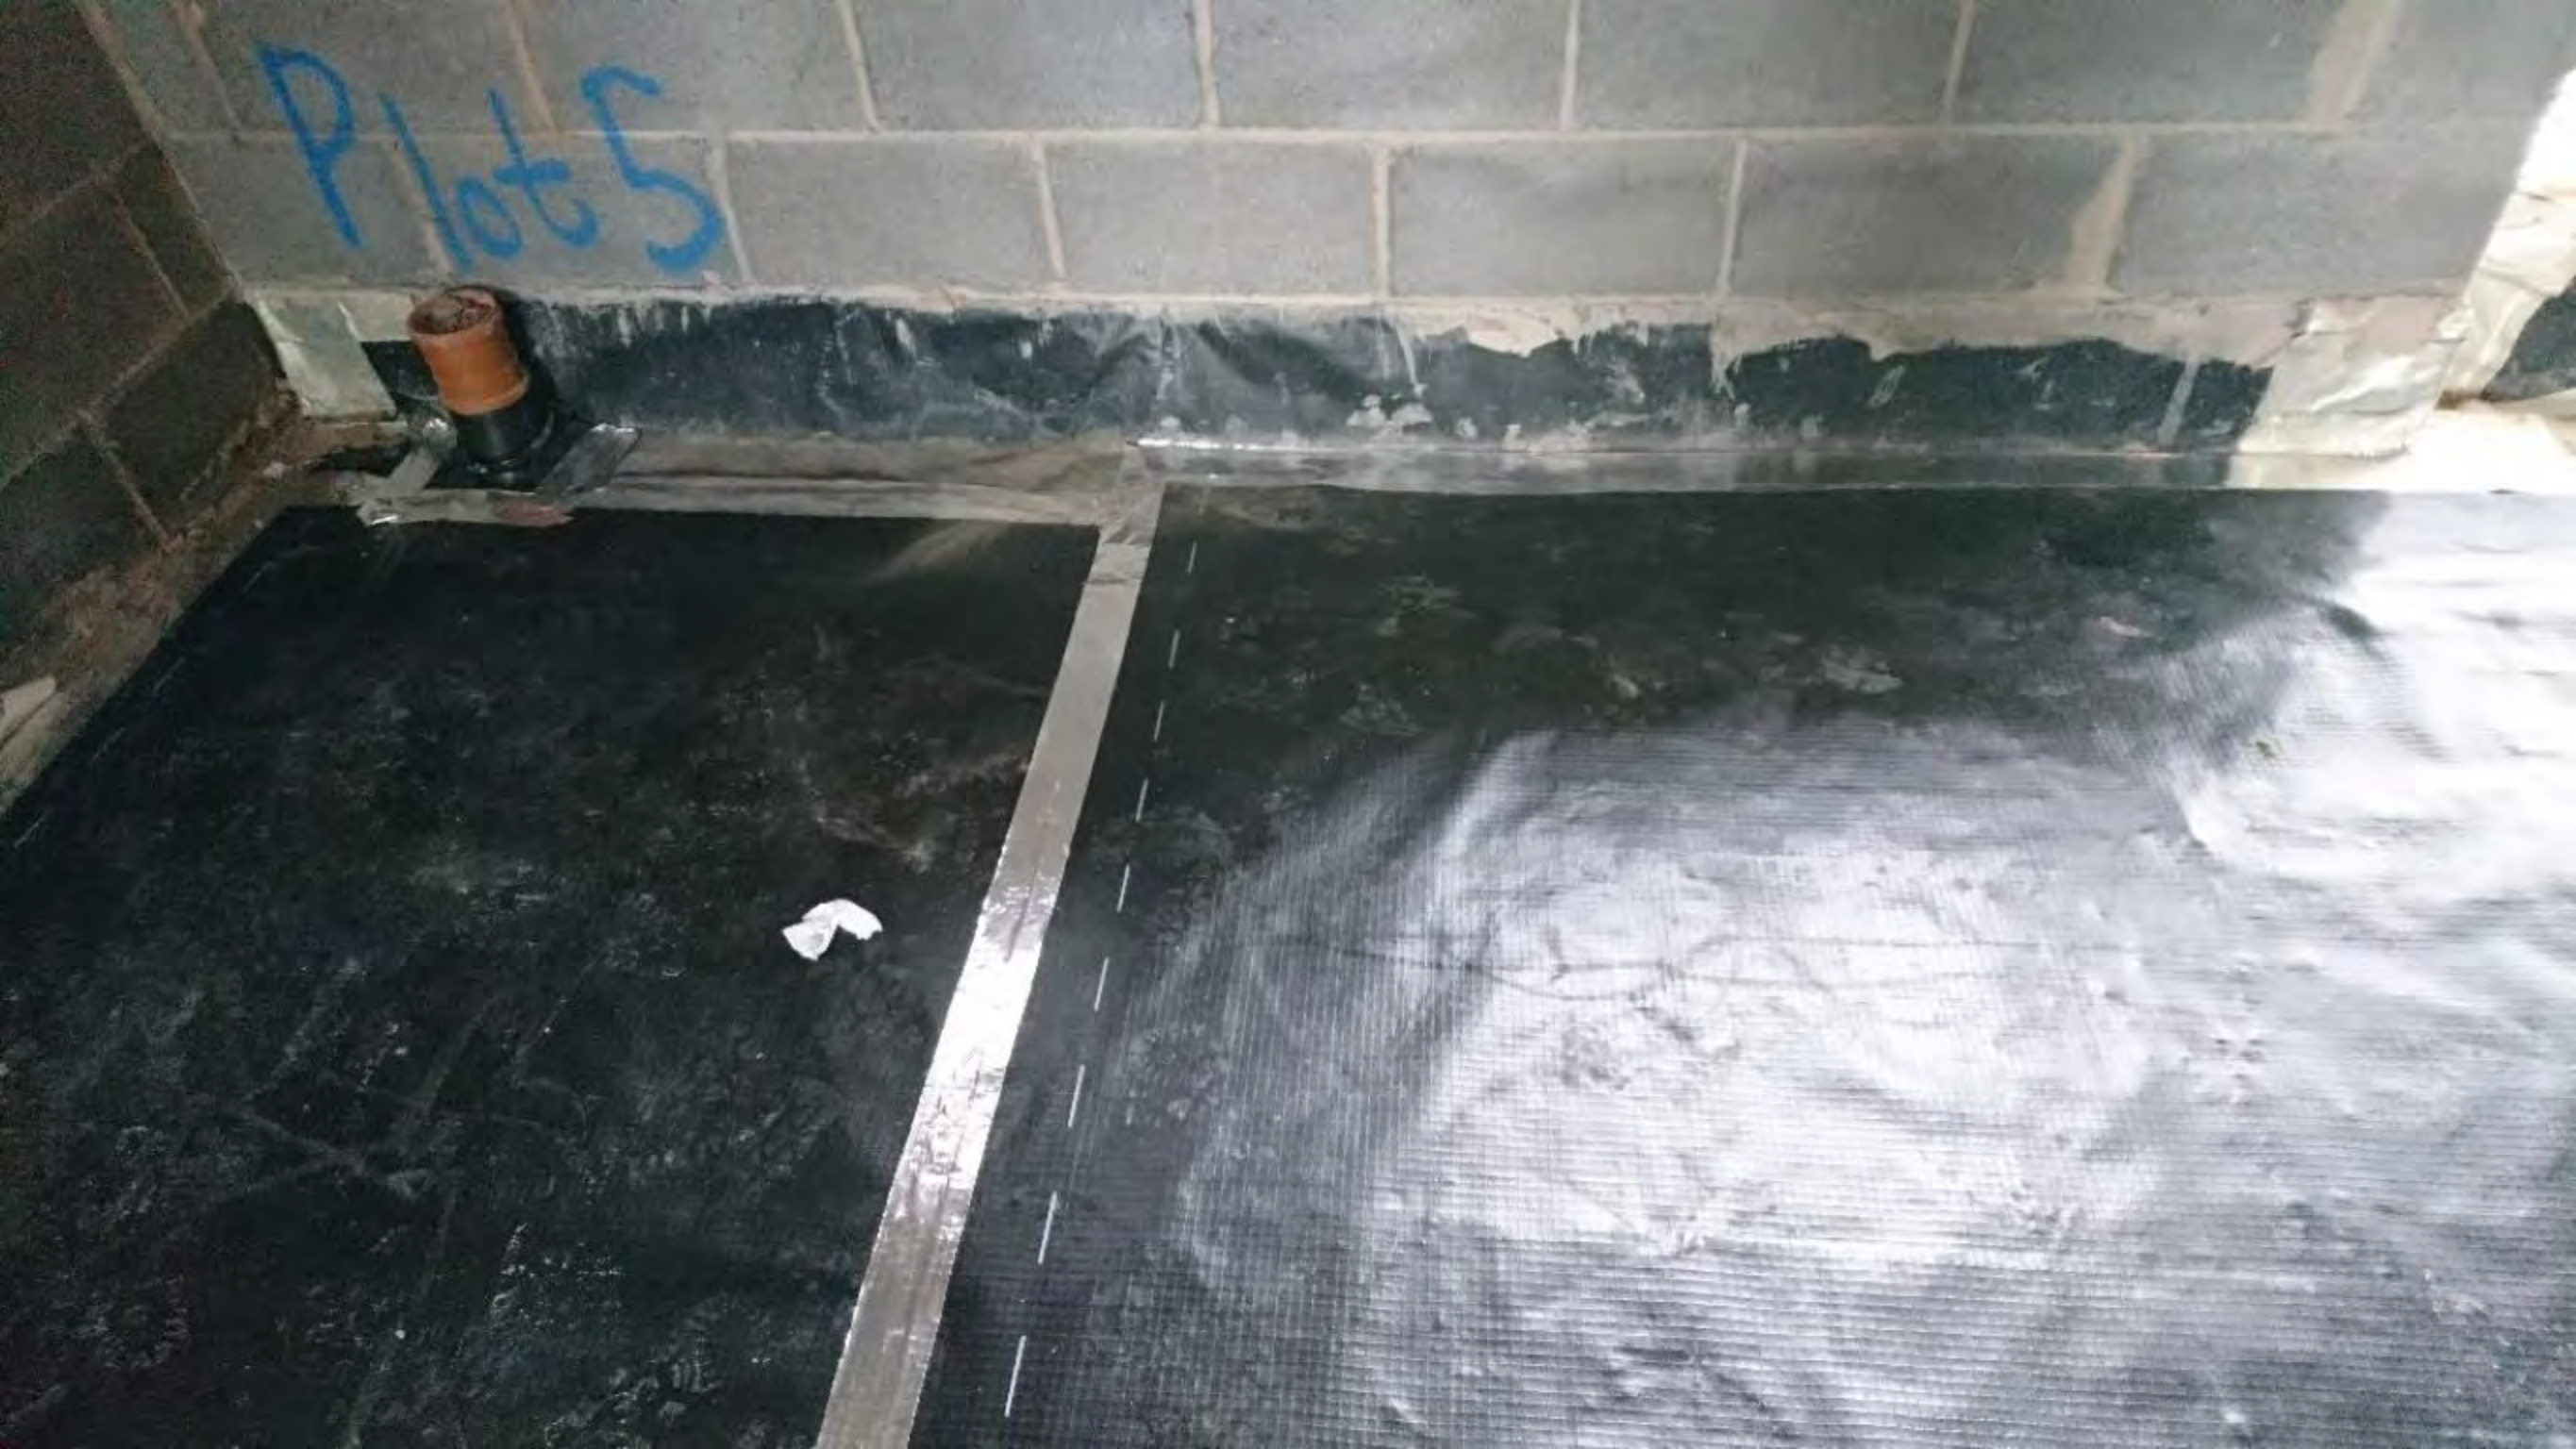
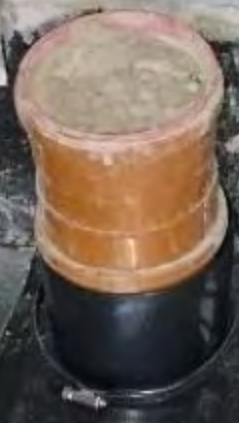
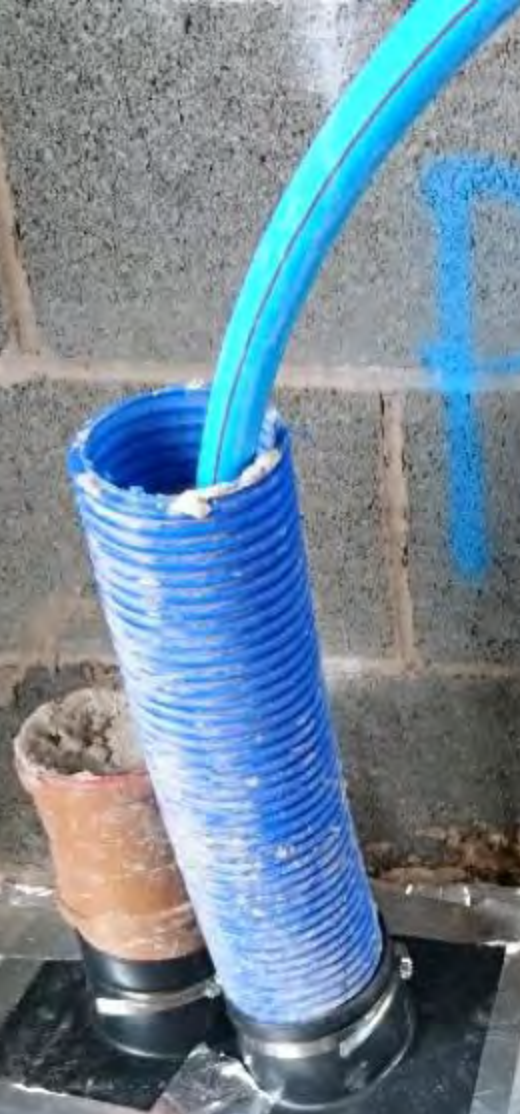
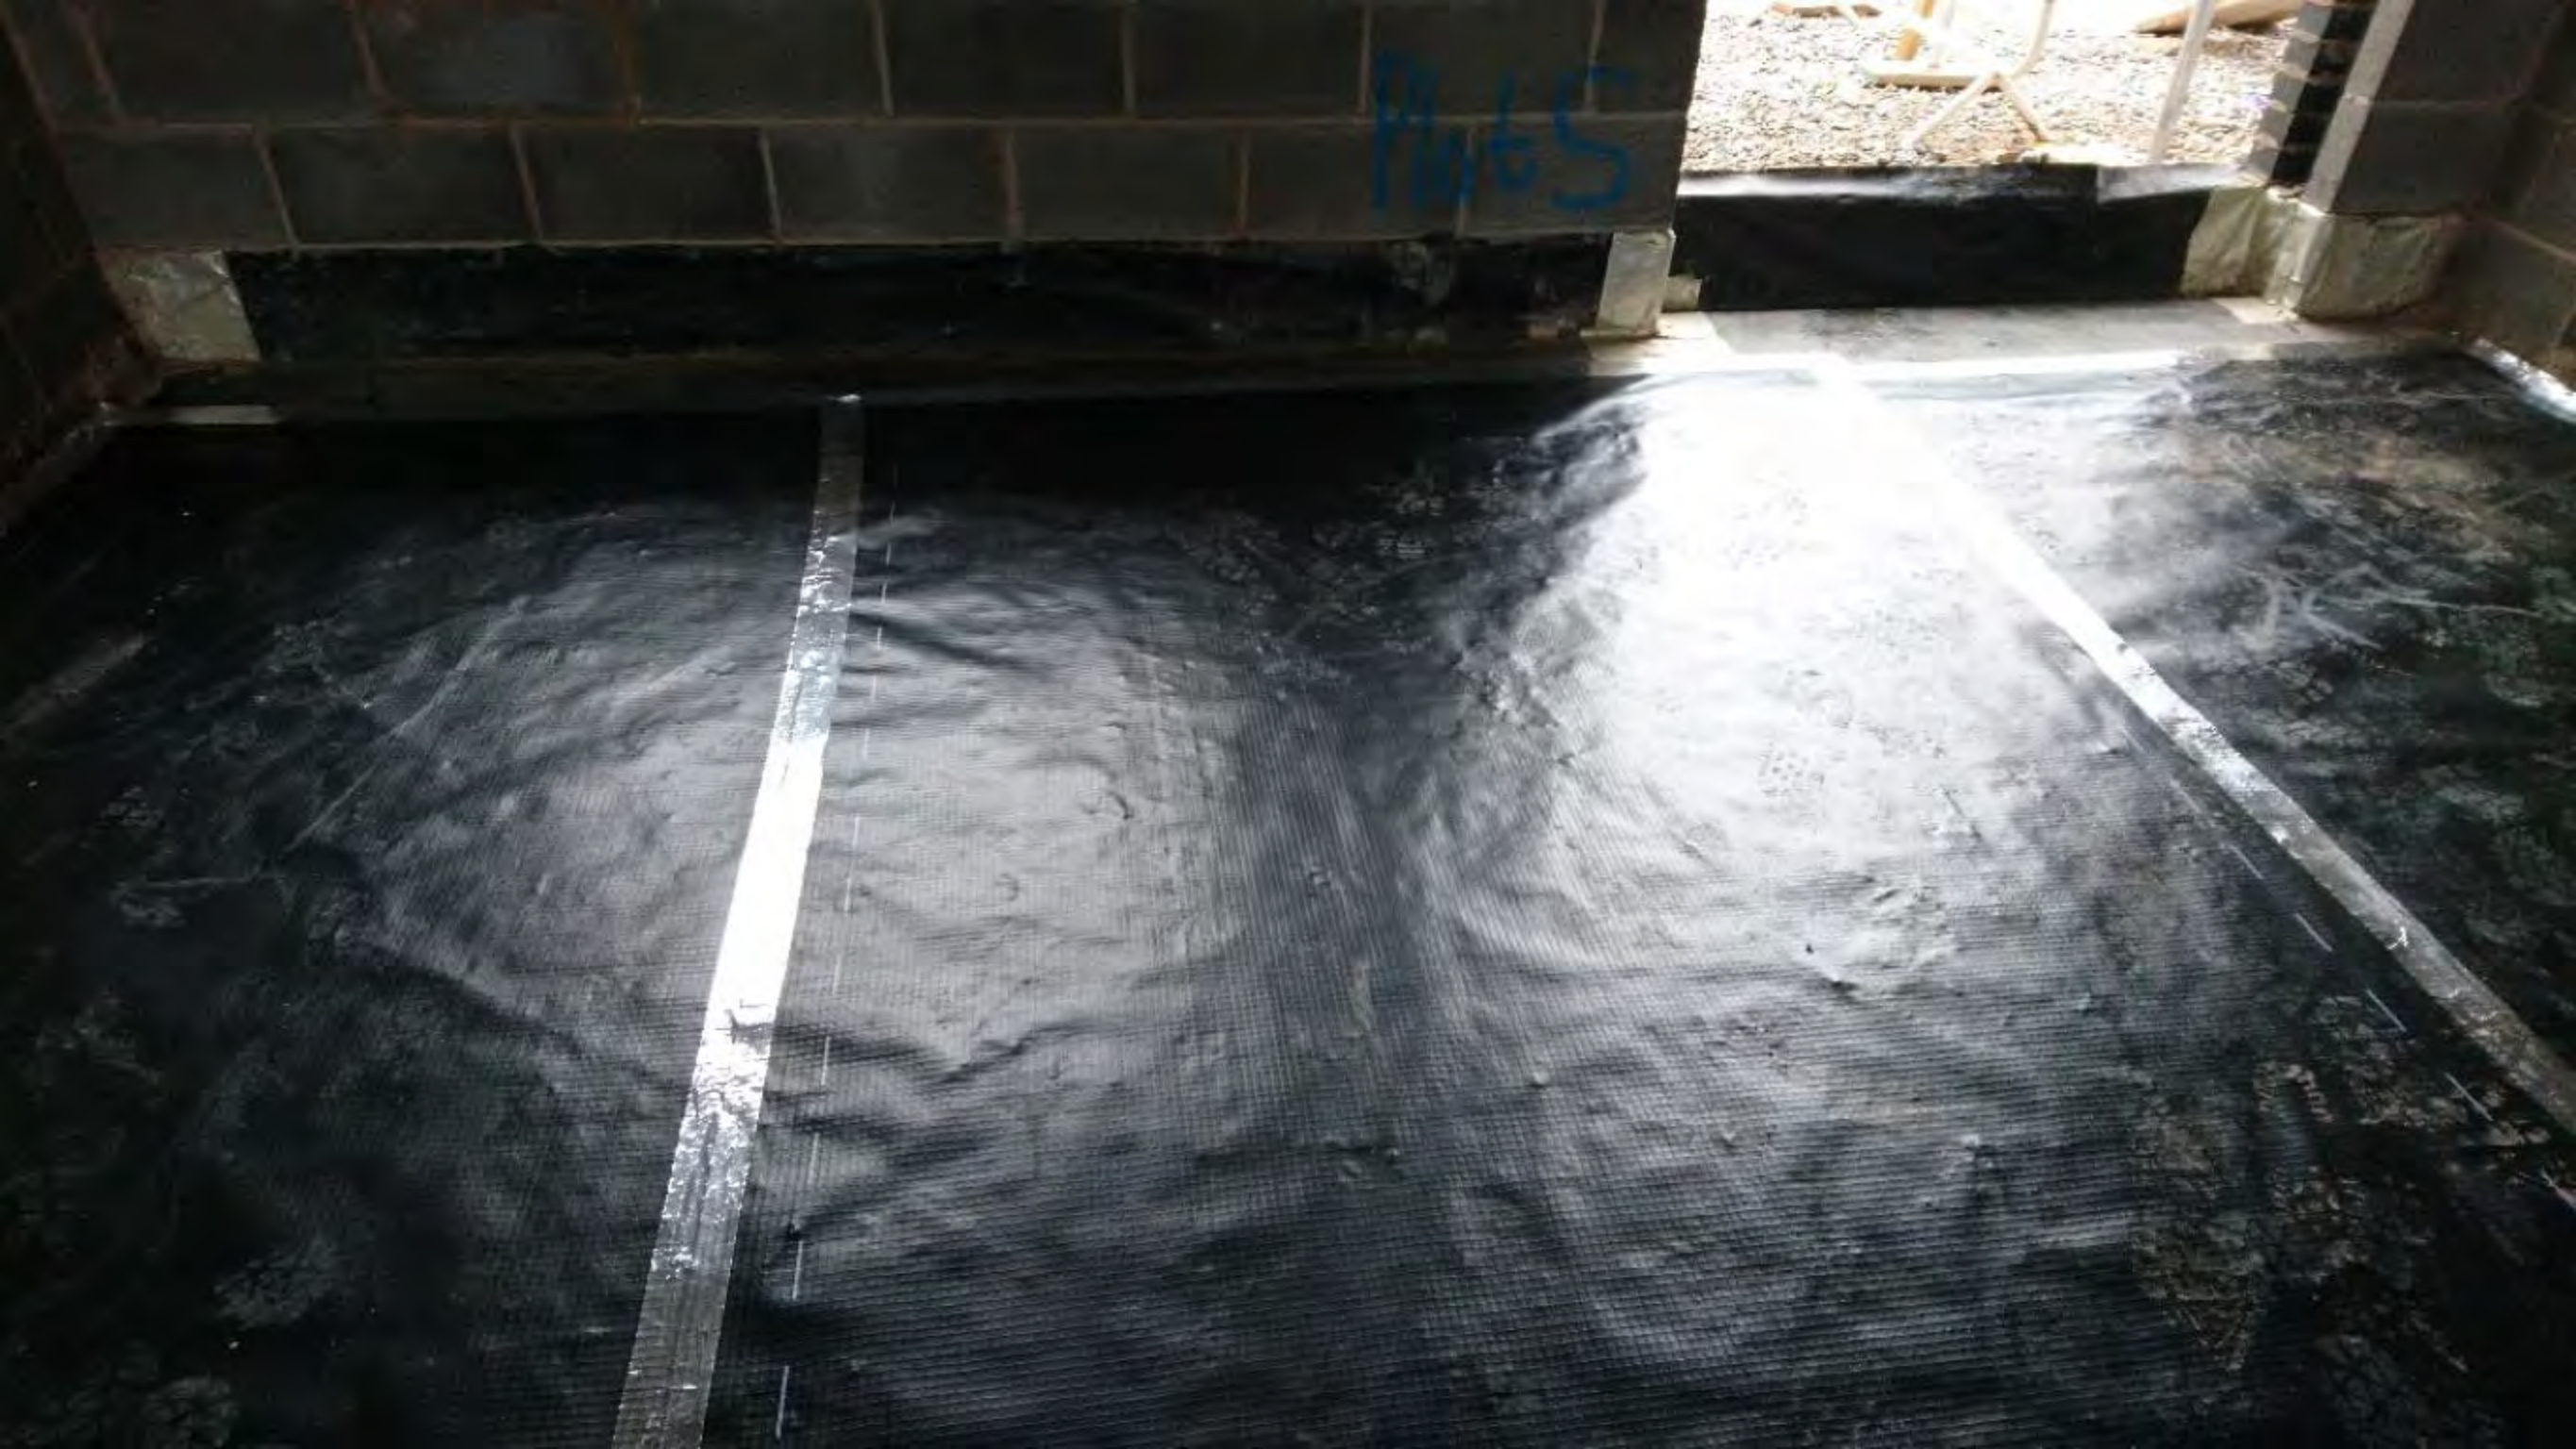
Plot 5

| 2.2 | Condition of sub-grade & underside of gas membrane | | GOOD QUALITY, FLOOR BRUSHED, ALL TAPES APPLIED WELL AND SEALED | | | | |
| 2.4 | Gas membrane condition and coverage | | GOOD, SEALED ON ALL FOUR SIDES | | | | |
| 2.7 | Condition of joints/seals | | ALL GOOD, VISIBLE OVERLAPS | | | | |
| 2.8 | Number and condition of service entry seals | | ALL OK, 3 NO. TOPHATS WITH SUBILEE CLIPS – ALL TAPES CHECKED | | | | |
| 2.10 | Repairs or Corrections: | | NONE VISIBLE | | | | |
