**This Record sheet is only applicable to block and beam floor slabs for Characteristic Situation 2 gas protection systems**

**For Residential Development at New Church Street, Radcliffe.**

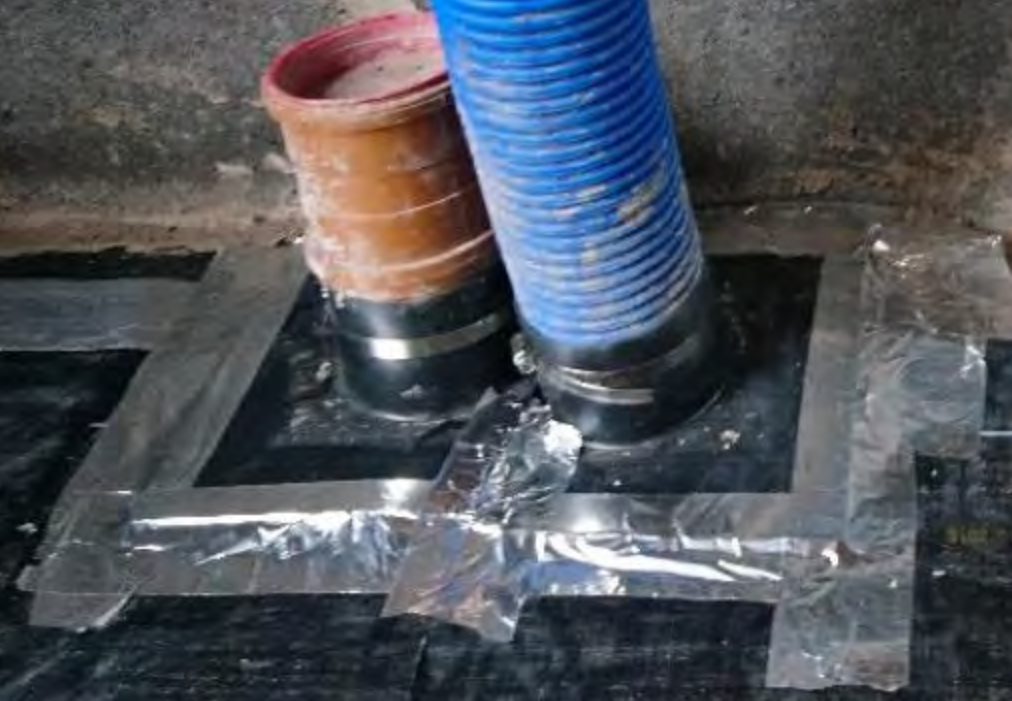
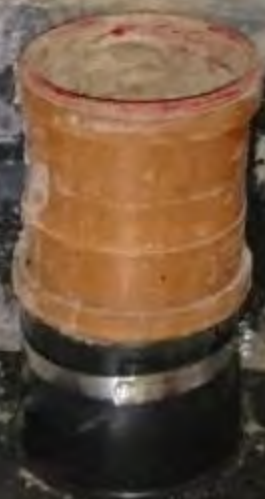
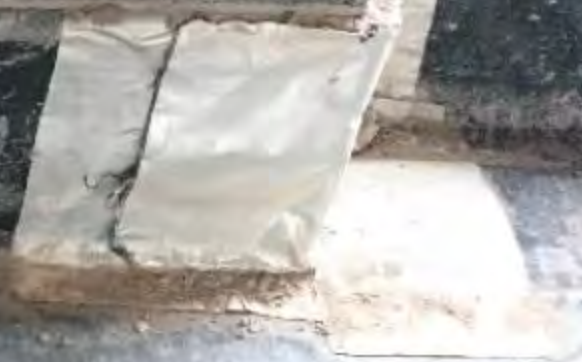
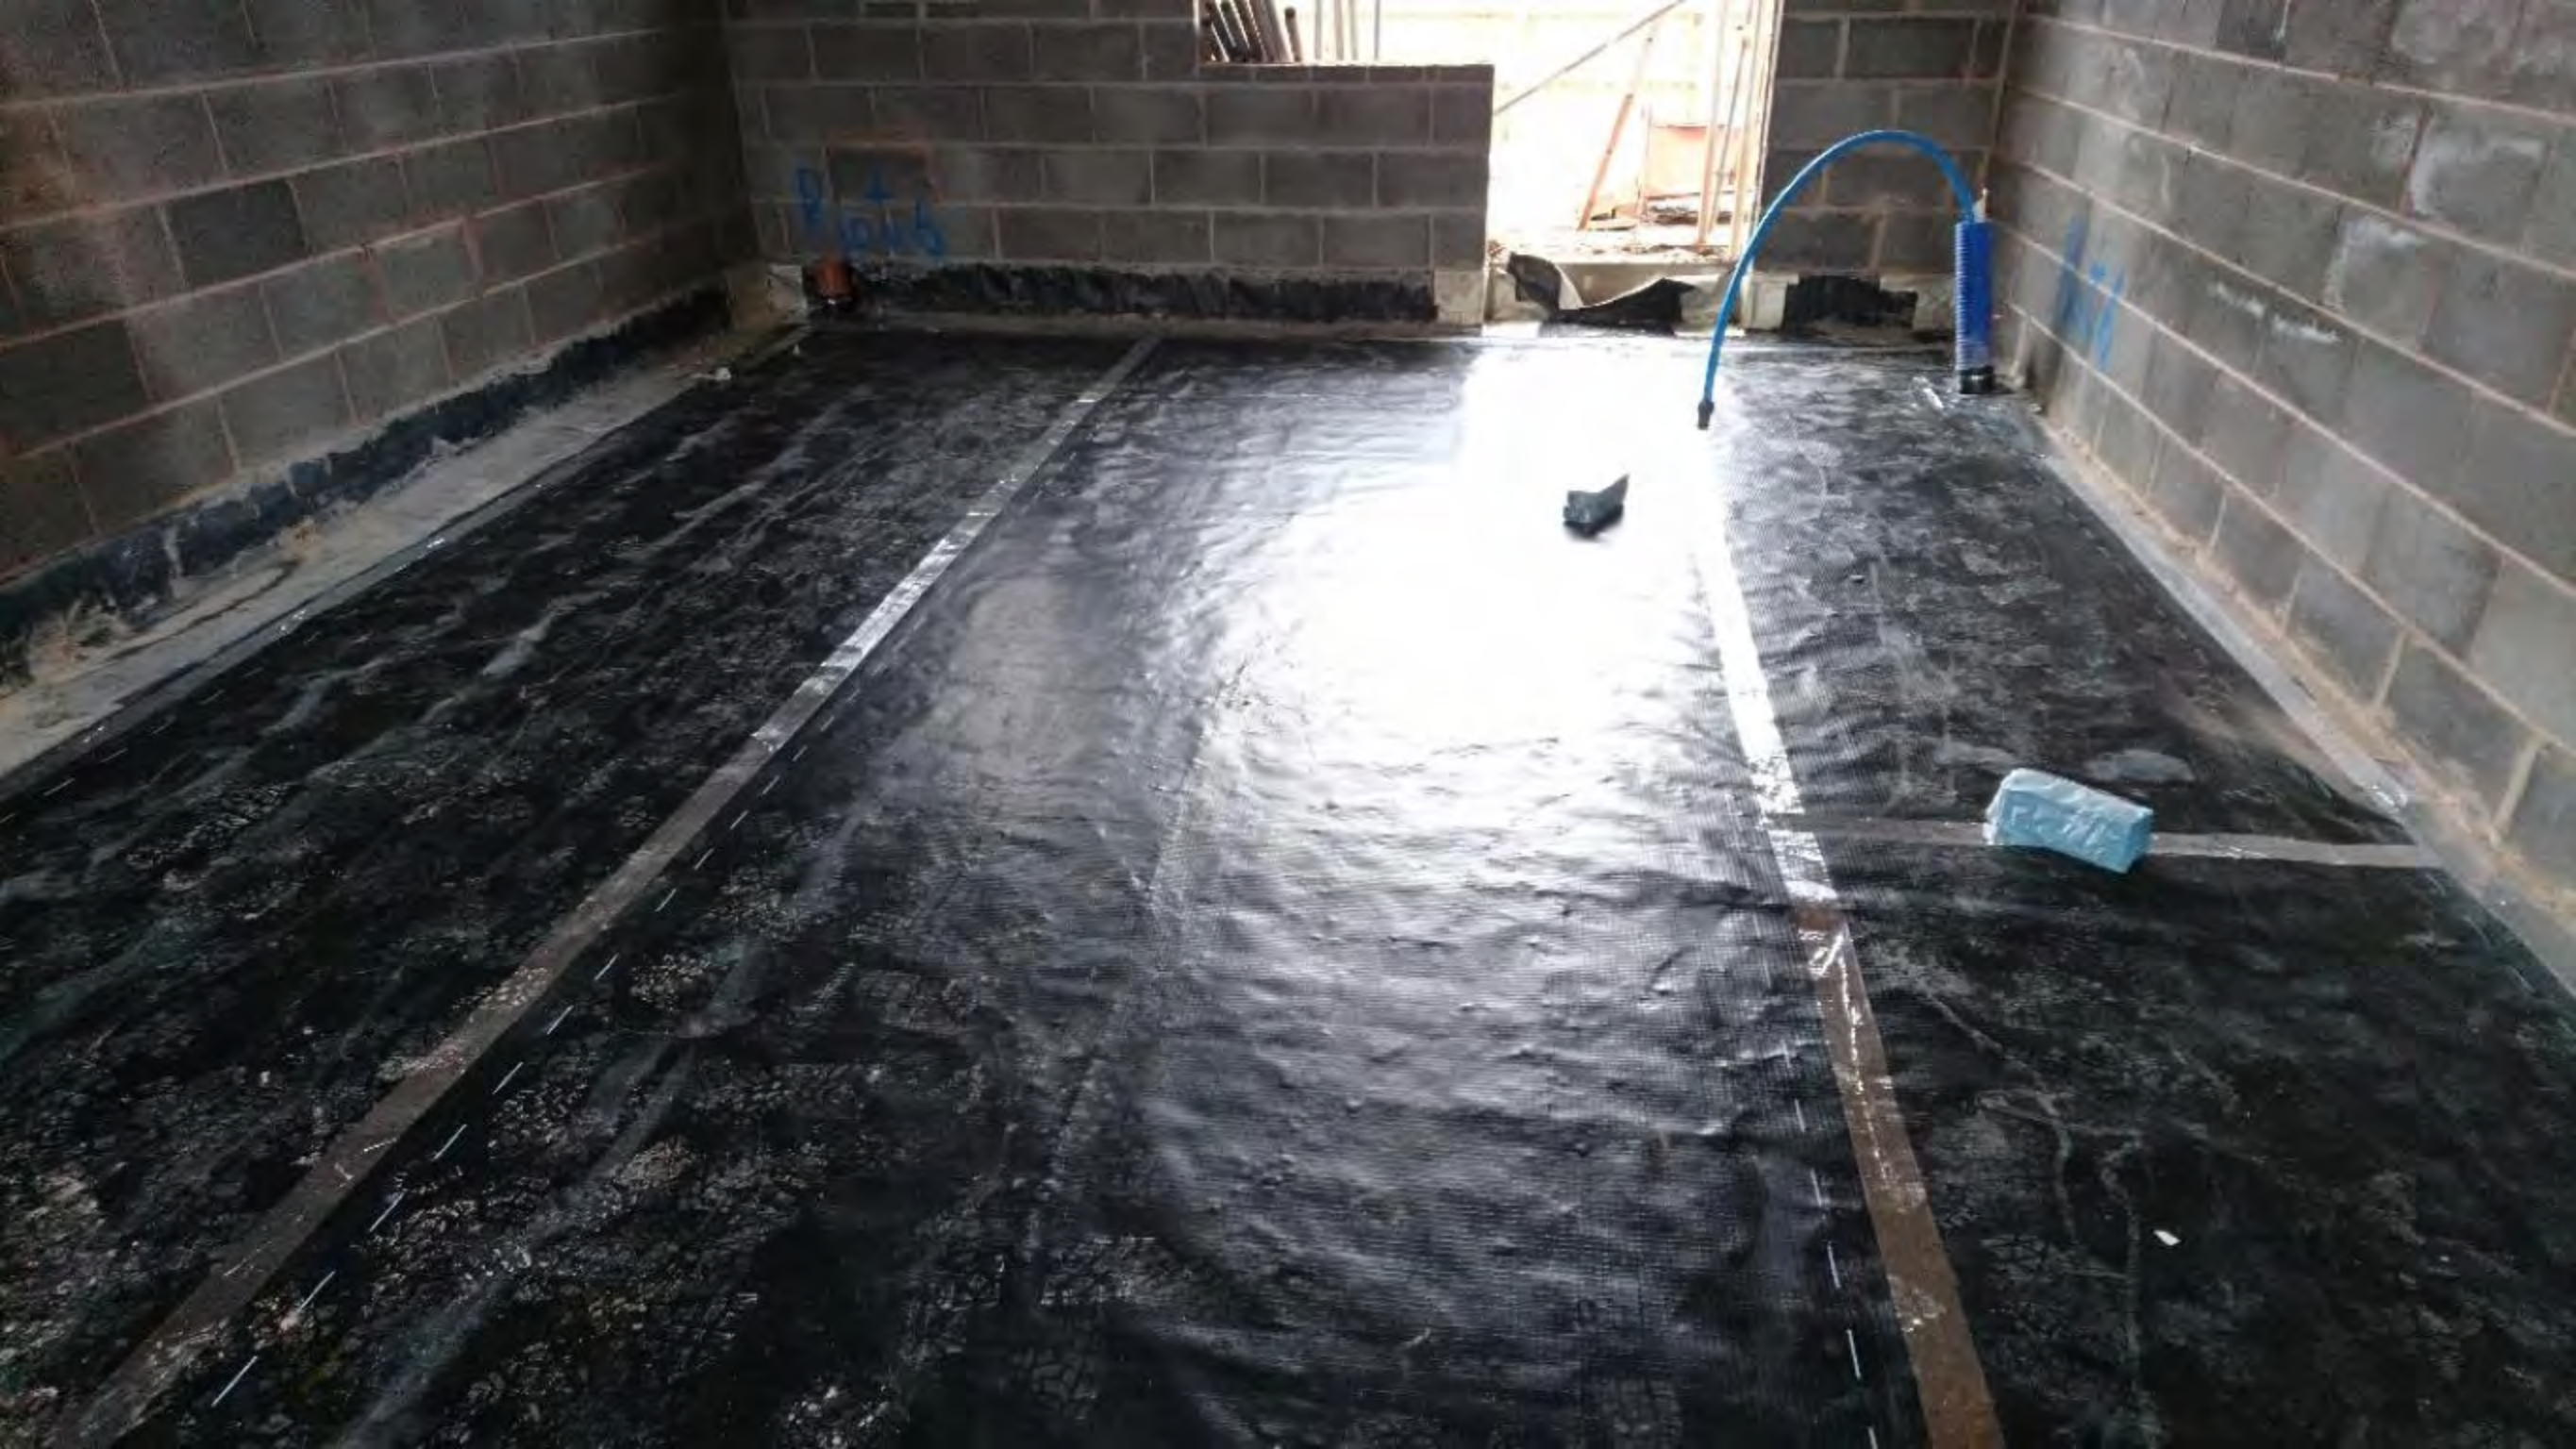
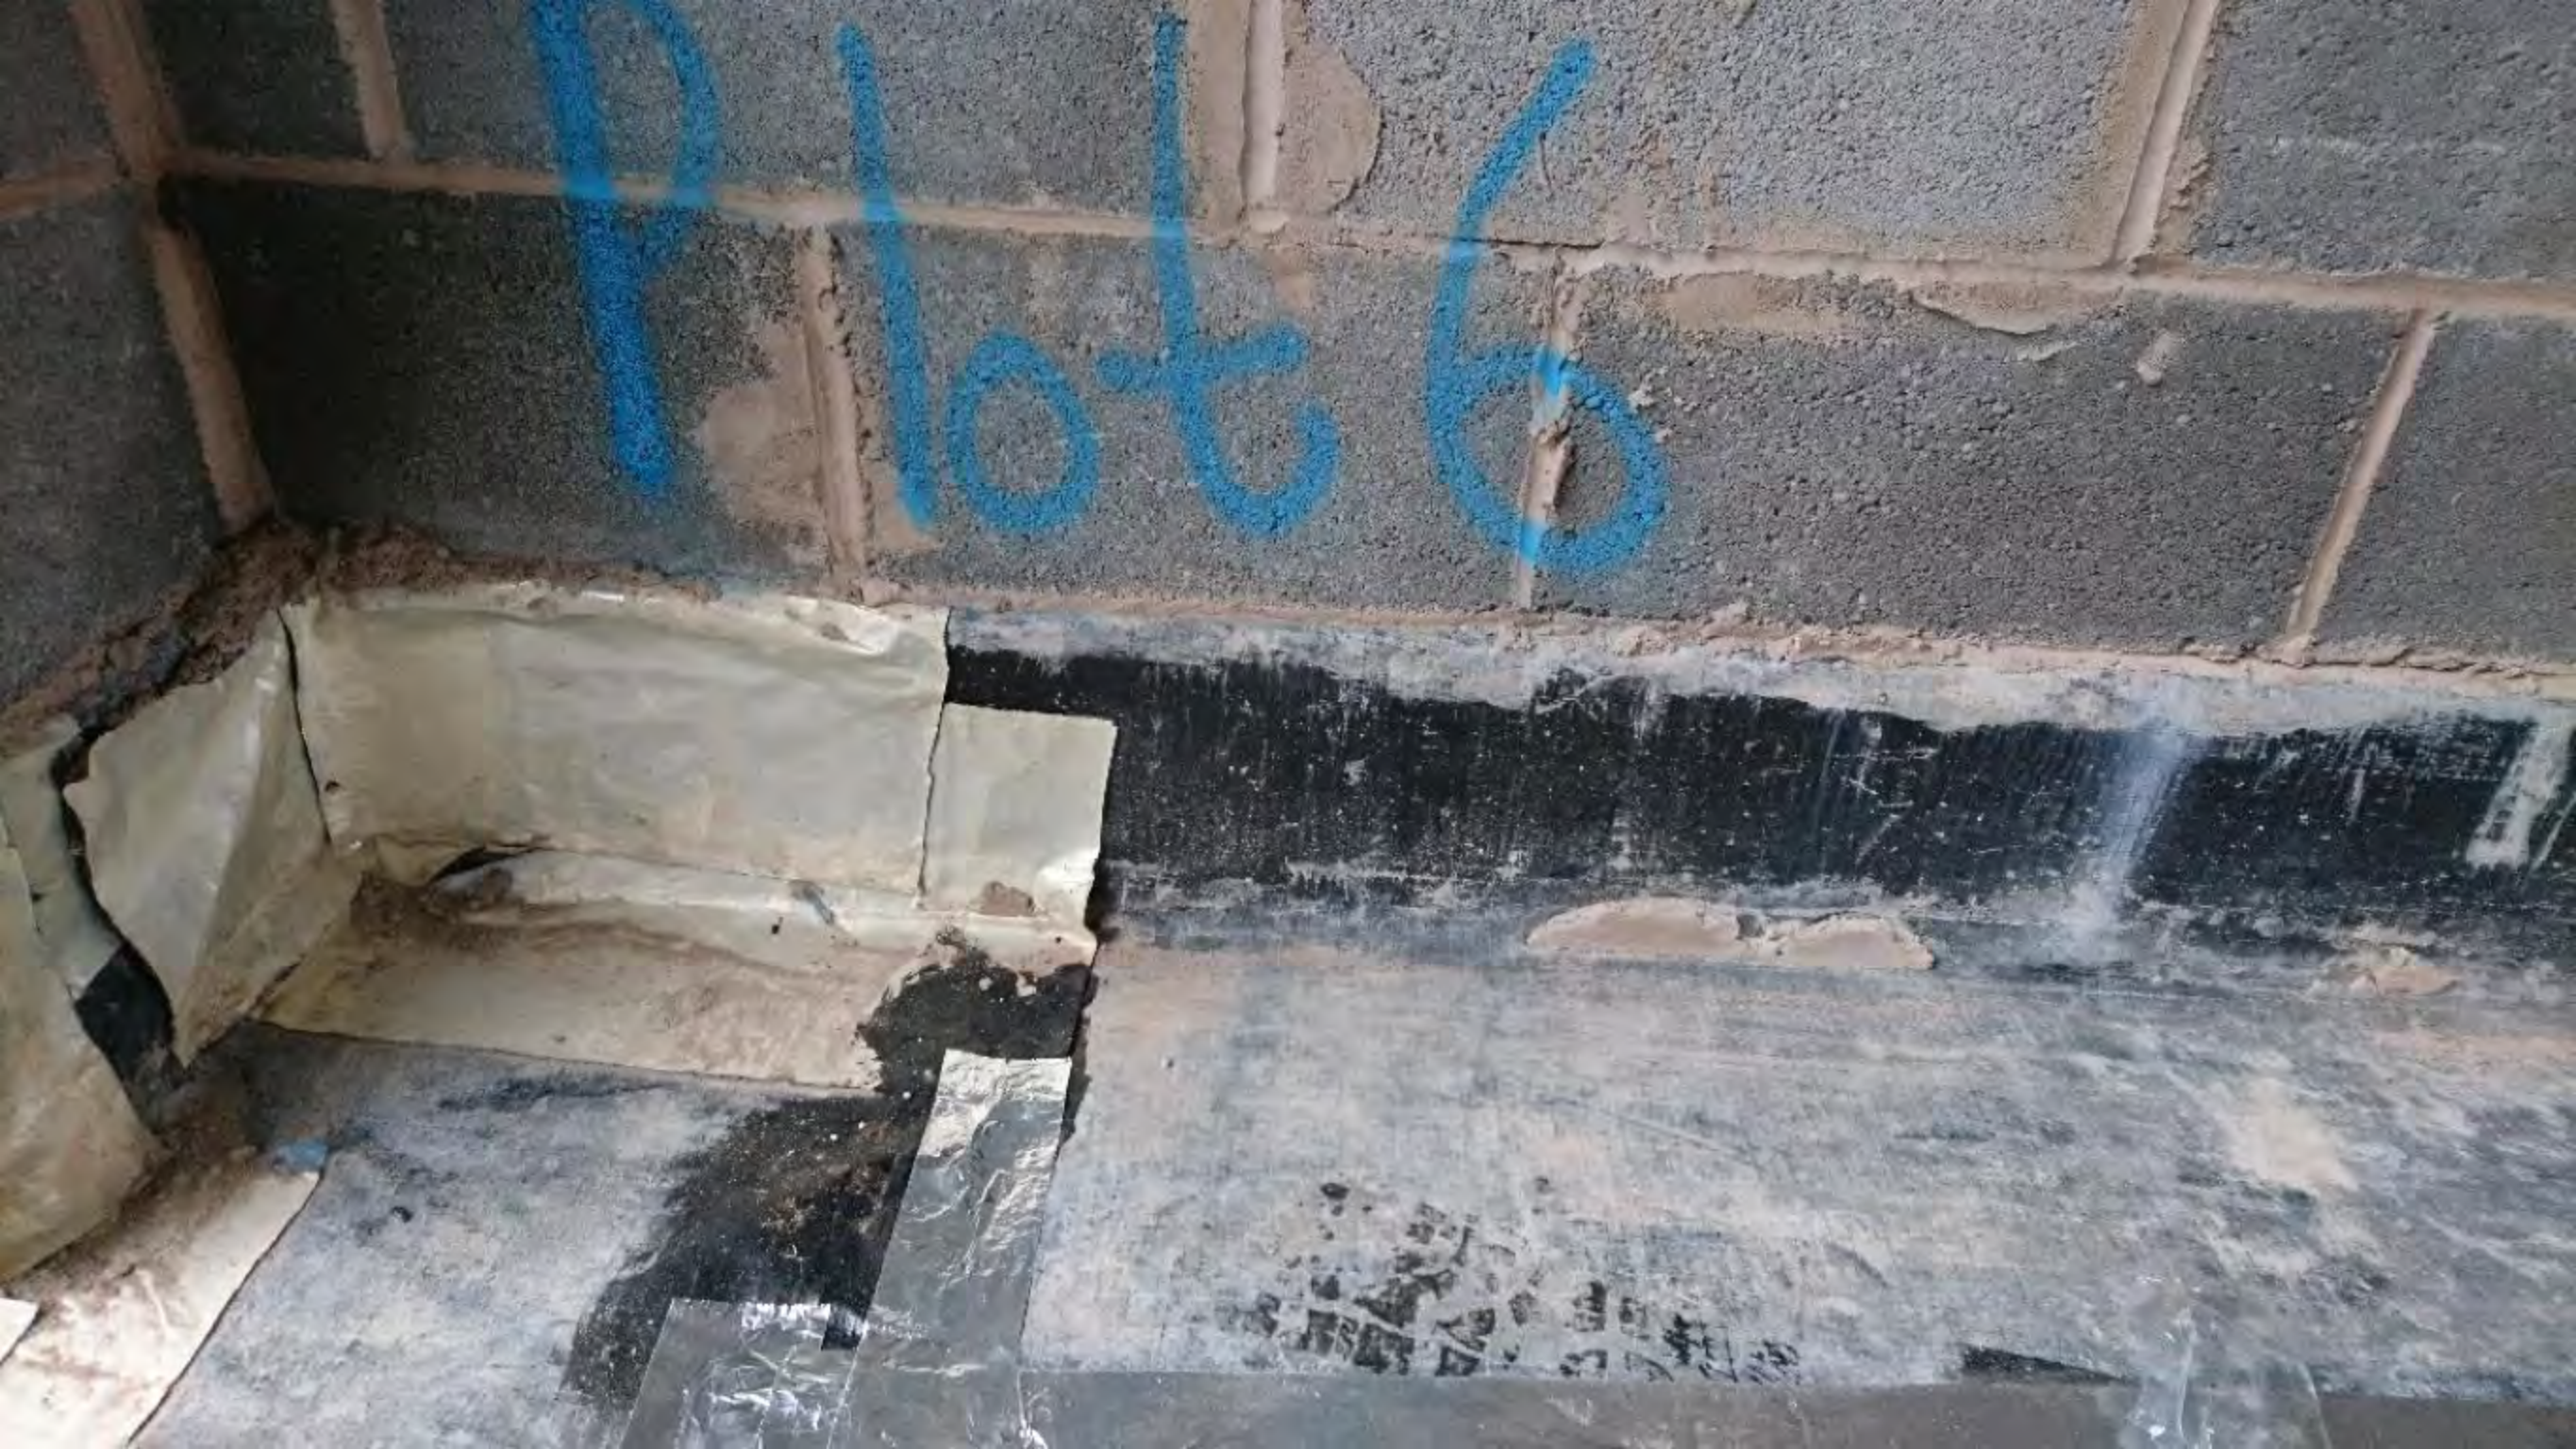
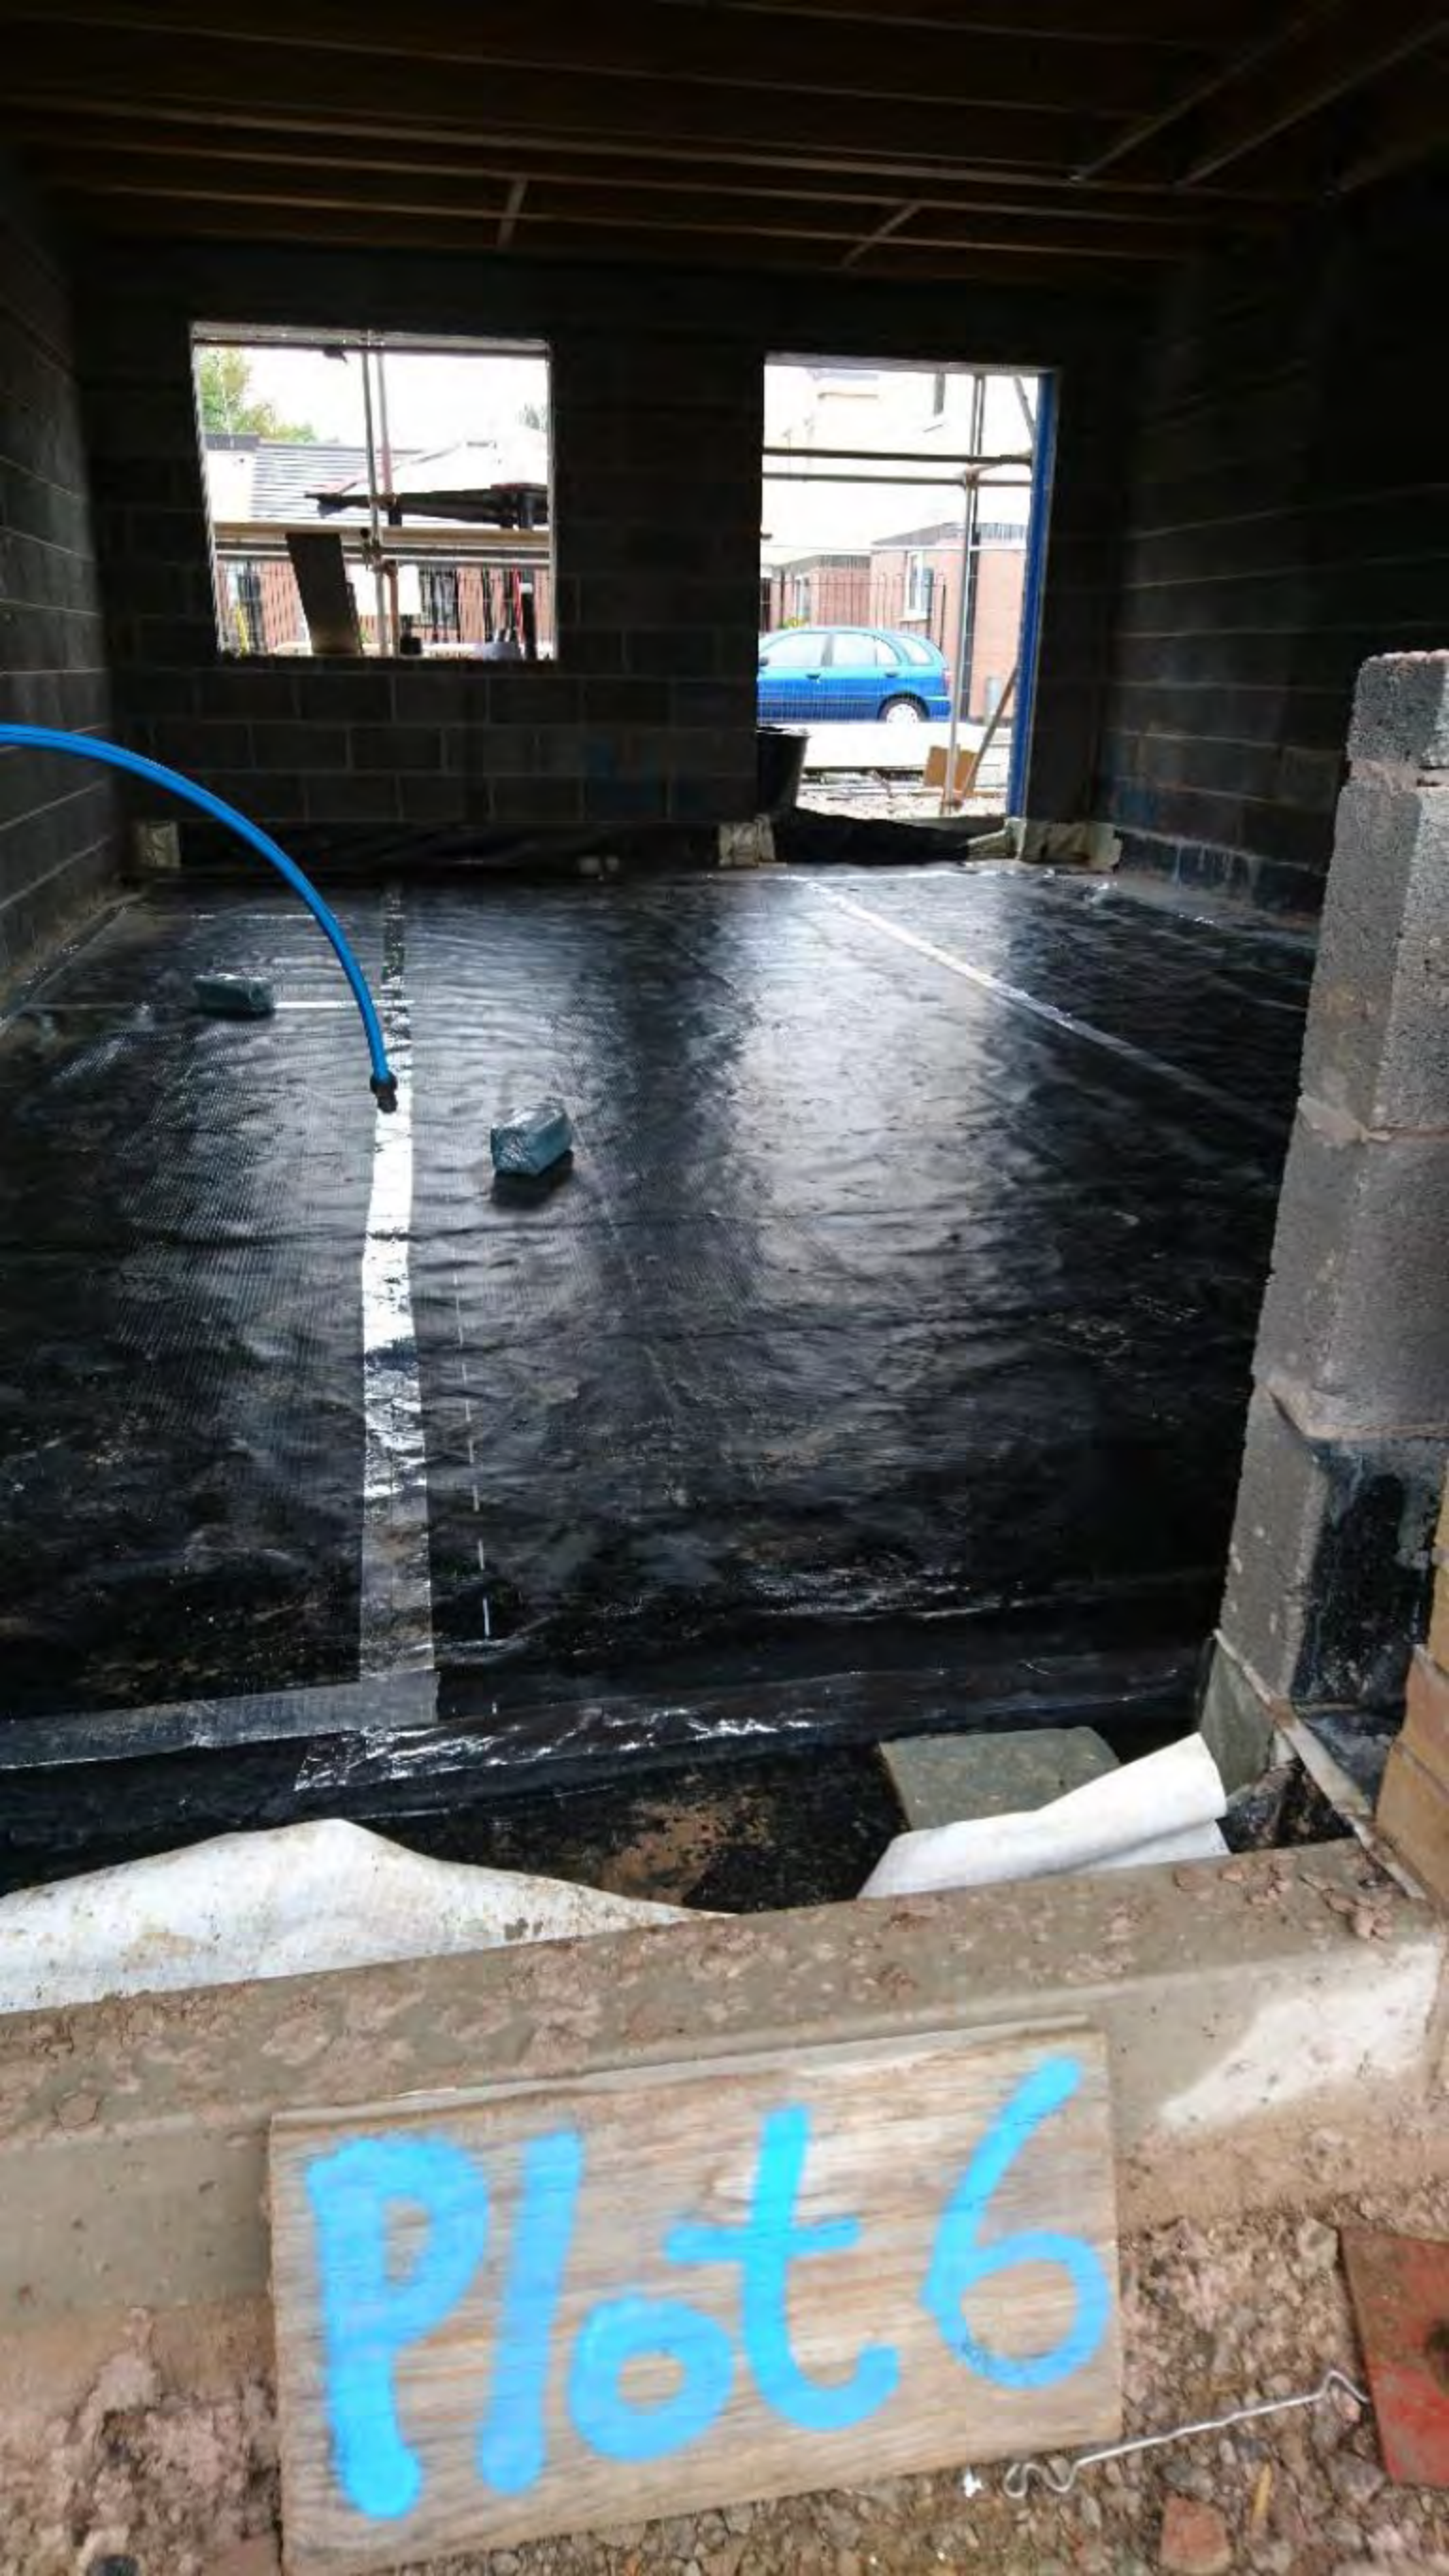
Plot 6

| 2.2 | Condition of sub-grade & underside of gas membrane | PLOT SWEEP OUT, FLOOR CLEAR, SCRAPED / LEVEL NO RIPS OR TEARS | | | | | |
| 2.4 | Gas membrane condition and coverage | RADBAR PRIMER APPLIED TO PERIMETER / CLEANED / SEALED TO STAGE 1 | | | | | |
| 2.7 | Condition of joints/seals | NO CREASING / LAID FLAT / JOINTS SEALS TIDY | | | | | |
| 2.8 | Number and condition of service entry seals | 3 NO WITH TOP HATS | | | | | |
| 2.10 | Repairs or Corrections: | NONE | | | | | |

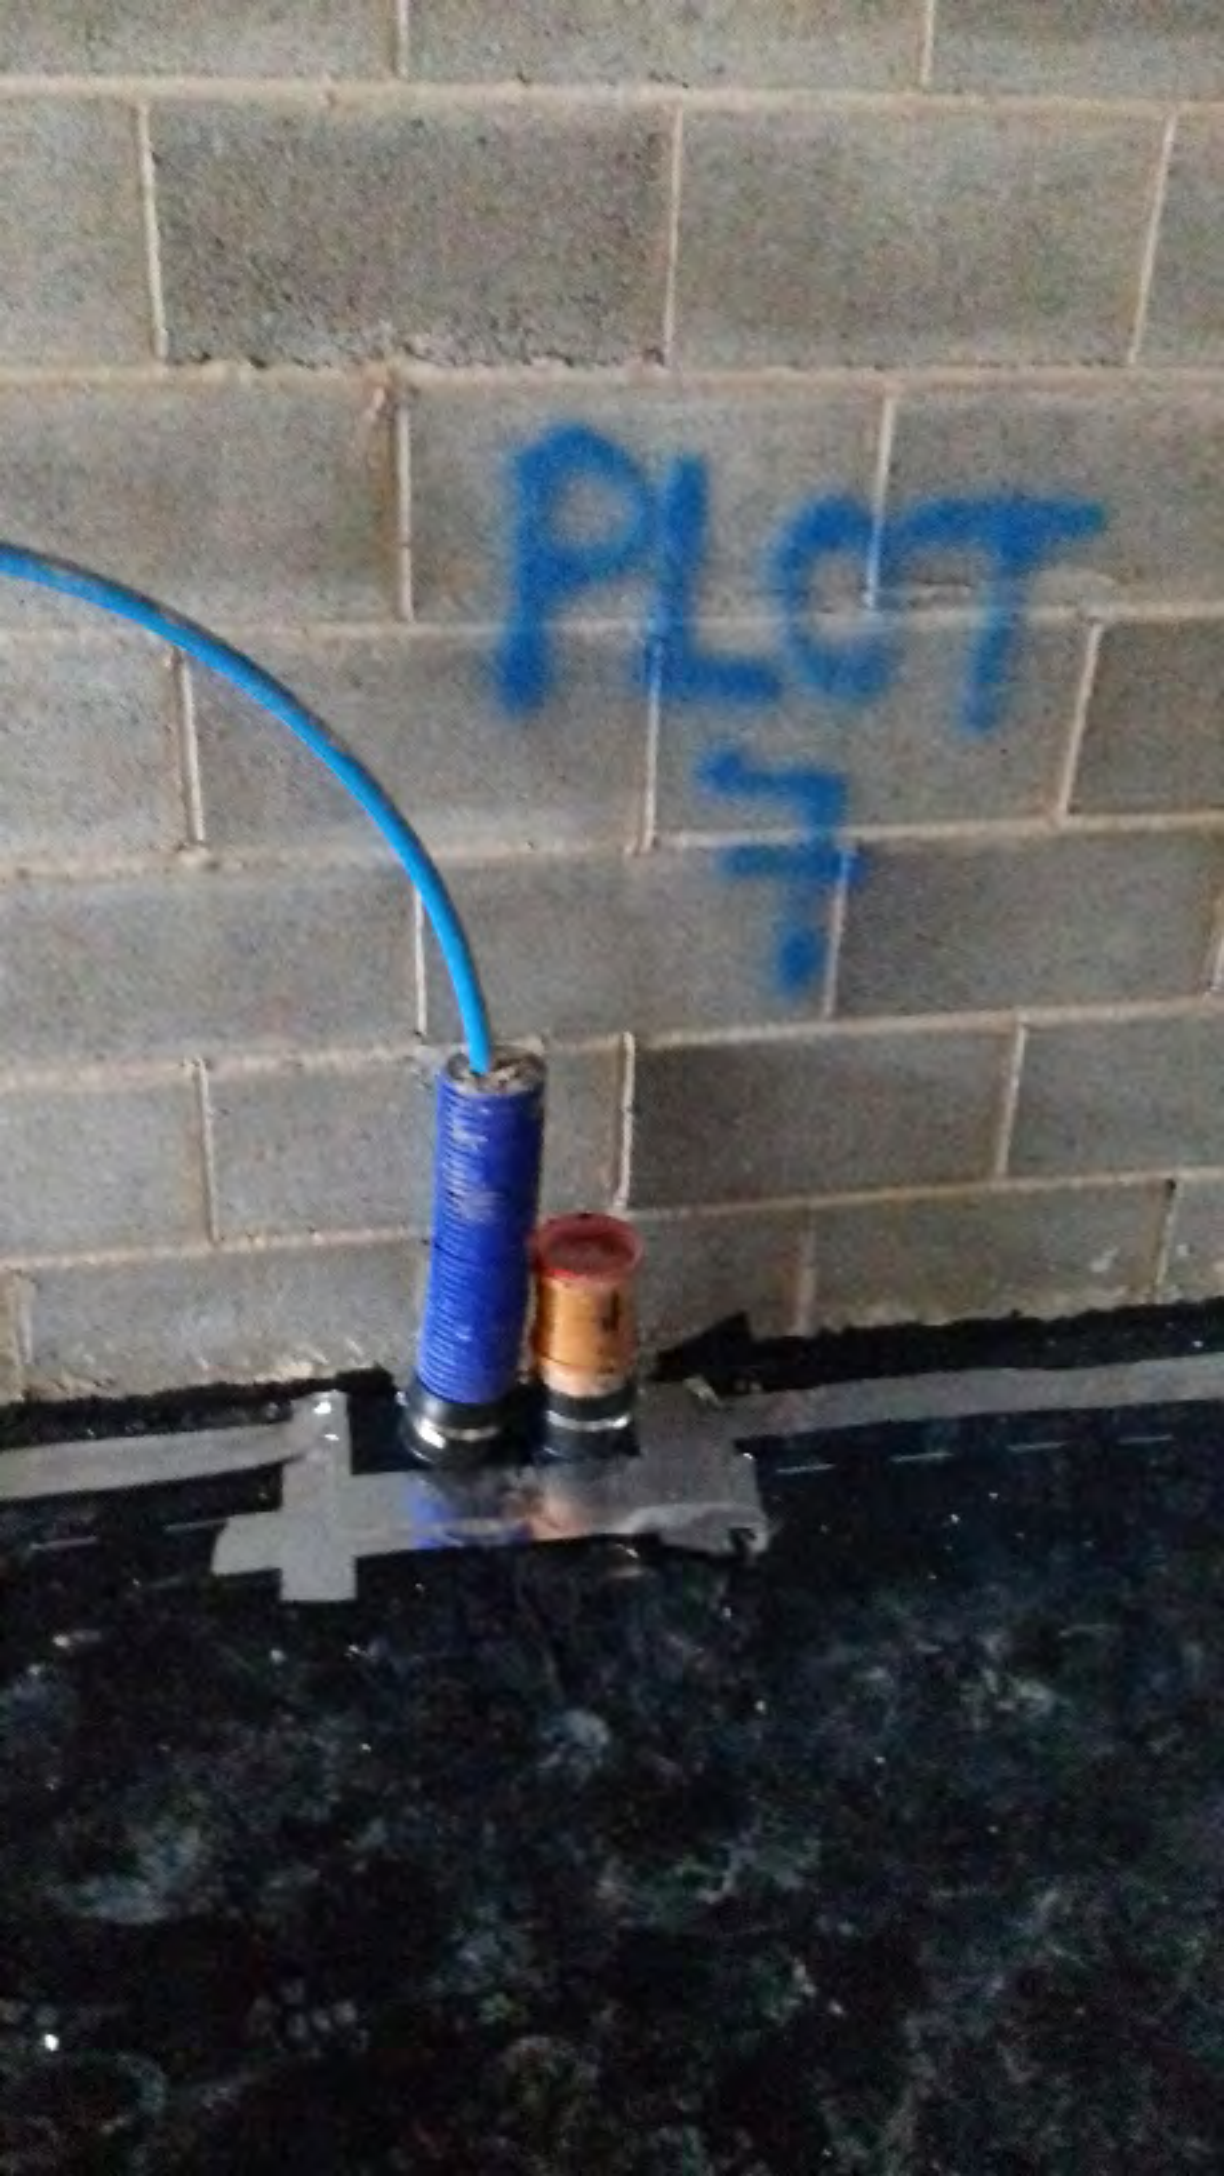
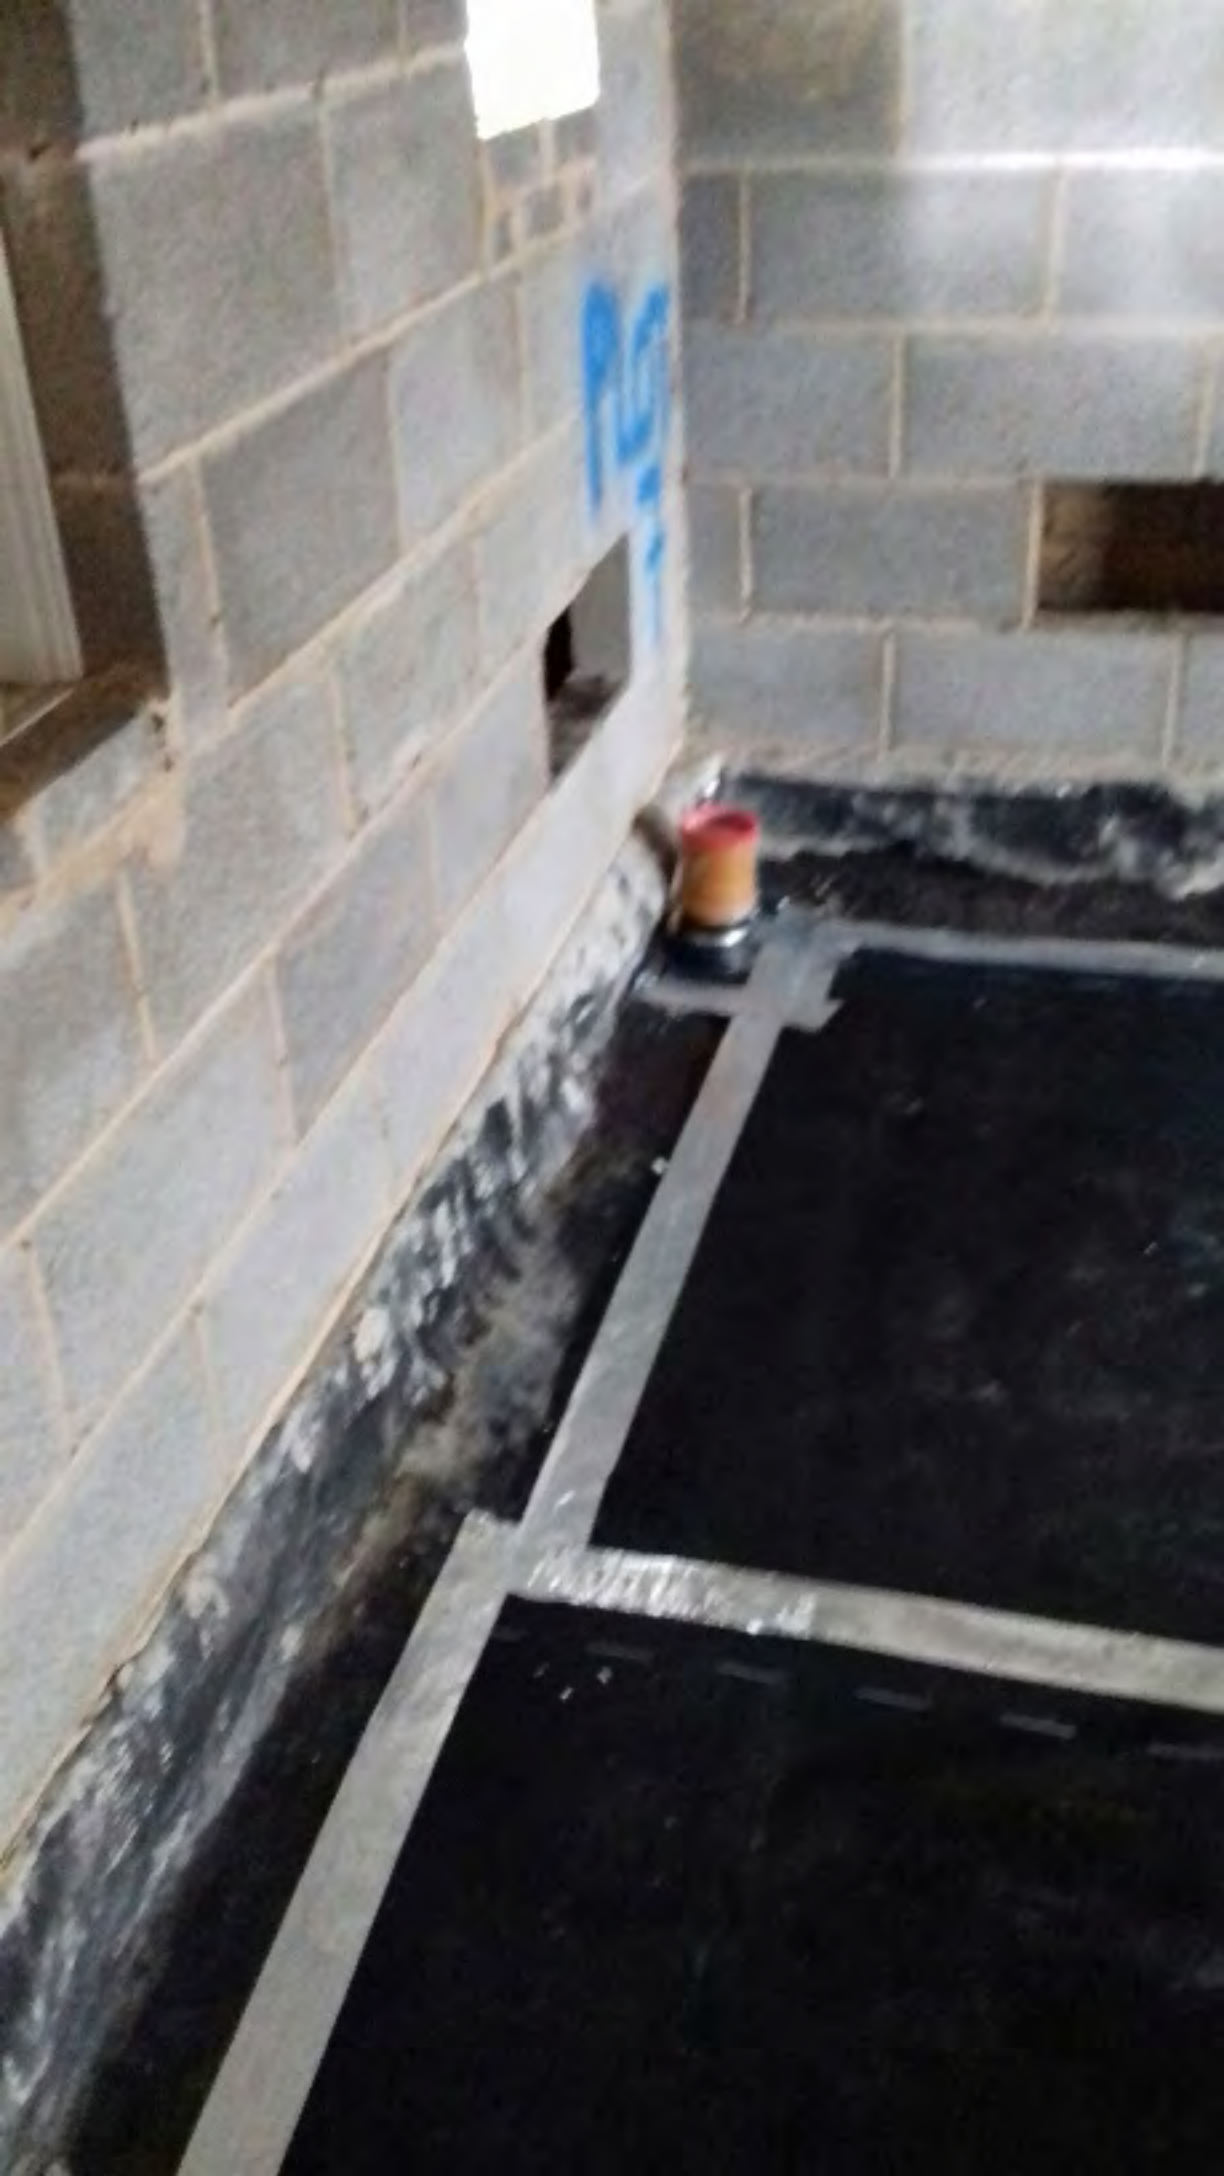
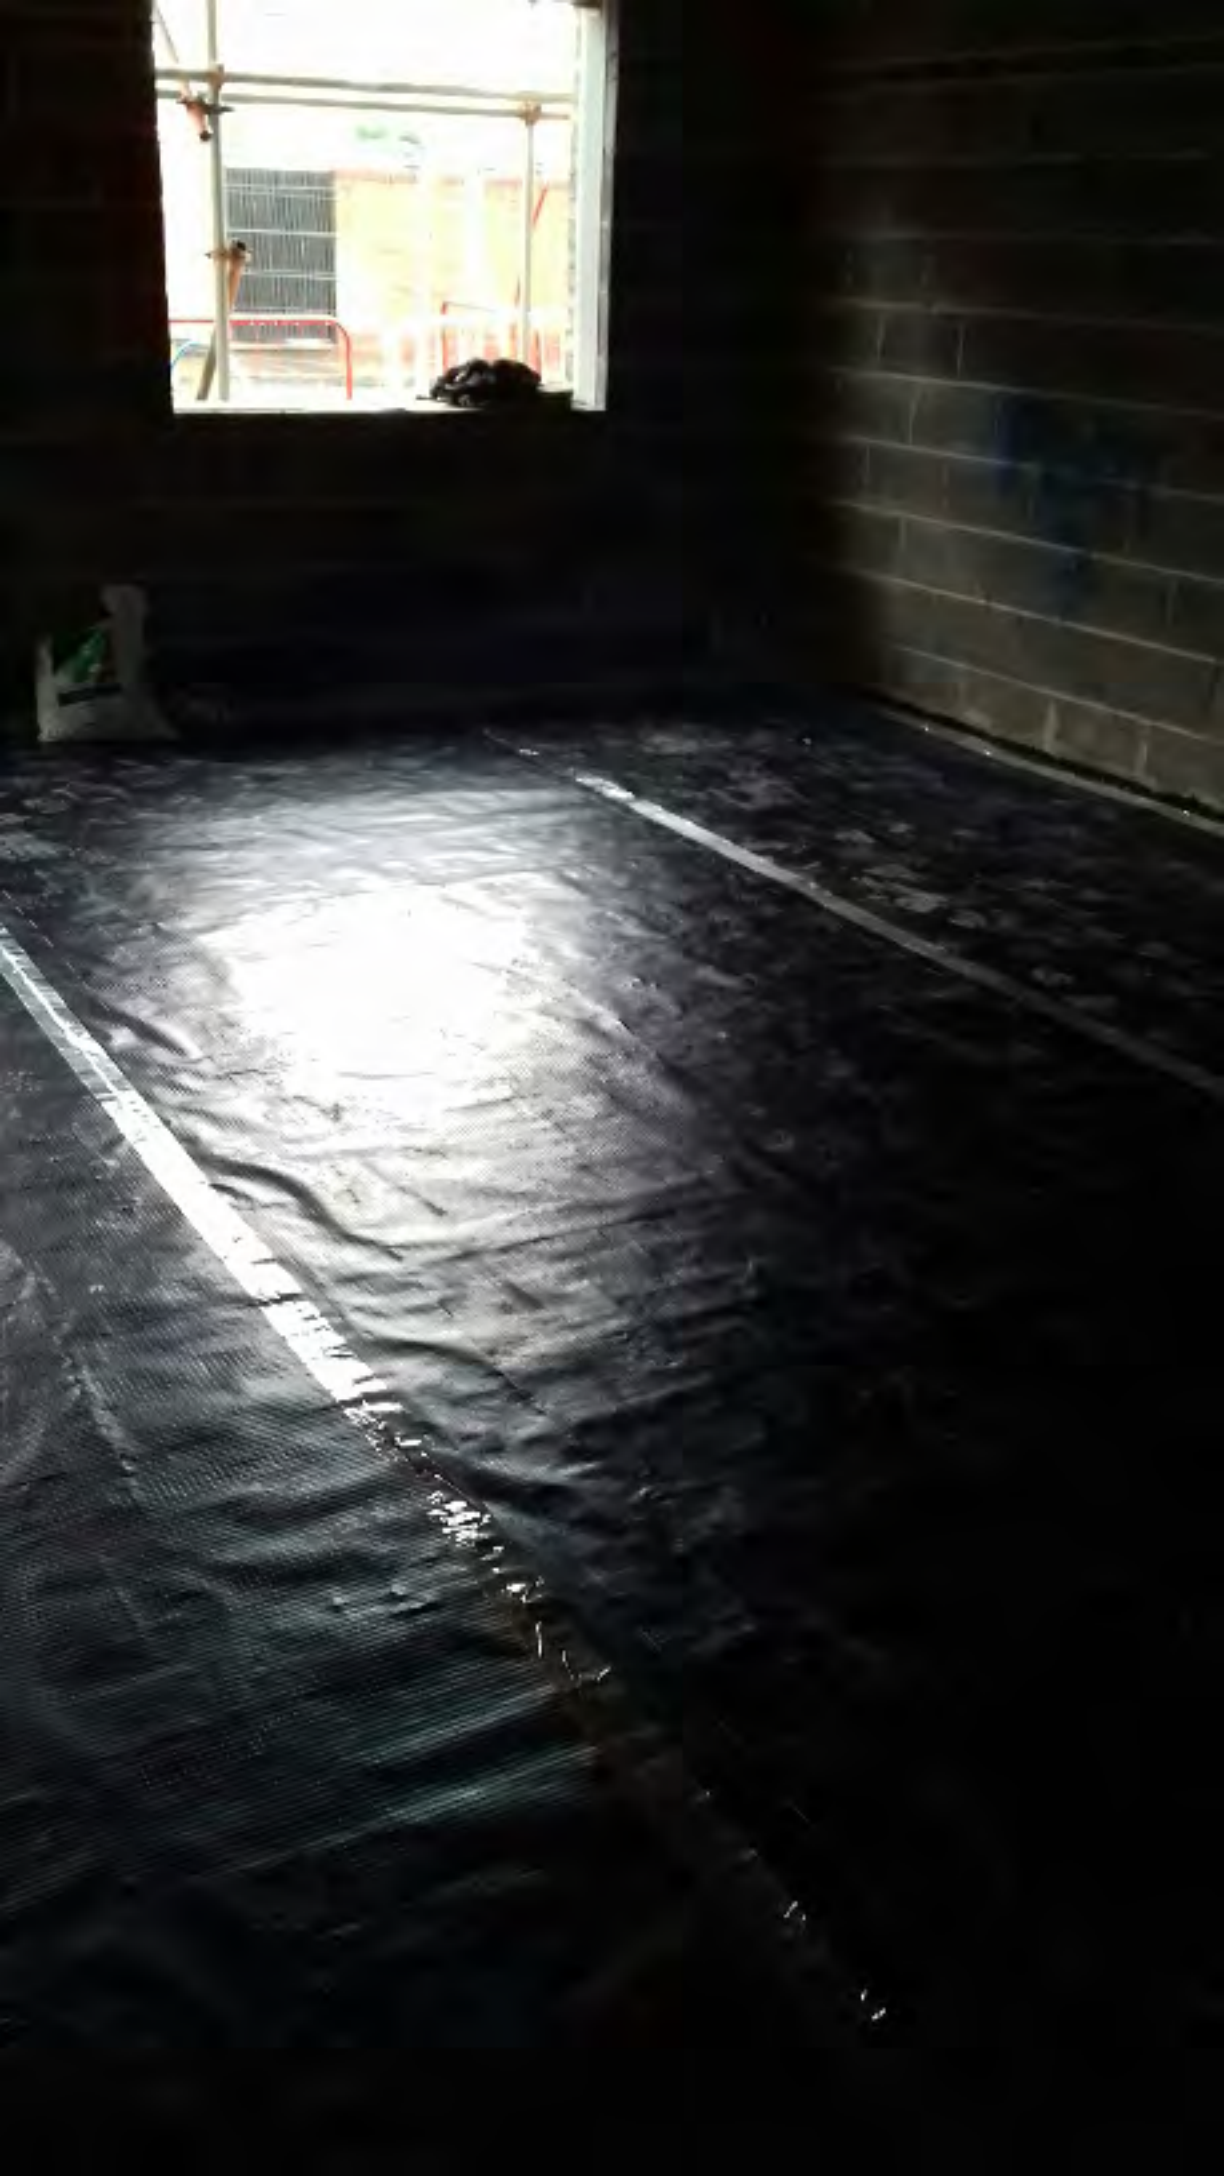
PLOT  
7

| 2.2 | Condition of sub-grade & underside of gas membrane | AMBER 2 MEMBRANE LAID | | | | | |
| 2.4 | Gas membrane condition and coverage | AMBER 2 | | | | | |
| 2.7 | Condition of joints/seals | RADBAR SILVER - ULTRA | | | | | |
| 2.8 | Number and condition of service entry seals | NO CRACKING / LAID FLAT / JOINTS SEALS TIDY | | | | | |
| 2.10 | Repairs or Corrections: | ALL CORNERS SEALED WELL | | | | | |
