**This Record sheet is only applicable to block and beam floor slabs for Characteristic Situation 2 gas protection systems**

**For Residential Development at New Church Street, Radcliffe.**

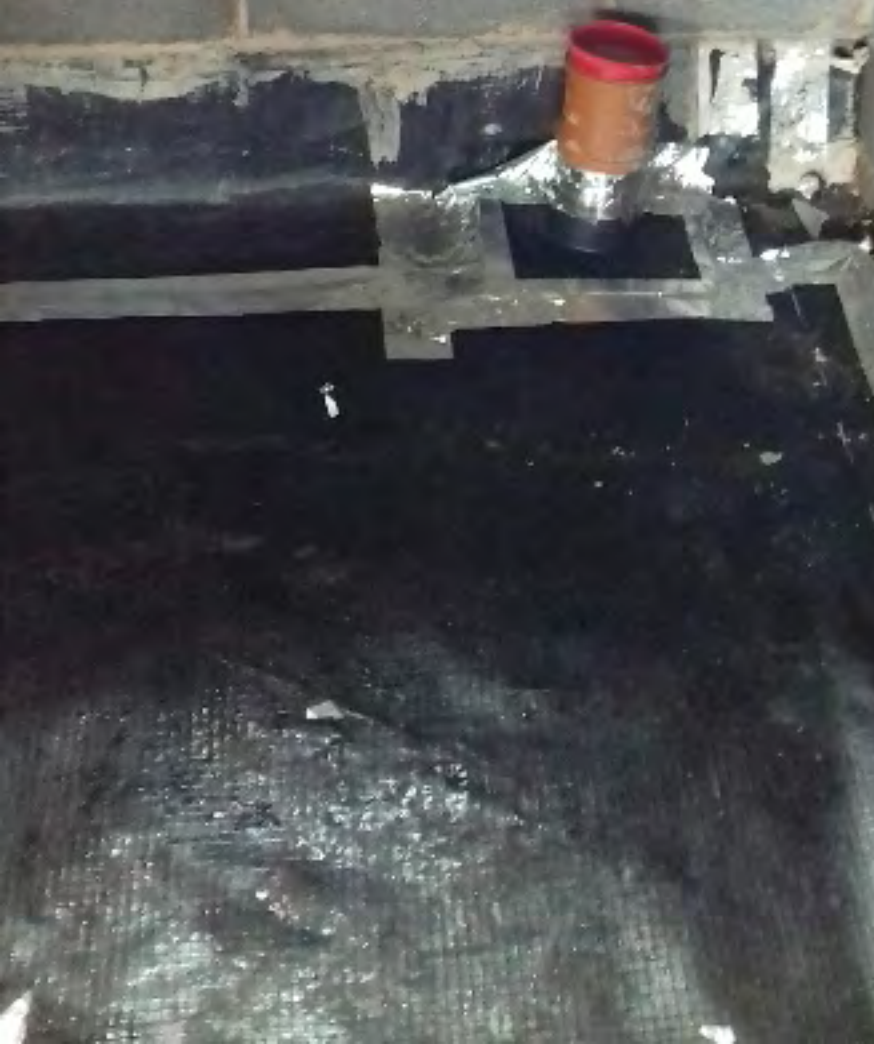
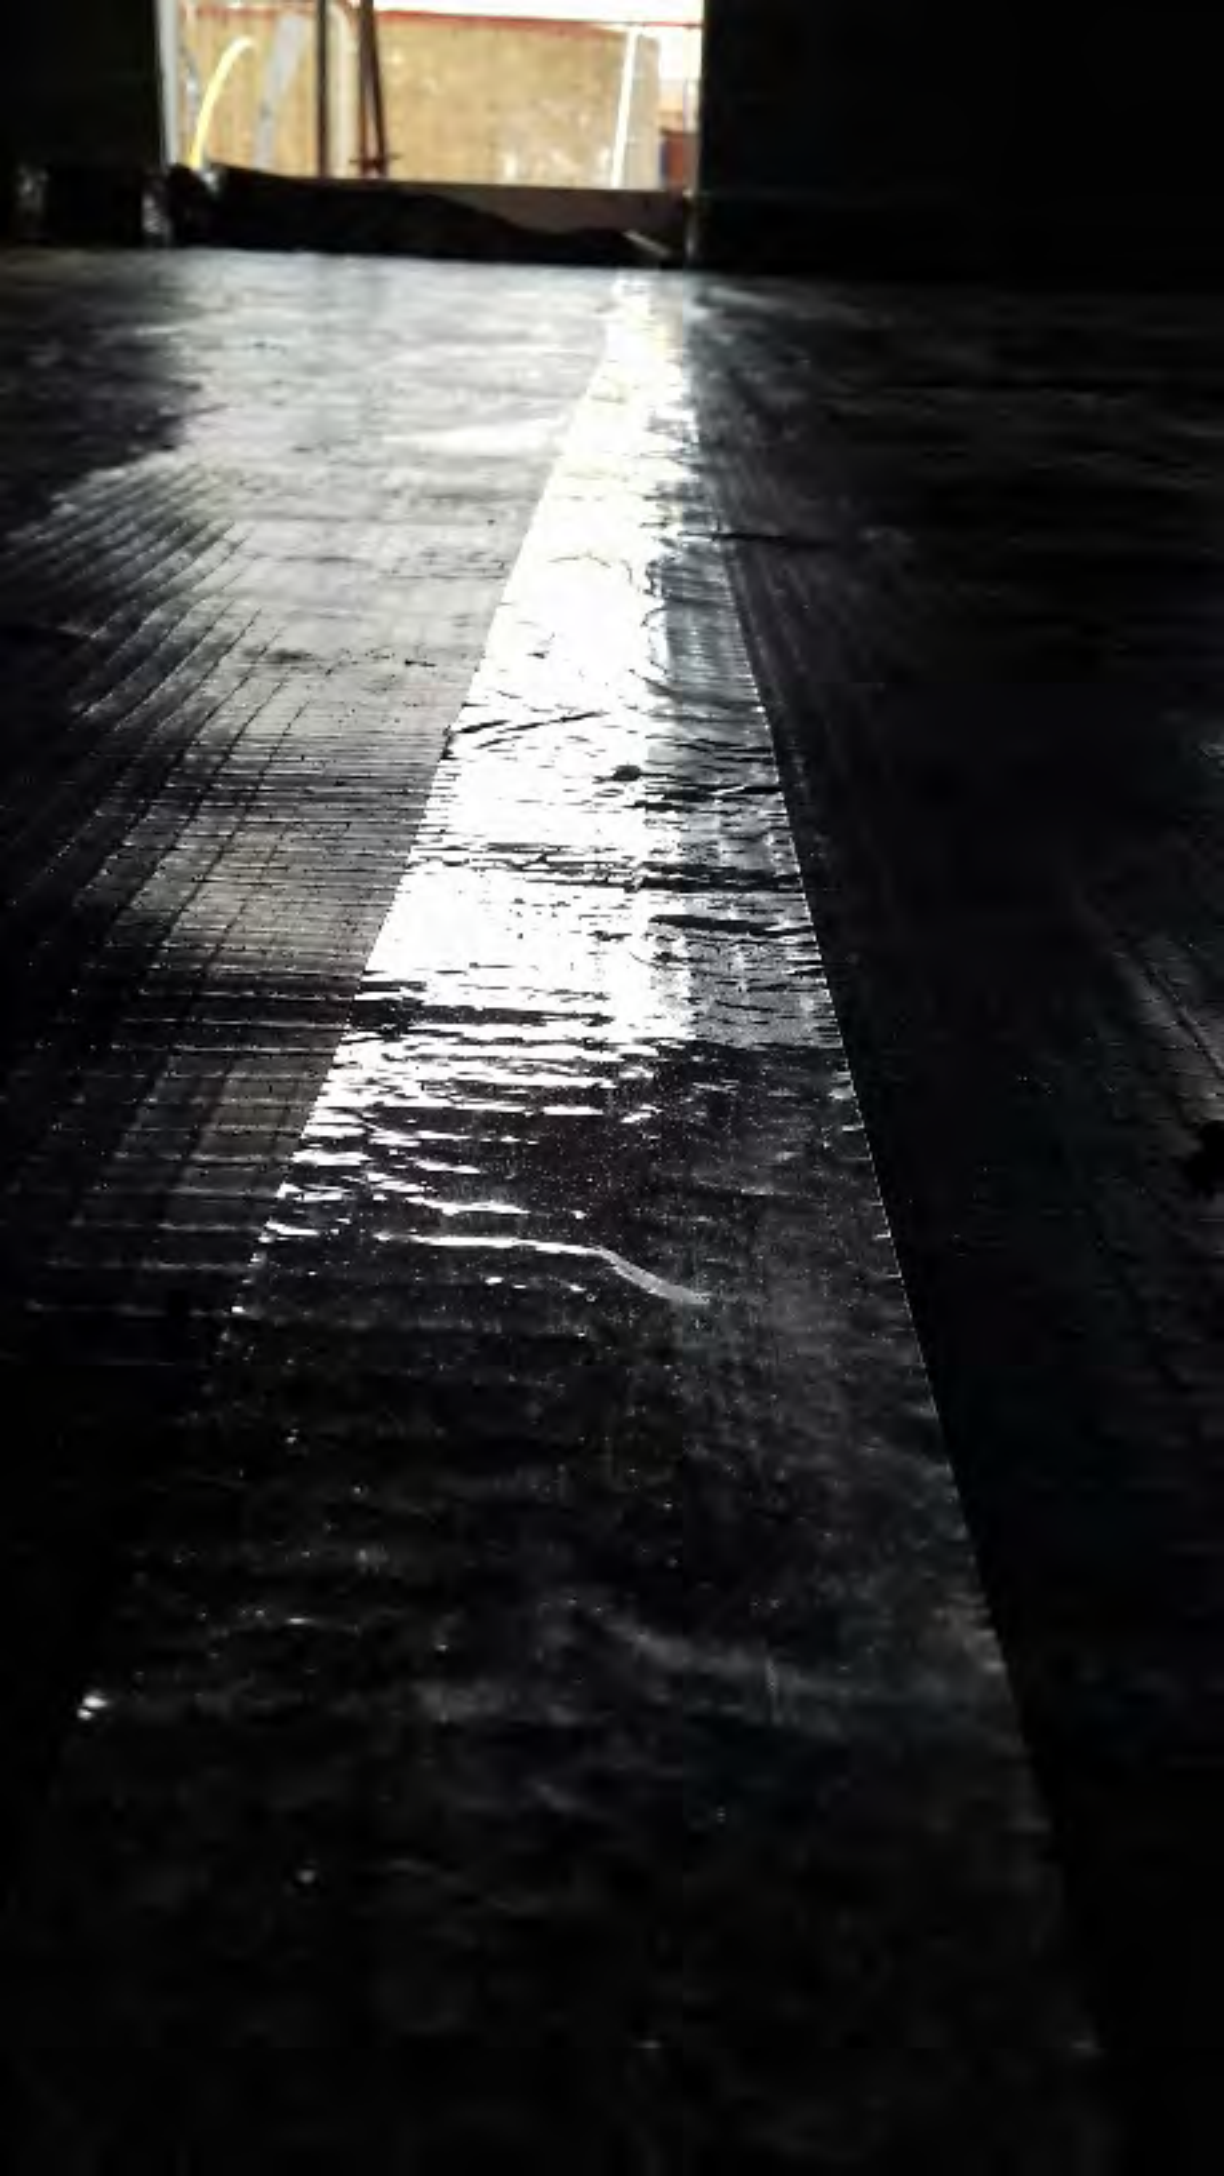
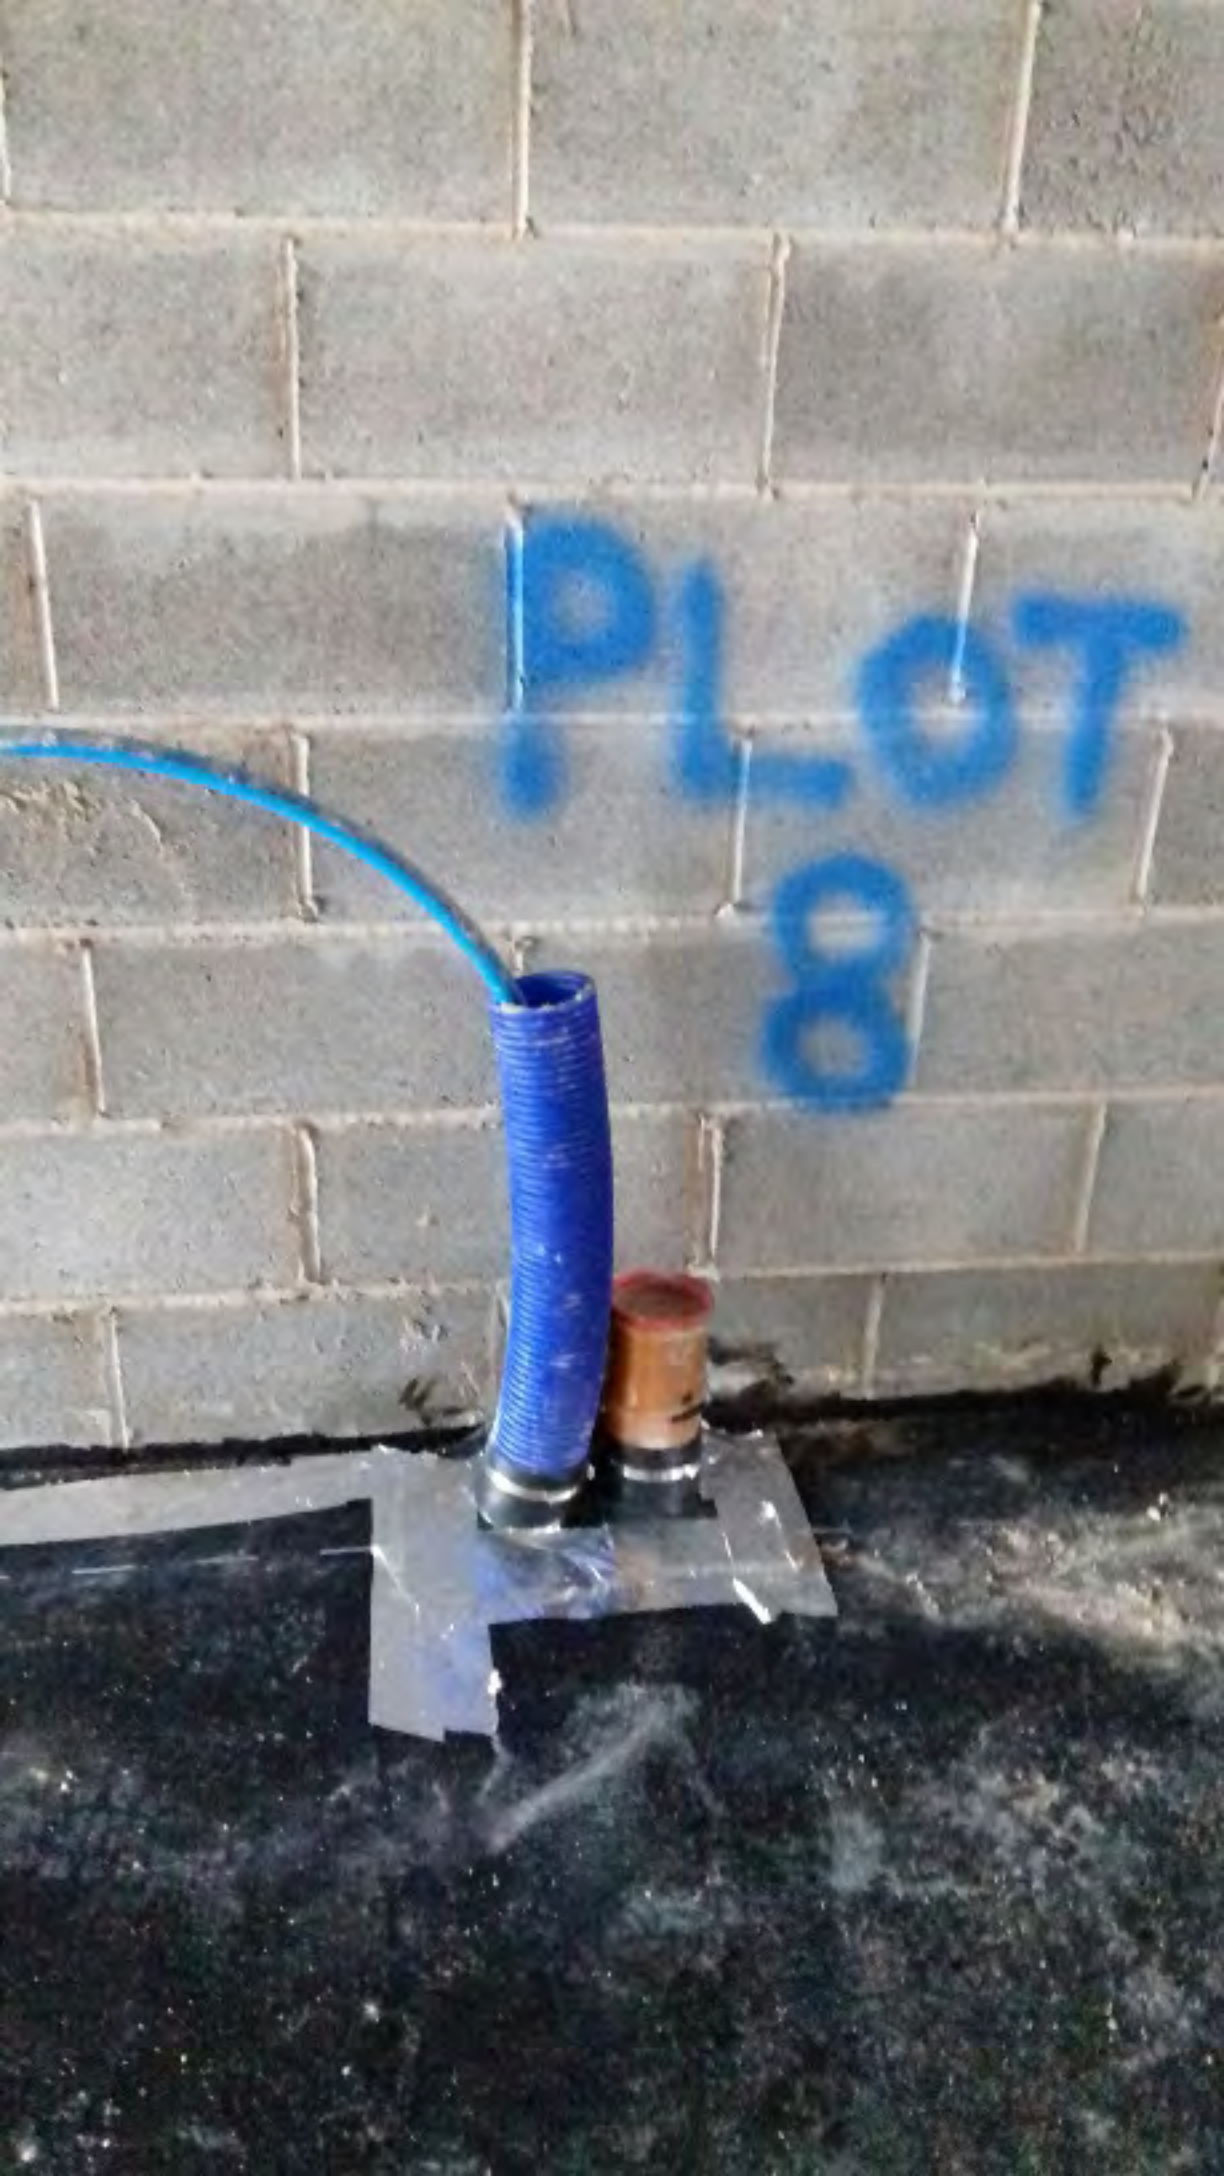
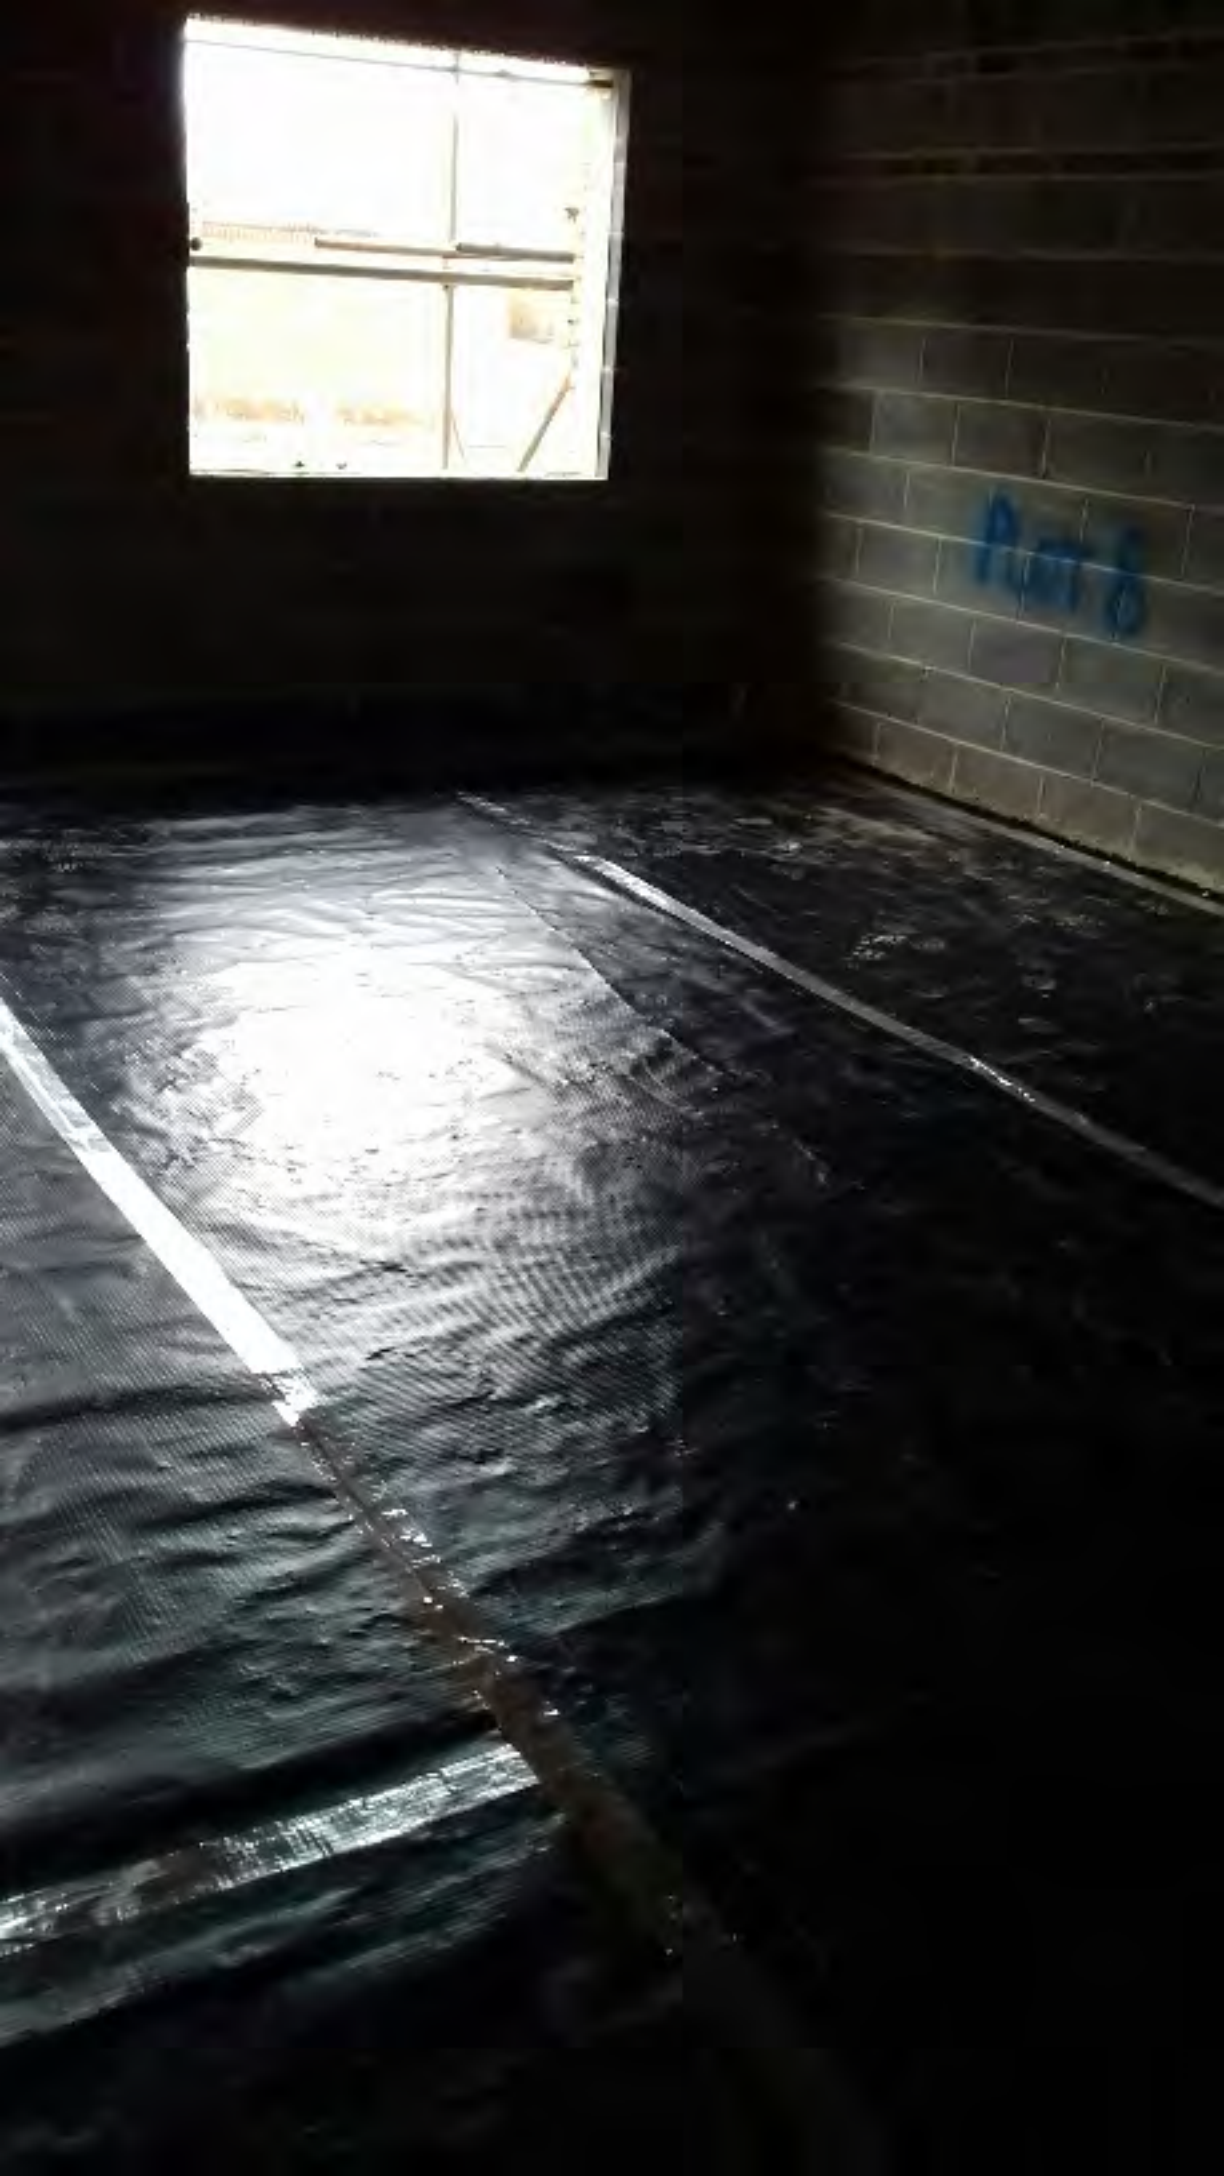
PLOT  
8

| 2.2 | Condition of sub-grade & underside of gas membrane | PLOT SWEEP OUT, FLOOR CLEAR, SCRAPED / LEVEL NO RIPS OR TEARS | | | | | |
| 2.4 | Gas membrane condition and coverage | RADBAR PRIMER APPLIED TO PERIMETER / CLEANED / SEALED TO STAGE 1 | | | | | |
| 2.7 | Condition of joints/seals | NO CREASING / LAID FLAT / JOINTS SEALS TIDY | | | | | |
| 2.8 | Number and condition of service entry seals | 3 NO WITH TOP HATS | | | | | |
| 2.10 | Repairs or Corrections: | NONE | | | | | |

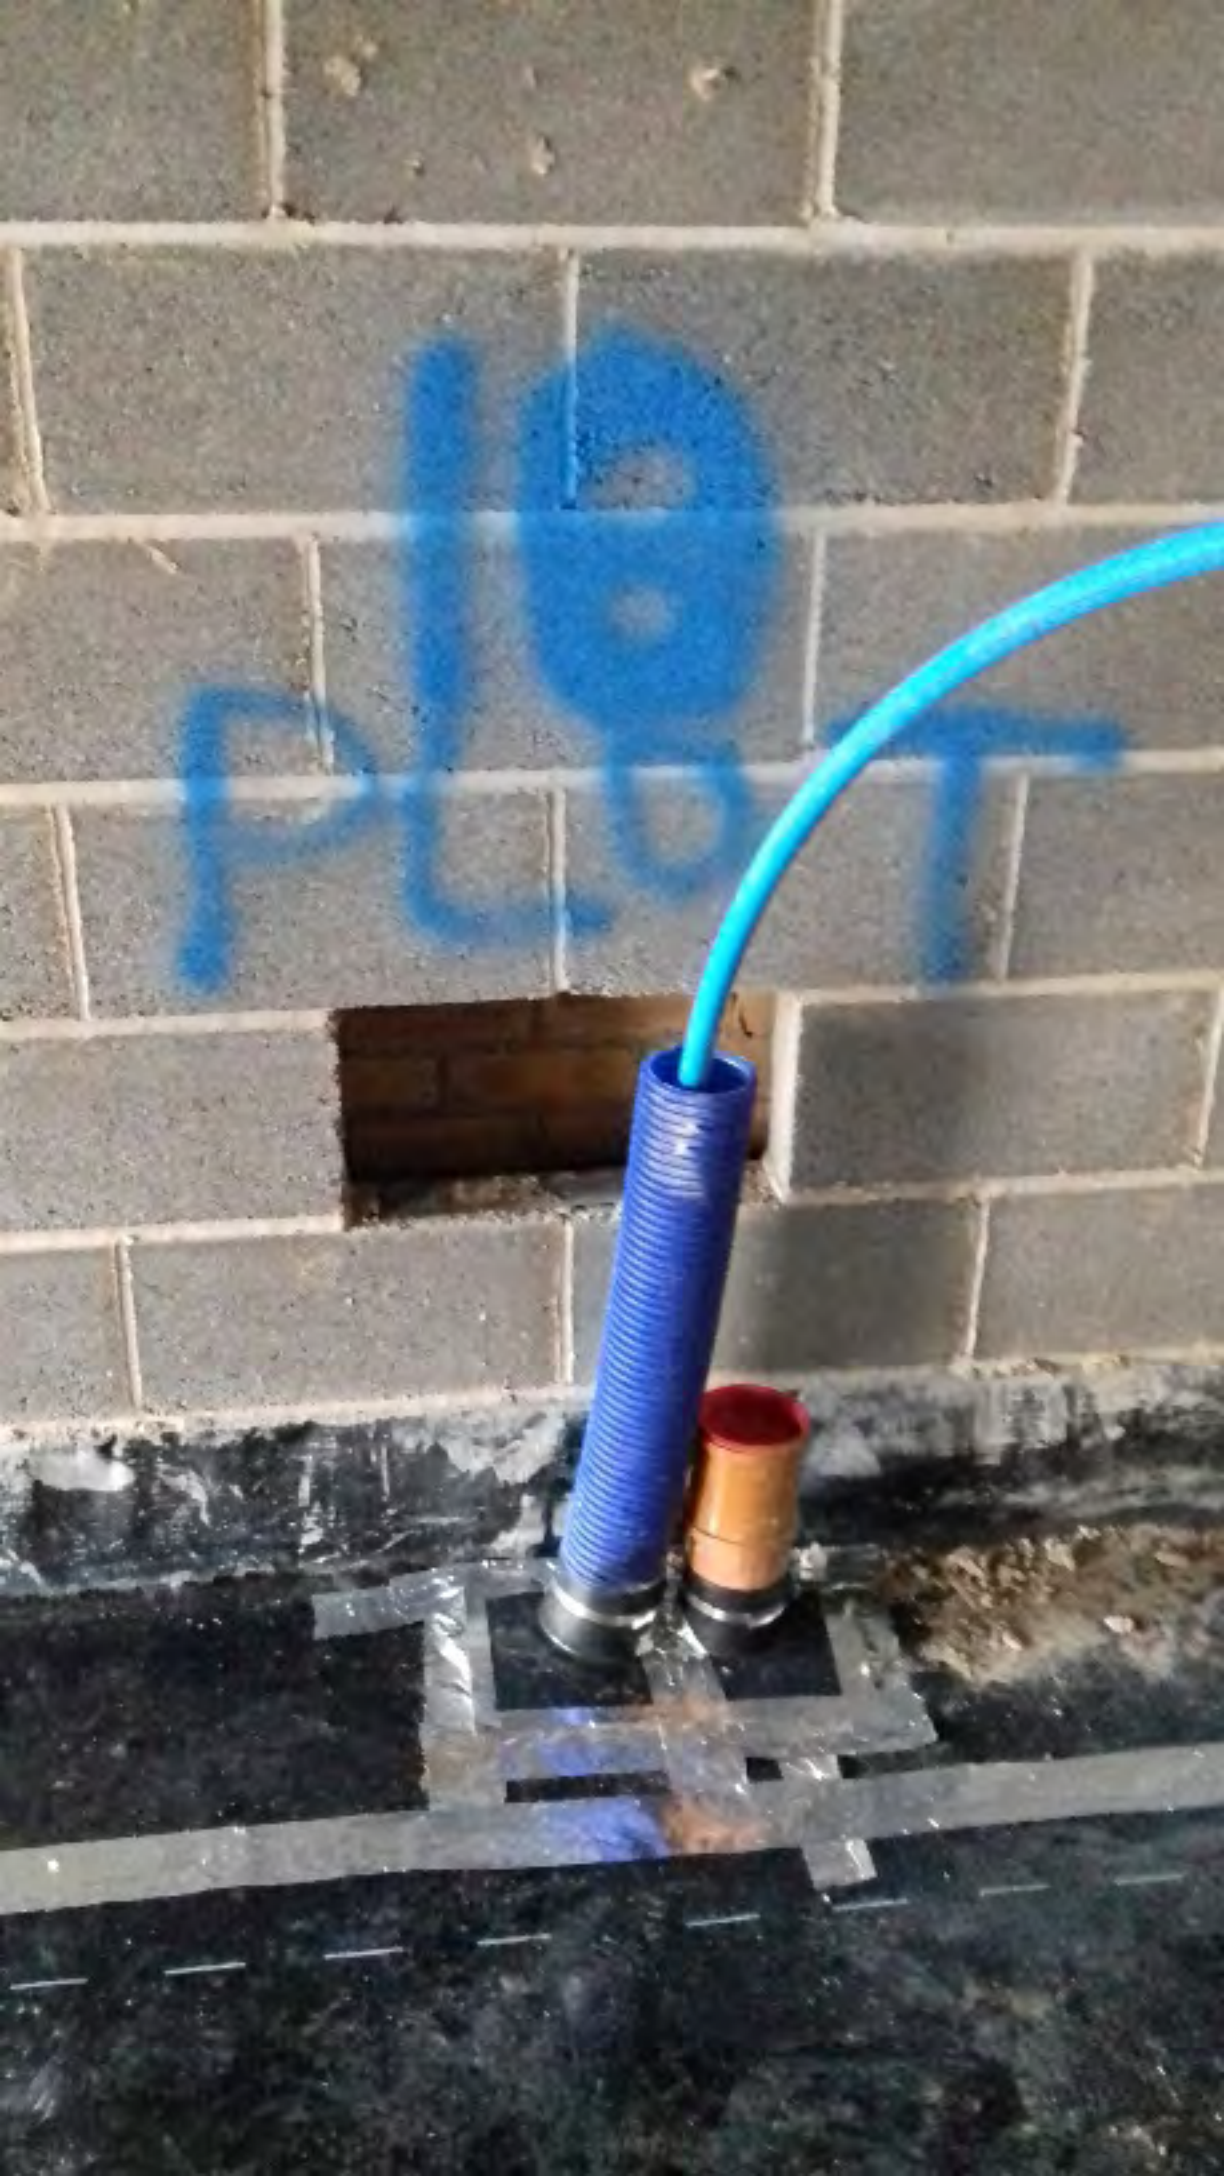
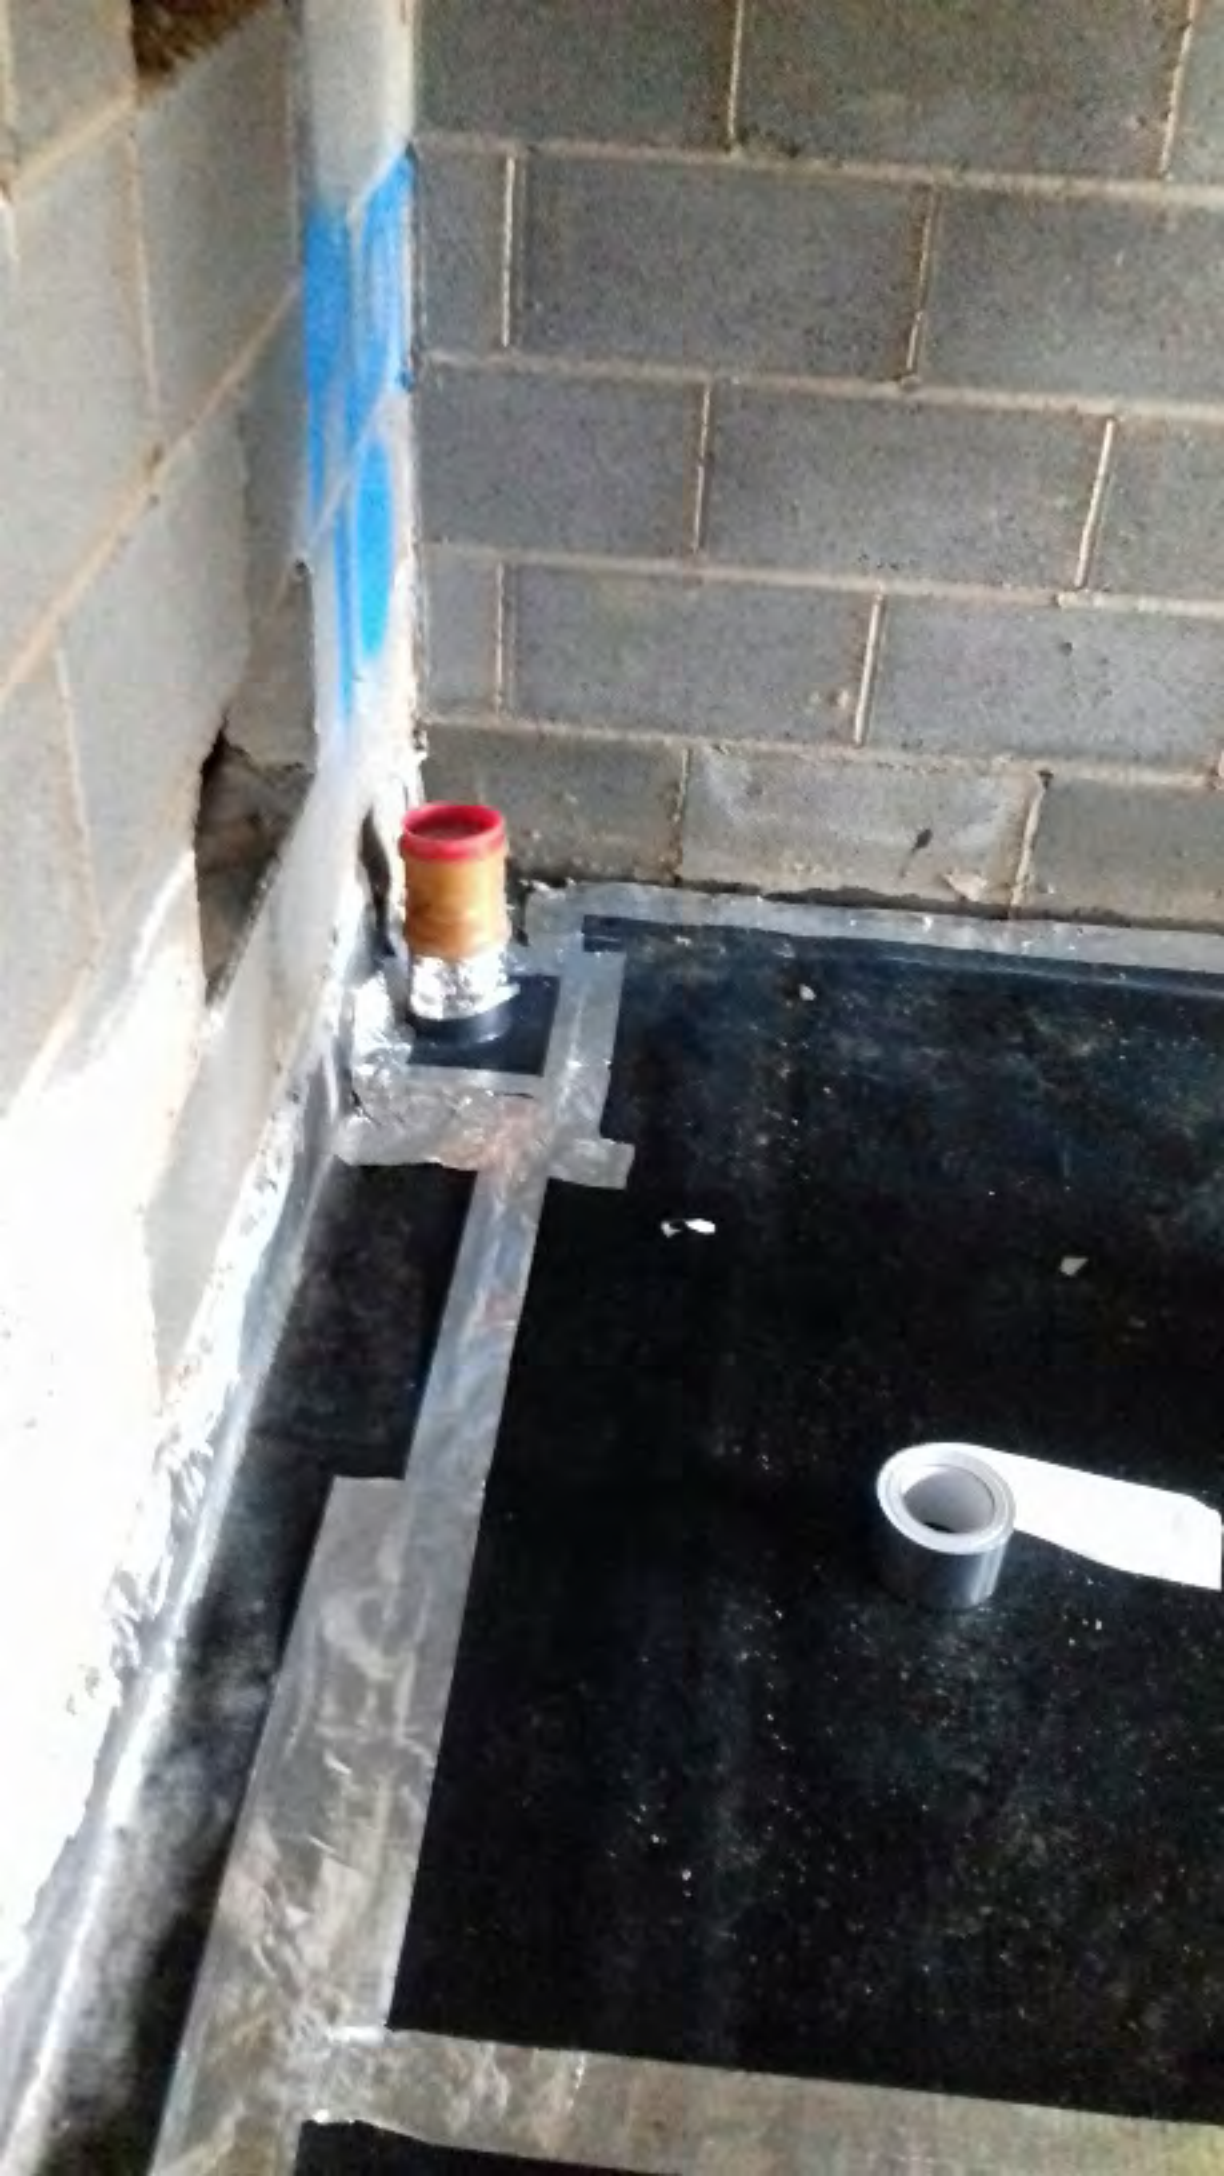
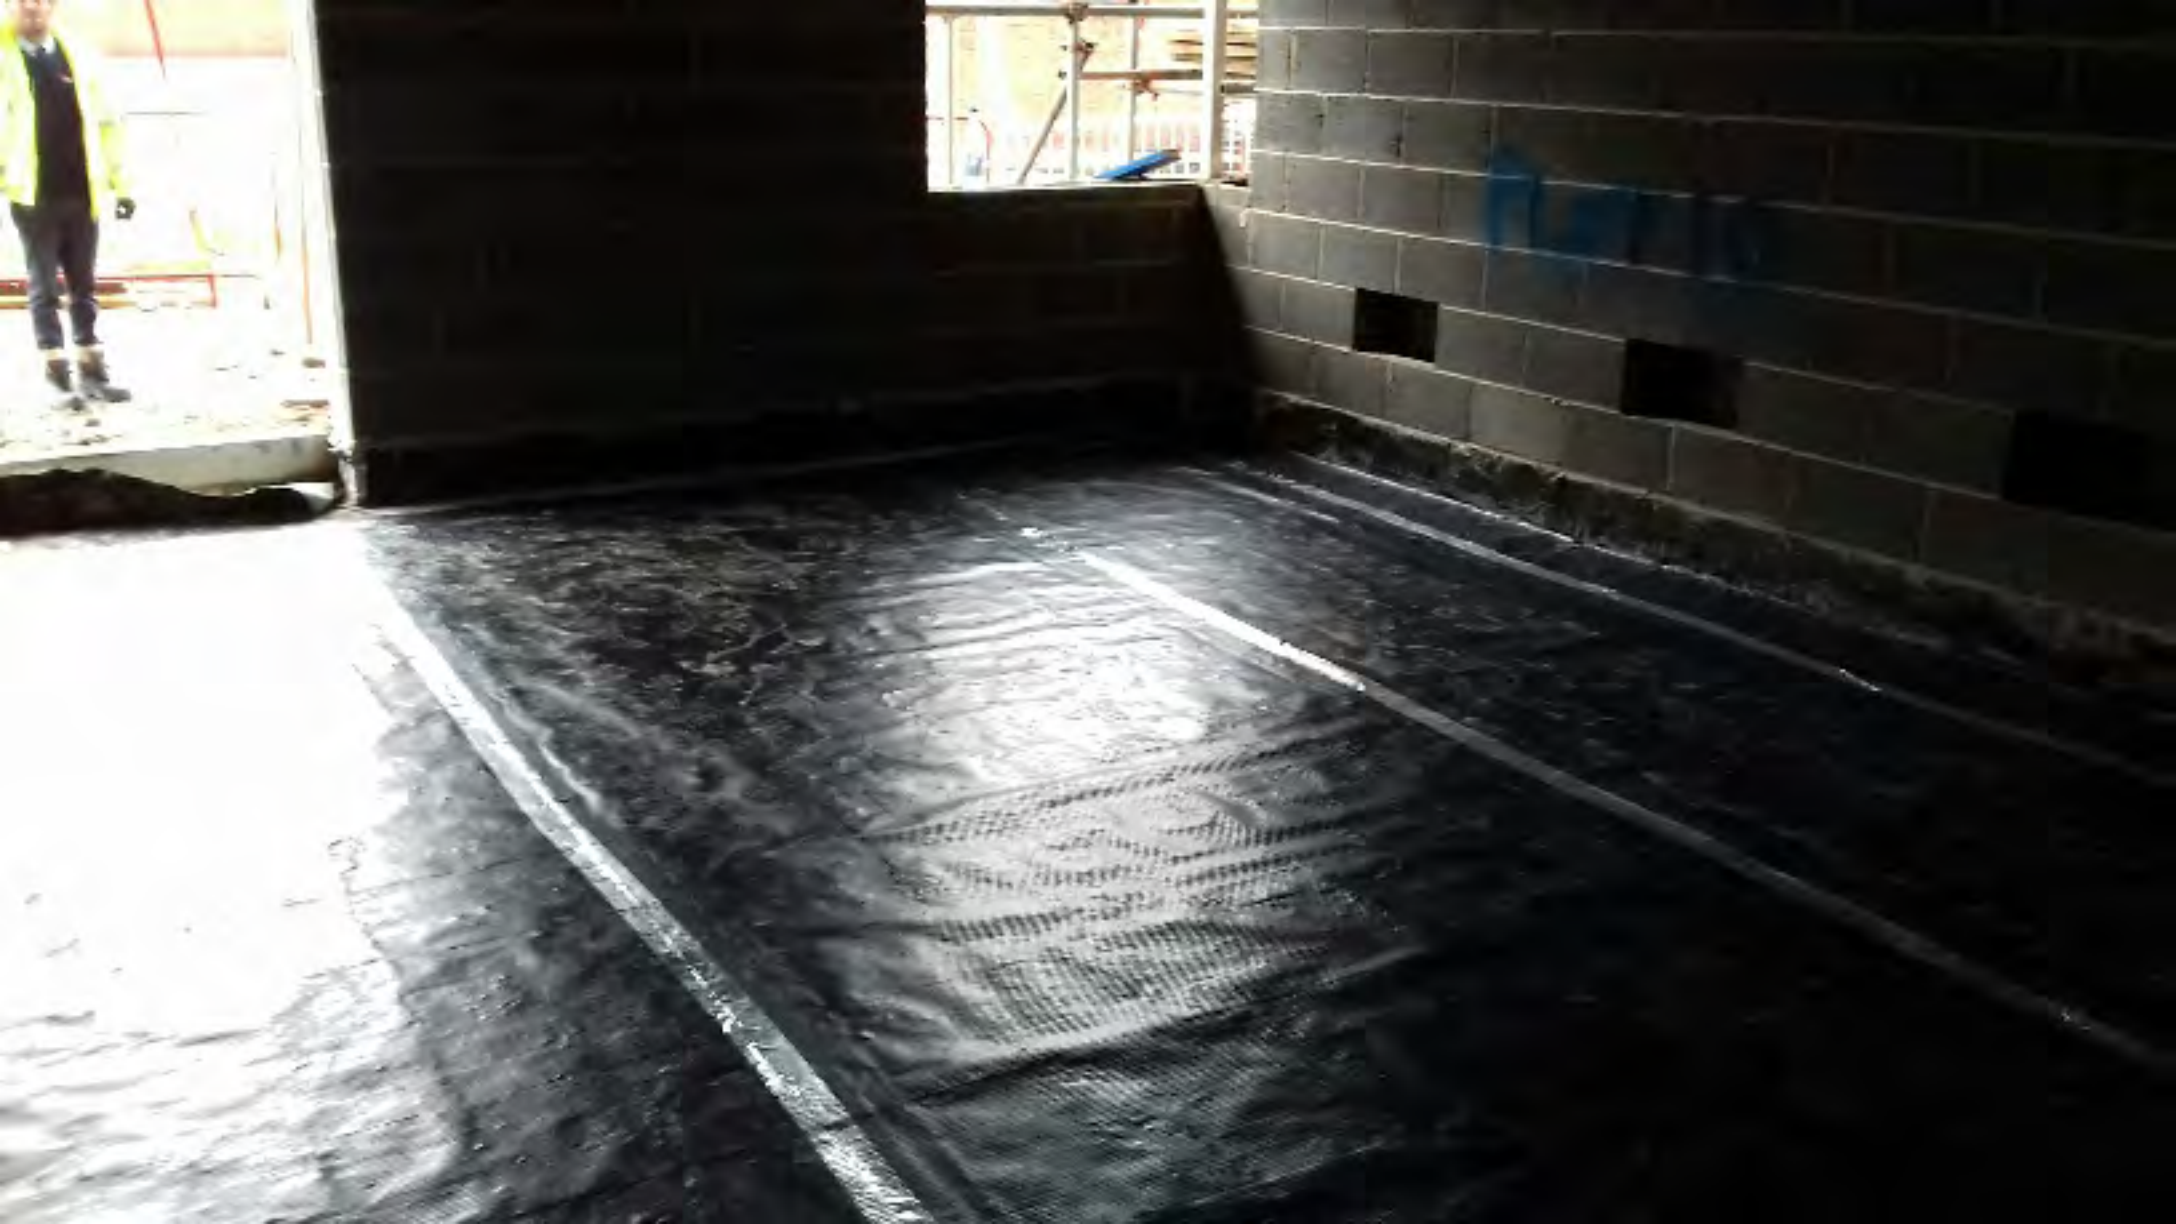
PLOT  
10

| 2.2 | Condition of sub-grade & underside of gas membrane | Plot swept, Floor scraped, Floor flat & level, no Rips & tears visible | | | | | |
| 2.4 | Gas membrane condition and coverage | Primer applied to perimeter + membrane checked. Sealed to stage 1 against cavity | | | | | |
| 2.7 | Condition of joints/seals | No cracking membrane laid flat, joints & seals all tidy | | | | | |

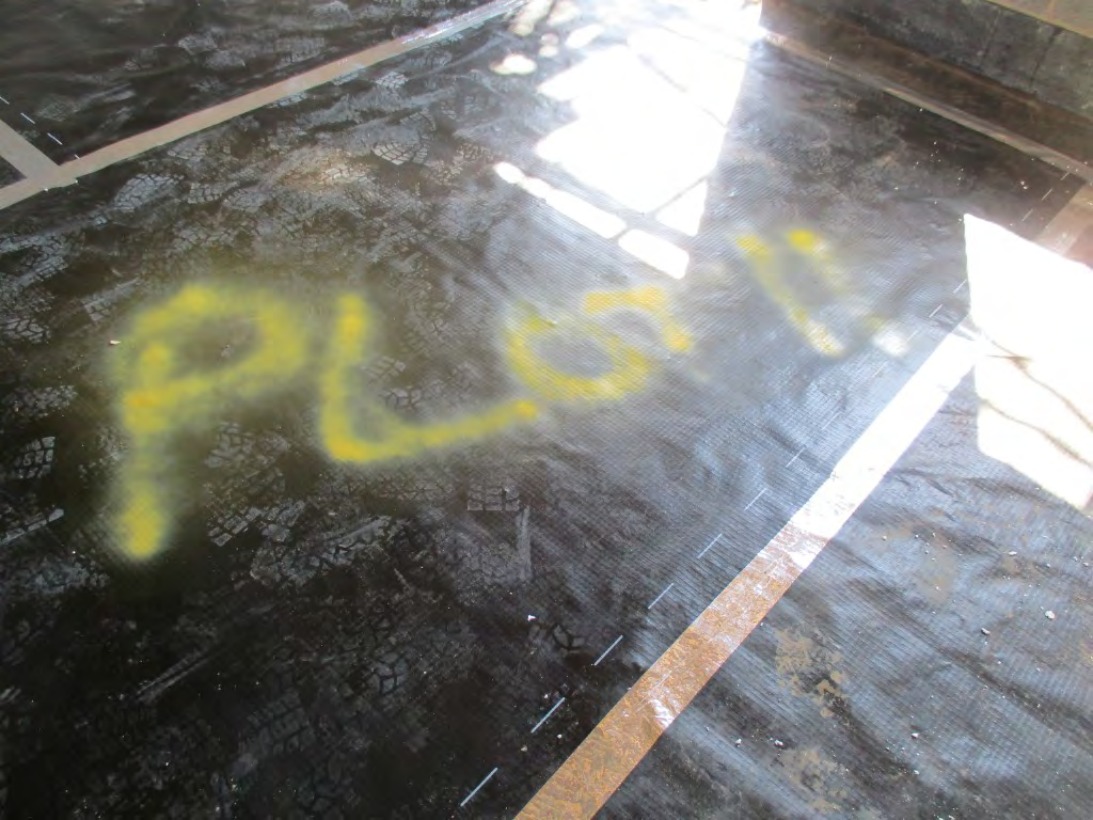
PLOT 11

Tophat repair inspected by Coopers, in addition to inspection carried out on site by Kier Living. Photograph dated 1st August 2017.
