**This Record sheet is only applicable to block and beam floor slabs for Characteristic Situation 2 gas protection systems**

**For Residential Development at New Church Street, Radcliffe.**

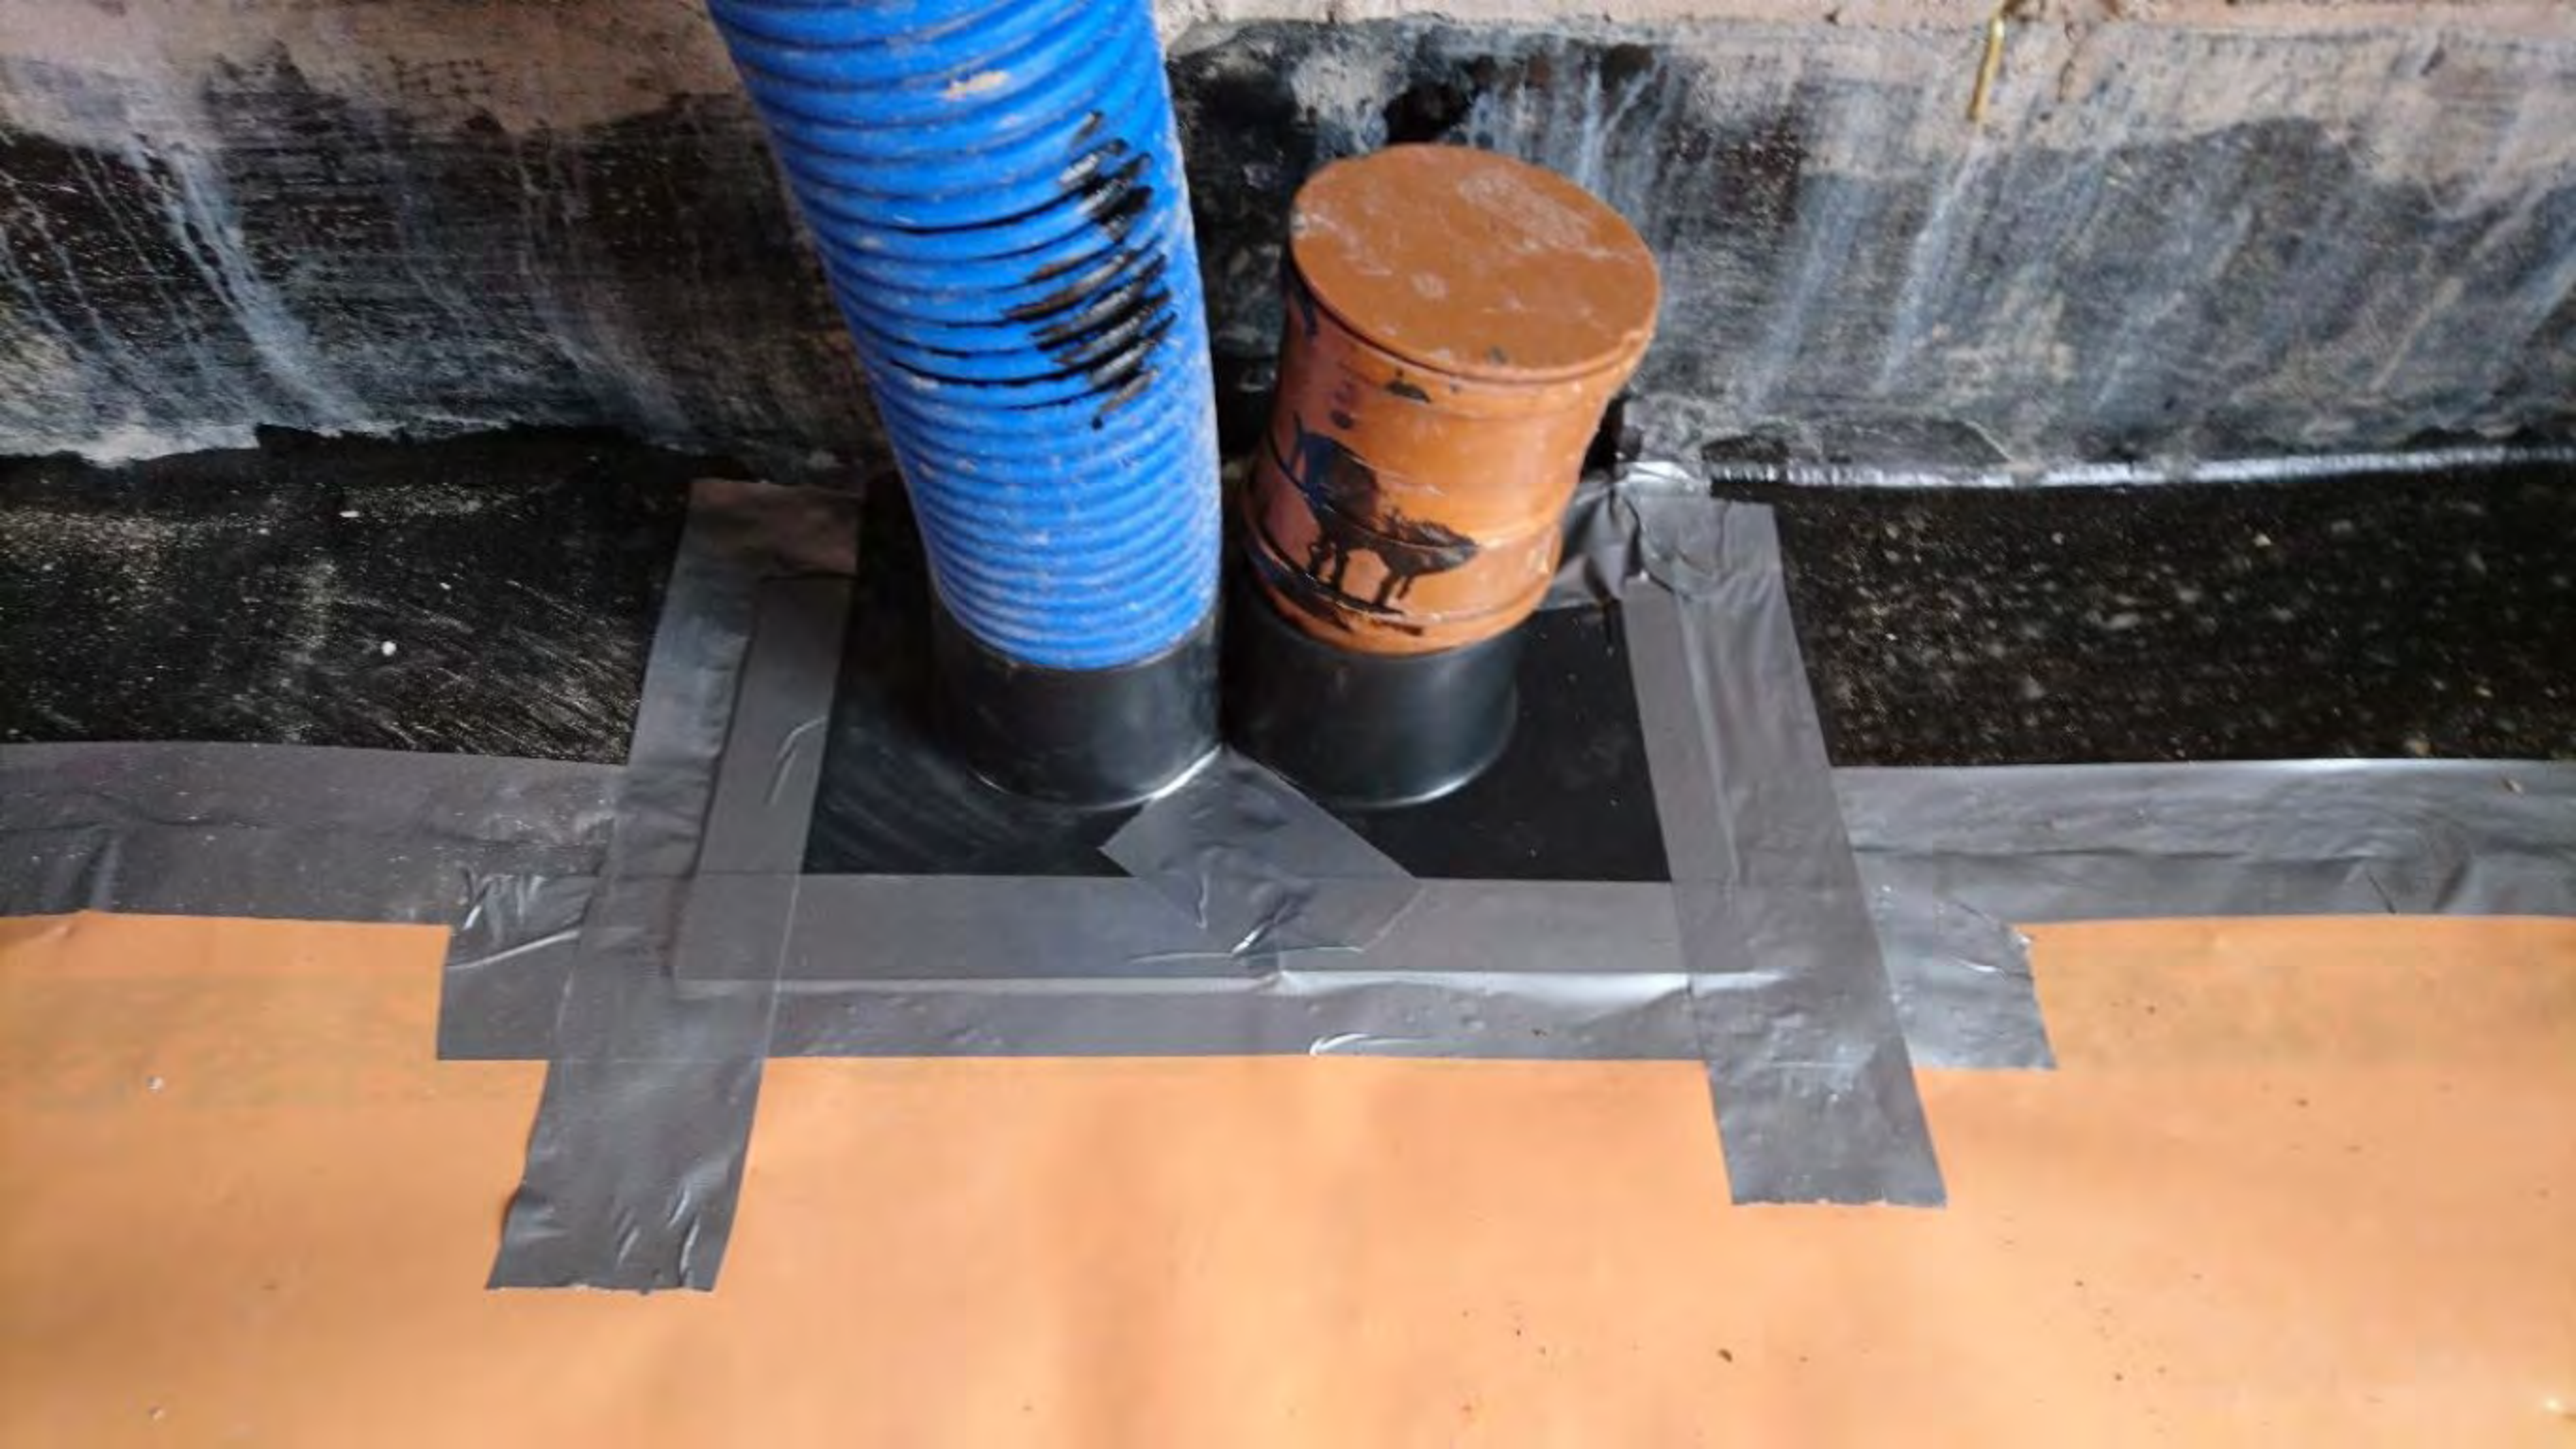
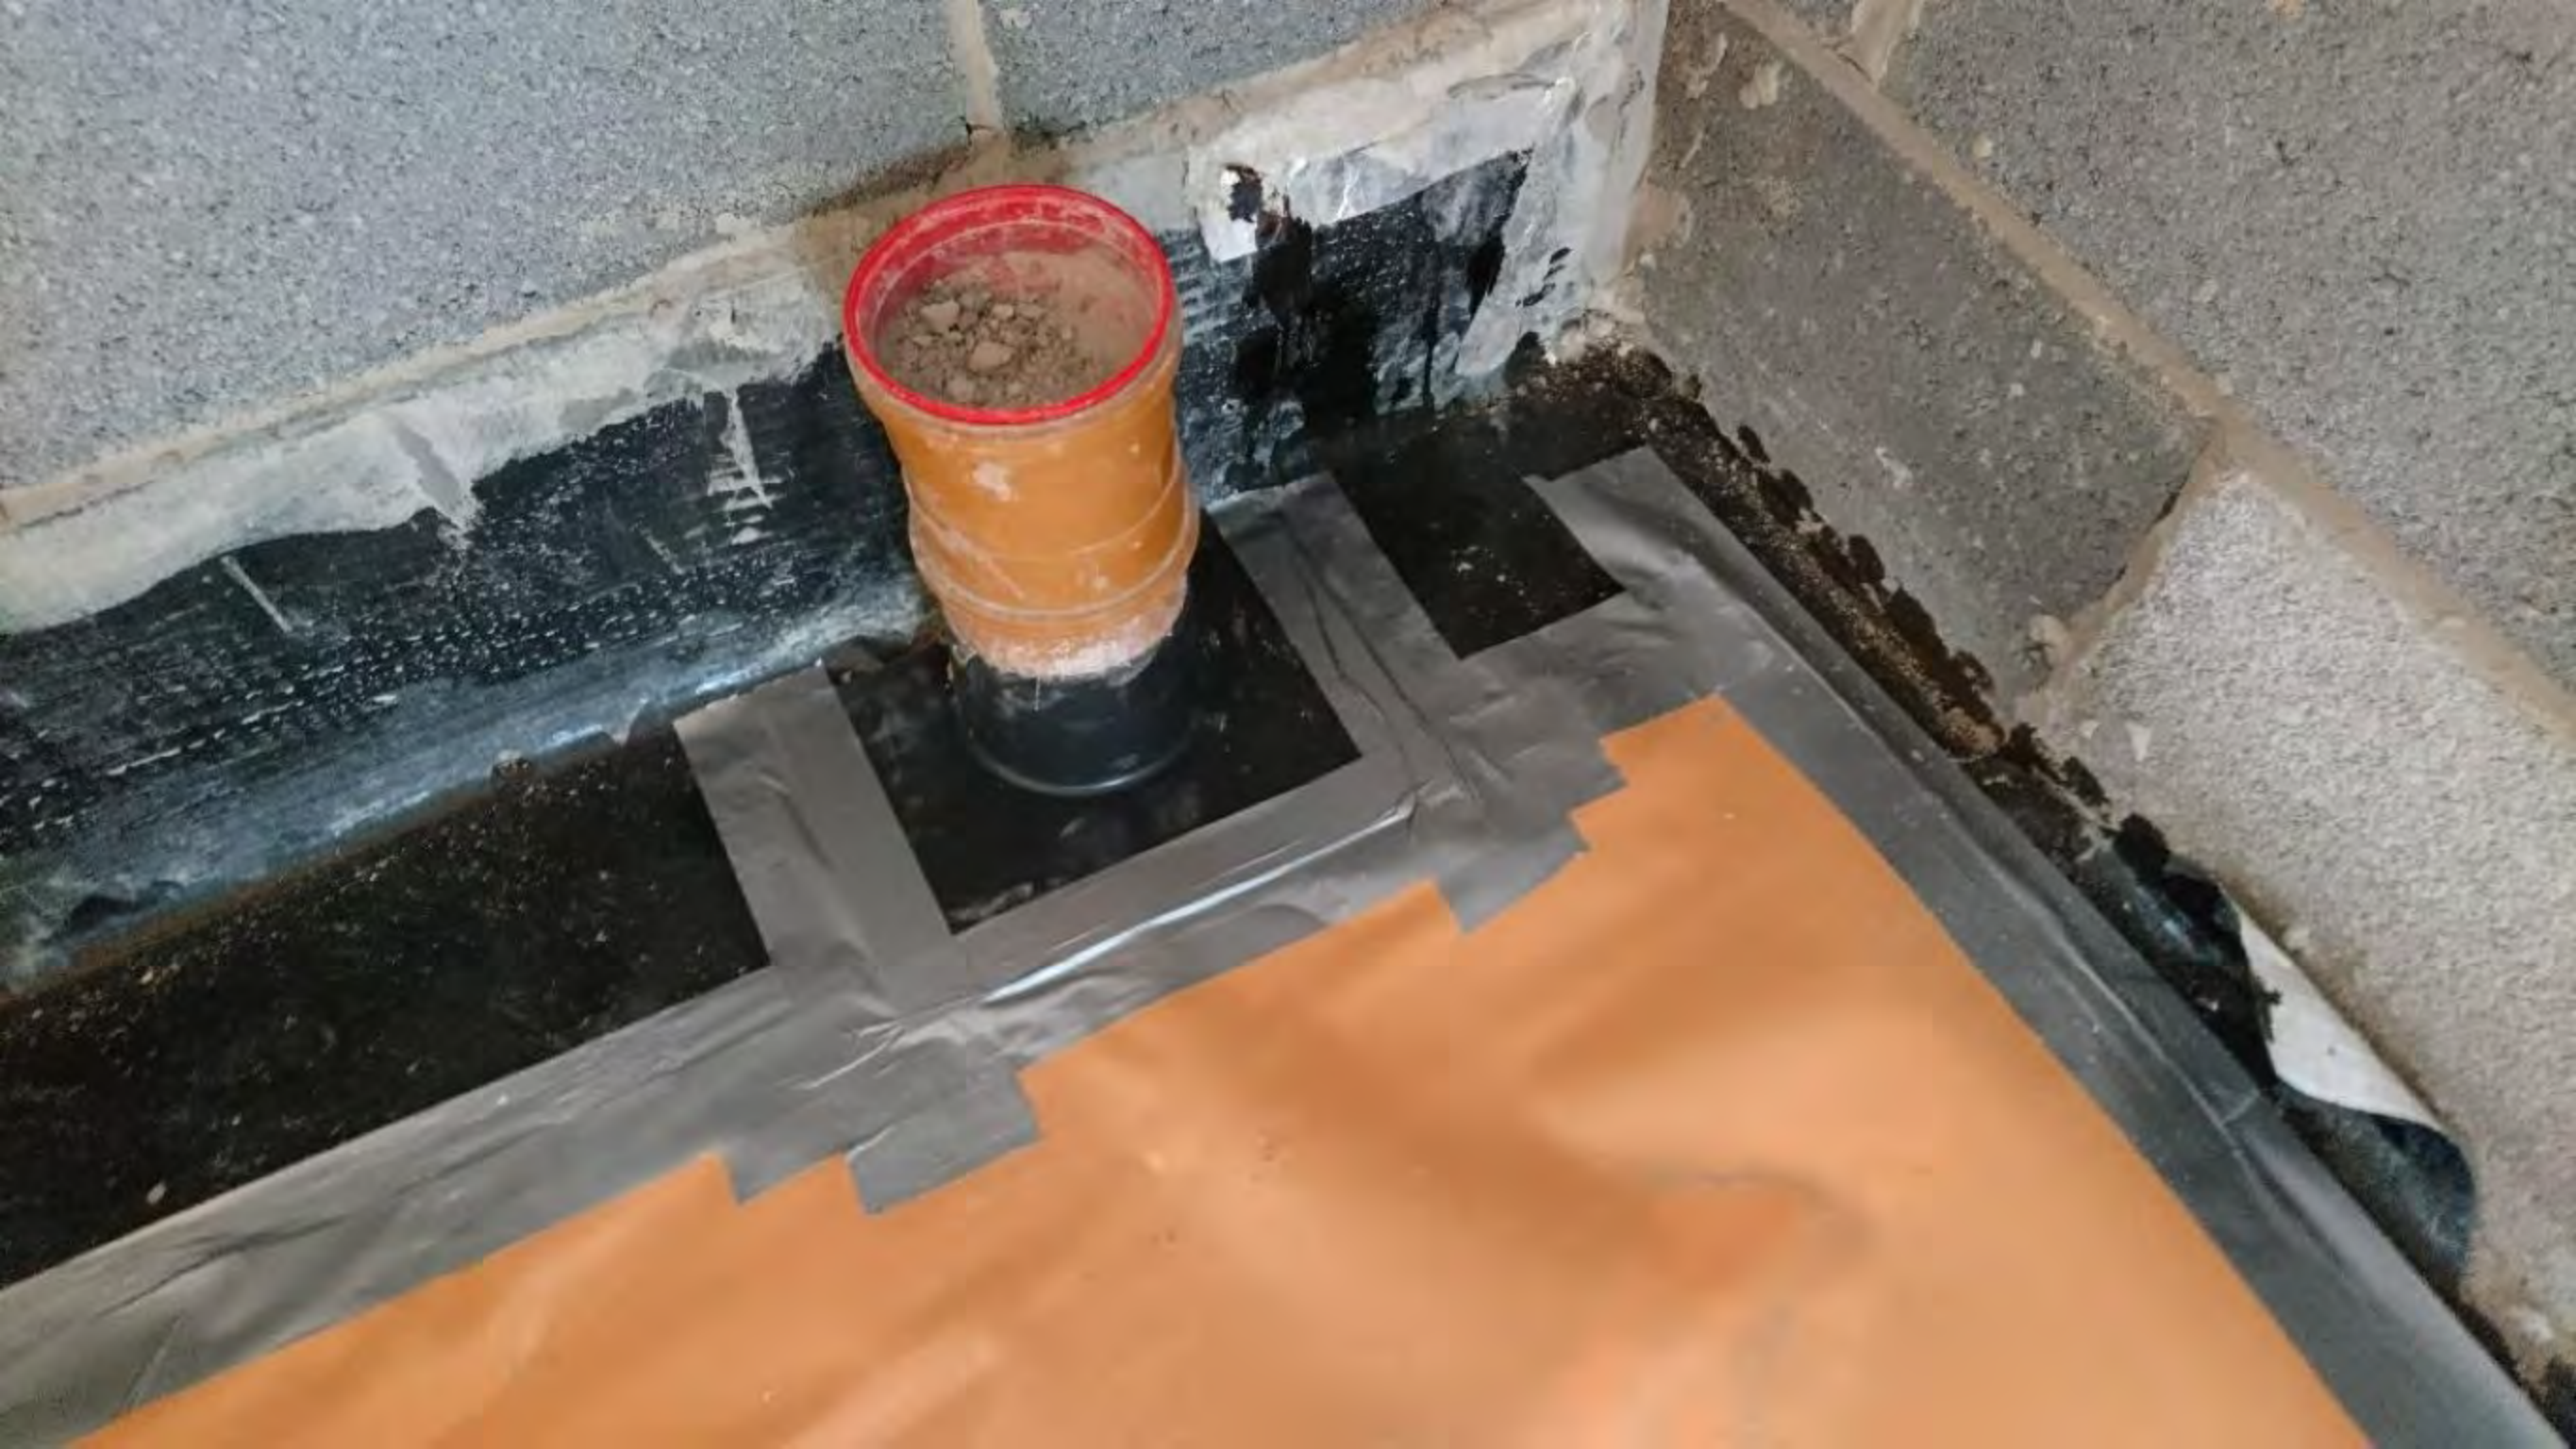
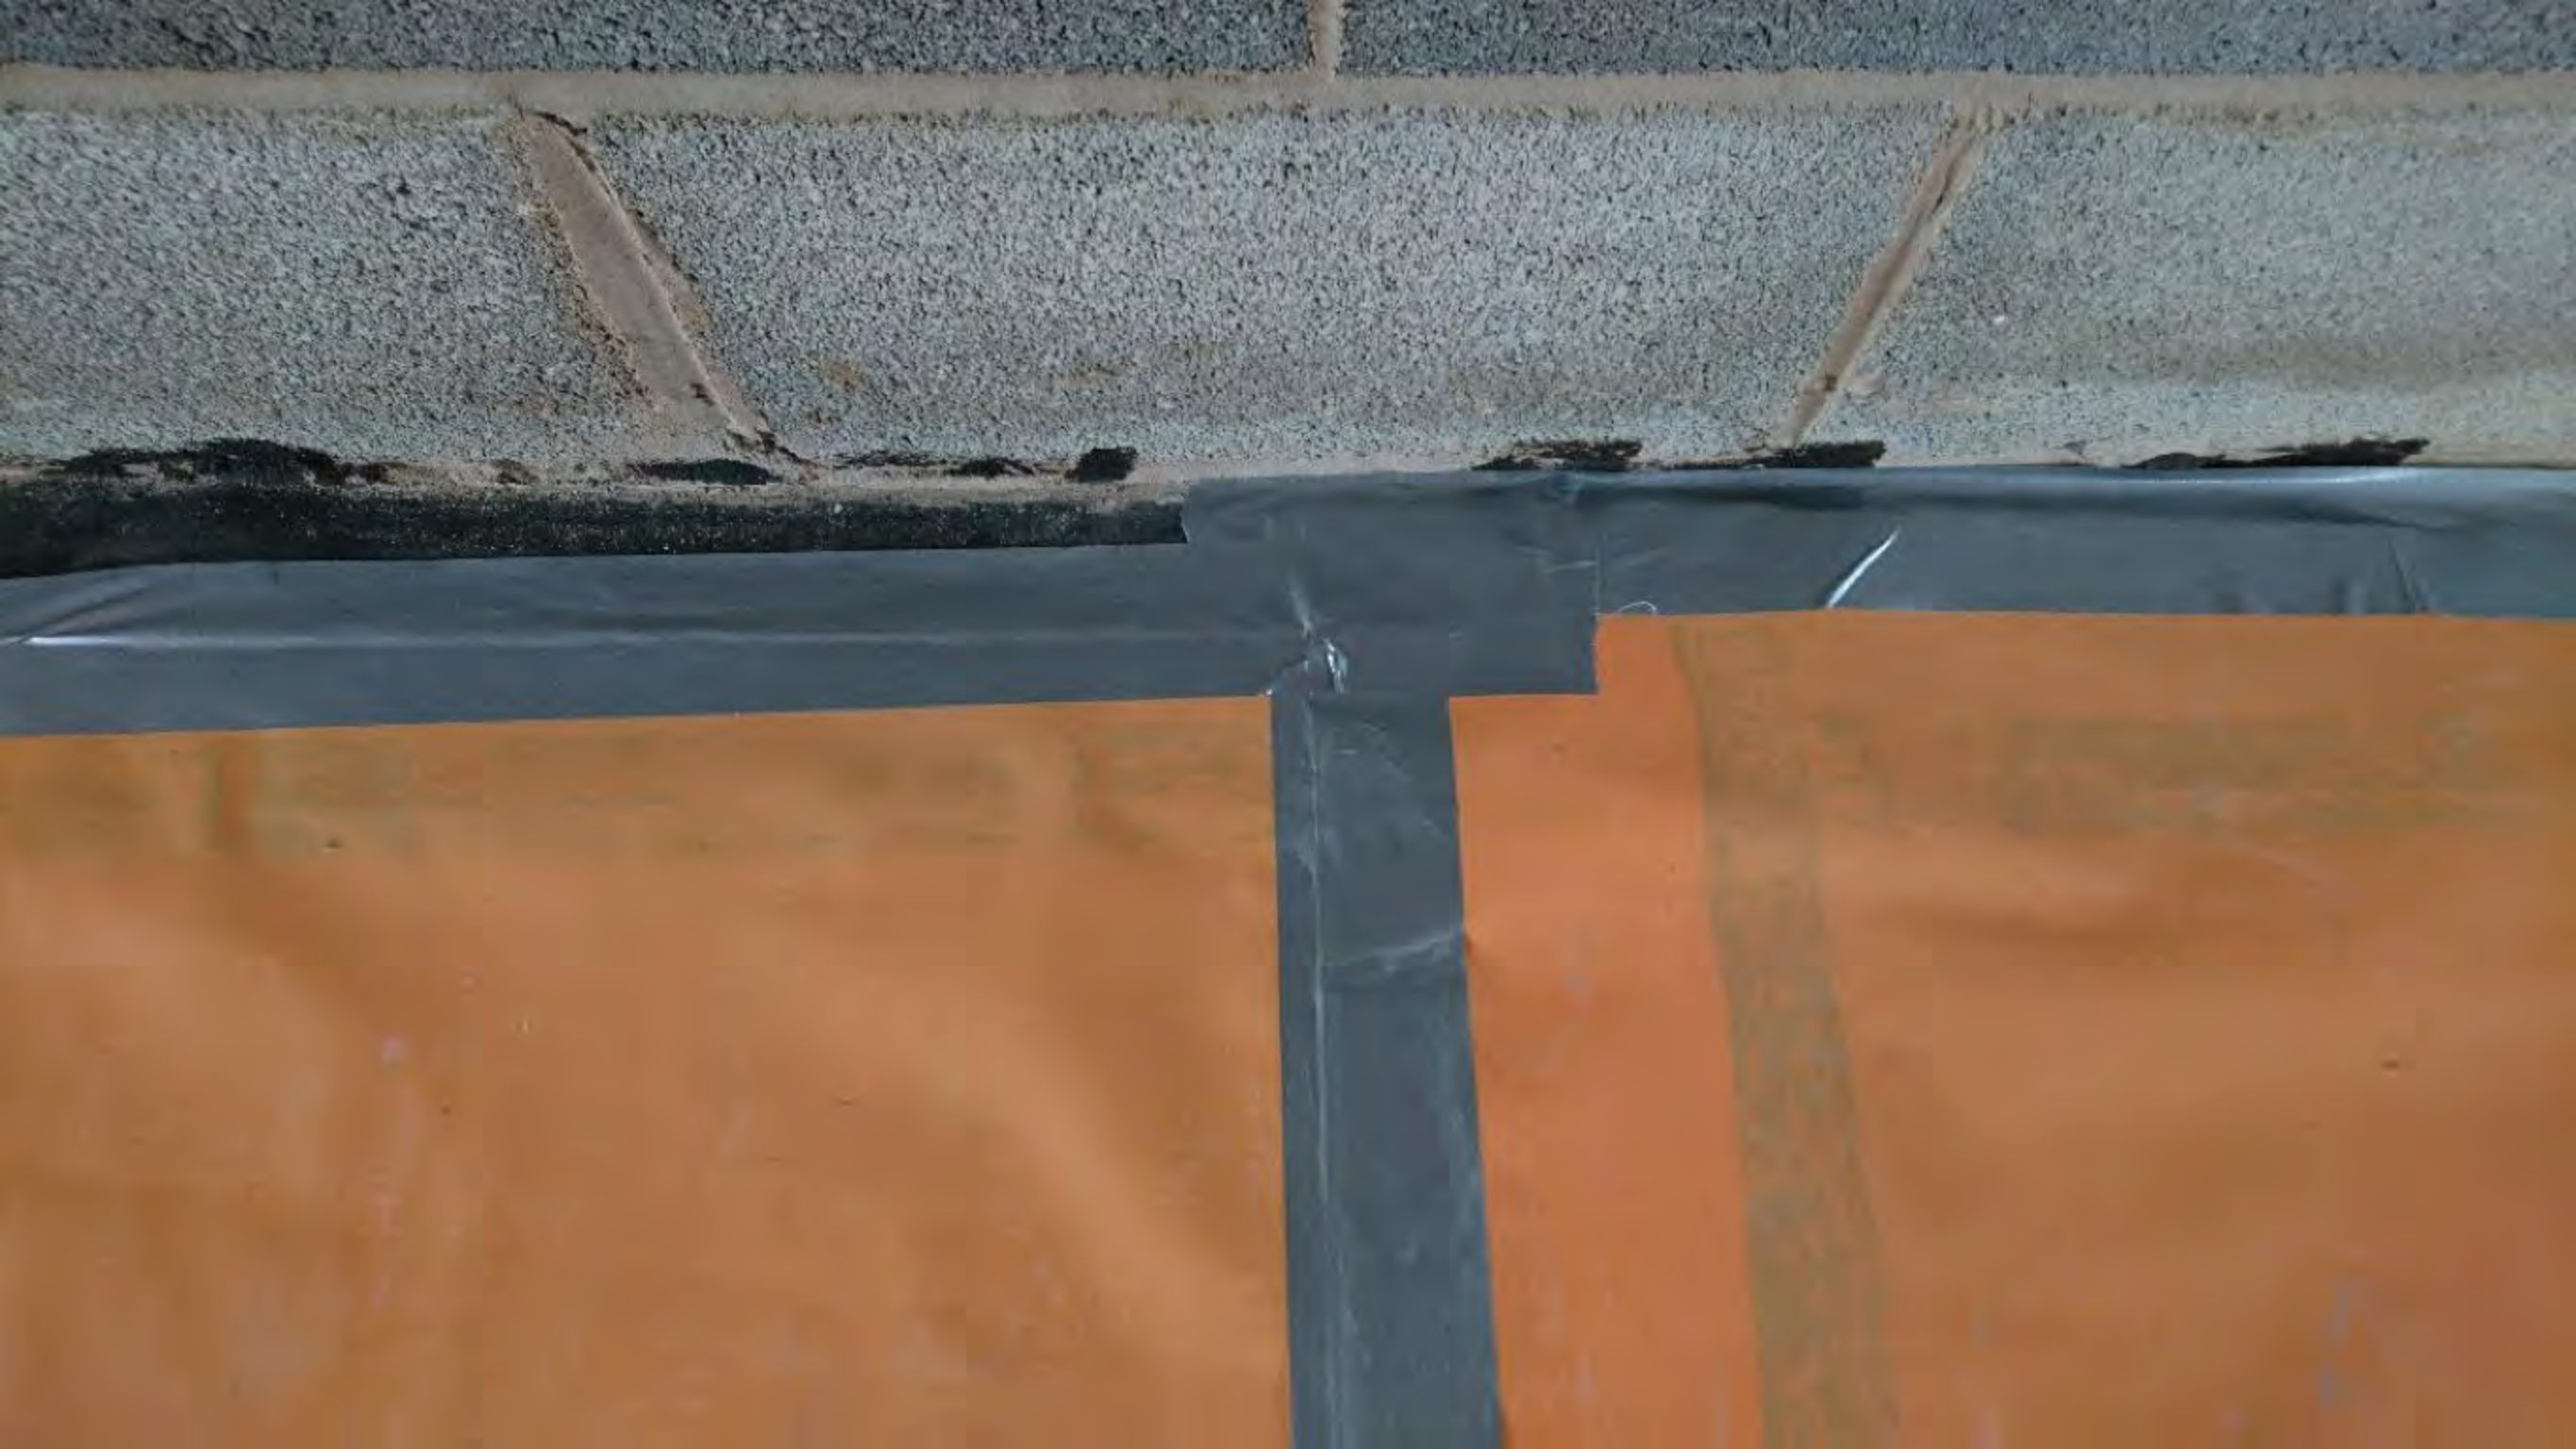
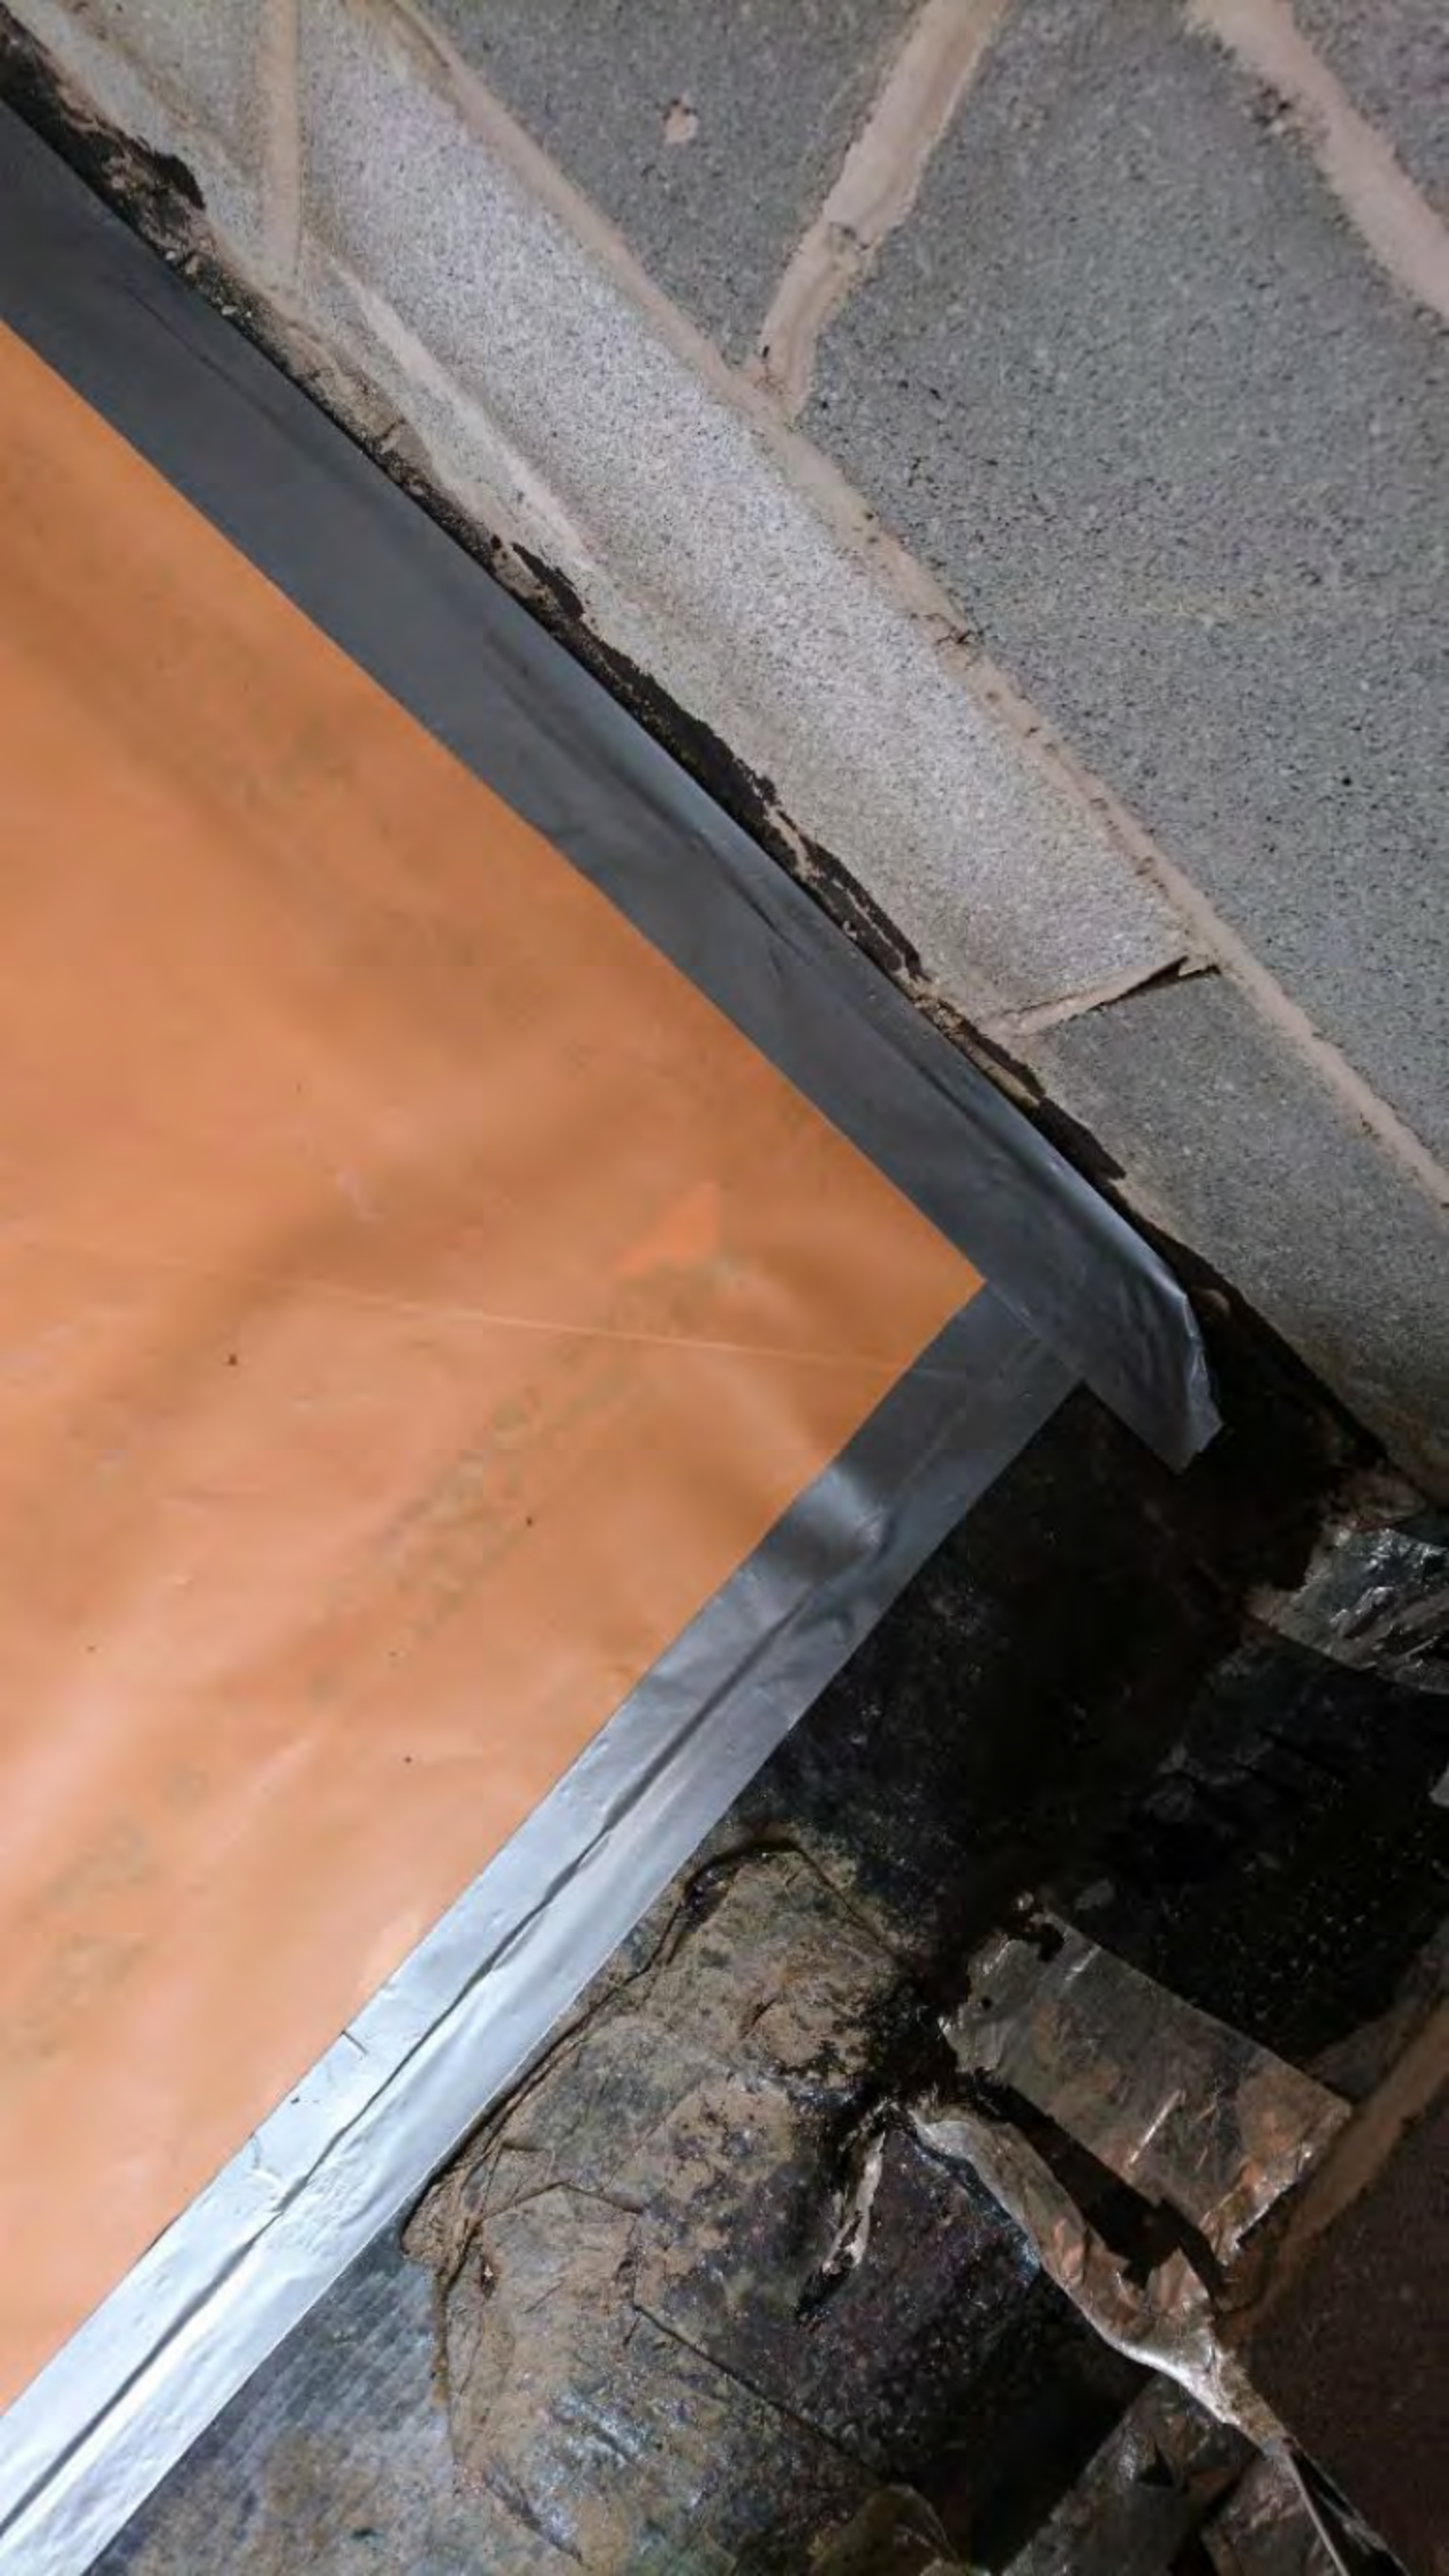
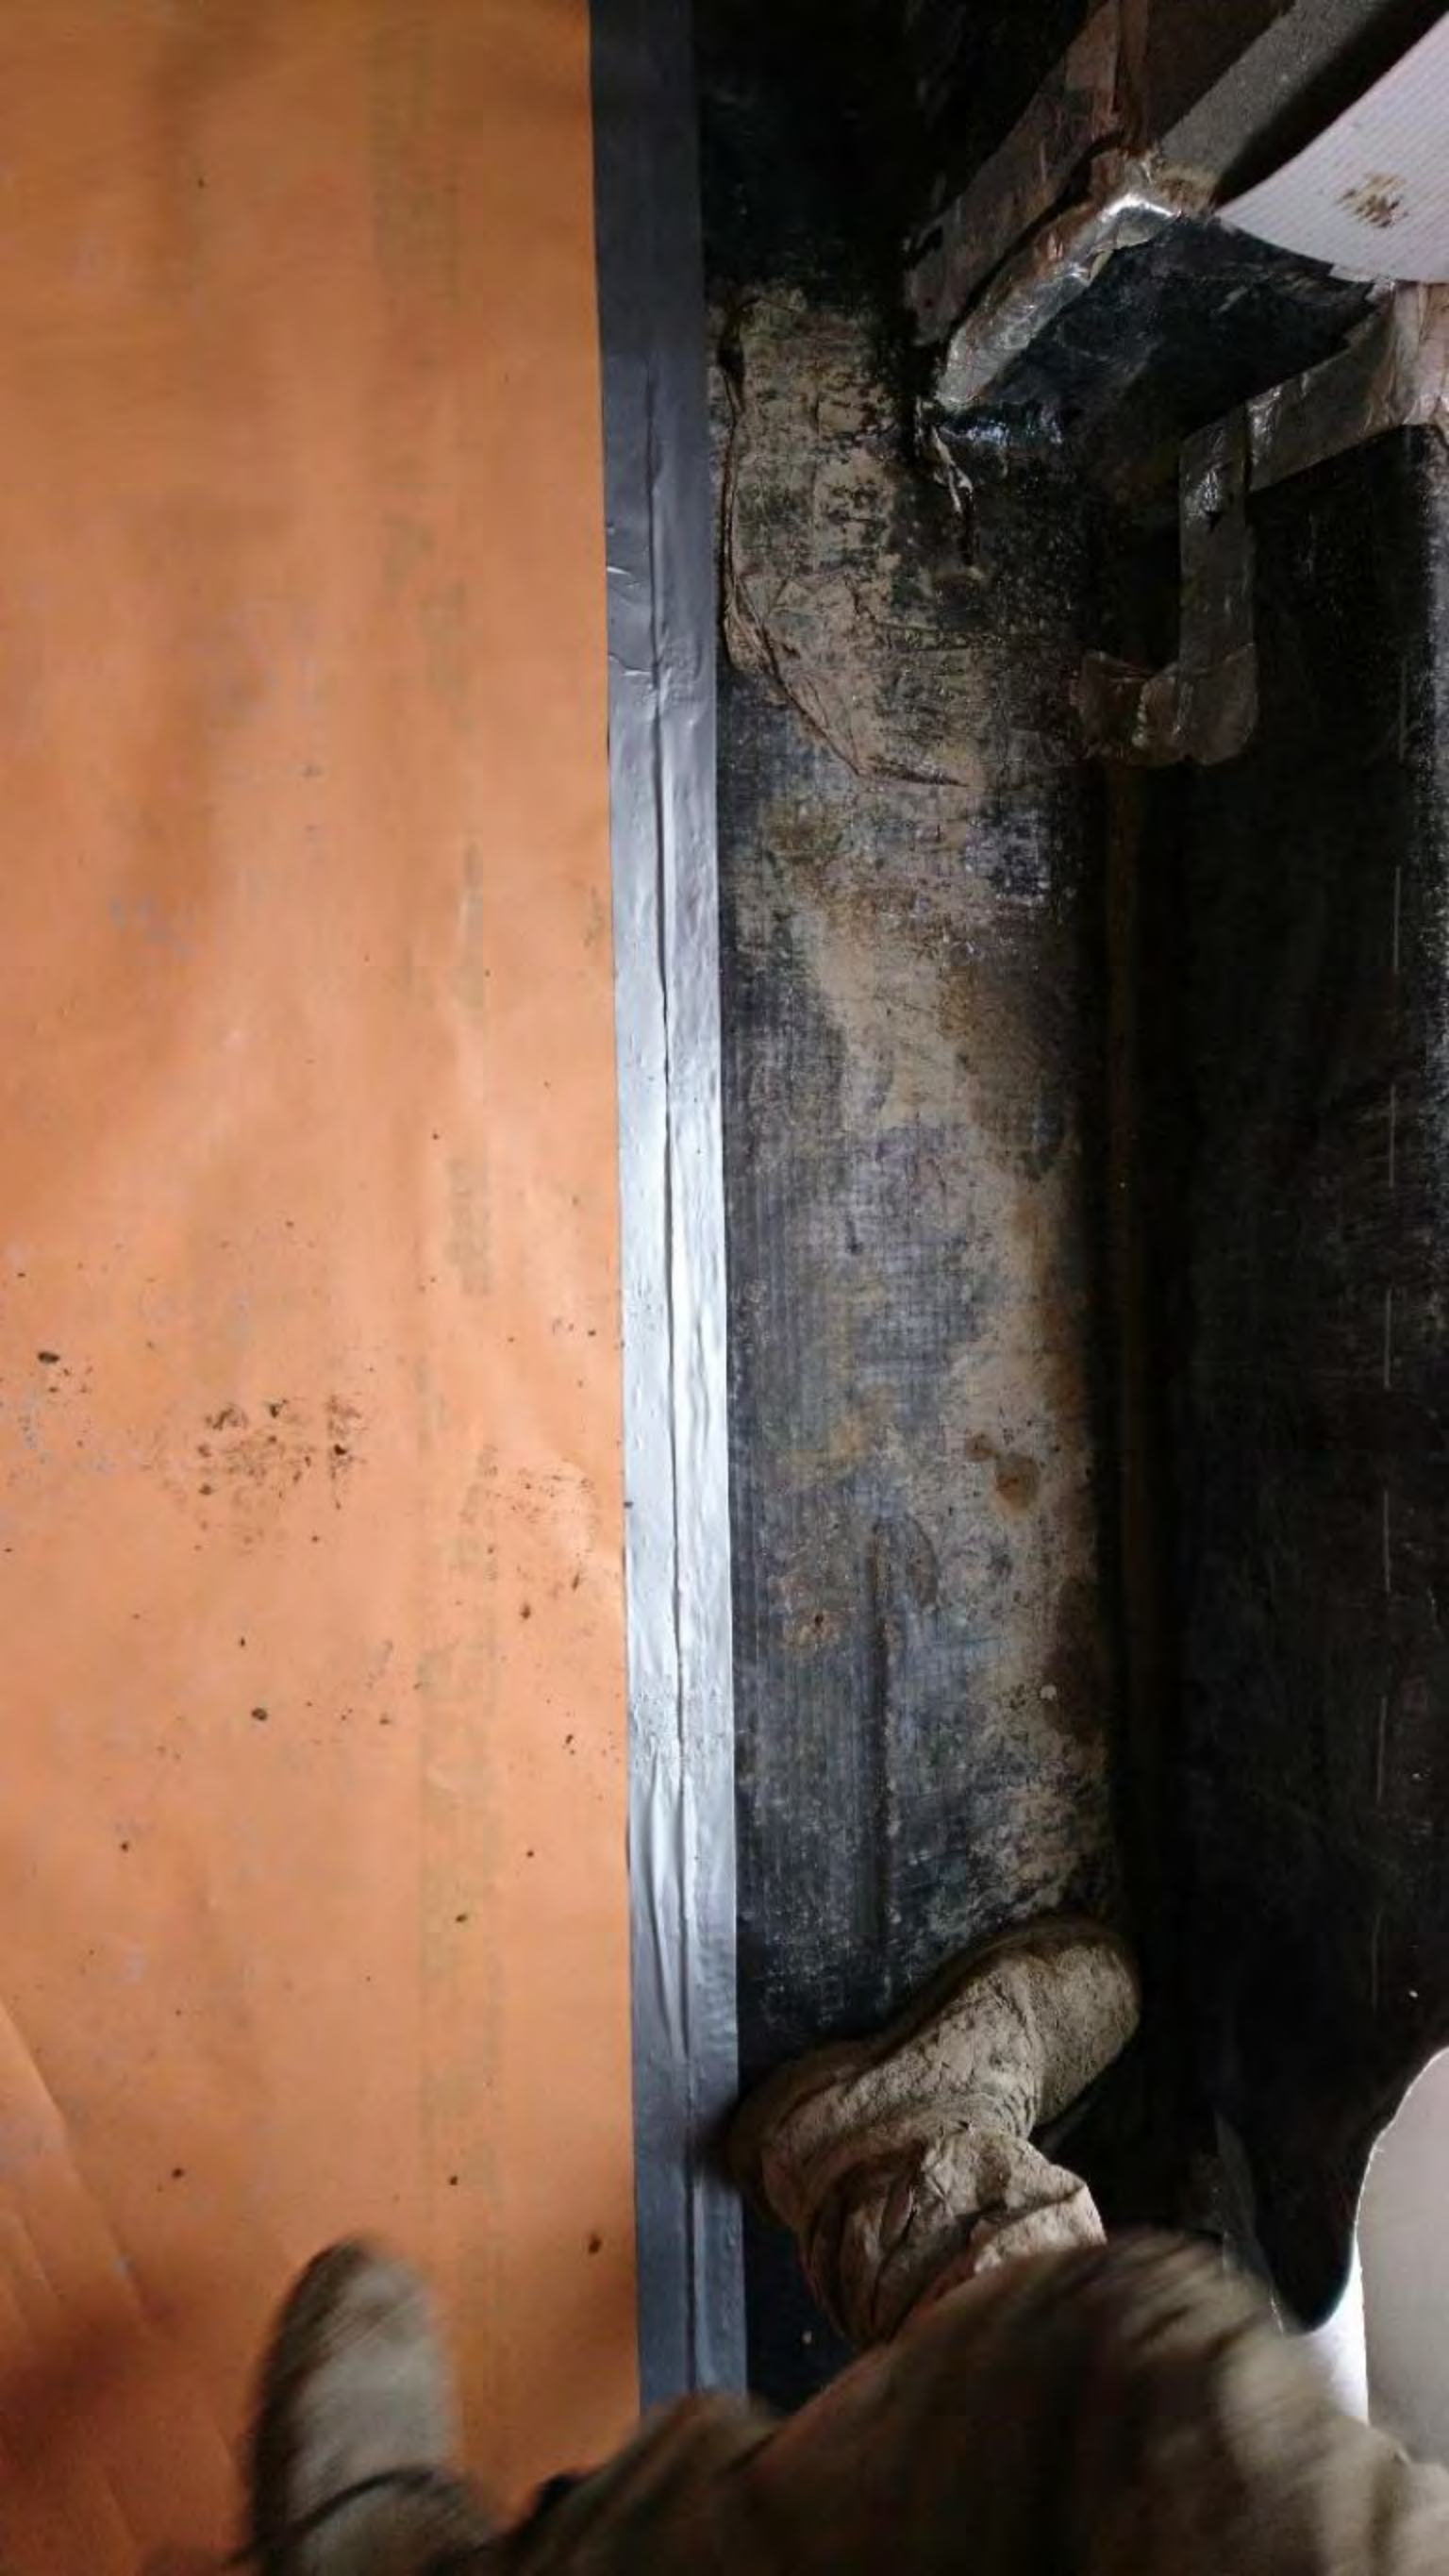
| 2.1 | Condition of sub-grade & underside of gas membrane | <u>Plot swept, snots removed, floor flat + level. NO RIPS AND TEARS VISIBLE.</u> | | | | | |
| 2.3 | Gas membrane condition and coverage | <u>PRIMER APPLIED + MEMBRANE CLEANED. SEALED TO STEEL AGAINST CAVITY.</u> | | | | | |
| 2.6 | Condition of joints/seals | <u>NO CREAKING, JOINTS + SEALS ALL TIGHT.</u> | | | | | |
| 2.7 | Number and condition of service entry seals | <u>TCP-KATS INSTALLED (AS PER PHOTO'S)</u> | | | | | |

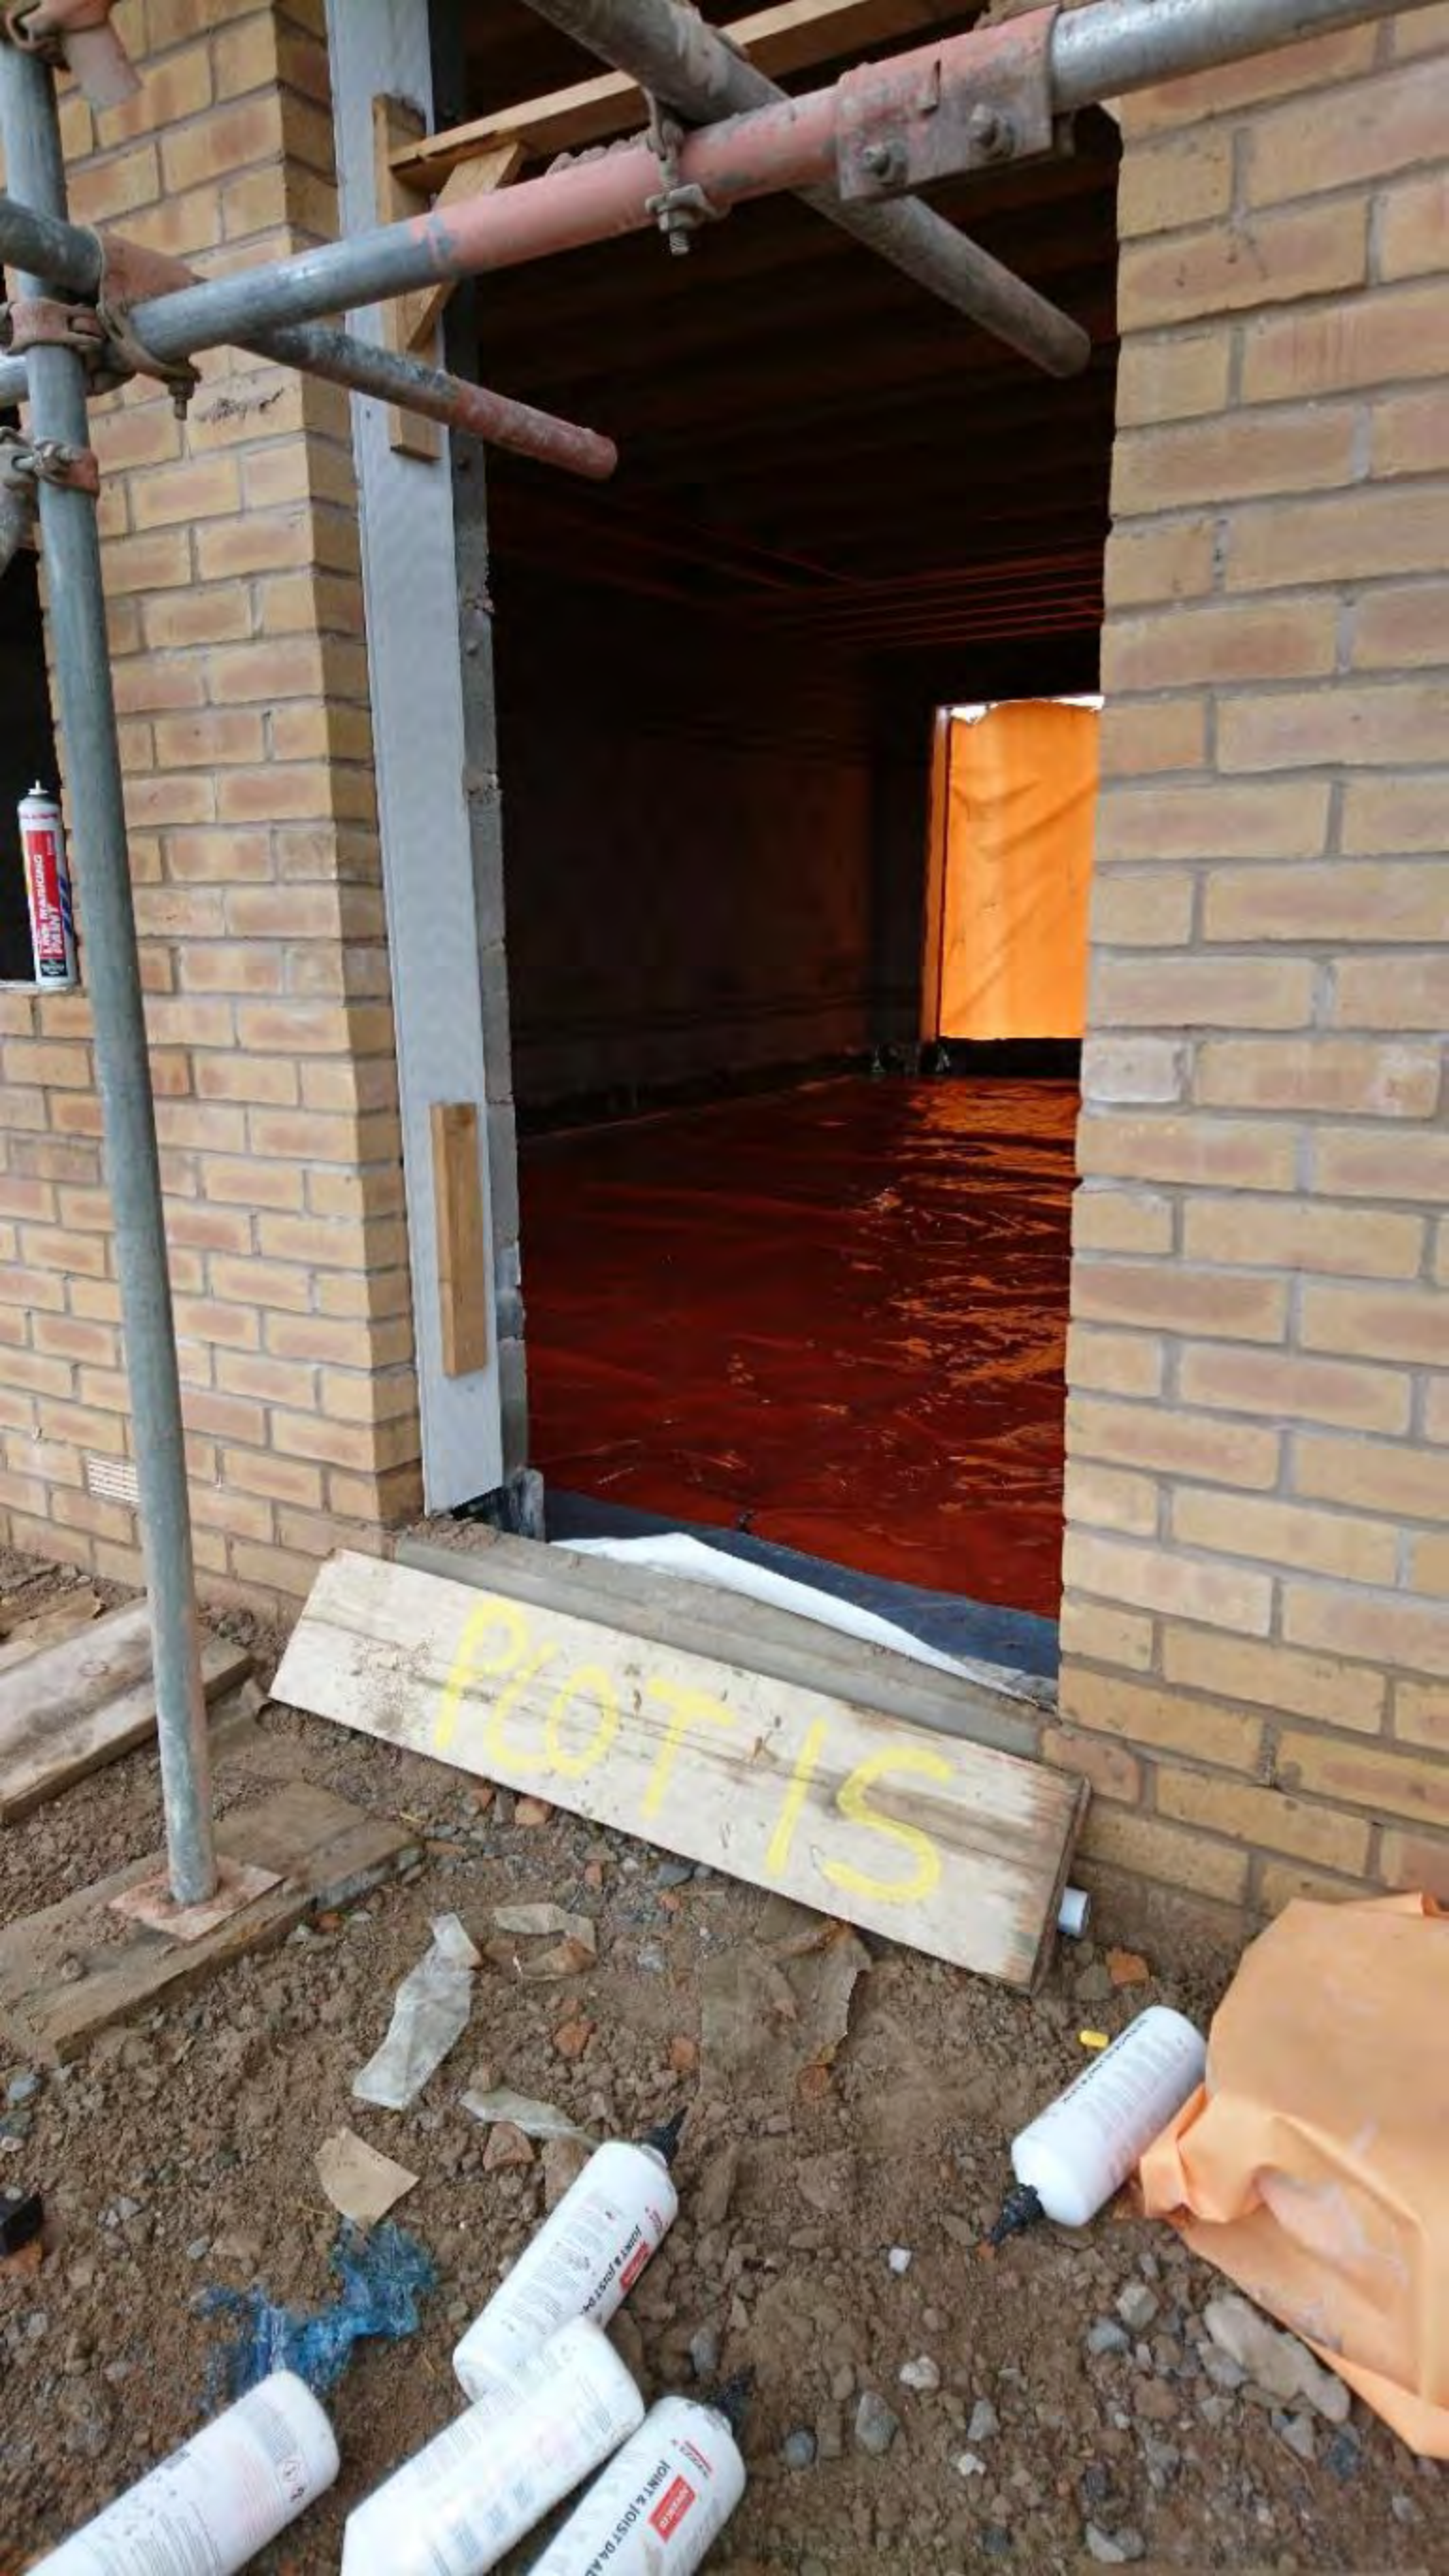
| 2.1 | Condition of sub-grade & underside of gas membrane | <u>PLOT SWEEP + SNOTS REMOVED, FLOOR LEVEL + FLAT. NO RIPS OR TEARS VISIBLE.</u> | | | | | |
| 2.3 | Gas membrane condition and coverage | <u>PRIMER APPLIED, MEMBRANE CLEANED. NEAT + TIDY, SEALED TO STAGE 1 AGAINST WALL CAVITY</u> | | | | | |
| 2.6 | Condition of joints/seals | <u>CREASINE PRESENT, SO 300mm RADBAR DETAILING TAPE APPLIED ON FULL PERIMETER.</u> | | | | | |
| 2.7 | Number and condition of service entry seals | <u>TWO, 1 TOPHAT - PREFORMED</u> | | | | | |

| 2.9 | Repairs or Corrections: | <u>AS PER PHOTOS, ADDITIONAL 300mm RADBAR DETAILING TAPE USED AS SHOWN</u> | | | | | |
