## Gas Protection - Validation Record Sheet

**This Record sheet is only applicable to block and beam floor slabs for Characteristic Situation 2 gas protection systems**

**For Residential Development at New Church Street, Radcliffe.**

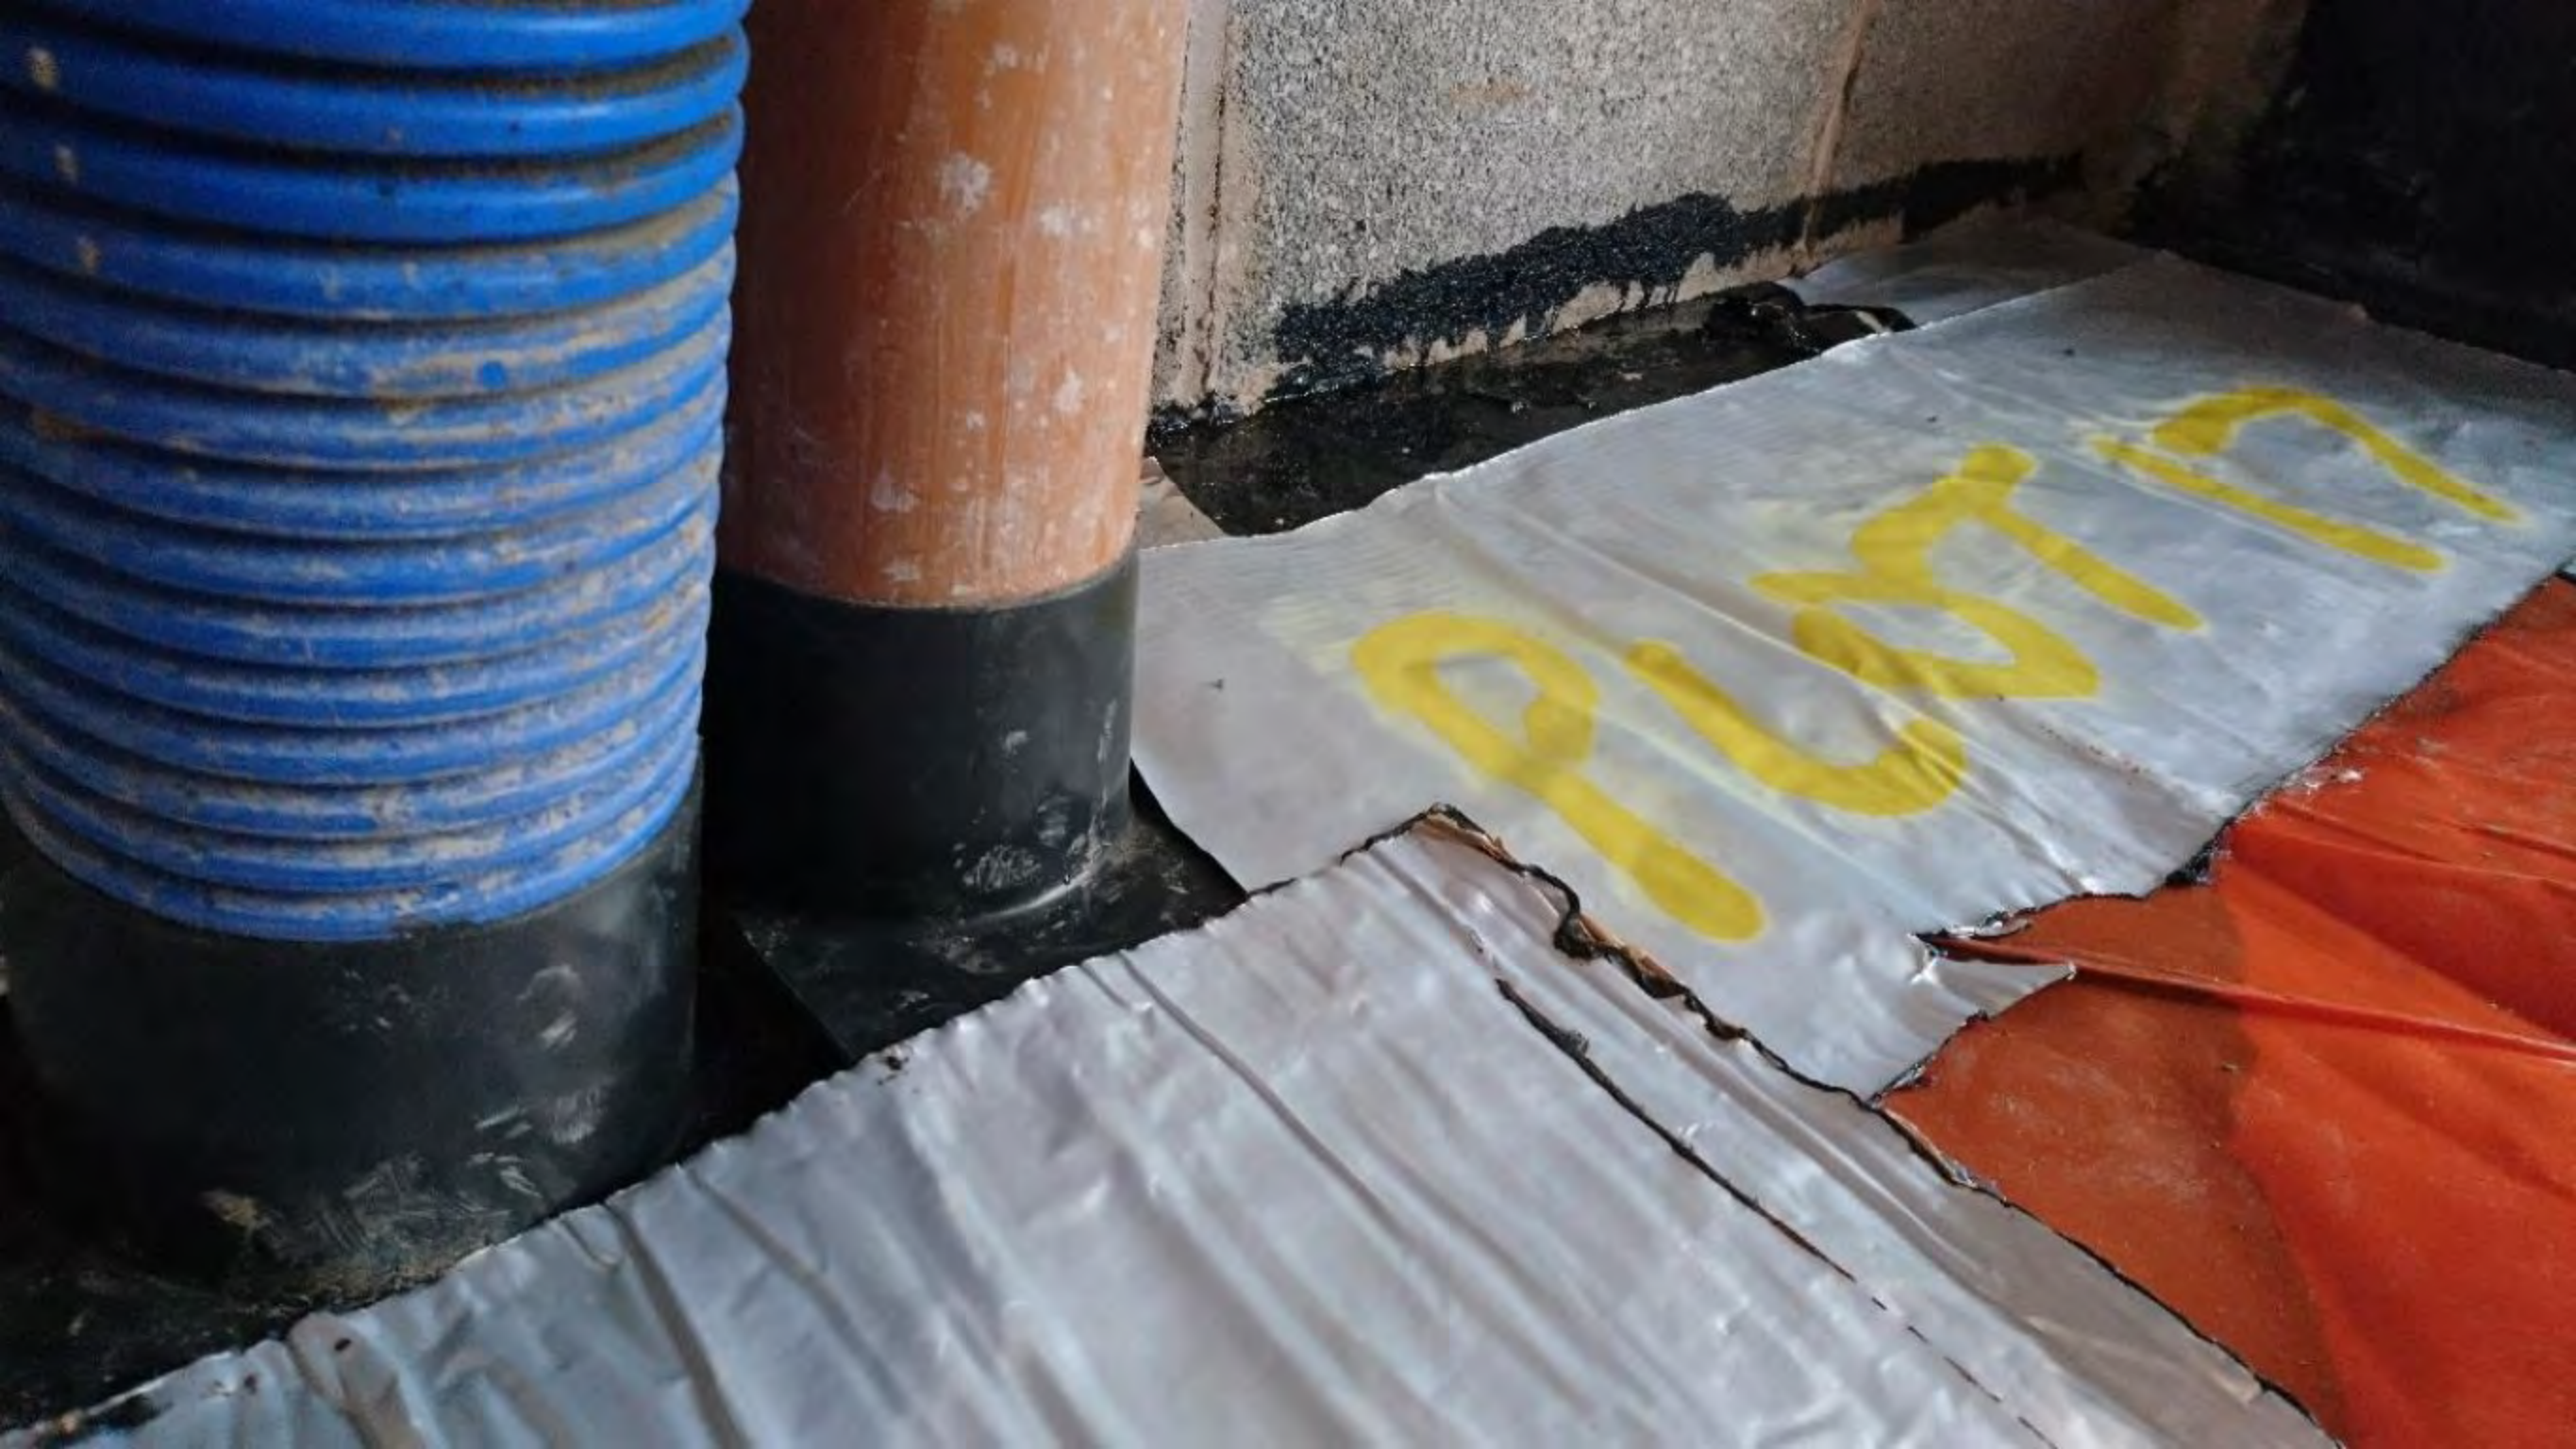
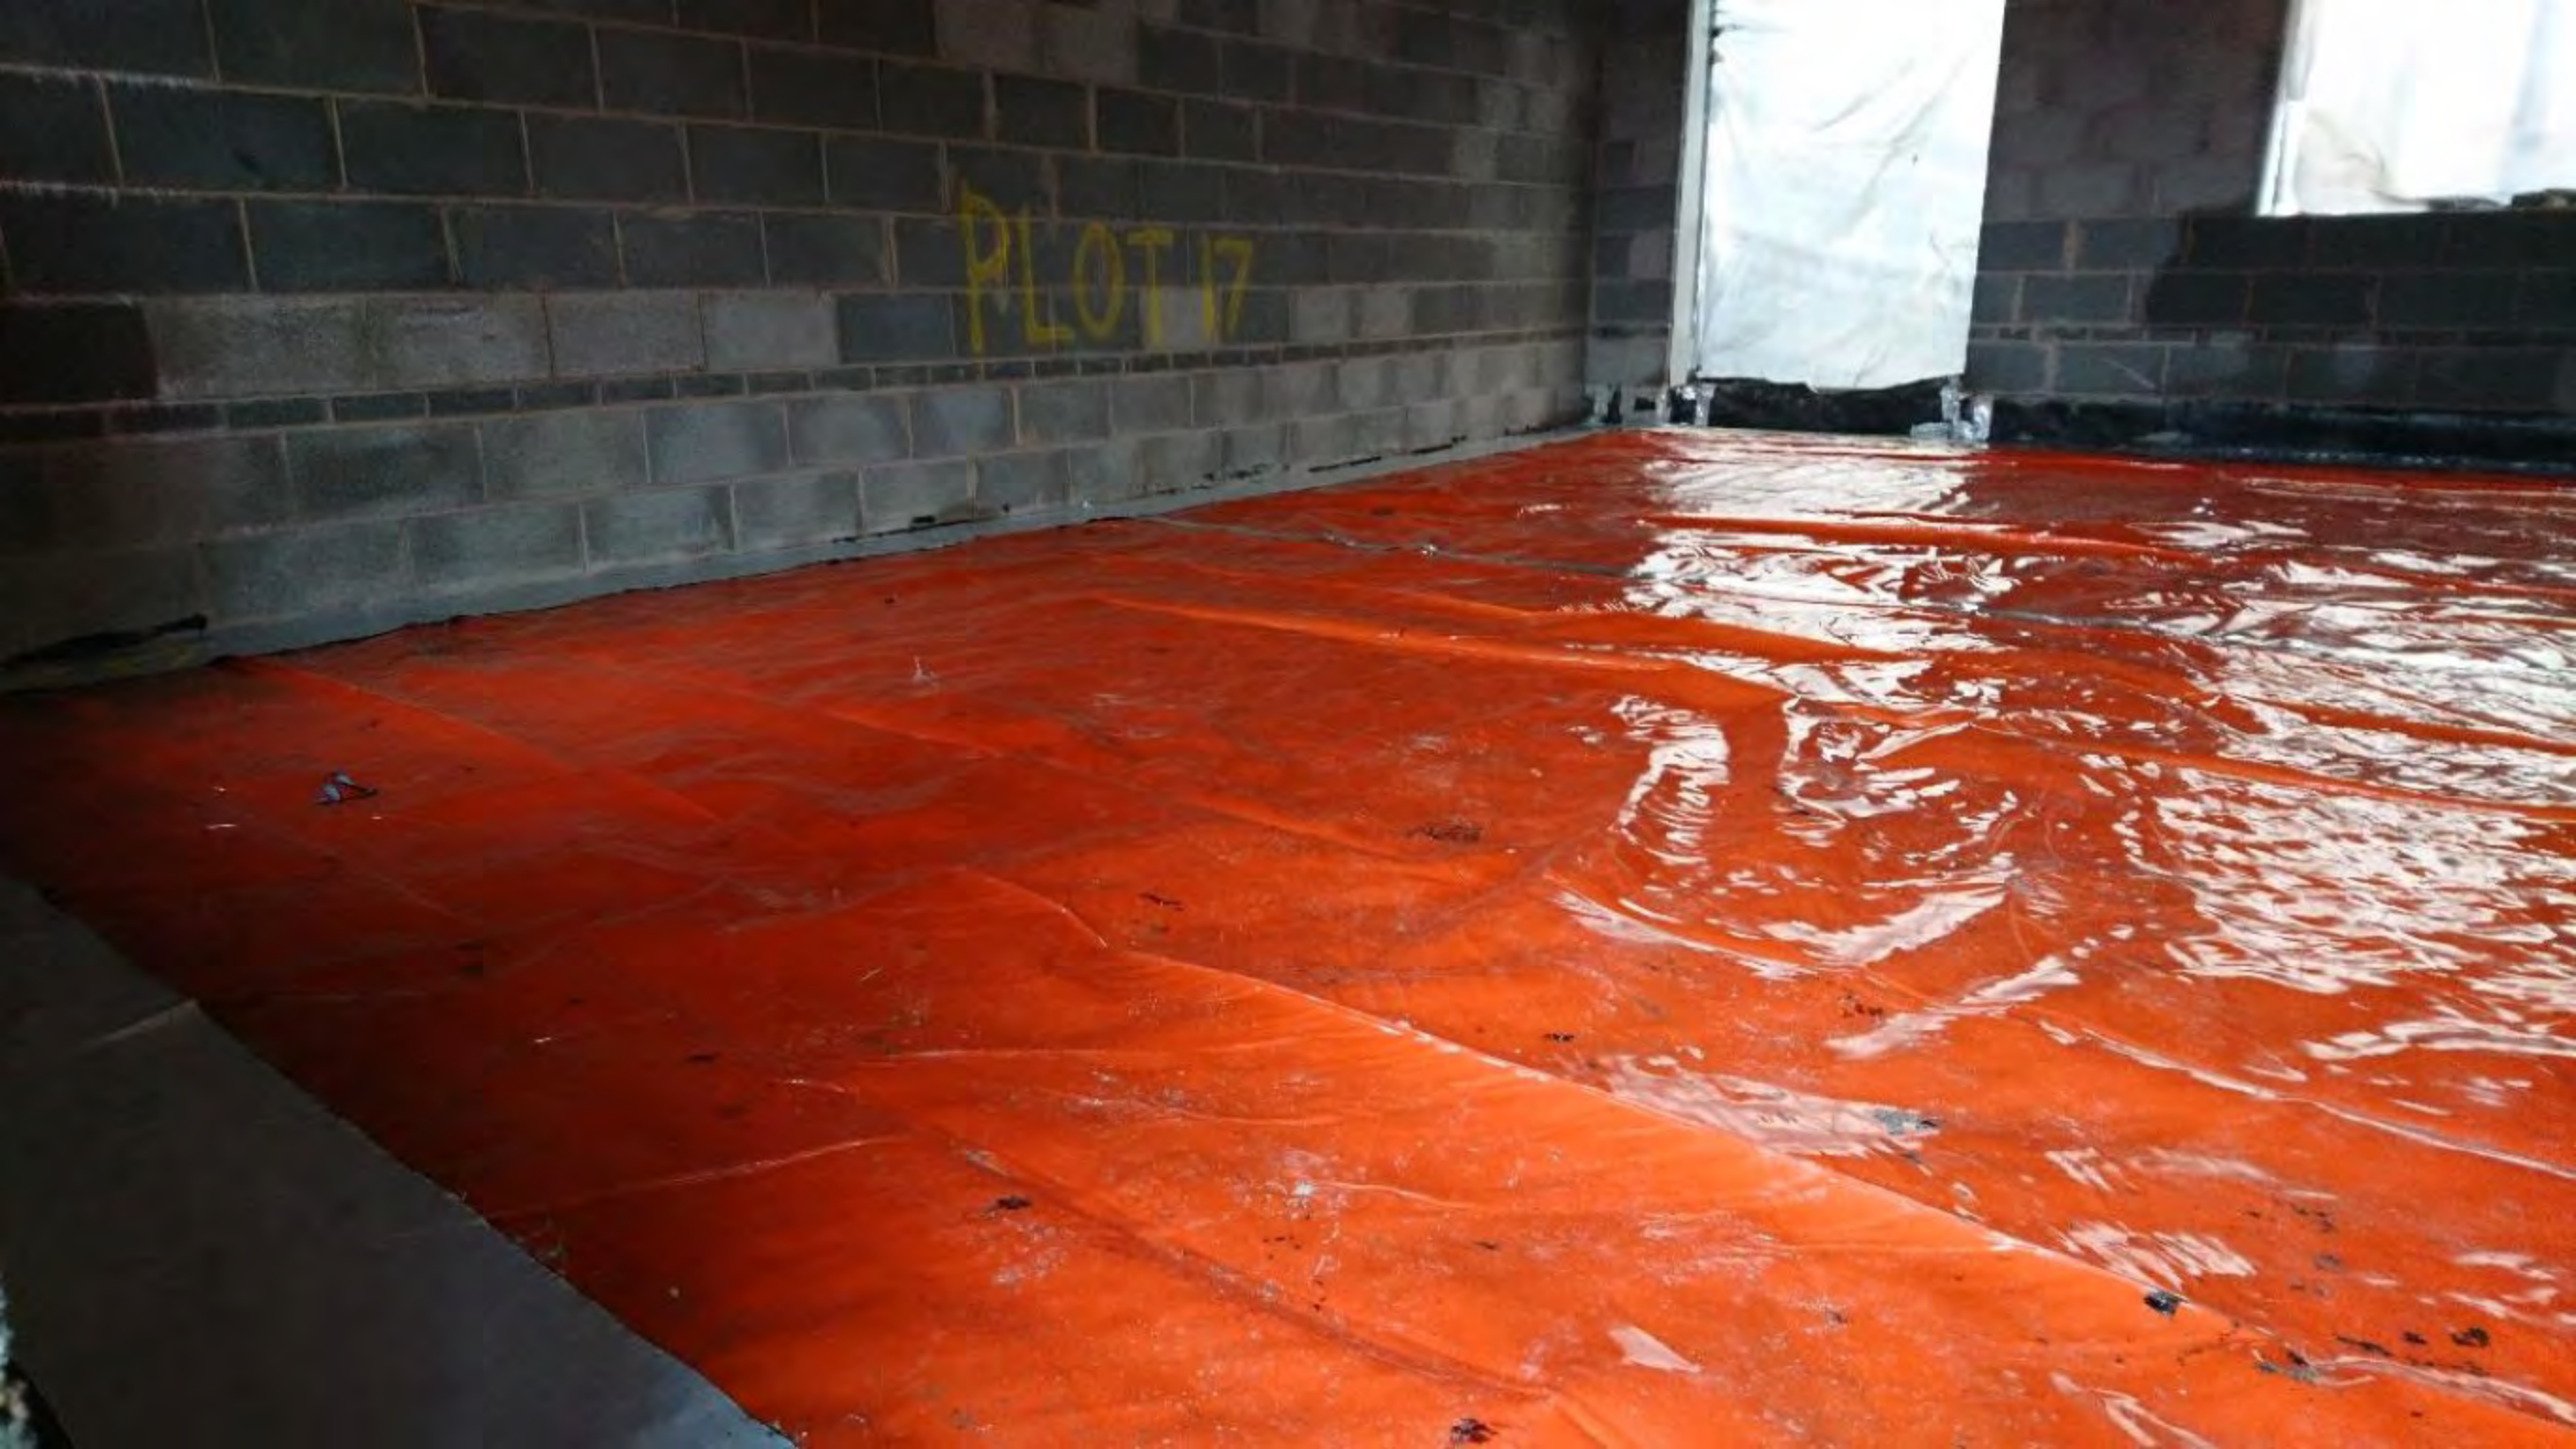
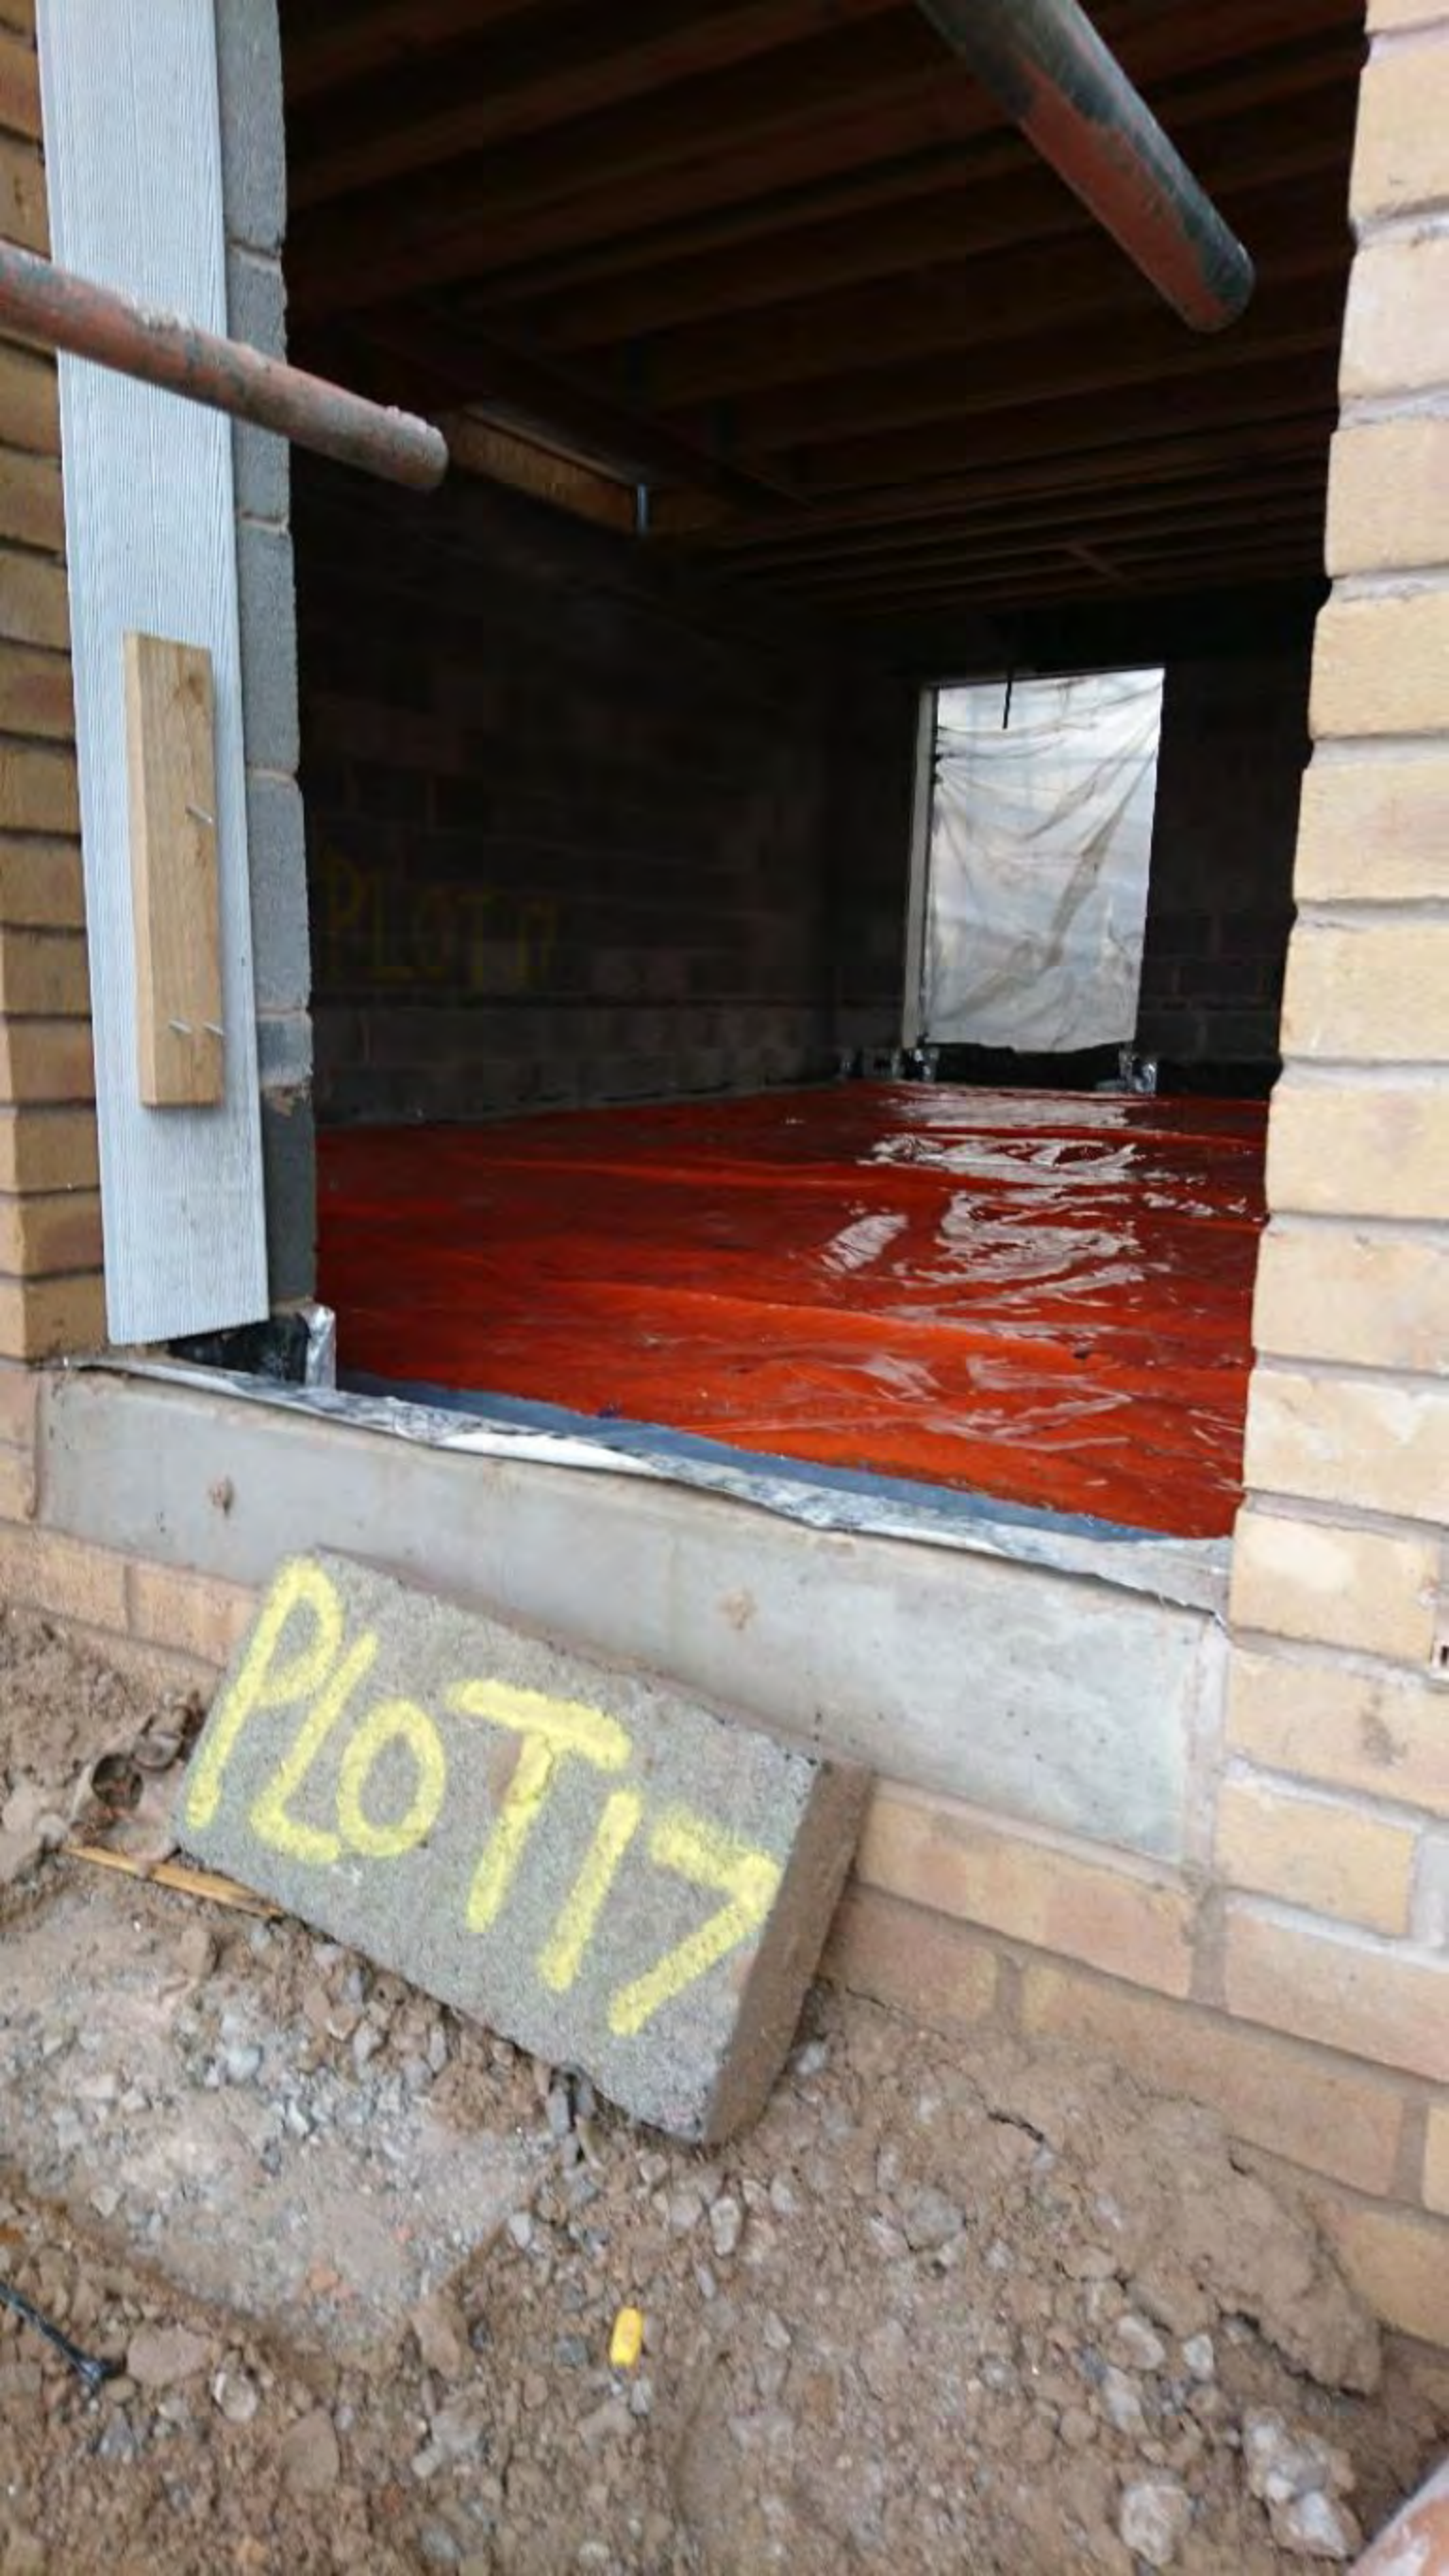
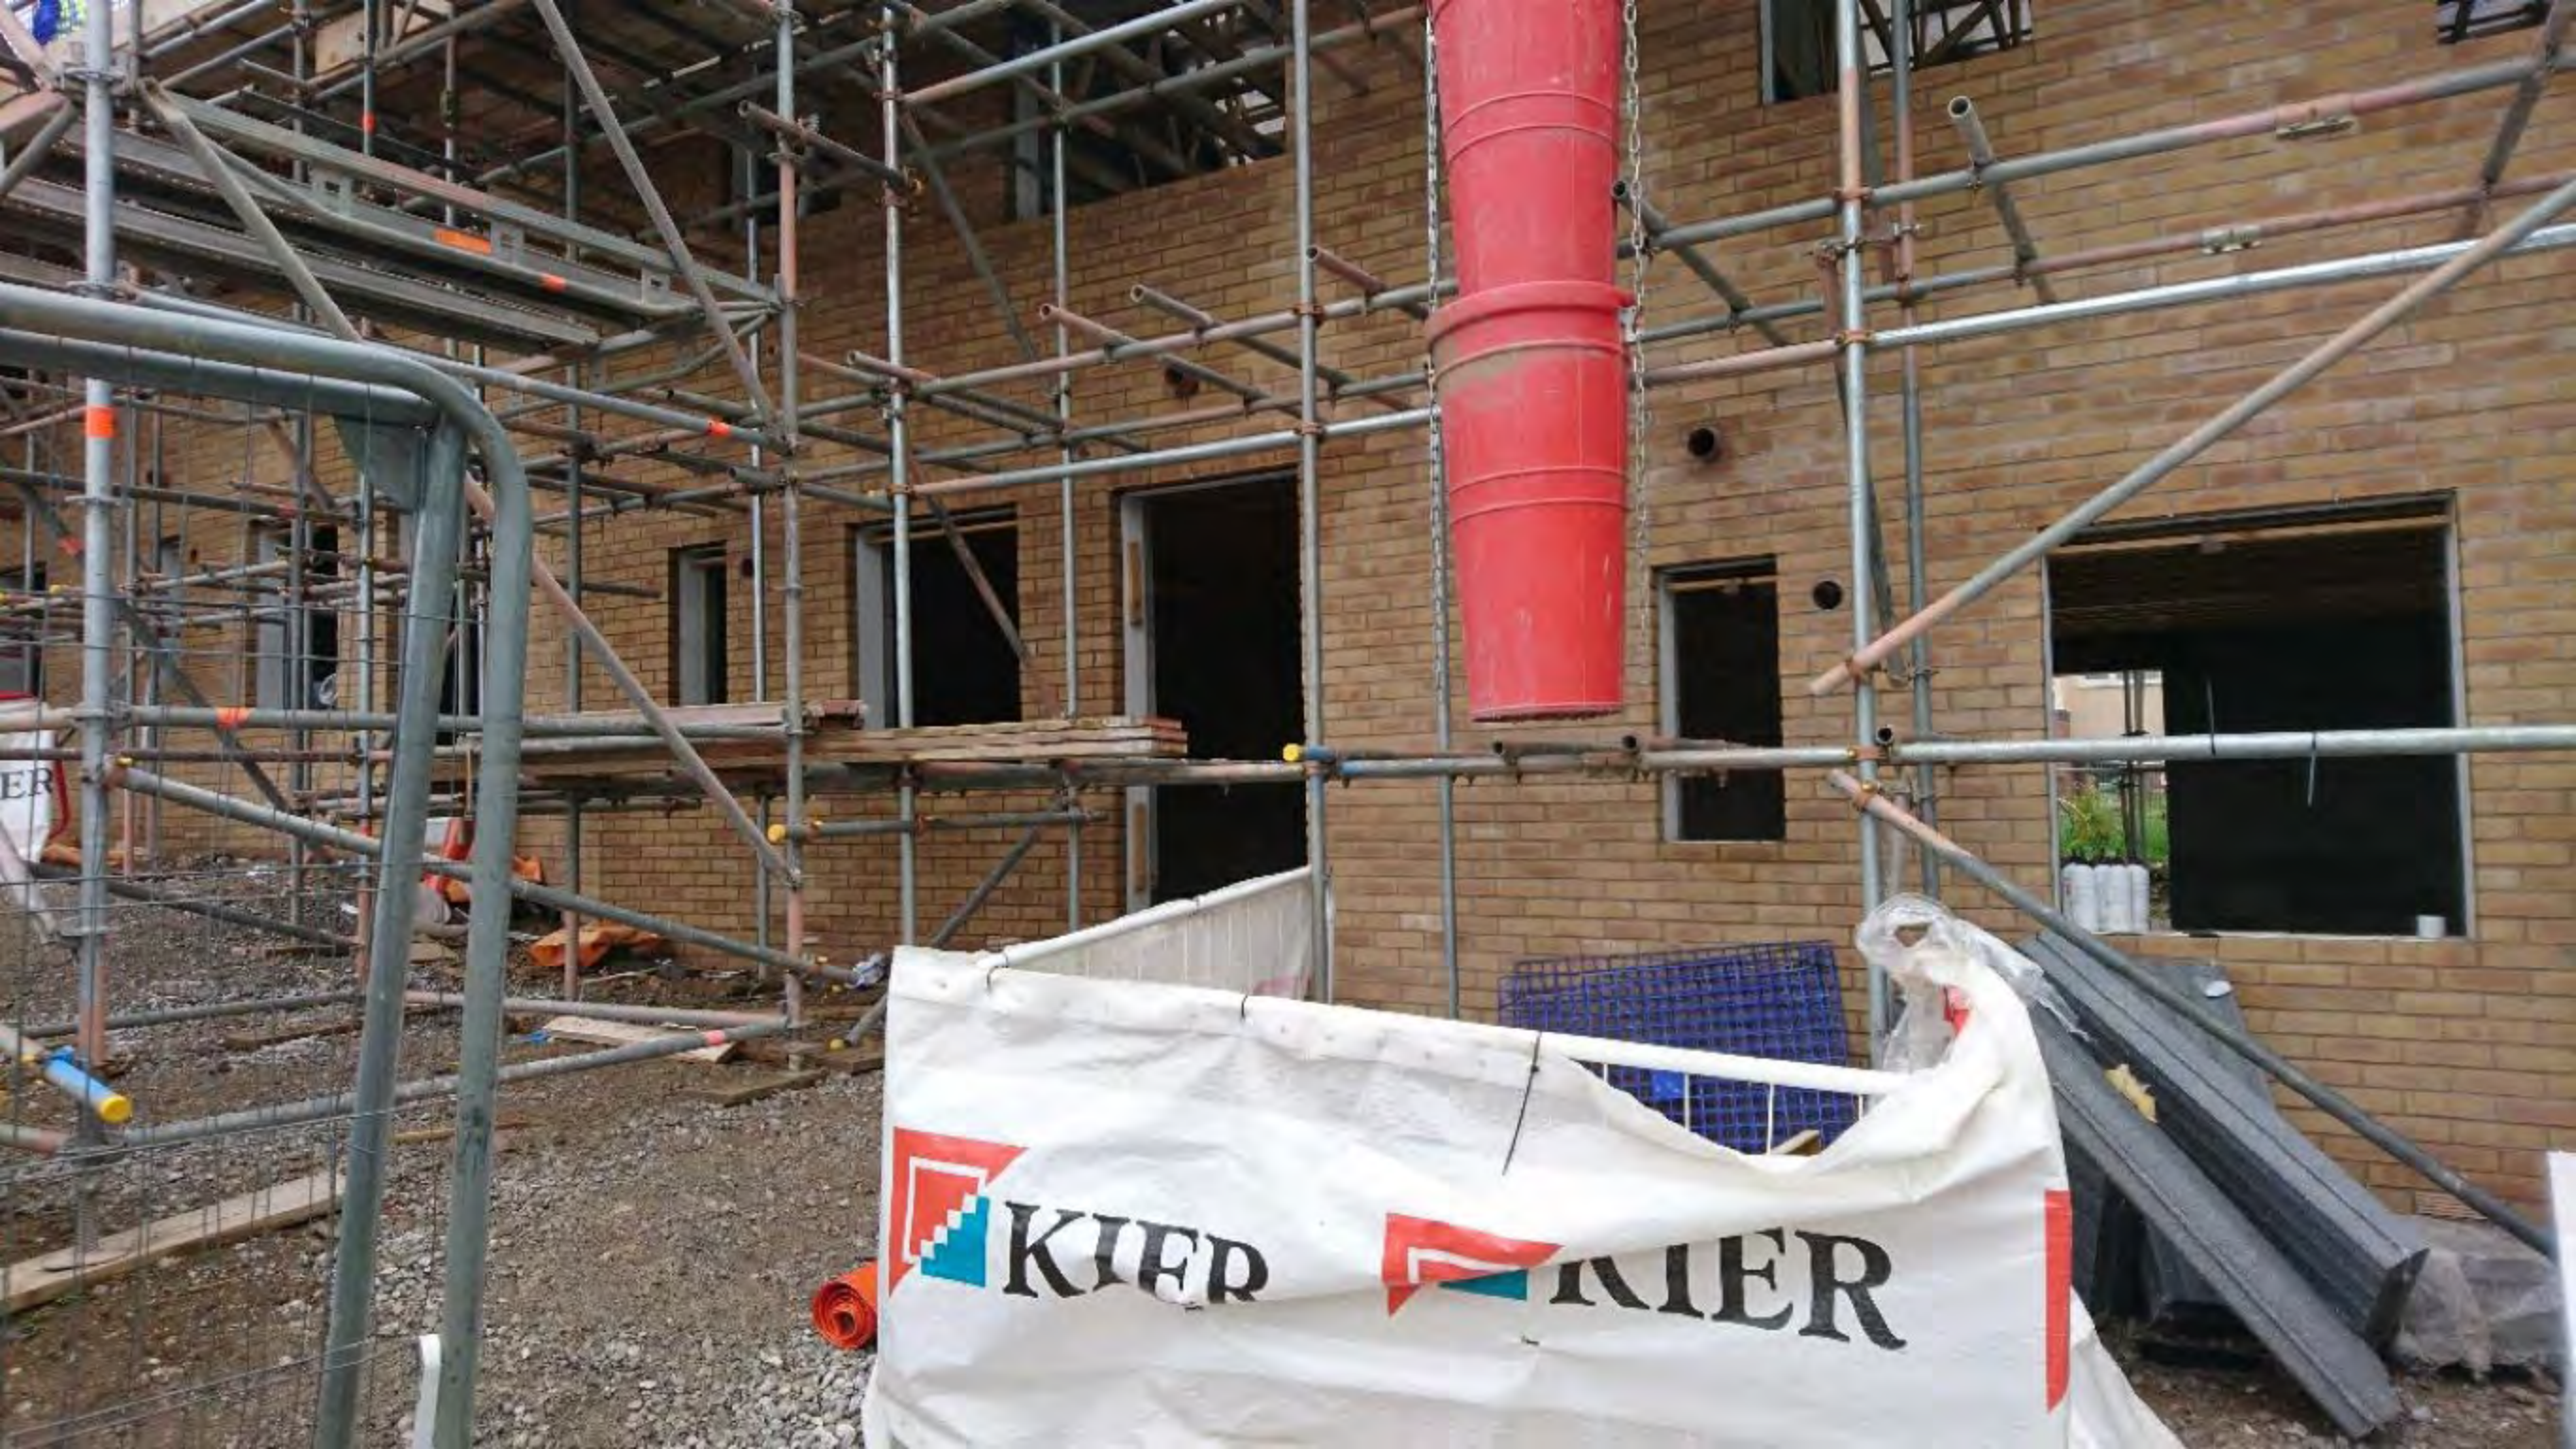
PLOT 17

| 2.2 | Condition of sub-grade & underside of gas membrane | FLOOR SCRAPPED & BRUSHED, PERIMETER MEMBRANE CLEANED, ALL TAPES APPLIED WELL, SEALED TO A GOOD QUALITY | | | | | |
| 2.4 | Gas membrane condition and coverage | SEALED ON ALL 4 SIDES - ALL GOOD | | | | | |
| 2.7 | Condition of joints/seals | VISIBLE OVERLAPS - ALL GOOD | | | | | |
| 2.8 | Number and condition of service entry seals | 3 <sup>rd</sup> TOP HATS FITTED AROUND DRAINAGE/WATER, JUBILEE CLIPS + TAPED ALL GOOD | | | | | |
| 2.10 | Repairs or Corrections: | NONE VISIBLE | | | | | |

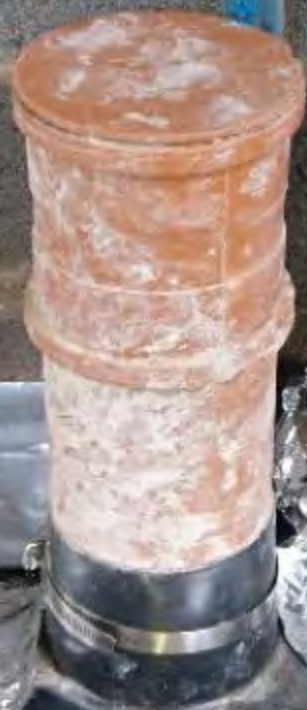
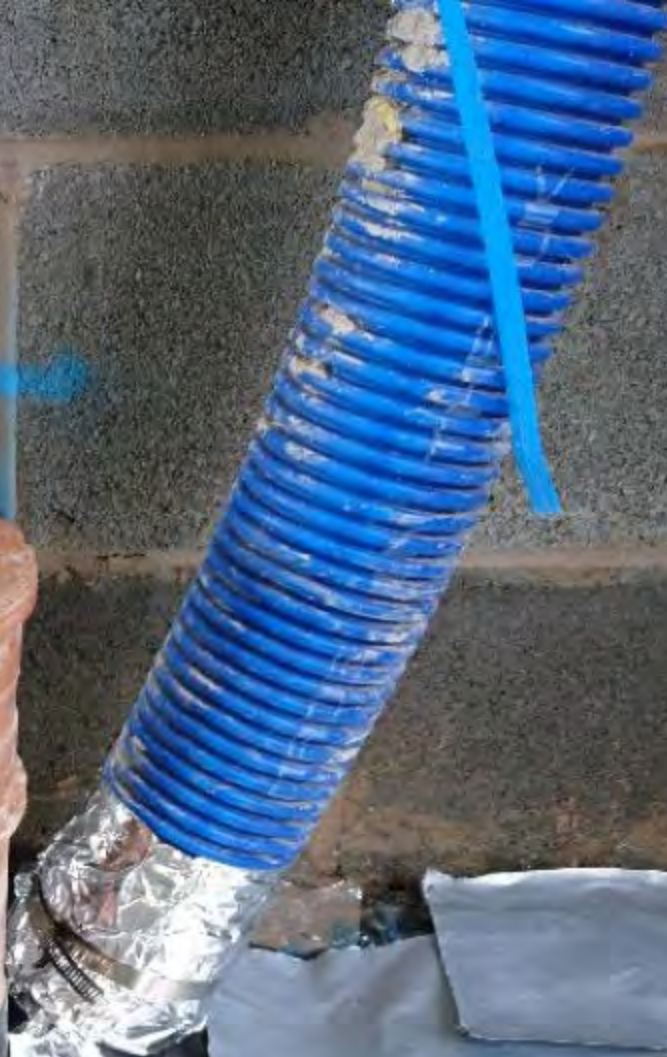
Plot 24

| 2.2 | Condition of sub-grade & underside of gas membrane | ALL TAPES APPLIED WELL + SEALED TO A GOOD QUALITY. FLOOR BRUSHED | | | | | |
| 2.4 | Gas membrane condition and coverage | GOOD AND SEALED ON ALL FOUR SIDES | | | | | |
| 2.7 | Condition of joints/seals | VISIBLE OVERLAPS, ALL APPEAR GOOD | | | | | |
| 2.8 | Number and condition of service entry seals | 3 NO TOPHATS WITH SUBILEE CLIPS (PICTURED). TAPES CHECKED, ALL OK | | | | | |
| 2.10 | Repairs or Corrections: | NONE VISIBLE | | | | | |

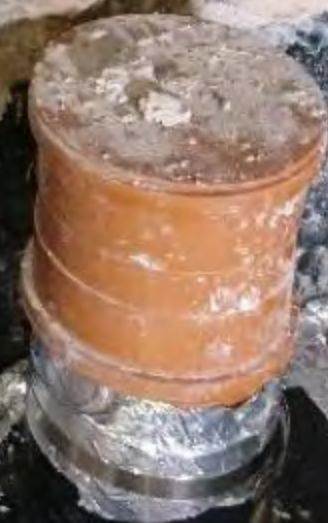
PLOT 26

| 2.2 | Condition of sub-grade & underside of gas membrane | SEALED TO A GOOD QUALITY. FLOOR BRUSHED AND ALL TAPES APPLIED WELL | | | | | |
| 2.4 | Gas membrane condition and coverage | SEALED ON ALL FOUR SIDES AND IN GOOD CONDITION | | | | | |
| 2.7 | Condition of joints/seals | VISIBLE OVERLAPS AND ALL GOOD | | | | | |
| 2.8 | Number and condition of service entry seals | 3 NO. TOPHATS WITH JUBILEE CLIPS – TAPES CHECKED AND ALL OK | | | | | |
